Coastal Protection and Restoration Authority of Louisiana

2008 Annual Inspection Report

GIWW/CLOVELLY HYDROLOGIC RESTORATION

State Project Number BA-02
Priority Project List 1

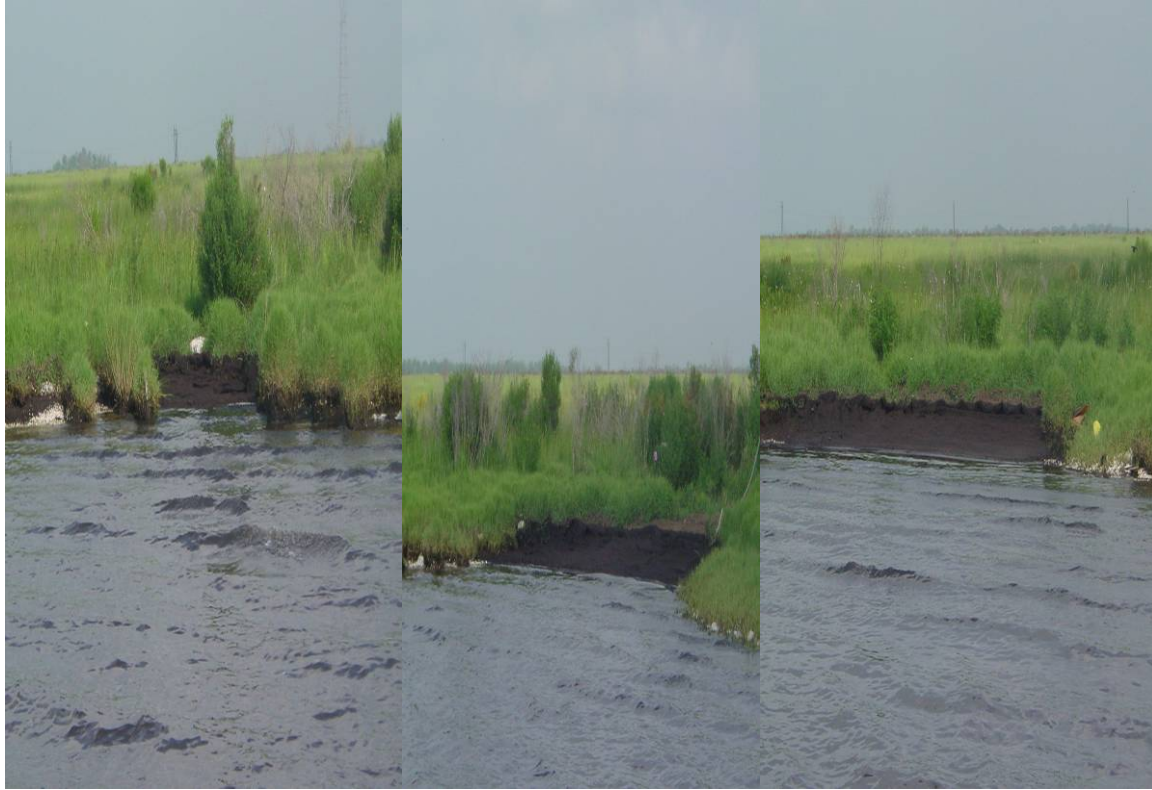
Figure 4. Area B. Small (10 to 30 feet wide) “notches” or indentations in the shoreline.

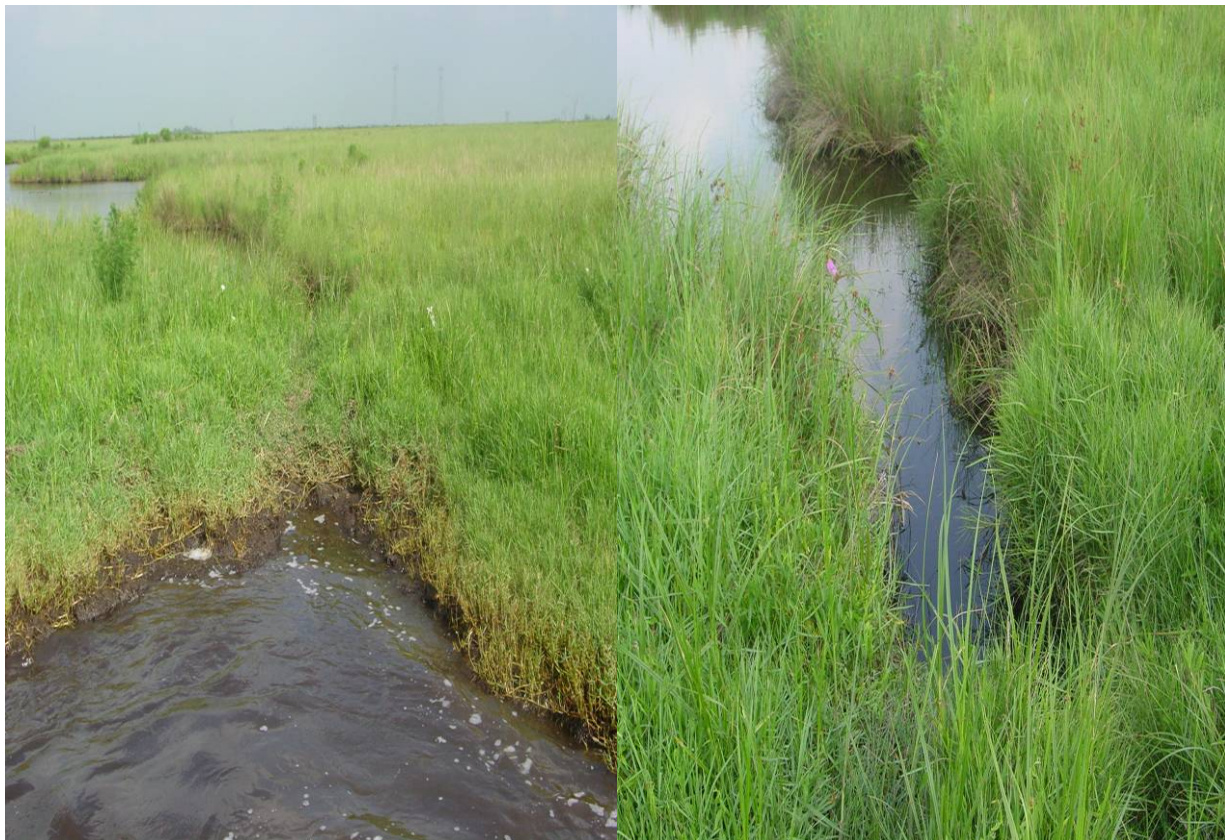
Figure 5. Area C. This site appears to be an alligator crossing, with there being only about 10 to 12 feet of land between the lake and interior pond.

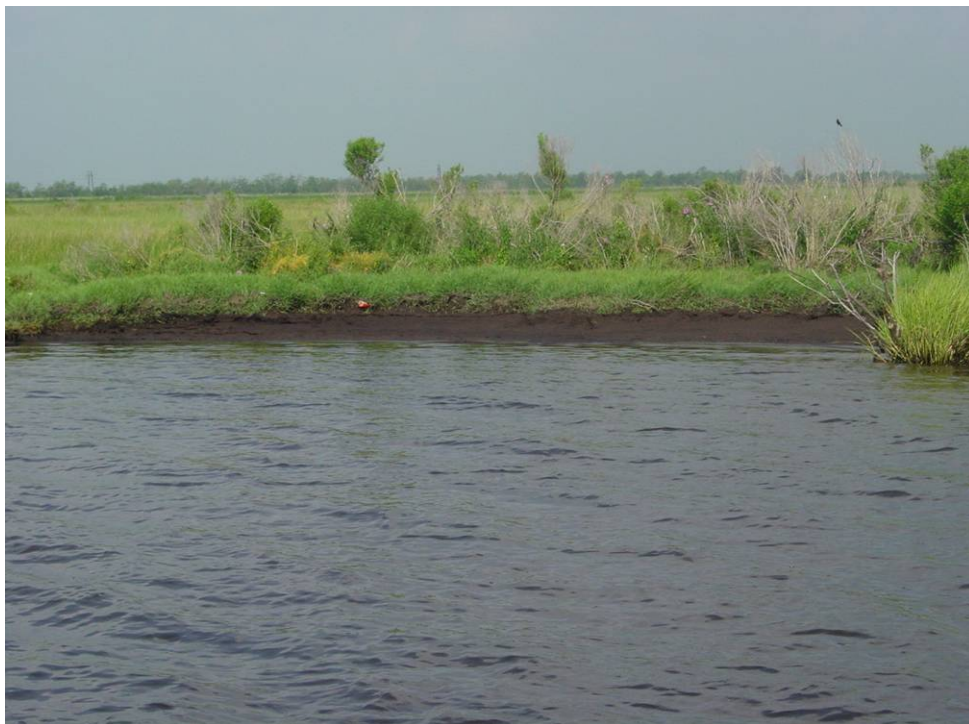
Area D. This area is very representative of the remaining BA-2 Little Lake shoreline as you travel south. It includes a pronounced “notch” or indentation. On-site observations and review of periodic aerial photography should continue so as to identify areas where shoreline breaches could affect the hydrology of BA-02.

Figure 6. Area D. Pronounced “notch” or indentation in the shoreline that is very representative of the remaining BA-2 Little Lake shoreline as you travel south.
