**2009 Operations, Maintenance, and
Monitoring Report**

**Boston Canal/Vermilion Bay Shoreline
Stabilization Project (TV-09)**

State Project Number TV-09
Priority Project List 2

June, 2009
Vermilion Parish

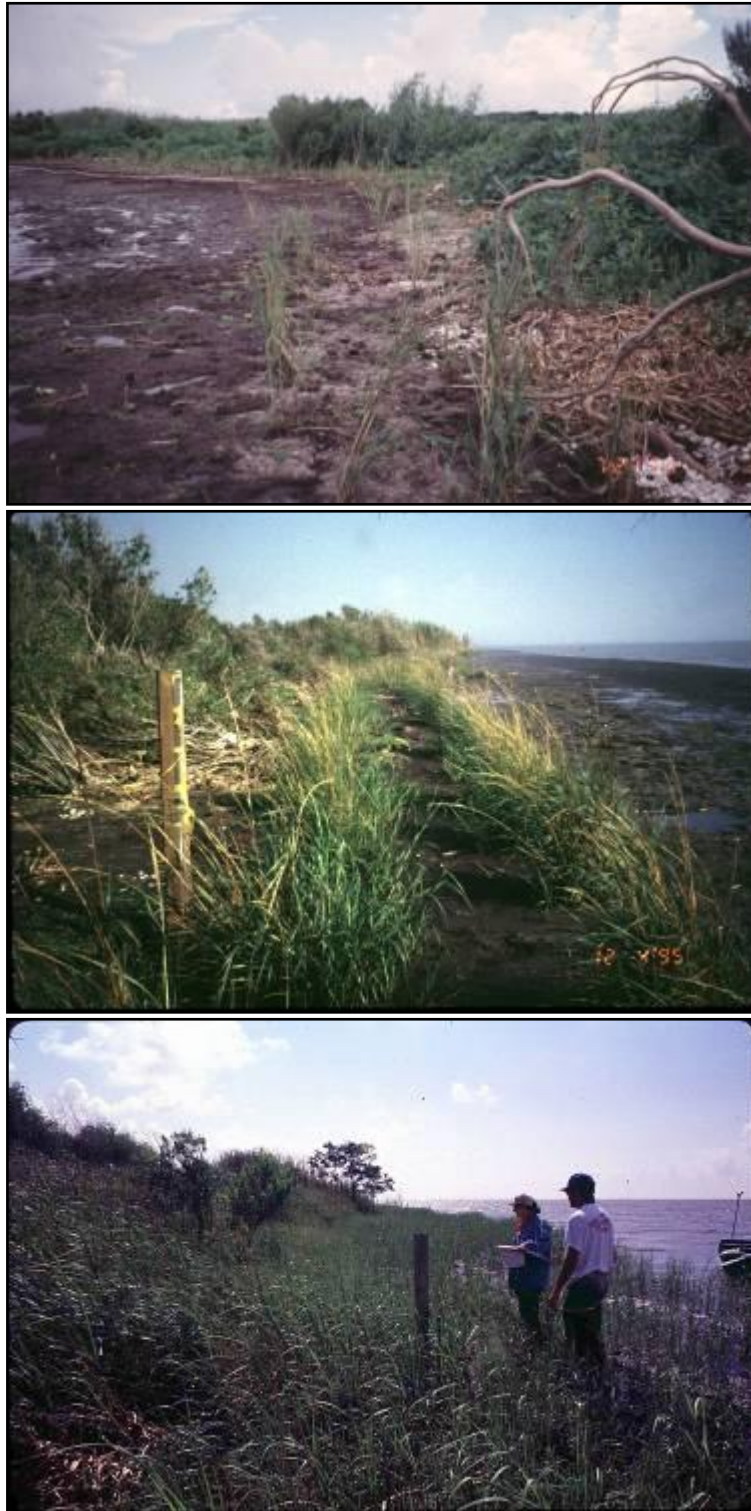
Percent survival of *S. alterniflora* at the 36 month post-planting averaged 90.6 % among all land types (figure 5). The high average percent survival and percent cover of the *S. alterniflora* on the shoreline indicate that the plants have become established (figure 6). Percent survival of *S. alterniflora* at the 36 month post-planting in the high, medium and low *P. australis* coverage was 12.5 %, 62.5 %, and 89.1 %, respectively (figure 7). Percent cover of *S. alterniflora* at the 36 month post-planting in high, medium, and low *P. australis* coverage was 5.6 %, 56.9 %, and 75.9 %, respectively (figure 8). Survivorship and percent cover of *S. alterniflora* was lessened in established stands of *P. australis*. Data collection on vegetation is complete as per the 1999 vegetation survey because individual plants in the plots were indistinguishable. During the 2004 shoreline mapping the vegetation along some of the shoreline was photographed and appeared to be in good condition (figure 9 and 10).

Figure 9. *Spartina alterniflora* planting at the 6 (upper), 12 (center) and 36 (lower) month post-planting monitoring.

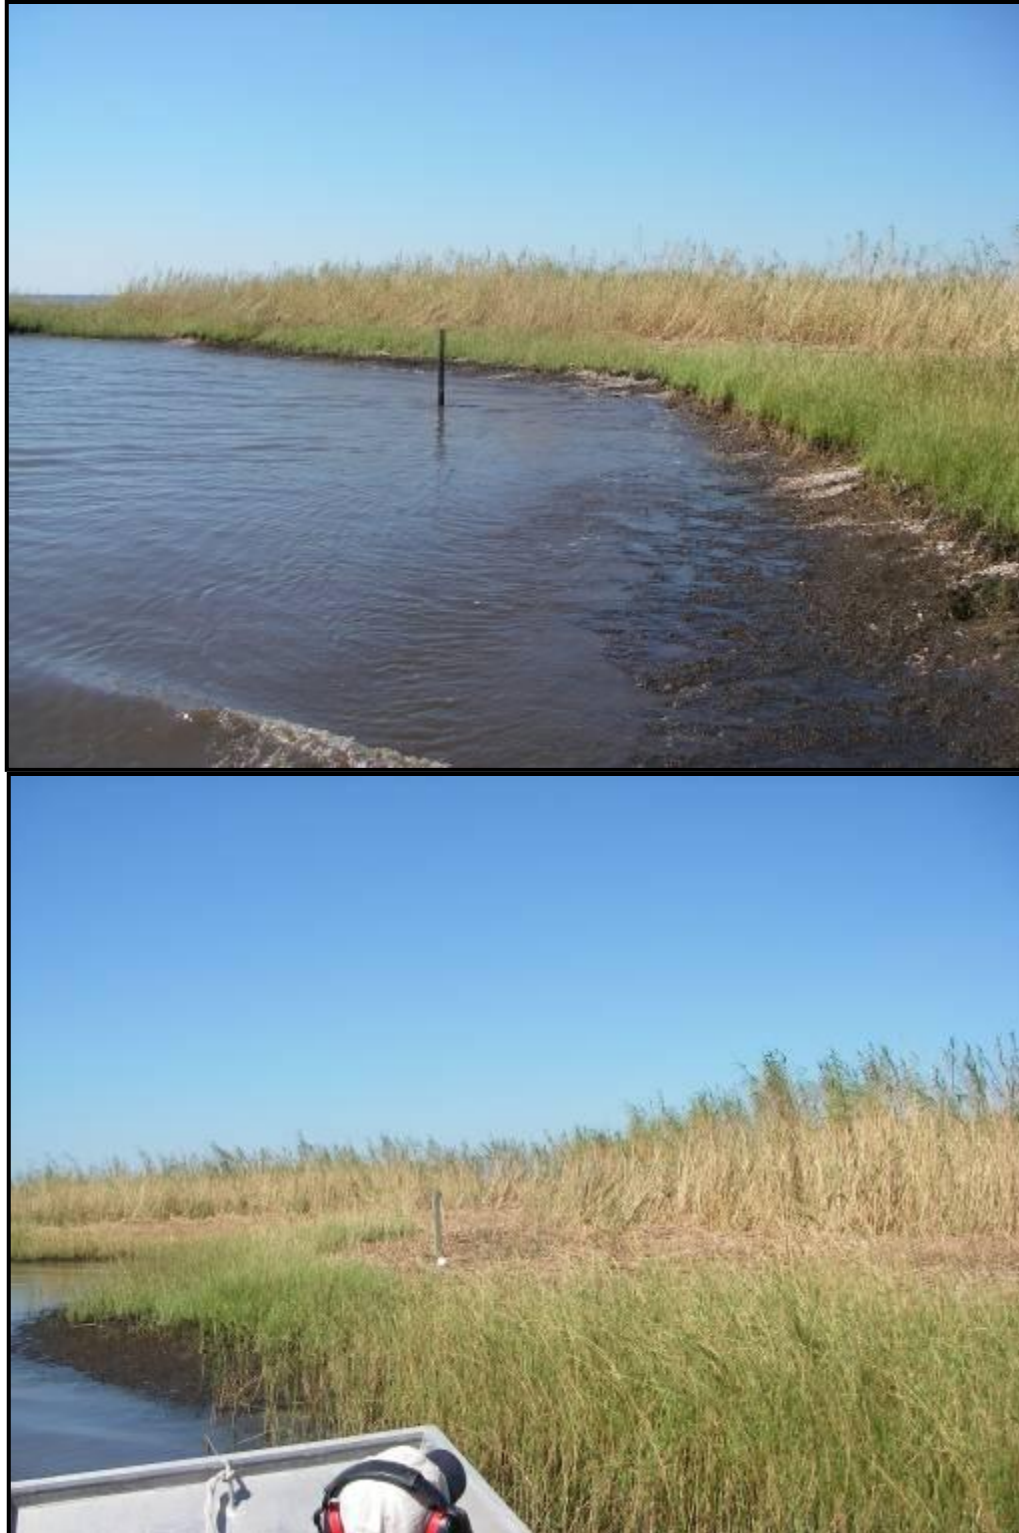
Figure 10. Boston Canal/Vermilion Bay Shoreline Stabilization Project GPS shoreline survey September 9, 2008. The wooden post in the upper photo shows erosion since initial planting and the lower photo is an area where the vegetation has extended towards the bay.

The shoreline was mapped in 1998, 2004, and 2008 (figure 10). A comparison of DGPS mapping of the 13.25 mile project shoreline from 1998 to 2004 indicates a stable shoreline with an average loss of 0.46 m/yr (1.51 ft/yr) (figure 11). The highest losses from 1998 to 2004 occurred in an area west of Four Mile Canal and approximately 0.5 km (0.3 mi) east of Boston Canal, where average loss was between 3.27 m/yr (10.7 ft/yr) and 7.27 m/yr (23.6 ft/yr). The 1998 to 2008 time period indicated total average losses of 0.67 m/yr (2.2 ft/yr) and again loss east of Boston Canal (figure 9) was prominent (figure 12). Hurricane Lili impacted the area in 2002. Between the years of 2004 and 2008, average total shoreline losses were 1.04 m/yr (3.41 ft/yr). During the 2004-2008 mapping period, Hurricane Rita's storm surge in 2005 may have contributed to more rapid retreat of the shoreline (figure 13). Mapping in 2008 was performed prior to Hurricanes Gustav and Ike on September 9, 2008. Largest loss amounts from 2004 to 2008 were, east of the shoreline protection rock at the mouth of Boston Canal. Gains were mainly seen in the area between Four Mile Canal and Boston Canal during that 2004 to 2008 interval. Although not mapped in this effort, the shoreline areas behind the rock dikes were completely protected and have continued to accumulate sediment (figures 14 thru 17).

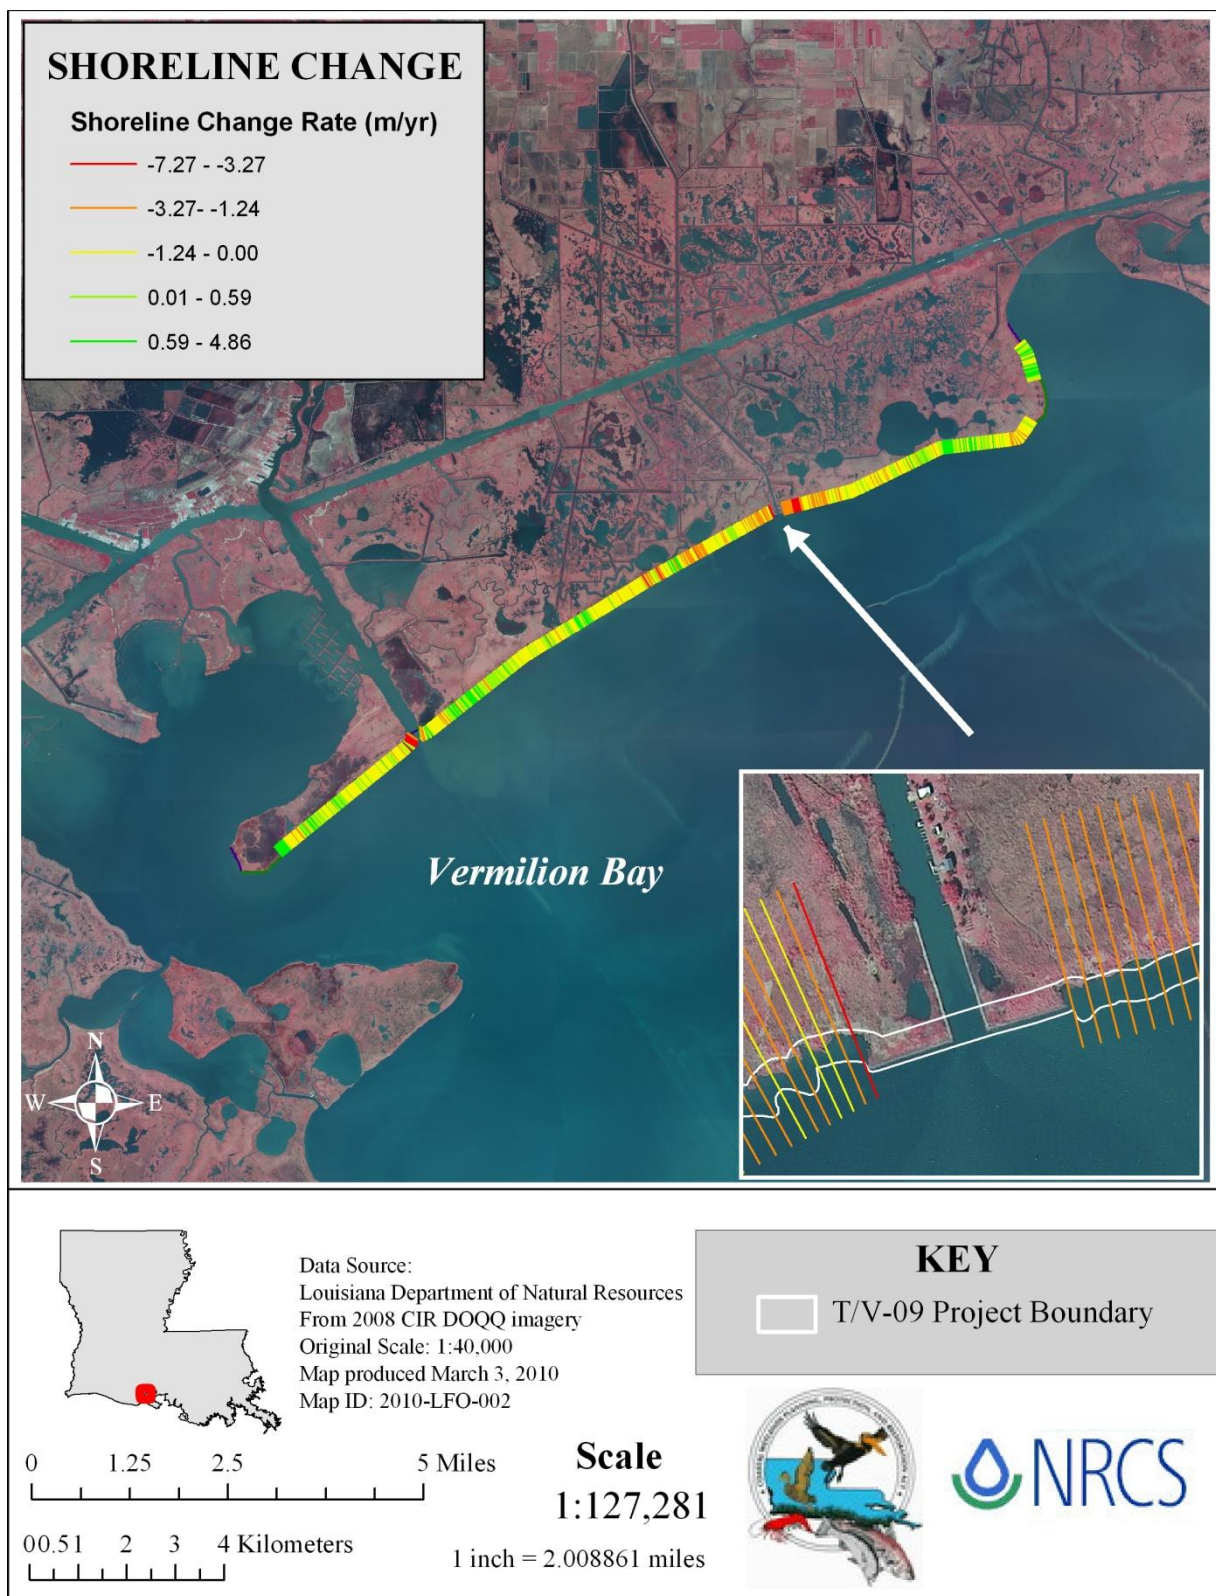
Figure 11. Shoreline position change for Boston Canal Shoreline Stabilization (TV-09) project using 1998 and 2004 differential global positioning system mapping data.

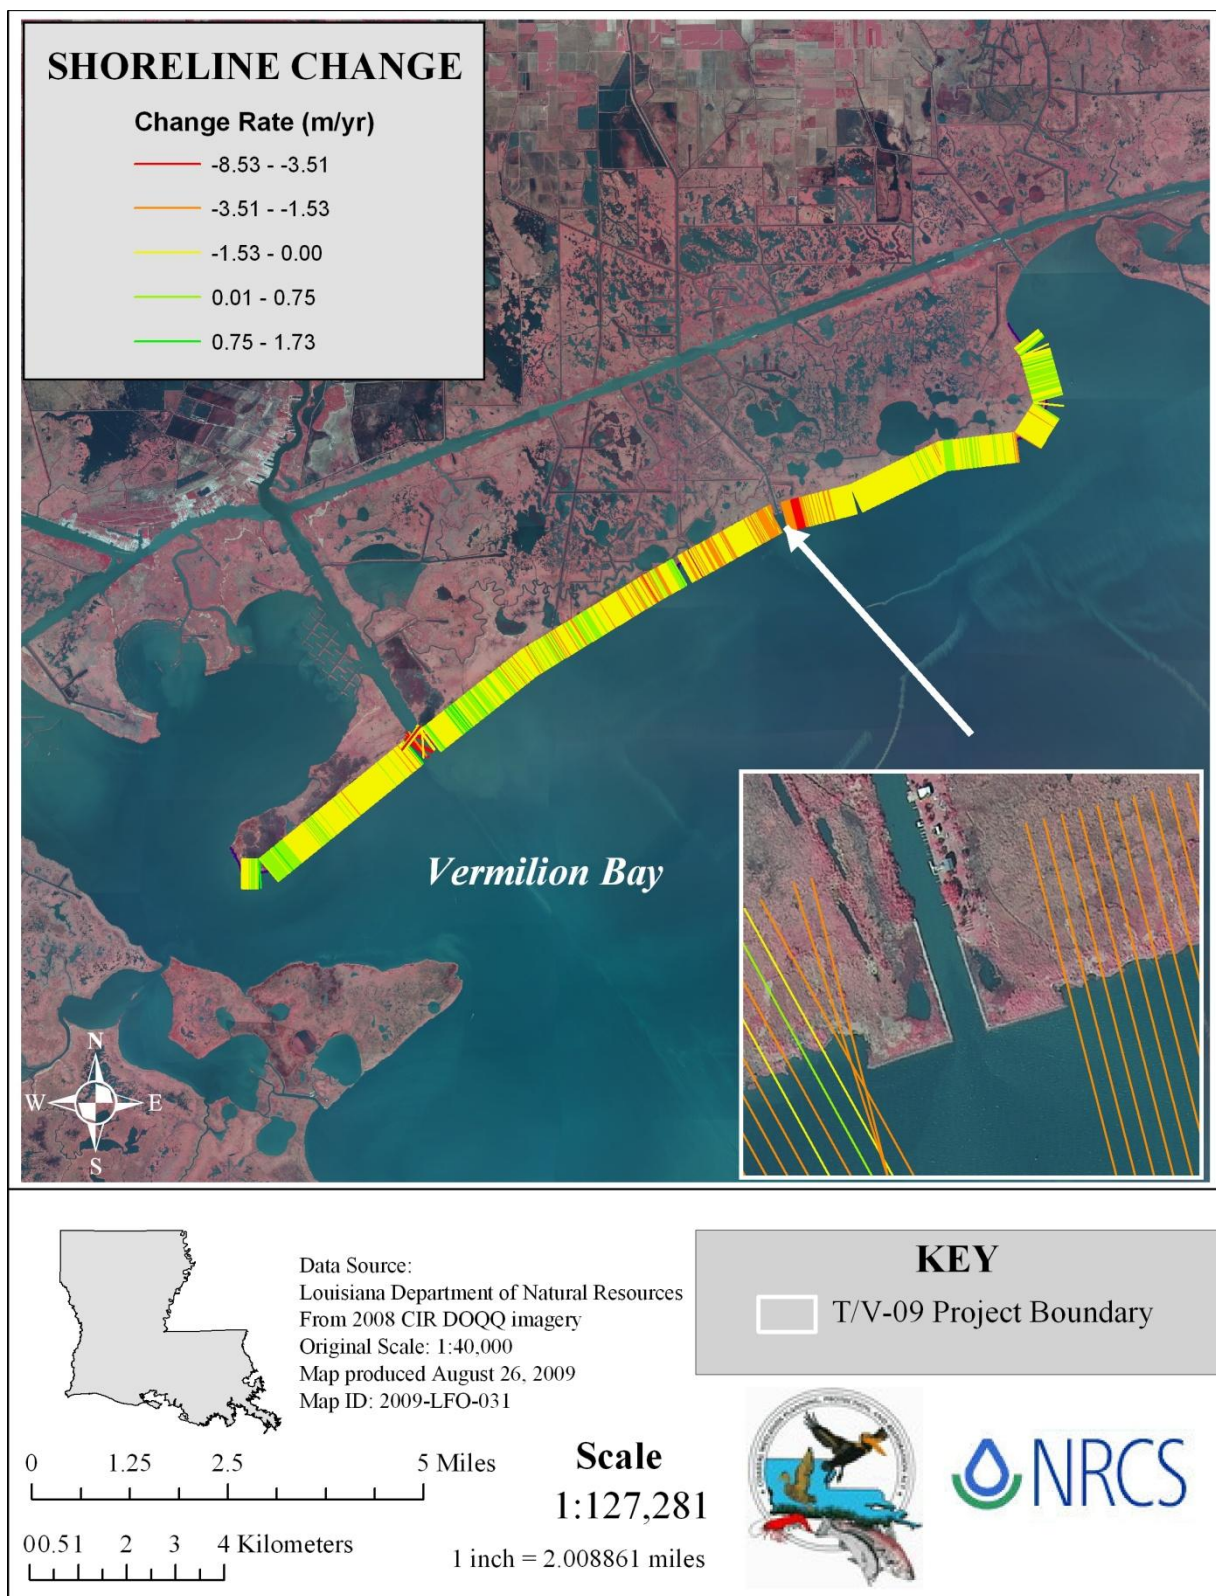
Figure 12. Shoreline position change for Boston Canal Shoreline Stabilization (TV-09) project using 1998 and 2008 differential global positioning system mapping data.

The project is experiencing erosion along the Vermilion Bay shoreline despite the success of the plantings. Shoreline mapping results from 1998 to 2008 show a loss of only 0.67 m/yr (2.2 ft/yr). The most recent mapping recorded an average loss of 1.04 m/yr (3.4 ft/yr) from 2004 to 2008. Of that 0.52m/yr (1.7 ft/yr) is gain and 1.33 m/yr (4.4 ft/yr) is loss. Hurricane Lili struck the Louisiana coast east of Vermilion Bay near Cote Blanche in October of 2002 and Hurricanes Rita in 2005 and Ike in 2008 which produced a storm surge that caused extensive damage to the coast. Considering that the monitoring results from the first monitoring interval showed accretion occurred along some sections of shoreline and a net gain in acreage was achieved, it is highly probable that the wave energy from the storms produced the erosion and resulting net loss in the following interval. Other moderate losses have occurred from *Eichhornia crassipes* (water hyacinth) mats and other wrack material thrown onshore from bay waters via wave action that smothered establishment of vegetation. The now established *S. alterniflora* community has persisted for the most part, but along some sections of the shoreline where loss or gain occurred, the community moves along with the shoreline edge to maintain occupation of its niche in the intertidal zone. This explains why there is still a 'hedge' of stems existing behind - or in front of some monitoring posts. Although the plantings of *S. alterniflora* have become well established and are indistinguishable from each other along most of the shoreline, the plantings cannot protect shorelines from hurricane force wave energy.

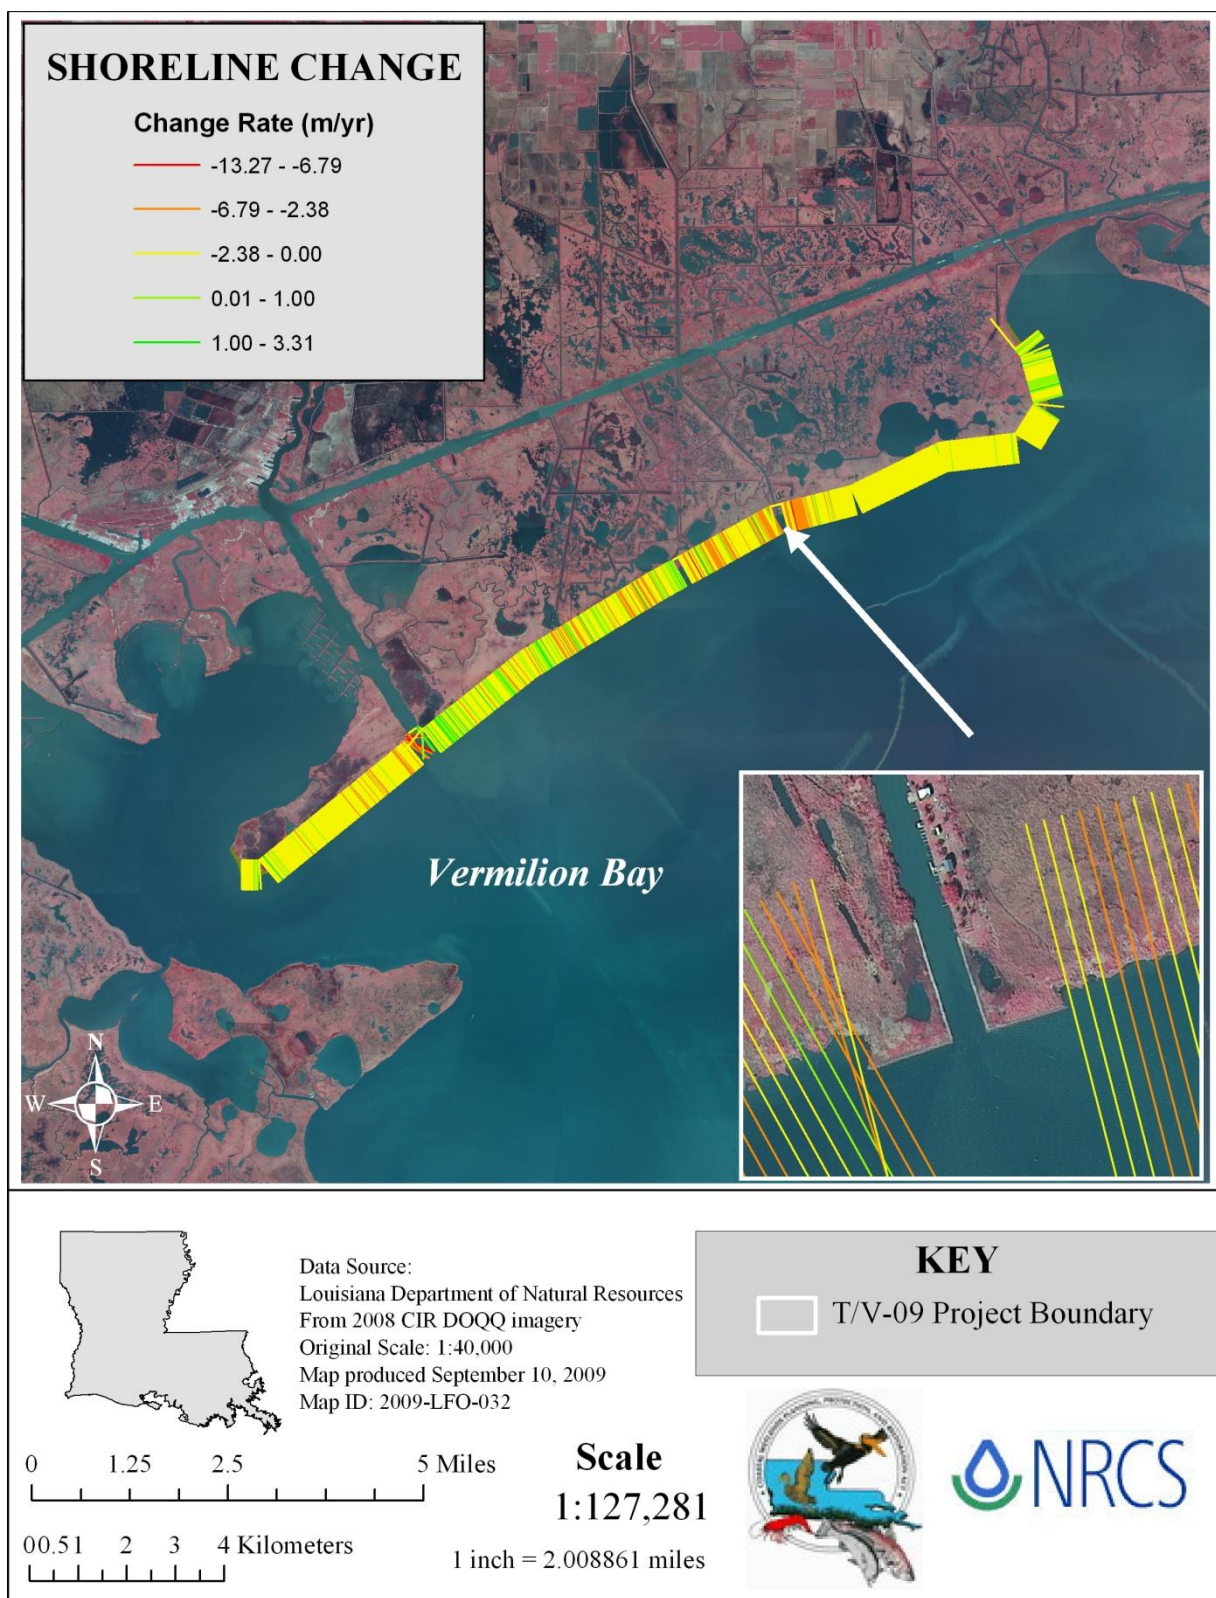
Figure 13. Shoreline position change for Boston Canal Shoreline Stabilization (TV-09) project using 2004 and 2008 differential global positioning system mapping data.

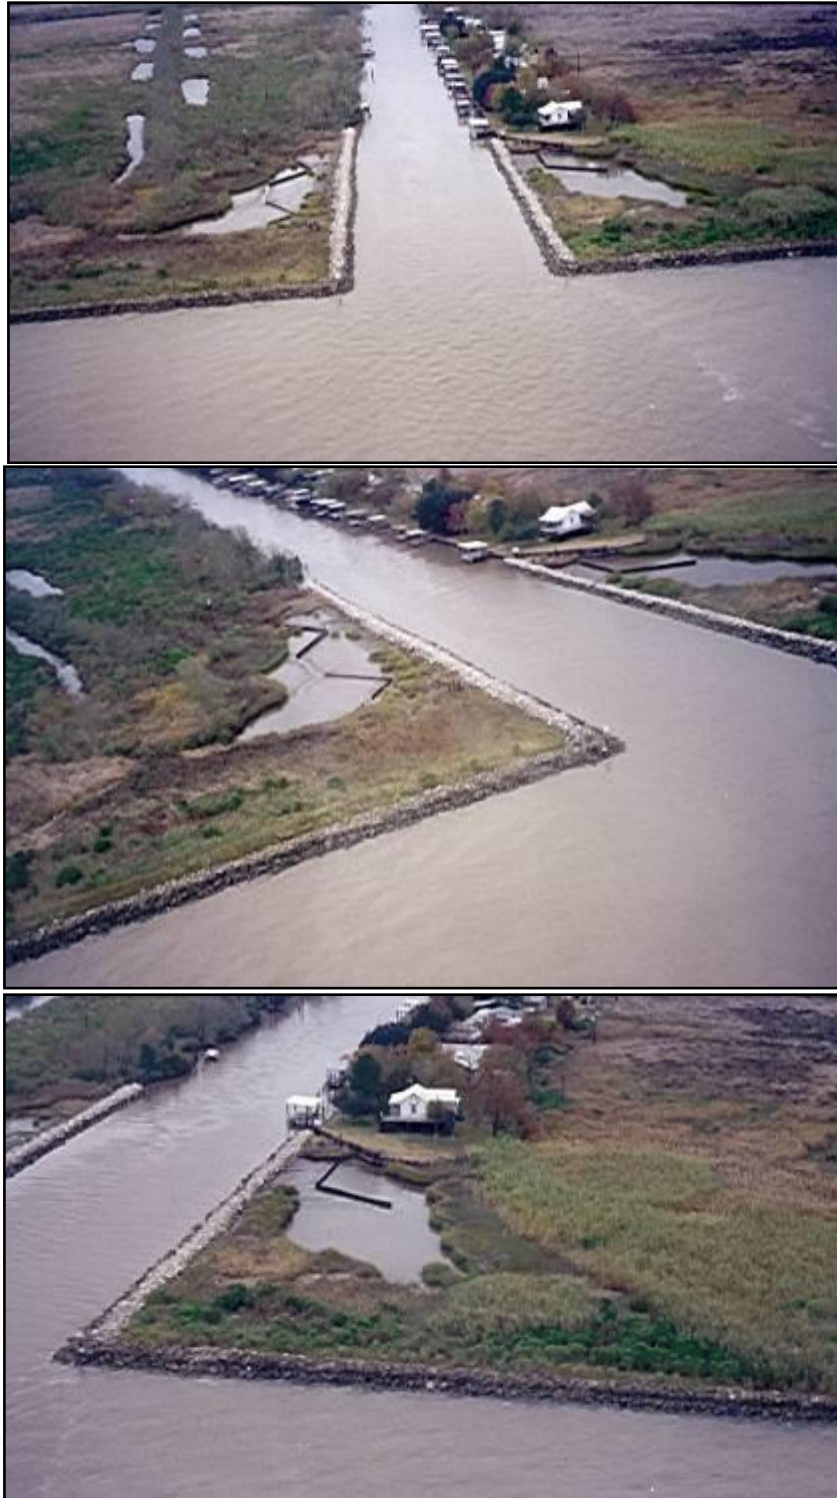
Figure 14. Boston Canal/Vermilion Bay Shoreline Stabilization (TV-09) rock dike and sediment fences at the mouth of Boston Canal (January 2001).

Sediment build-up behind the dike on the east and west sides is continuing and vegetation has taken over the exposed mud flats (figures 14-17).

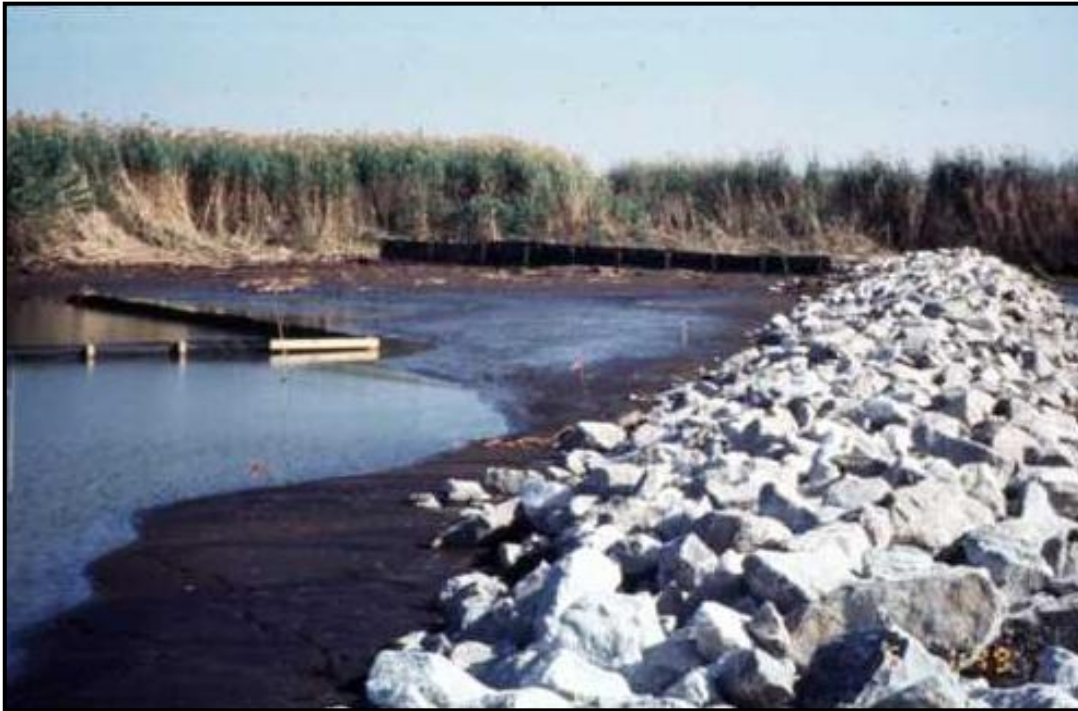
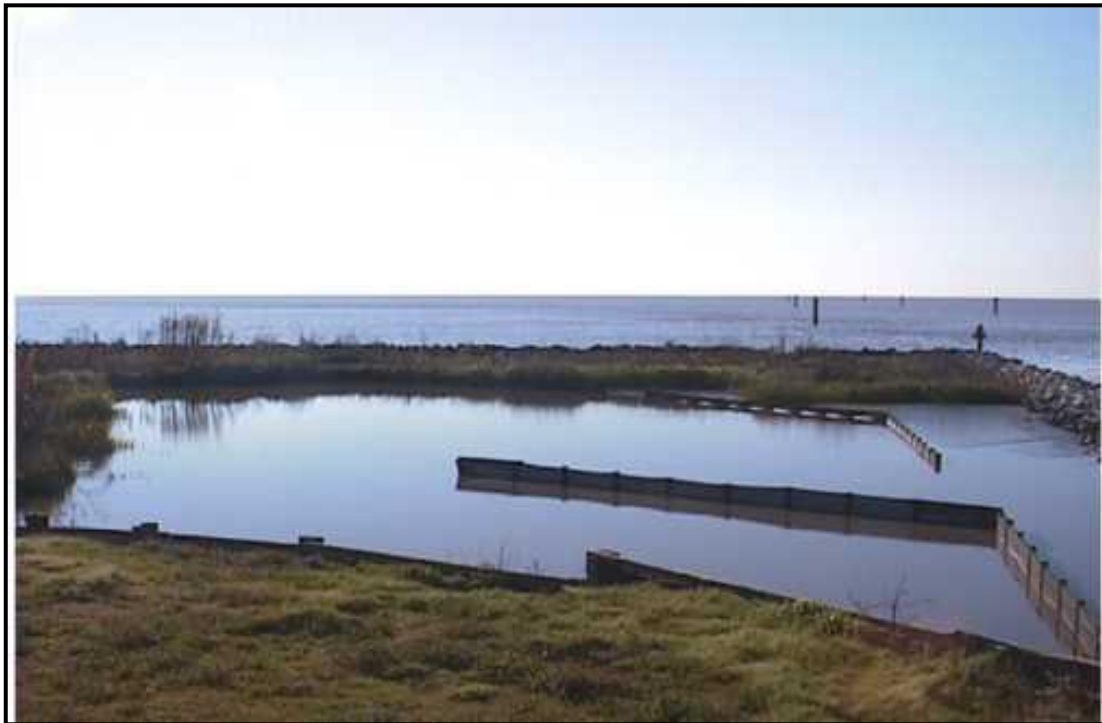
Figure 15. Boston Canal/Vermilion Bay Shoreline Stabilization (T/V-09) photographs: (A) sedimentation behind the dike December 1994: (B) vegetation growing behind the dike in February 1998.

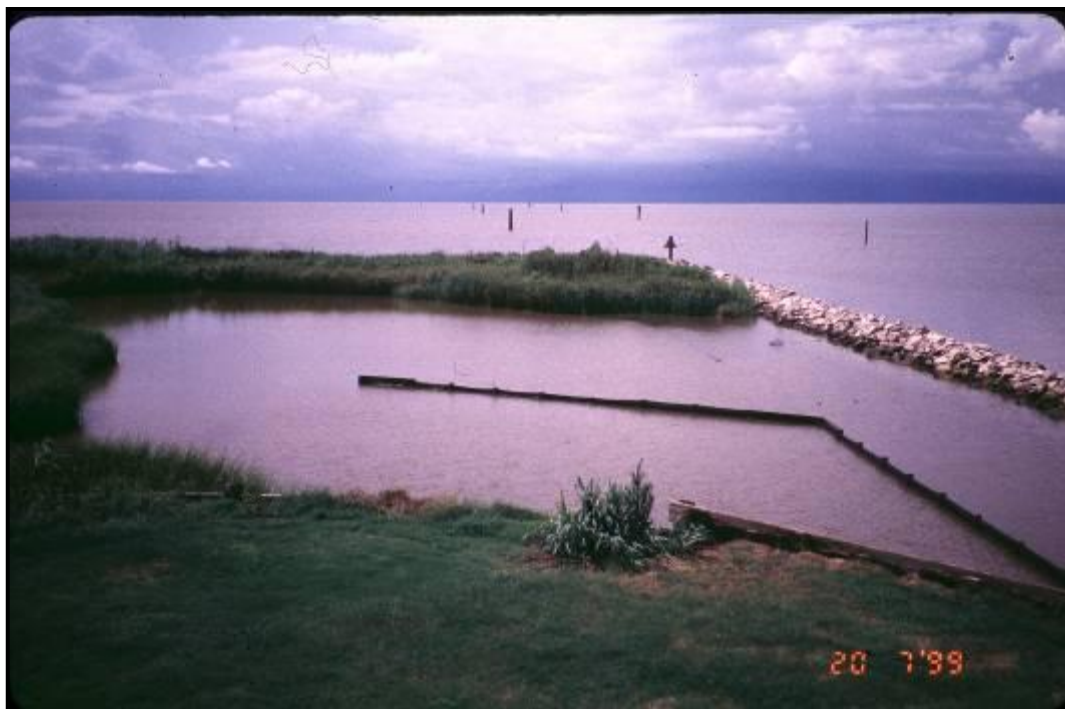
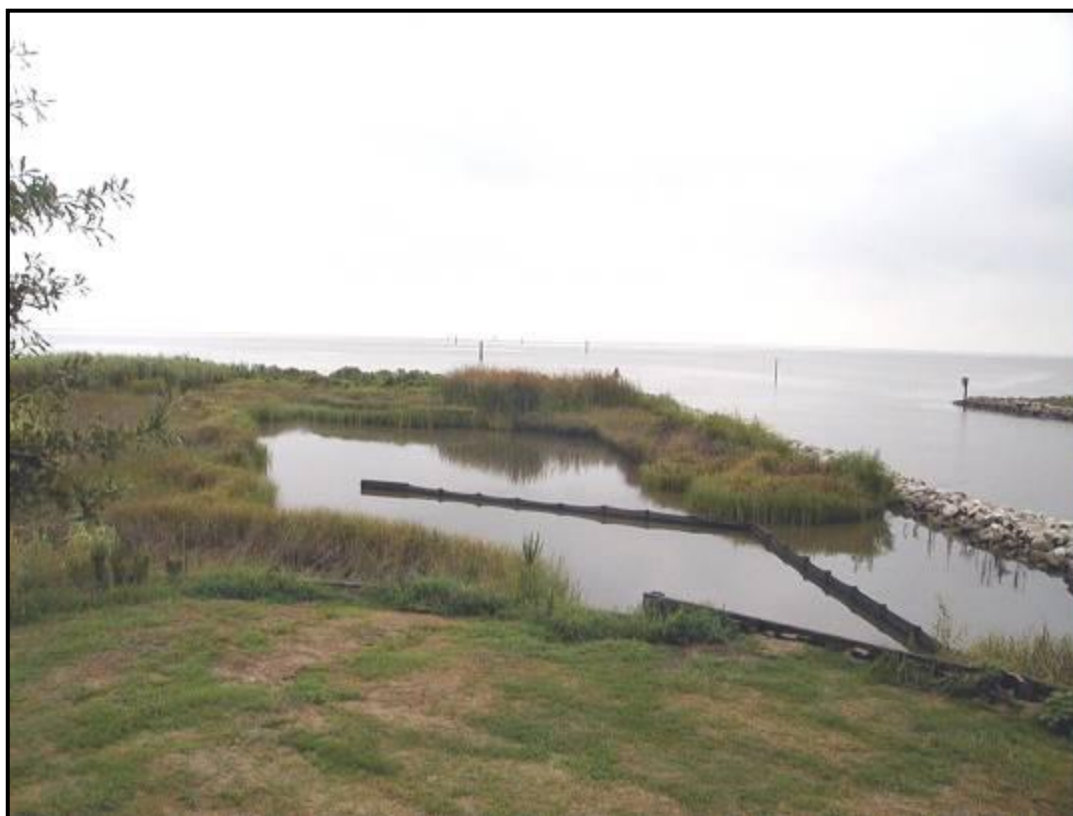
Figure 16. Boston Canal/Vermilion Bay Shoreline Stabilization (T/V-09) photographs: (Upper) vegetation behind the dike July 1999: (Lower) vegetation behind the dike in October 2001.

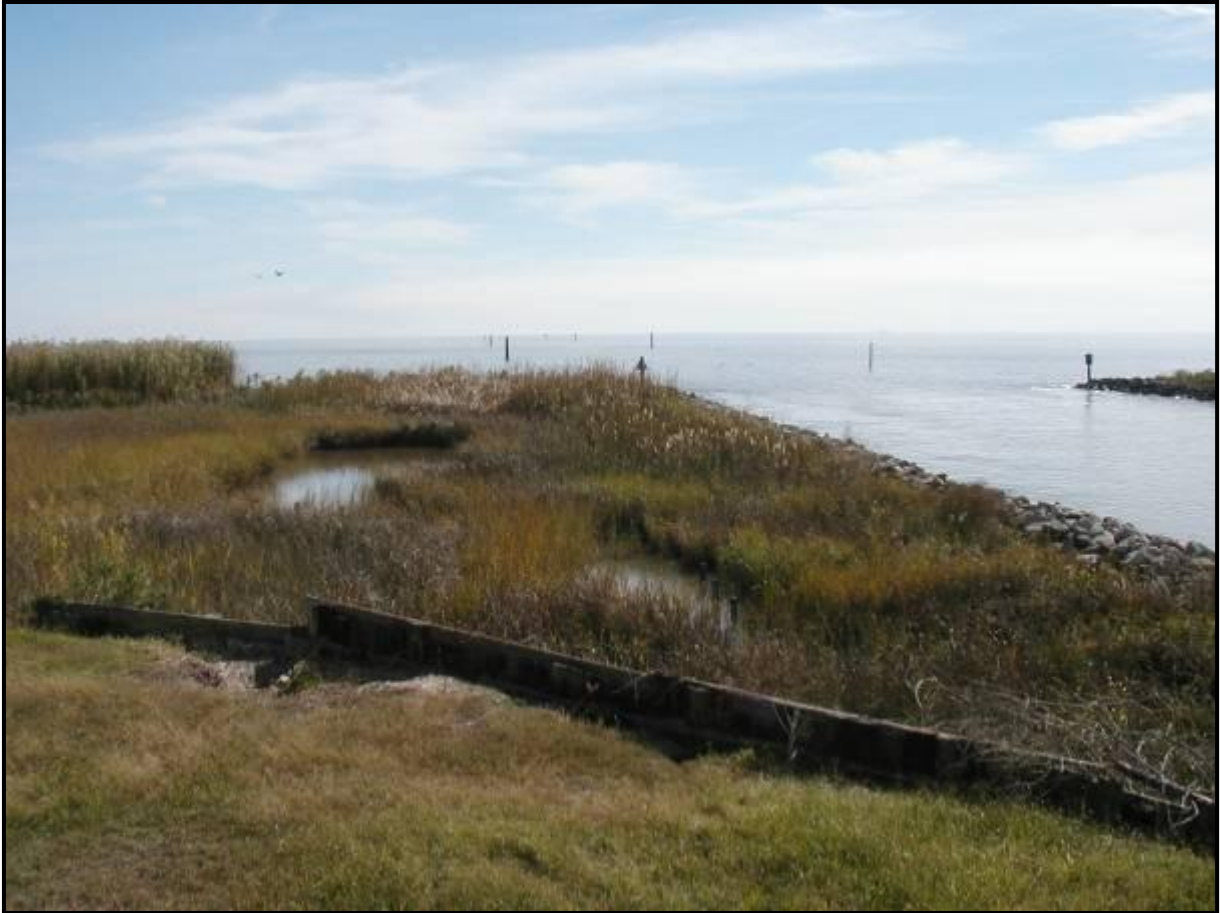
Figure 17. Boston Canal/Vermilion Bay Shoreline Stabilization Project behind the eastern rock dike November 9, 2004.

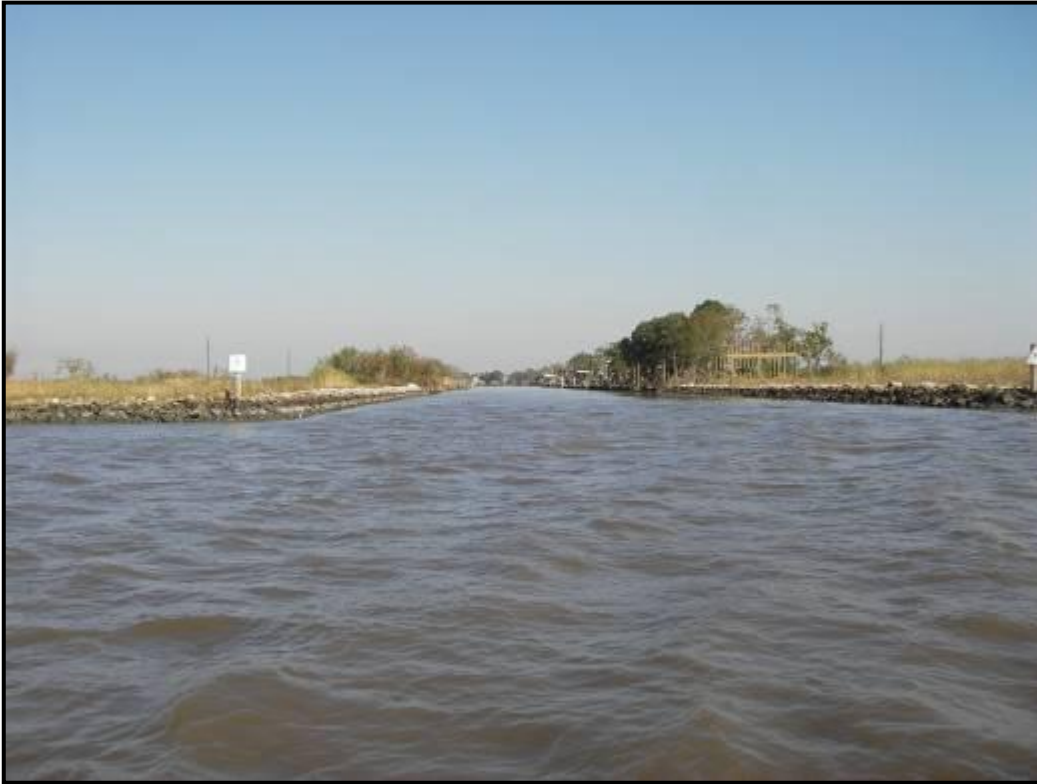
For the most part, the breakwaters are in excellent post construction condition and do not appear to have suffered any damages from Hurricane Ike. There is no apparent toe scour or rock displacement. The western end of the dike where it ties into the Vermilion Bay shoreline has not significantly worsened erosion in this area. A small gap left during original construction appears to have caused this problem. While the situation is similar on the SE tie-in, it is not as severe. No gap was left on this end during construction. Recommendations made to repair these gaps during the O & M inspection of June 2003 have been reconsidered

due to costs and logistics associated with such repairs. These areas have been and will continue to be closely monitored, and should the situation significantly worsen, steps will be taken to close/stabilize these areas. Signage and associated pilings are stable and functioning. (Photos: Appendix A, Photos 1 - 2)

Photo No. 1, View of Boston Canal at the bay shore looking north

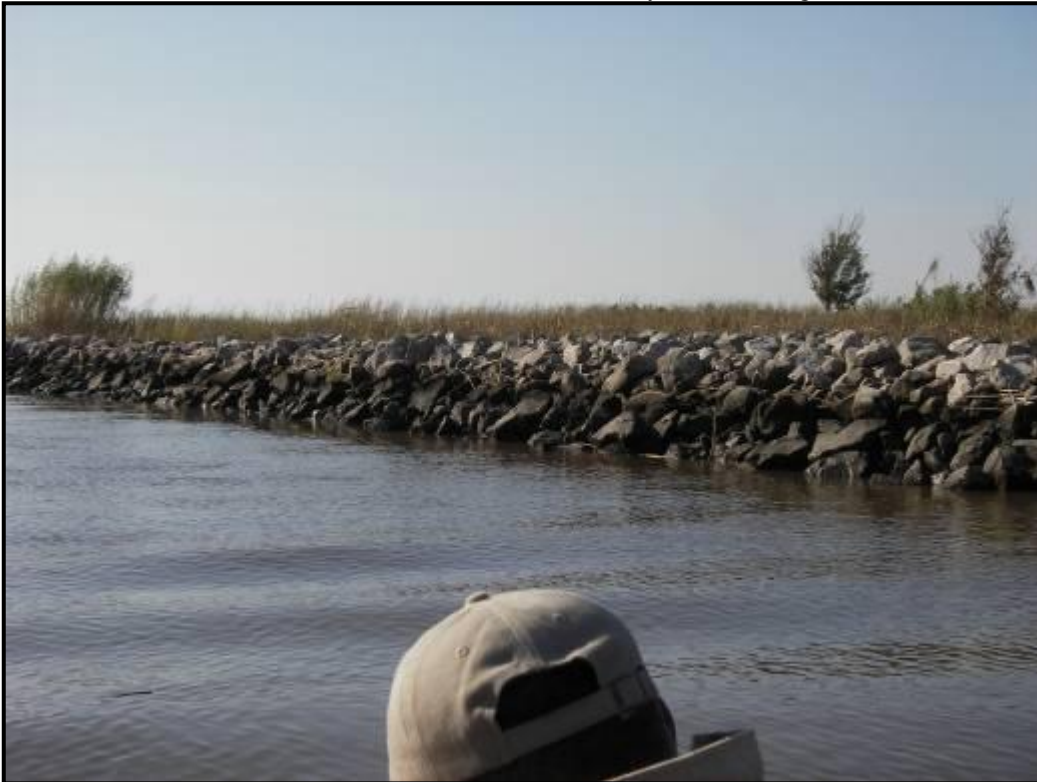
Photo No. 2, Close up view of the rock dike

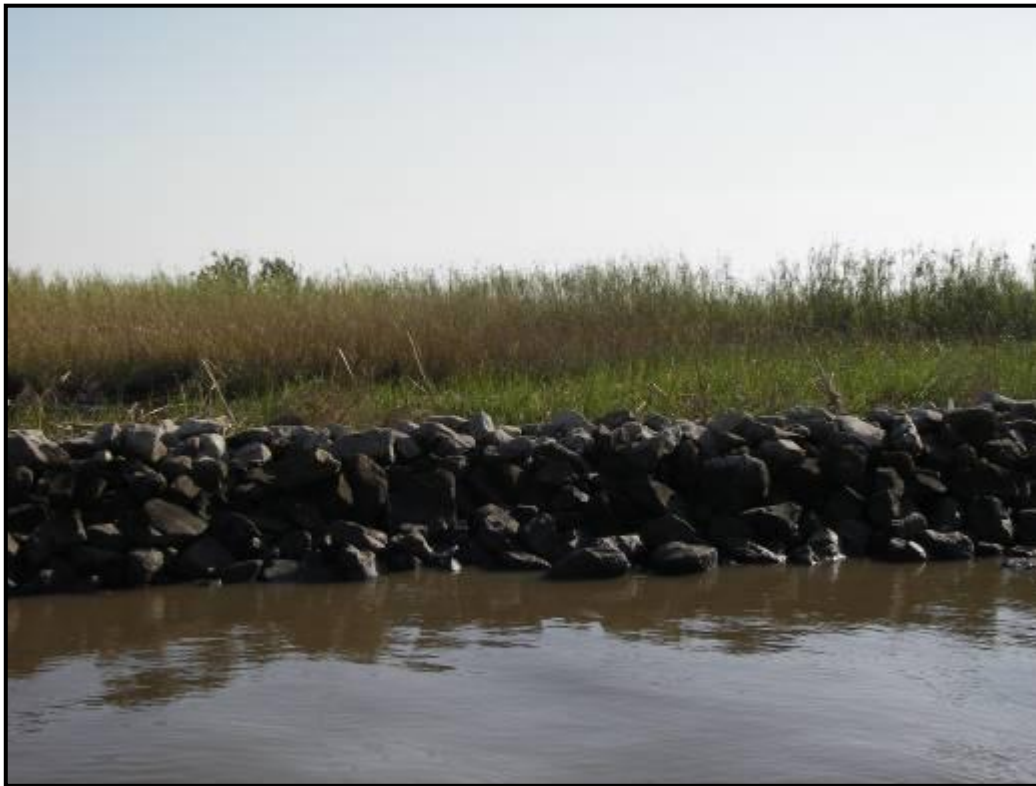
The shoreline plantings were not directly inspected on this trip due to time and wave constraints. There were some pockets of eroded shoreline where the smooth cordgrass is missing near the mouth of Boston Canal as a result of the storm and it is expected that this condition was typical along the remainder of the bay shore. All vegetation in the area adjacent to the mouth of the Boston Canal, including the vegetation behind the rock dikes, is in good condition. (Photos: Appendix A, Photos 3-4)

Photo No. 3, Close up view of vegetation behind the rock dike

Install a staff gage, replace vegetative plantings in eroded pockets along shoreline.

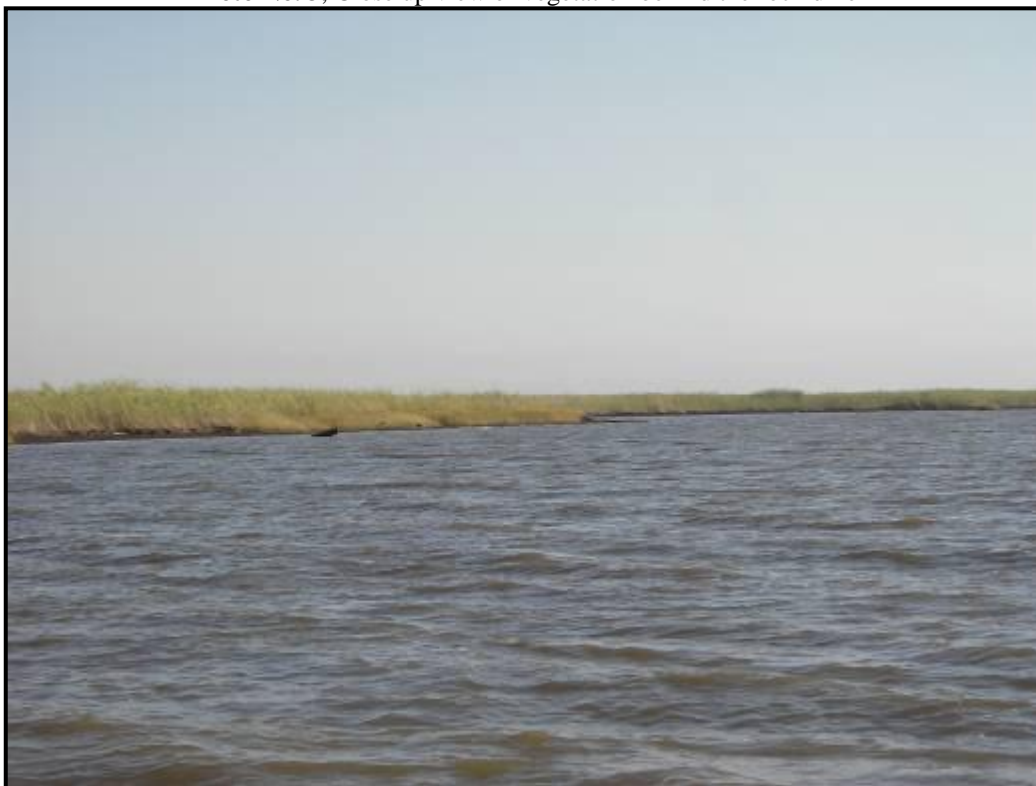
Photo No. 4, Typical view of vegetative plantings along the bay shore
