**State of Louisiana  
Department of Natural Resources  
Coastal Restoration Division**

**2006 Annual Inspection Report**

**Bayou Sauvage Refuge Restoration  
Phase I**

State Project Number PO-16  
Priority Project List 1

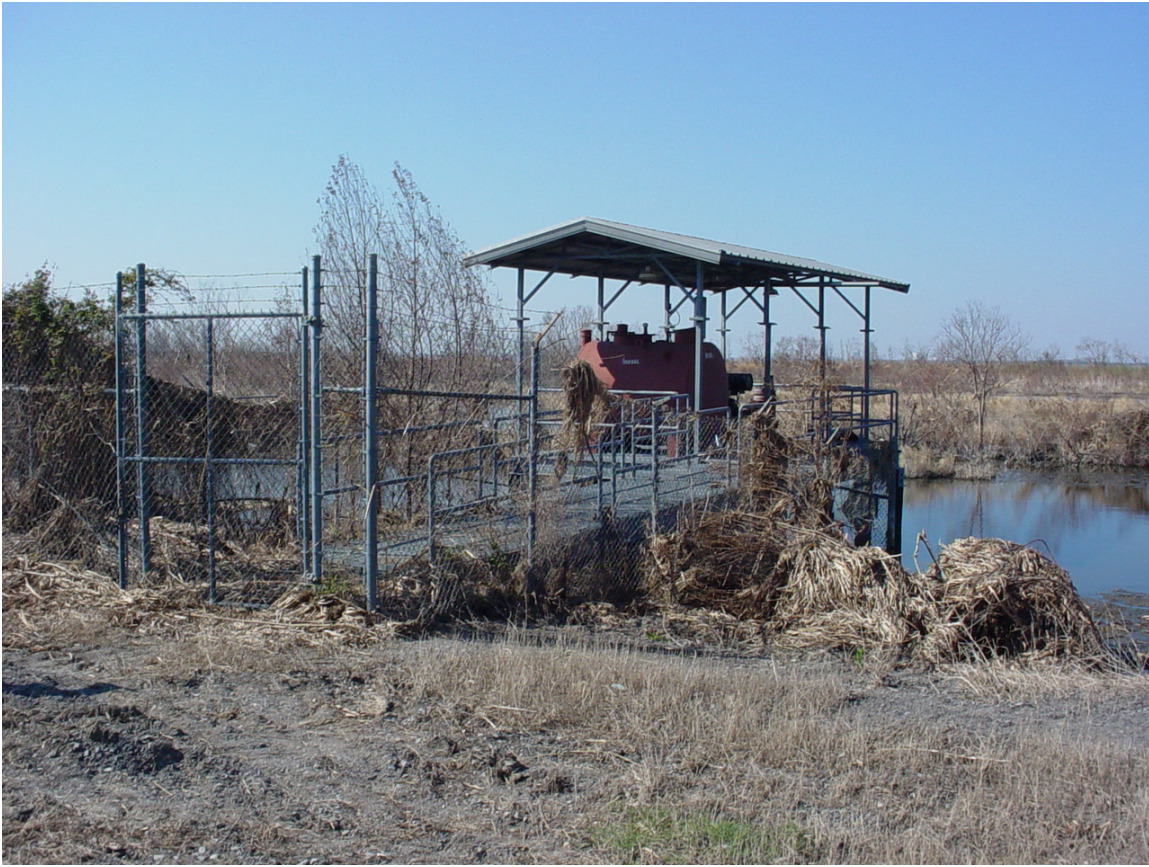
Pump #6 had also been flooded during the Hurricane and was also inoperable (Photo #1). USFWS made arrangements to repair/replace the damaged machinery for this pump at the same time as Pump #5. In January, 2006, USFWS advised LDNR that all repairs to Pump #6 had been completed and the system was operational.

**Photo #1 – Pump #6.** Notice the debris on the fencing for the walkway showing that the water was at least that high at one point.

Item	Condition	Physical Damage	Corrosion	Photo #	Observations and Remarks
Pump Platform	Good	None	Light	1	
Trash Rack	Appeared good but inspected from distance	Not inspected closely	Not inspected closely	1	
Fuel tank	Fair	None	Yes	1	Someone is leaving trash on tank.
Pump Drive Engine	Poor	None	Yes	1	Flooded during Hurricane Katrina
Pump gear box	Poor	None	Moderate		Flooded during Hurricane Katrina
Piping	Good	None	None observed

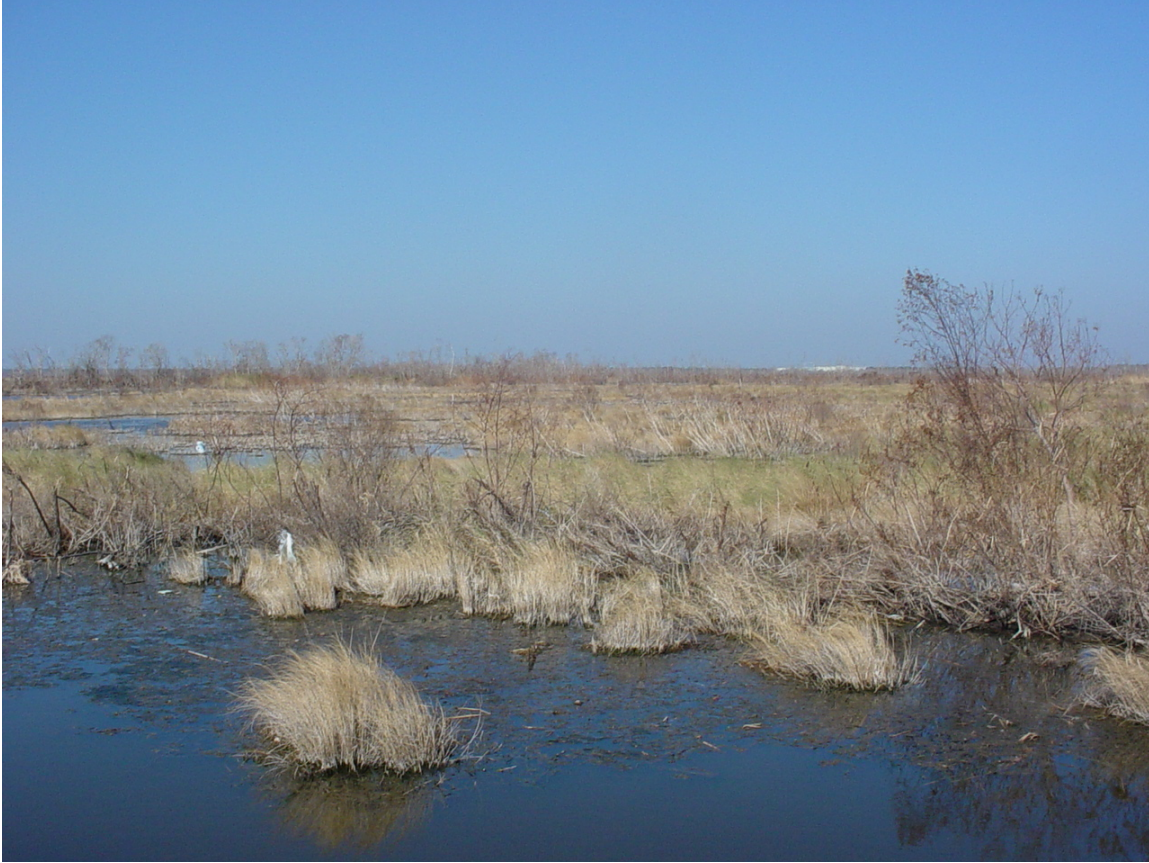
The structures sustained a great deal of damage from Hurricane Katrina. However, the quick response from USFWS helped get everything repaired and running again. It was noted that the storm surge brought a large amount of high salinity water into the project area. This caused the marsh to become stressed which could slow or even prevent the recovery process (Photo #2). There is no way to flush the project area with fresh water so there is very little that can be done for this except monitor the situation.

**Photo #2 – Interior Marsh.** There are very few live plants inside the project area due to the high salinity.

There is no need for additional repairs at this time. The Hwy 11 culvert situation and the marsh situation will continue to be monitored.
