**State of Louisiana  
Department of Natural Resources  
Coastal Restoration Division**

**2006 Annual Inspection Report**

**Bayou Sauvage Refuge Restoration  
Phase II**

State Project Number PO-18  
Priority Project List 2

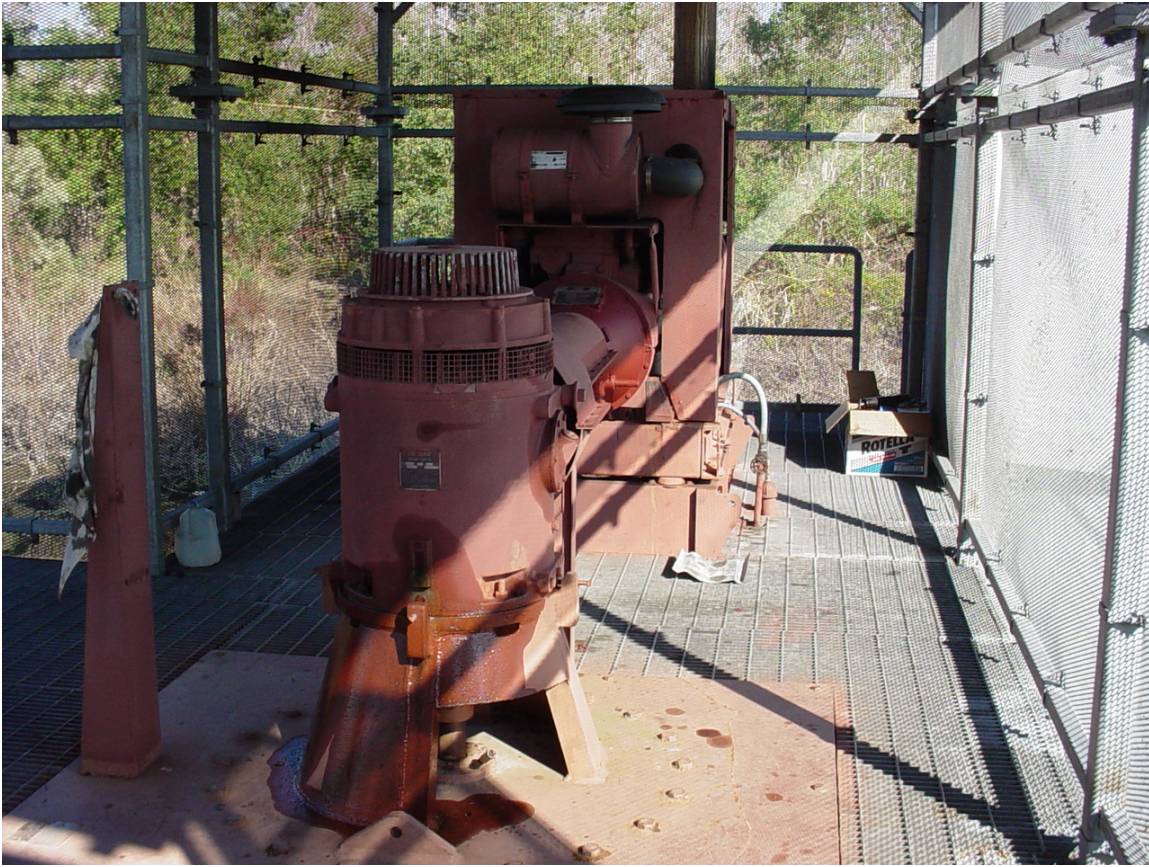
After Hurricane Katrina this was one of the two pumps that remained operable. It was used to pump the flood waters out of the project area and out into Lake Pontchartrain. Because of this extra load, and extended pump time, the clutch for Pump #3 froze. USFWS has recently replaced the clutch, and the pump is fully operational.

**Photo #1 – Pump #3.** This pump was working until the clutch froze. Note the leaking fluid.

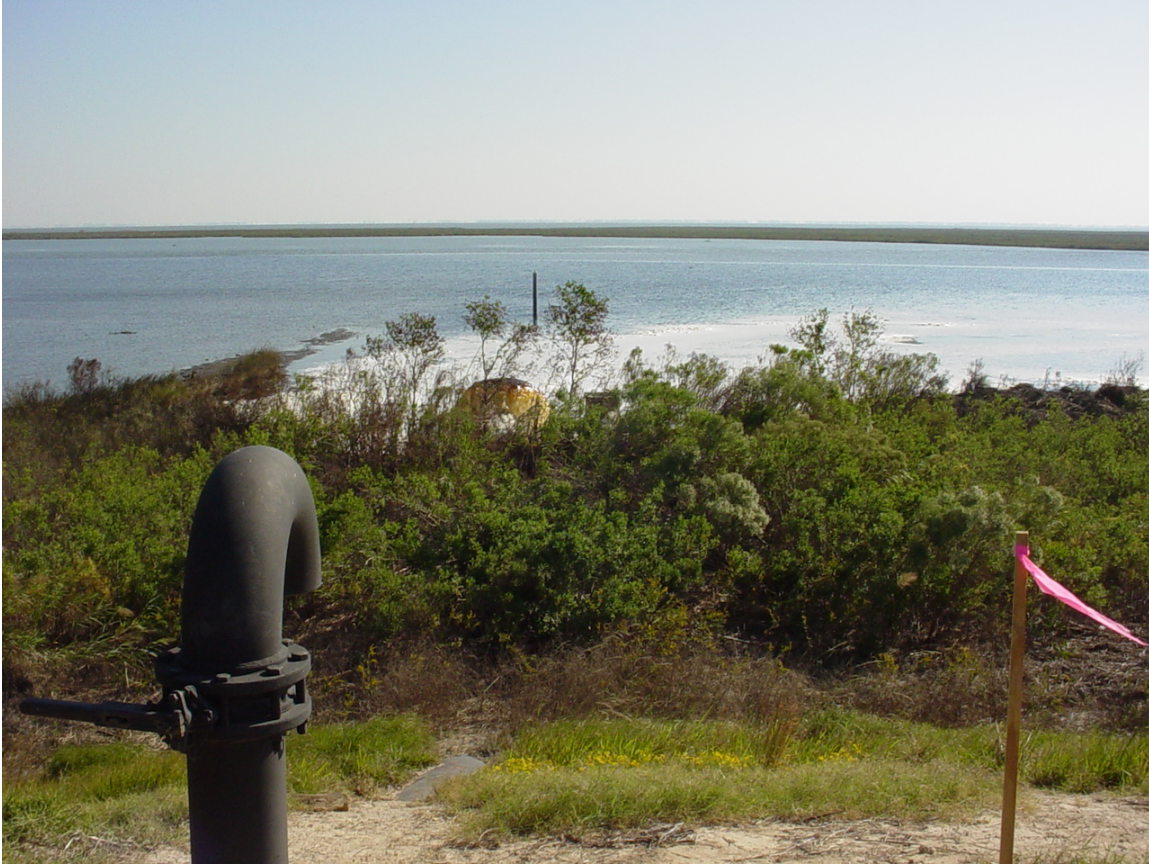
The structures sustained little damage from Hurricane Katrina. There was some noticeable biofoam coming from the outflow into the Lake (Photo #2). This did not prove to be harmful. The storm surge brought a large amount of high salinity water into the project area. This caused the marsh to become stressed which could slow or even prevent the recovery process. There is no way to flush the project area with fresh water so there is very little that can be done for this except monitor the situation.

**Photo #2 – Outflow.** This is where the water empties into Lake Pontchartrain from the pumps. Note the biofoam flowing into the open water.
