**State of Louisiana
Department of Natural Resources
Coastal Restoration Division**

2006 Annual Inspection Report

Bayou Chevee Shoreline Protection

State Project Number PO-22
Priority Project List 5

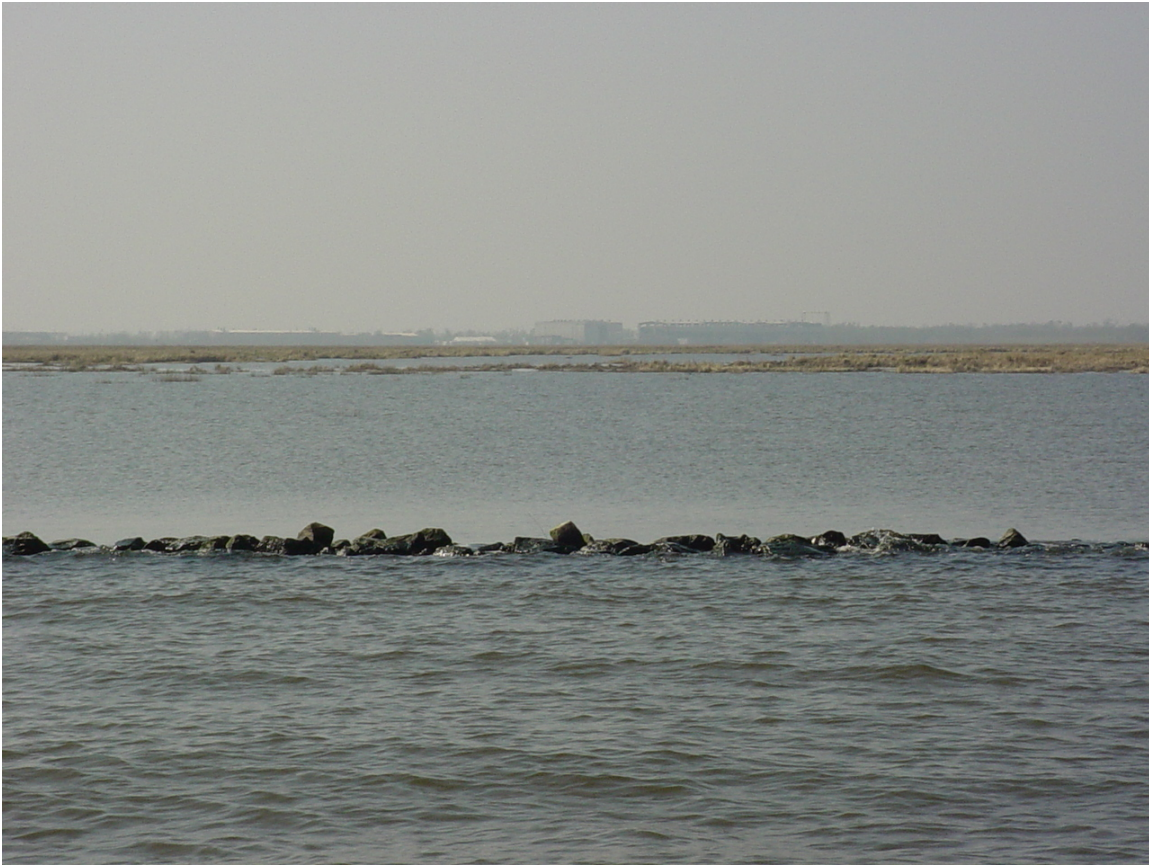
There was no visible damage to the dikes from the Hurricanes (Photo #1). Structures appear to be settling, however, it was not noticeable enough to warrant any action at this time.

Photo #1 – Rock Dike. Looking toward the project area from Lake Pontchartrain.
Notice the difference in surface water activity inside and outside the project area.

There is no need for any maintenance activity at this time. The marsh situation will continue to be monitored.

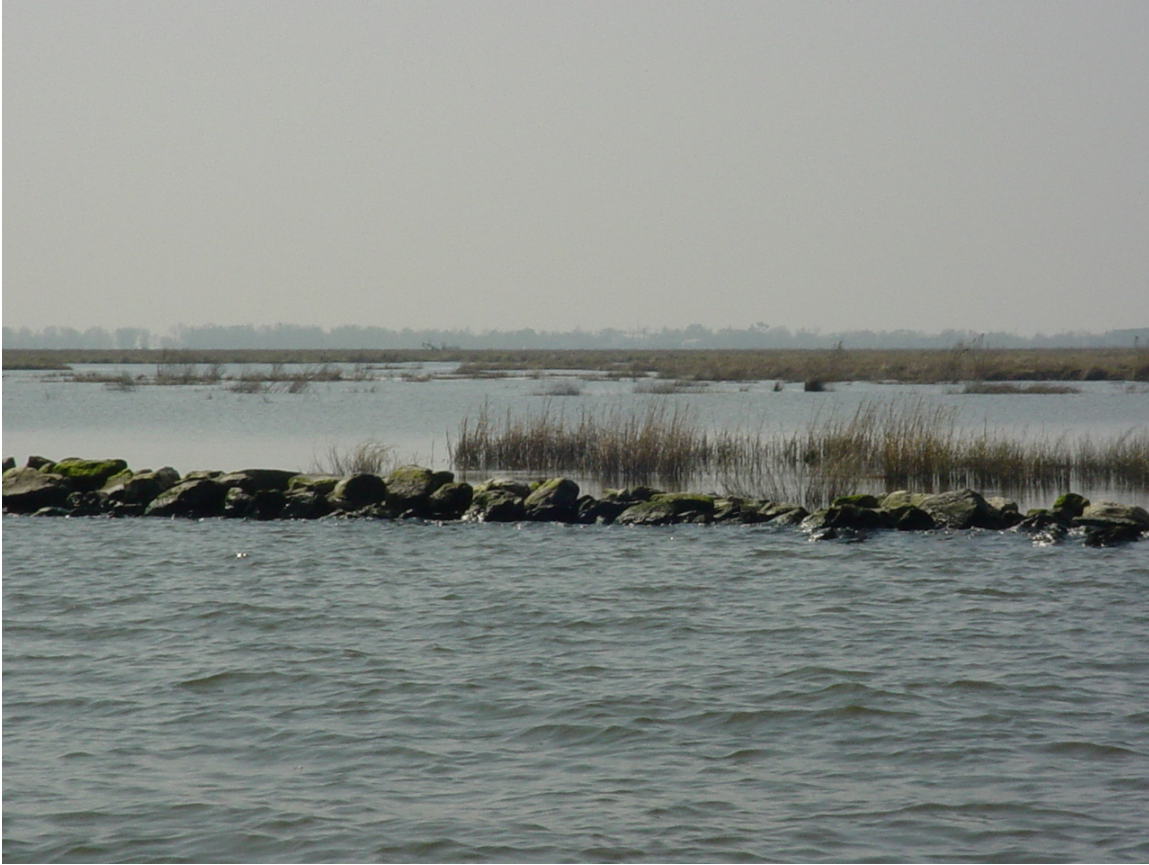
The structures on the North and South Coves appear to be performing as designed. The storm surge from Hurricane Katrina caused some damage to the marsh inside of the project area (Photo #2). Most of this damage occurred in the South Cove section of the project, near Chef Pass, where the structure ends and leaves a portion of the cove exposed. This project would be greatly benefited by extending the structure on the South Cove to meet Chef Pass.

Photo #2 – South Cove Marsh. Notice how broken up the marsh is behind this structure.
