**State of Louisiana
Department of Natural Resources
Coastal Restoration Division**

2006 Annual Inspection Report

Hopedale Hydrologic Restoration

State Project Number PO-24
Priority Project List 8

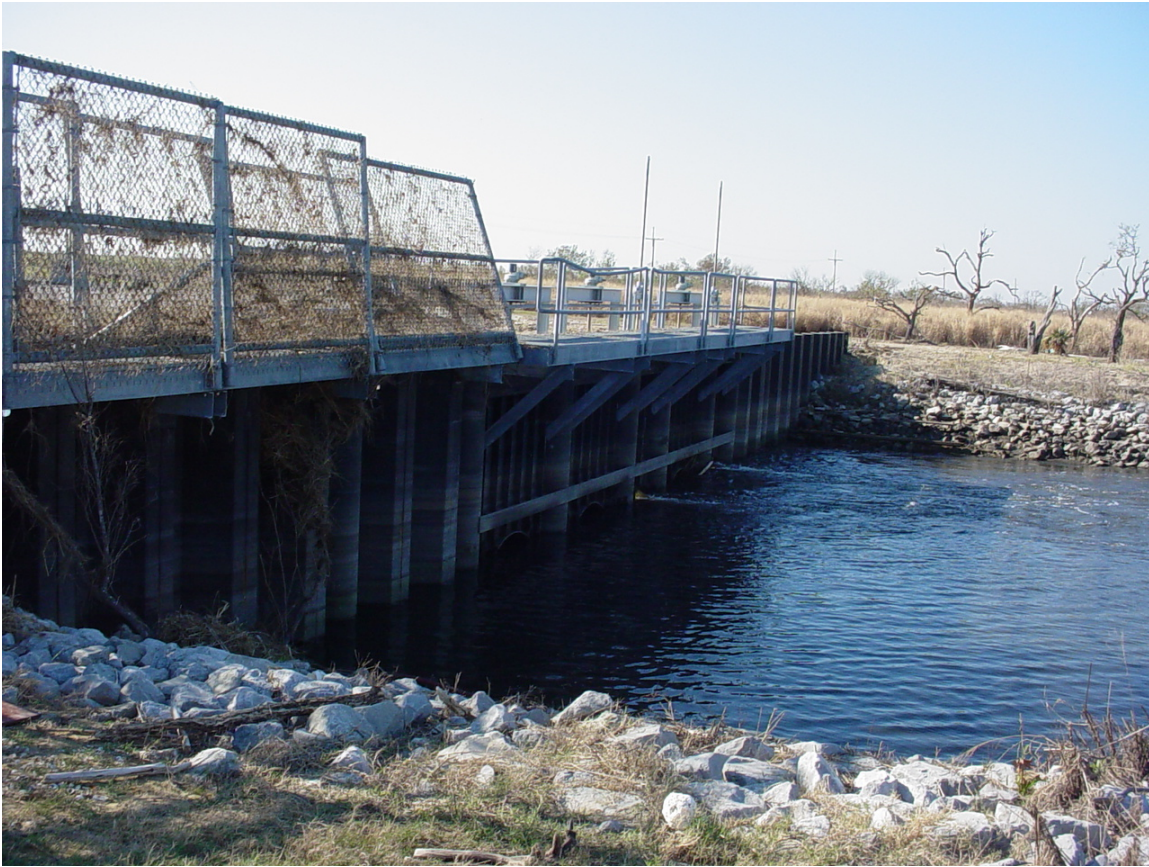
There was only slight damage to the main Hopedale Structure. The transparent vinyl gate stem protective covers were missing on all 5 gates, and some of the chain link security fencing on the structure had been dislodged and was lying on the structure floor (Photo #1). The structure; however, is operational in its present condition. The embankment adjacent to the structure was substantially eroded, and some of the upper bank rock protection around the structure was displaced by the storm surge. It is estimated that 75 cubic yards of earthen material was eroded and 60 tons of class "B" stone was displaced.

Photo #1 – Water Control Structure. Standing on the East bank looking south. Note the damage to the railing, fencing, and the debris still in the fencing.

Item	Condition	Physical Damage	Corrosion	Photo #	Observations and Remarks
Swing Gates 84" D	Good	None	None		Gate Screw Coverings which indicate gate height are missing.
Fish Gates 24" x 84"	Good	None	None		No change due to Hurricanes.
Handrails Grating Hardware etc.	Poor	Extensive	None	1	Some fencing collapsed or damaged. Some handrails bent or damaged.
Galv. Pile Caps	Good	None	None		No change due to Hurricanes.
Signage /Supports	Good	None	None		No change due to Hurricanes.
Riprap	Good	None	None		No change due to Hurricanes.
Silt/Fill	Good	None	None		No change due to Hurricanes.

- Repair all the damage mentioned in Section IV.
