**State of Louisiana
Department of Natural Resources
Coastal Engineering Division**

**2005/2006 Annual Inspection
Report**

**FRESHWATER BAYOU
WETLANDS PROJECT
(ME-04)**

October 7, 2005
Vermilion Parish

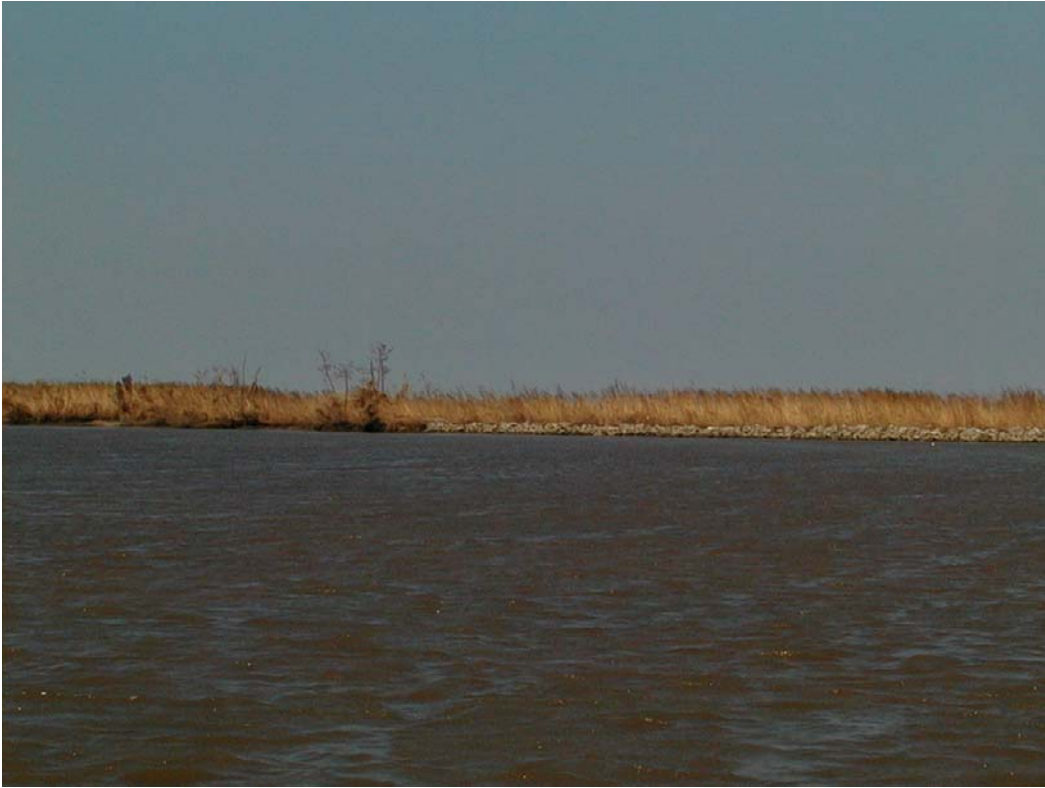
The inspection revealed the rock foreshore dike is in good condition and sustained no damage from the storm surge. The recently completed maintenance project to restore the dike to constructed elevations held up well through high water conditions. (Photos: Appendix B, Photos 1 & 2)

Photo 1, Typical rock dike

Item	Condition	Physical Damage	Corrosion	Photo #	Observations and Remarks
Steel Bulkhead / Caps	N/A				
Steel Grating	N/A				
Stop Logs	N/A				
Hardware	N/A				
Timber Piles	N/A				
Timber Wales	N/A				
Galv. Pile Caps	N/A				
Cables	N/A				
Signage / Supports	N/A				
Rip Rap (fill) (foreshore dike)	Good			1 & 2	Recent maintenance work to restore dike to constructed elevation sustained no damage from Hurricane RITA.
Earthen Embankment	N/A

Overall the Freshwater Bayou Wetland Project is in good condition and sustained no discernable damage from Hurricane RITA. No maintenance is required at this time.

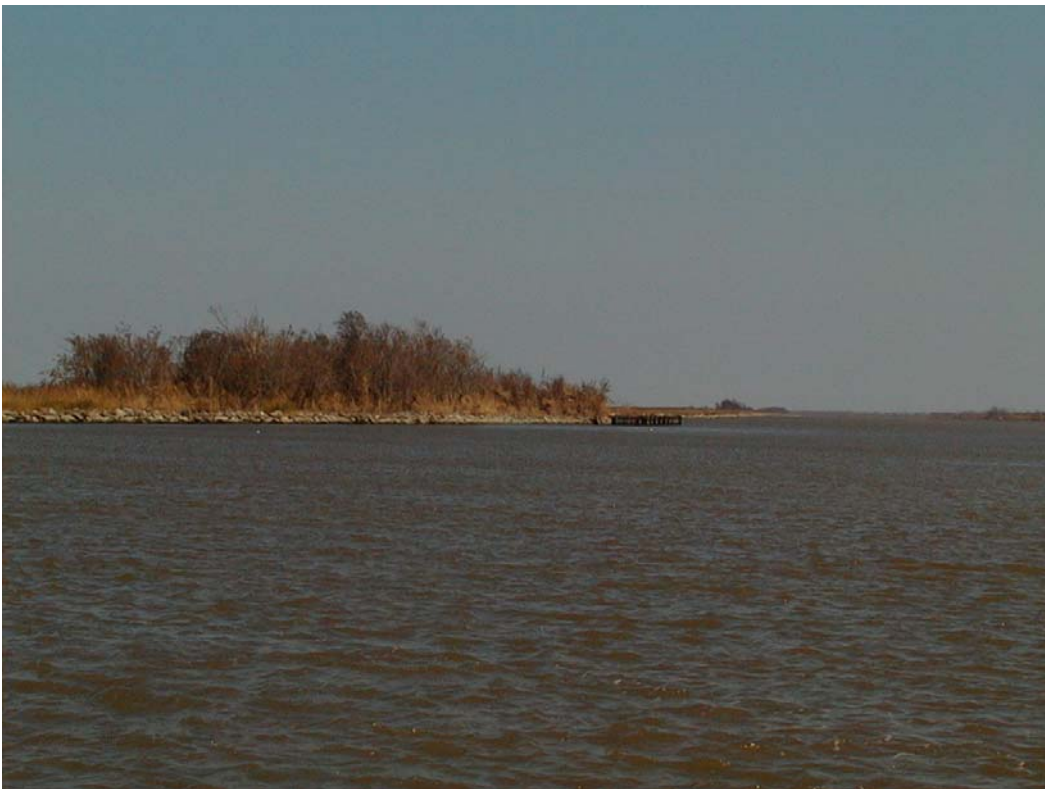
Photo 2, Typical rock dike.
