**2005/2006 Annual Inspection  
Report**

**CAMERON PRAIRIE REFUGE  
PROTECTION PROJECT  
(ME-09)**

State Project Number ME-09  
Priority Project List 1

October 21, 2005  
Cameron Parish

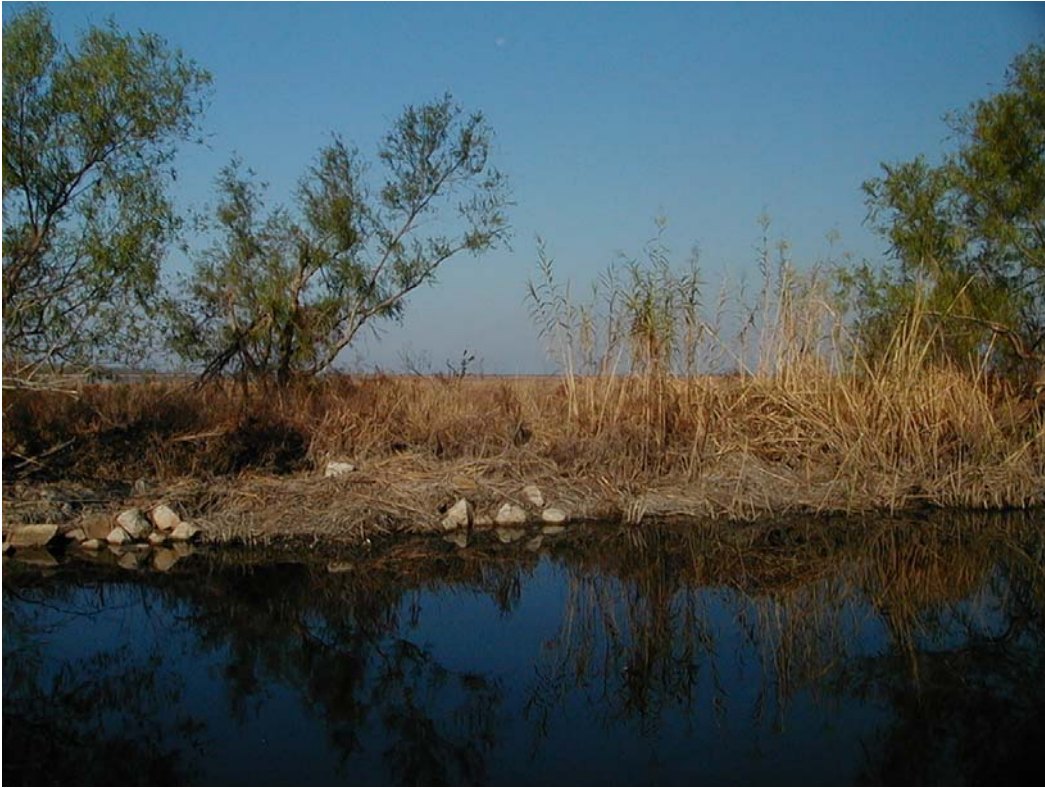
Photo 1, Tie in to North Prong Canal

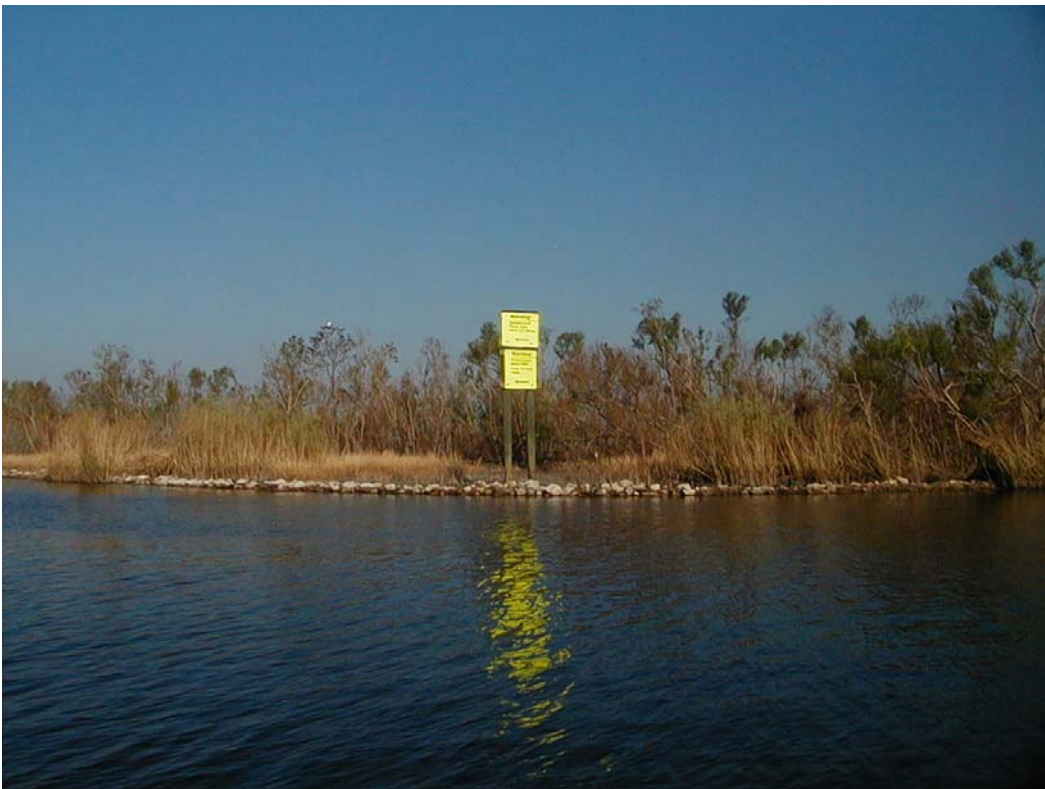
**2001 – Warning Sign Addition (USACE)** – The US Army Corps of Engineers added warning signs along the northern boundary of the project in August 2001 in response to complaints from the commercial traffic traveling along the GIWW. This is not a project feature to be maintained through CWPPRA.

Photo 2, Signs installed by USACE

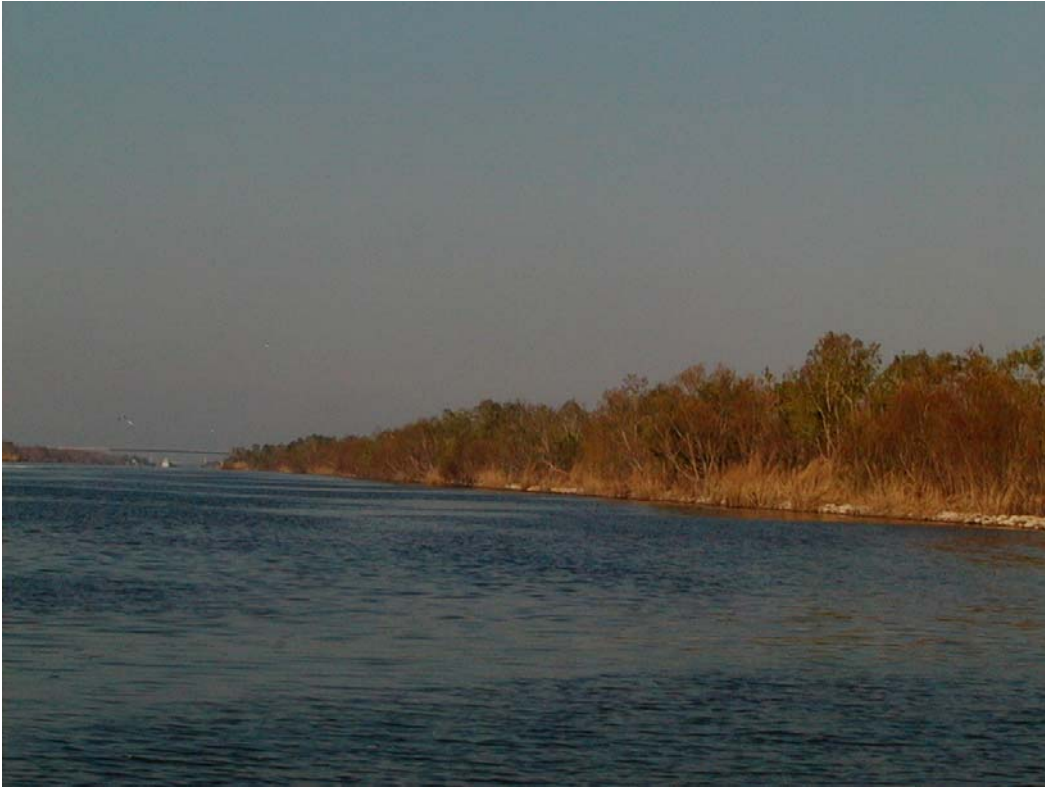
The dike is in excellent post construction condition and appears to be in the same condition as to what existed prior to the storm. There is a short section of dike that is low with some displaced rock. Vegetation in the area as well as trees along the canal bank was observed to be experiencing stress due to salt water inundation and strong winds. No need for any maintenance in the foreseeable future. (Photos: Appendix B, Photos 1 - 4)

Photo 3, Typical foreshore dike section.

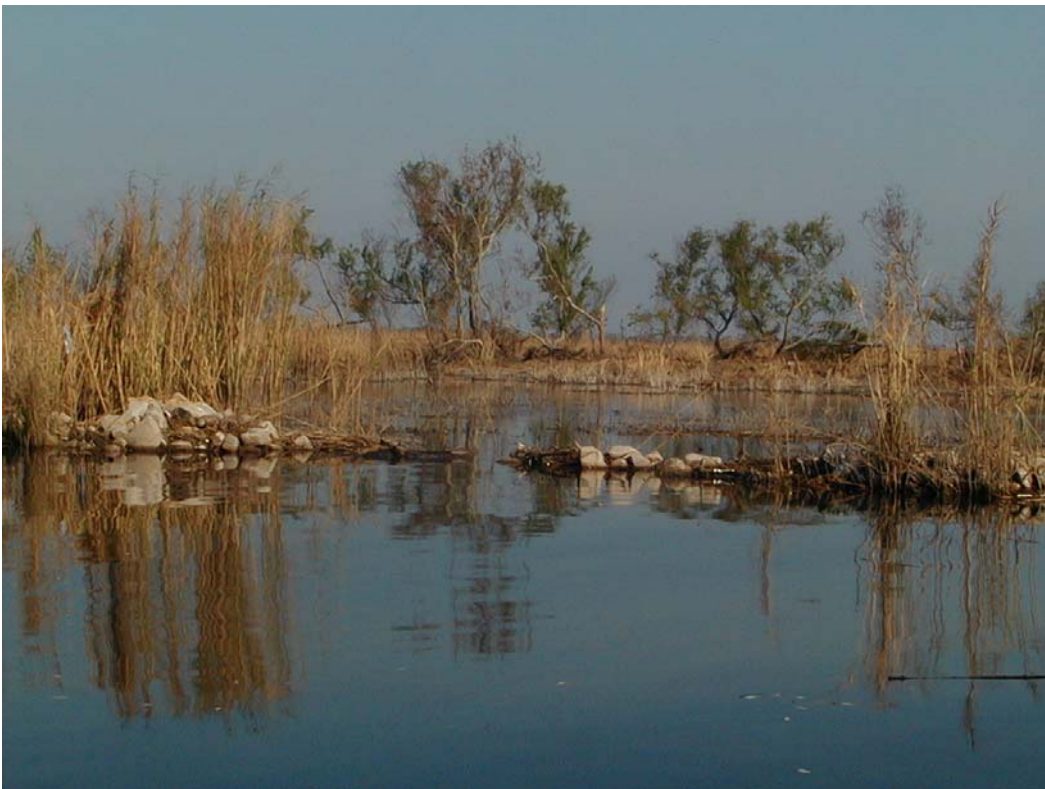
Photo 4, Low area/displaced rock area along dike.

Item	Condition	Physical Damage	Corrosion	Photo #	Observations and Remarks
Steel Bulkhead / Caps	N/A				
Steel Grating	N/A				
Stop Logs	N/A				
Hardware	N/A				
Timber Piles	N/A				
Timber Wales	N/A				
Galv. Pile Caps	N/A				
Cables	N/A				
Signage /Supports	Good			2	
Rip Rap (fill) (foreshore dike)	Excellent			1,3 & 4	One area of dike is low with displaced rock.
Earthen Embankment	N/A
