**State of Louisiana  
Department of Natural Resources  
Coastal Engineering Division**

**2005/2006 Annual Inspection  
Report**

**HUMBLE CANAL HYDROLOGIC  
RESTORATION PROJECT  
(ME-11)**

October 19, 2005  
Cameron Parish

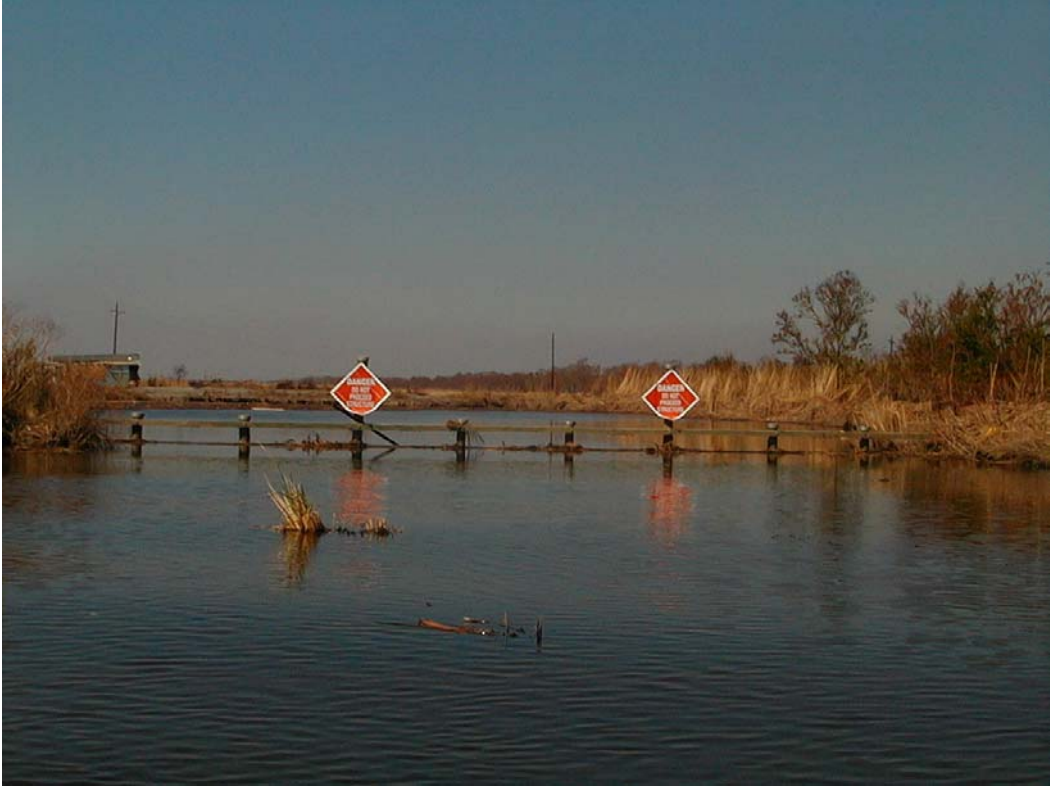
The structure is in excellent condition. Some shrinkage of the sign lettering has occurred and the signs are slightly bent from Hurricane RITA damage. Bank tie-ins, pile caps, hardware, etc. is in excellent condition. No maintenance is required at this time. (Photos: Appendix B, Photo 1)

Photo 1, Marine barrier with signage.

Item	Condition	Physical Damage	Corrosion	Photo #	Observations and Remarks
Steel Bulkhead / Caps	good				
Steel Grating					
Stop Logs	N/A				
Hardware	good				
Timber Piles	good				
Timber Wales	good				
Galv. Pile Caps	good				
Cables	N/A				
Signage / Supports	good			1	Some odd shrinkage of the lettering on the warning signs. Still no cause for concern. Signs slightly bent from Hurricane RITA damage.
Rip Rap (fill)	N/A				
Eathern Embankment	N/A

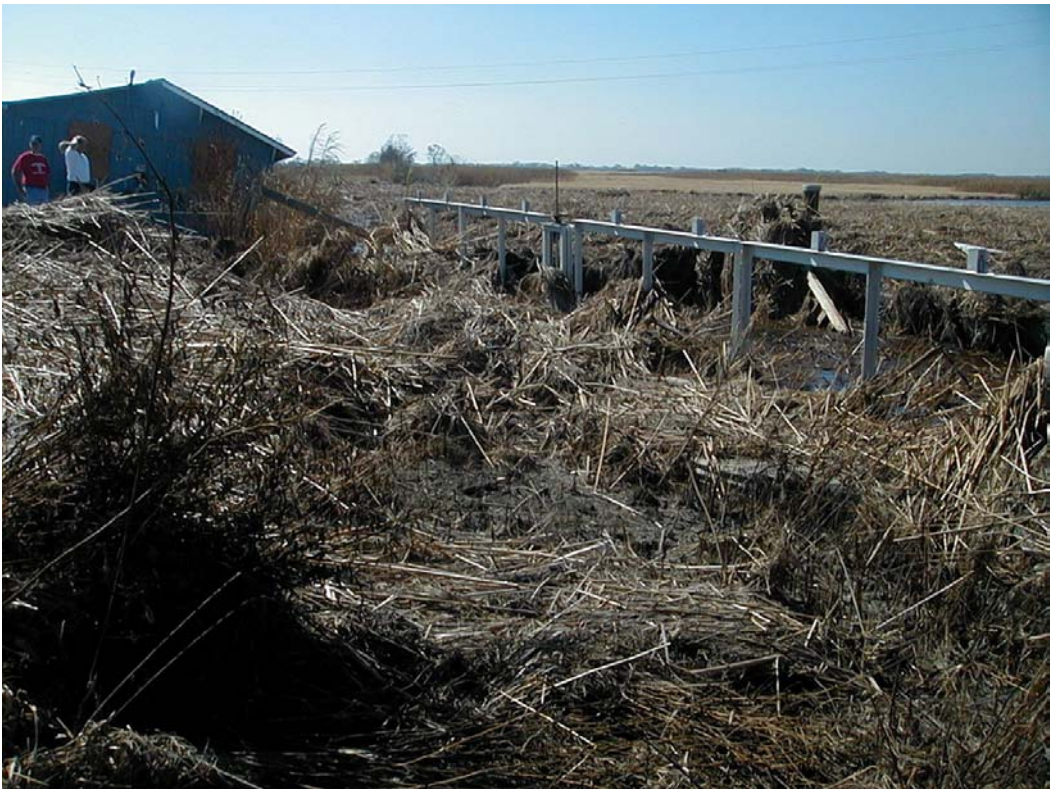
This feature is in good condition. There is a large amount of debris and wrack material clogging the hyacinth guard. Maintenance is required at this time. (Photos: Appendix B, Photo 2)

Photo 2, Inlet side showing hyacinth fence in background covered with debris, as well as embankment of structure.

Item	Condition	Physical Damage	Corrosion	Photo #	Observations and Remarks
Steel Bulkhead / Caps	good				
Steel Grating	N/A				
Stop Logs	N/A				
Hardware	fair			2	Hyacinth fence is covered with wrack and debris.
Timber Piles	good				
Timber Wales	good				
Galv. Pile Caps	good				
Cables	N/A				
Signage /Supports	N/A				
Rip Rap (fill)	N/A				
Earthen Embankment	N/A

**06/07 Description: Maintenance event to clean inlet channel, repair rock embankment (damages from Hurricane RITA)**

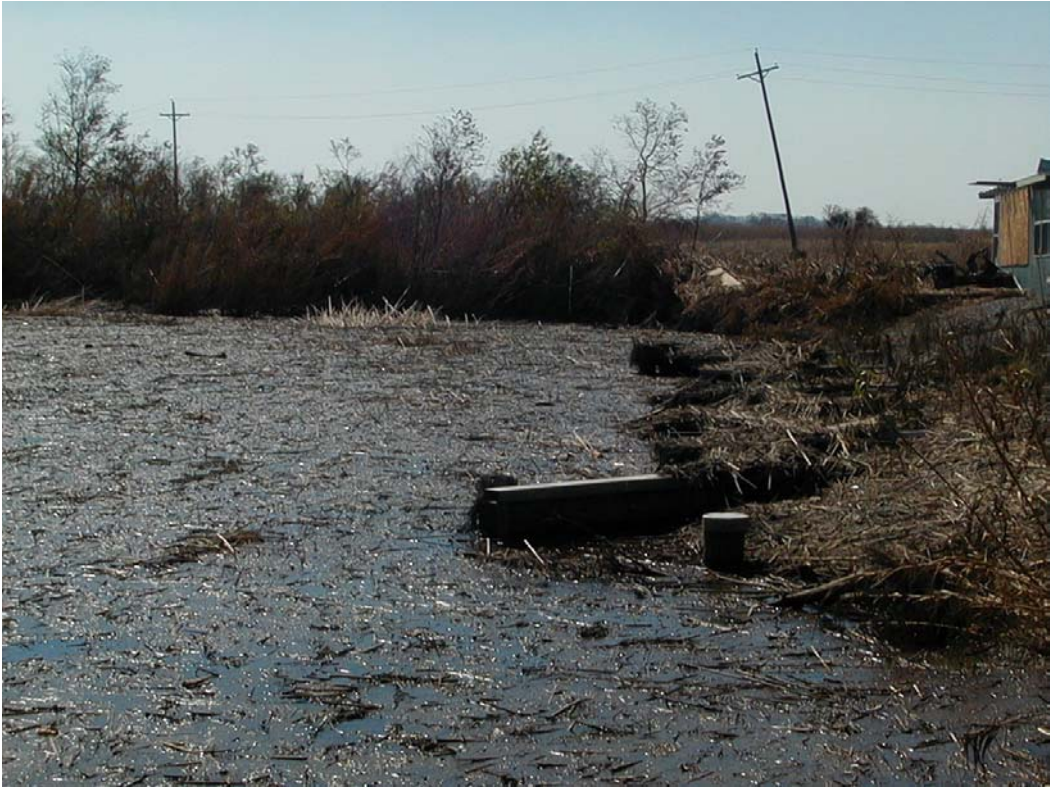
Overall, the structure is in good post construction condition. The inspection noted erosion of the embankment behind each wing wall and over the structure along with an extensive amount of wrack clogging the inlet channel which is affecting flow through the structure. A nearby camp building has been deposited on the southern portion of the structure from Hurricane RITA storm surge, however it is not impacting the operation of the structure. Maintenance will be required at this time. Both agencies agreed to perform a structural assessment survey in 2006/2007 for comparison to previous as-built surveys. (Photos: Appendix B, Photos 3, 4 & 5)

Photo 3, Outlet side of structure covered with wrack.

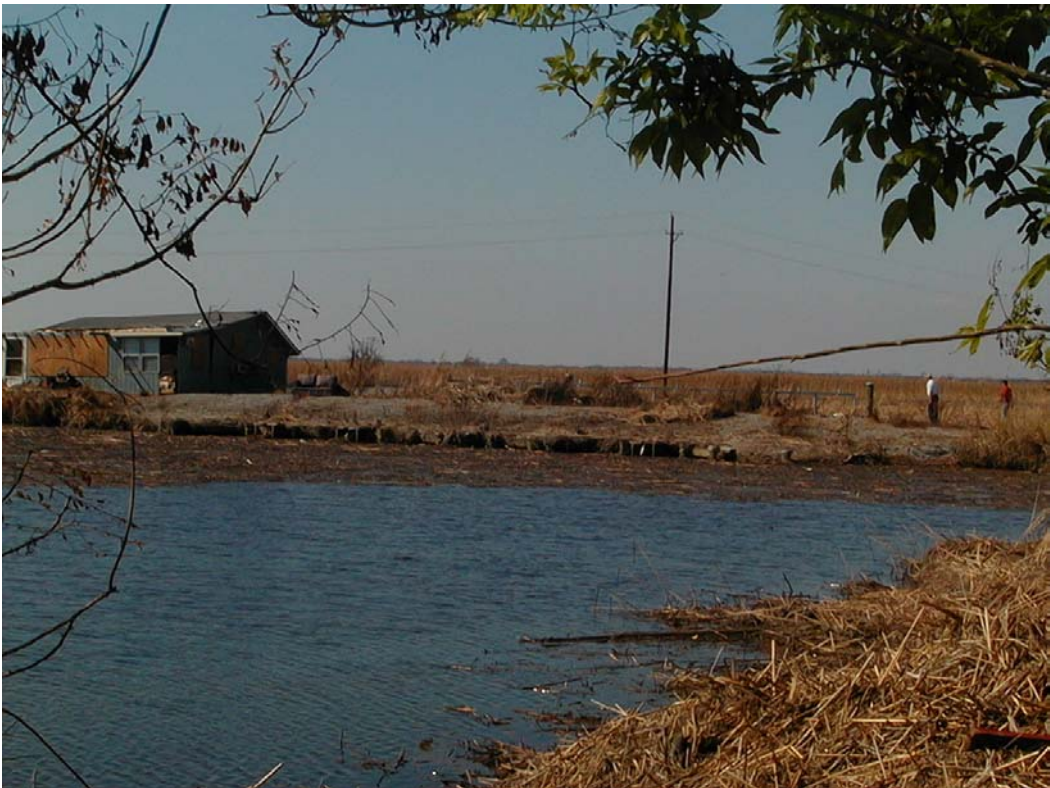
Photo 4, Showing camp on southern end of structure embankment.

Overall, the Humble Canal Hydrologic Restoration Project is in good condition however it is not functioning as designed due to the clogged inlet channel. The aluminum stoplog design that was used on this project appears to be easy to operate, light, and should have a long maintenance free lifespan. A maintenance event is planned to clean the wrack and debris from the inlet channel to restore flow and repair the embankment around the structure with stone. Repairs are also necessary on some of the flap gates and lifting arms. A FEMA claim has been submitted for repair of the structure. A structural assessment survey is recommended as noted above for fiscal year 2006/2007. Ownership of the camp will try to be determined and a decision made about final disposition of this building.

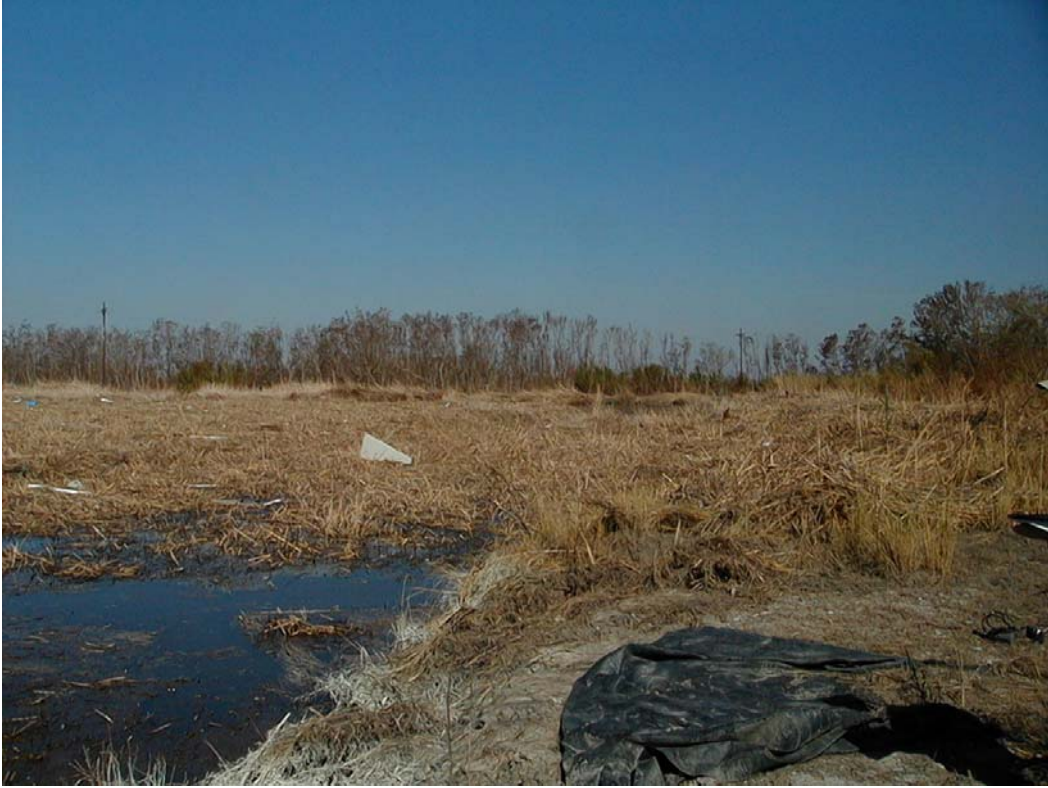
Photo 5, Showing clogged inlet channel, view looking north.

Item	Condition	Physical Damage	Corrosion	Photo #	Observations and Remarks
Steel Bulkhead / Caps	good				
Steel Grating	good				
Stop Logs	good				Stoplogs on this structure are made of aluminum and should last practically forever.
Hardware	good				
Timber Piles	good				
Timber Wales	good				
Galv. Pile Caps	good				
Cables/ lifting device	good				The lifting apparatus was not on site.
Signage /Supports	good				
Rip Rap (fill) (foreshore dike)	good				
Eathern Embankment	fair			3	Erosion has occurred behind each wingwall and over the structure.
Inlet Channel/Plug				4	A camp building has been deposited on the southern end of the structure.
				5 & 6	Inlet channel completely clogged with wrack and debris, earthen plug removed by Cameron Parish GDD.

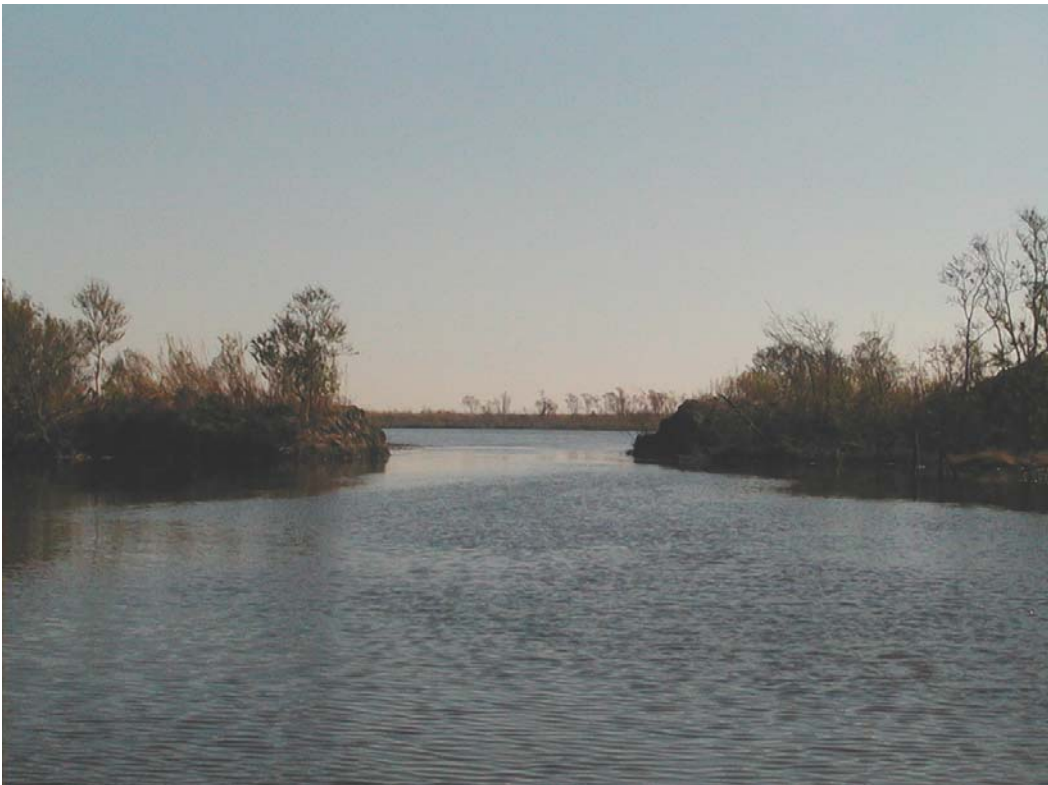
The earthen plug from the original Humble Canal was removed by Cameron Parish Gravity District to relieve high water levels from the storm surge of Hurricane RITA. (Photos: Appendix B, Photo 6)

Photo 6, Earthen plugged removed by Cameron Parish Gravity District to relieve high water levels.
