**State of Louisiana
Department of Natural Resources
Coastal Engineering Division**

**2005/2006 Annual Inspection
Report**

**FRESHWATER BAYOU CANAL
BANK STABILIZATION
PROJECT (ME-13)**

October 7, 2005
Vermilion Parish

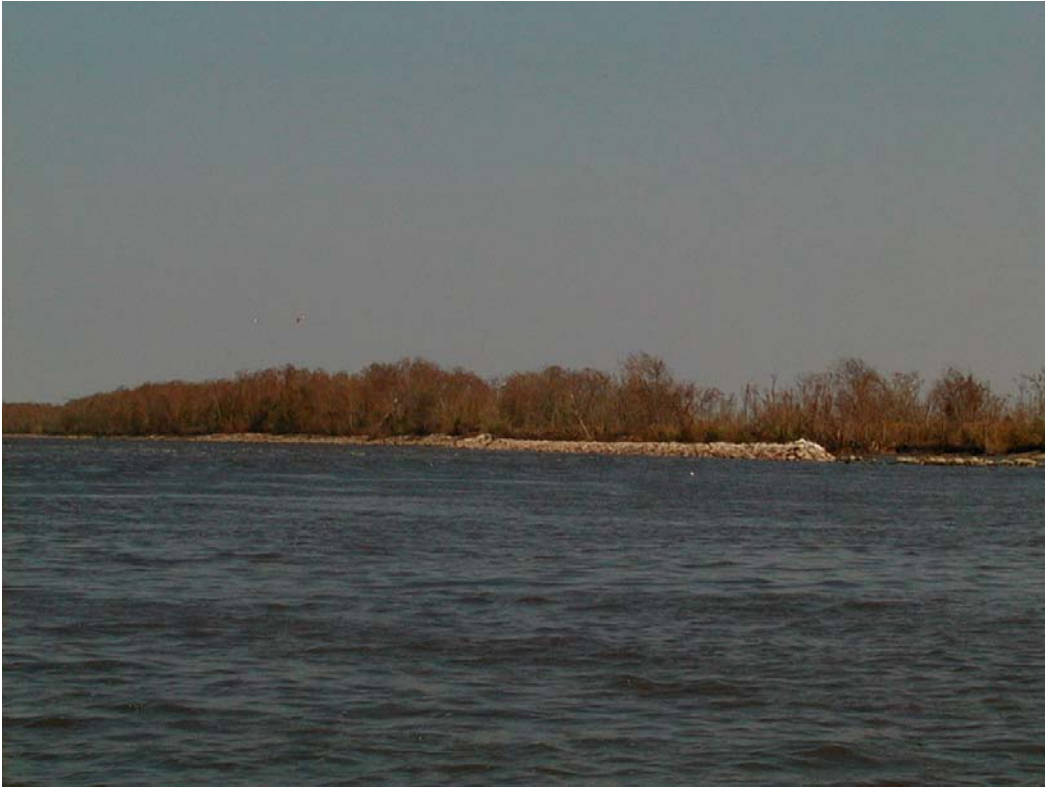
The inspection revealed the rock foreshore dike is in good condition and sustained no damage from the storm surge. The recently completed maintenance project to restore the dike to constructed elevations held up well through high water conditions. (Photos: Appendix B, Photos 1 & 2)

Photo 1, Typical rock dike

Item	Condition	Physical Damage	Corrosion	Photo #	Observations and Remarks
Steel Bulkhead / Caps	N/A				
Steel Grating	N/A				
Stop Logs	N/A				
Hardware	N/A				
Timber Piles	N/A				
Timber Wales	N/A				
Galv. Pile Caps	N/A				
Cables	N/A				
Signage / Supports	N/A				
Rip Rap (fill) (foreshore dike)	Good			1 & 2	Recent maintenance work to restore dike to constructed elevation sustained no damage from Hurricane RITA.
Earthen Embankment	N/A

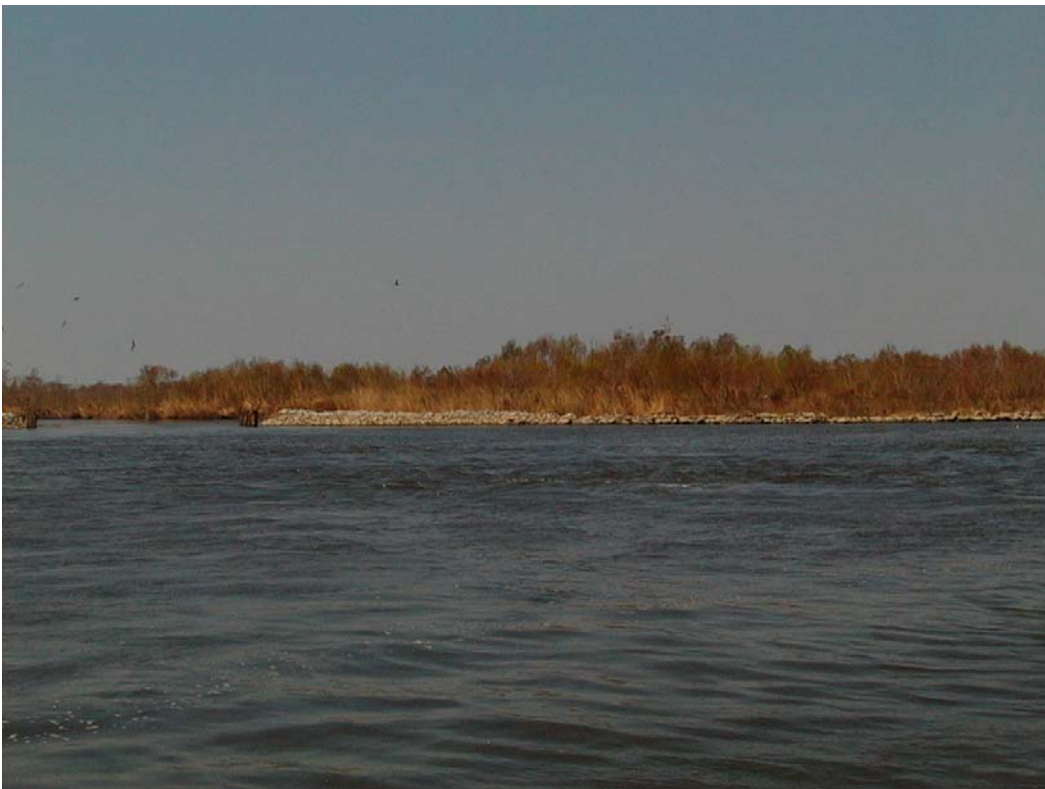
Photo 2, Typical rock dike.
