**State of Louisiana  
Department of Natural Resources  
Coastal Engineering Division**

**2005/2006 Annual Inspection  
Report**

**PECAN ISLAND TERRACING  
PROJECT  
(ME-14)**

October 20, 2005  
Vermilion Parish

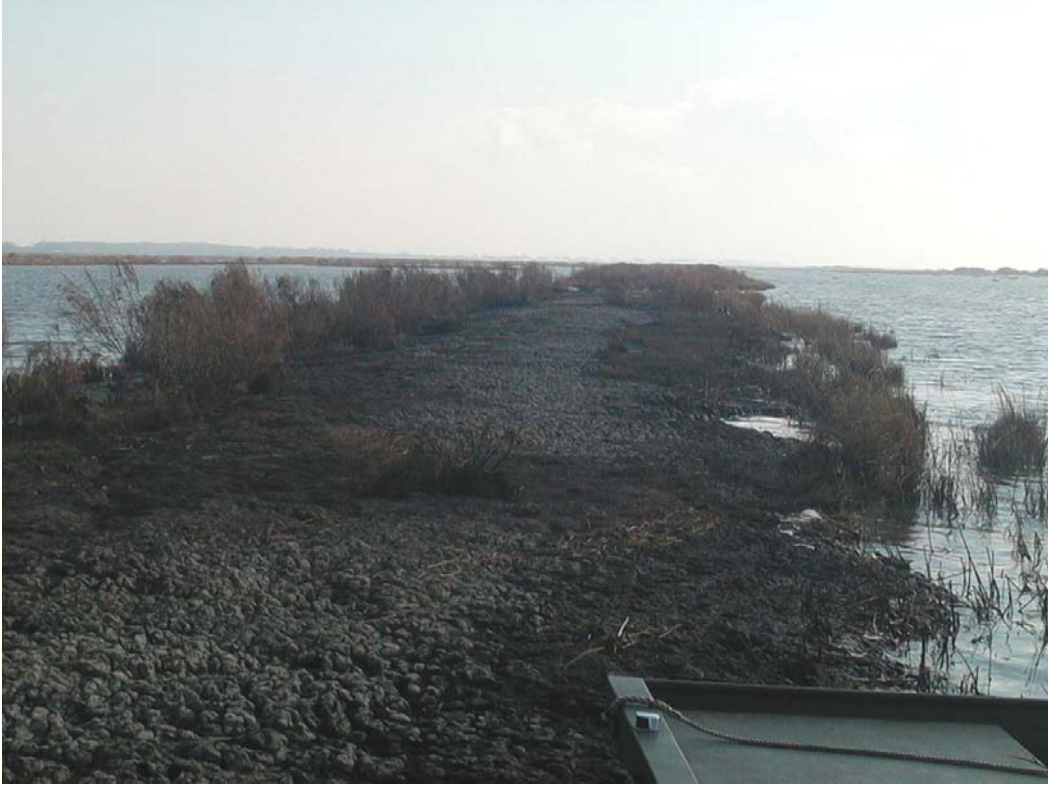
The earthen terraces are in very good condition and did not sustain damages from the storm. Anticipated erosion on the southern sacrificial terraces has occurred. However, those sacrificial terraces are still providing protection for the interior earthen terraces. No maintenance required at this time. (Photos: Appendix B, Photo 1)

Photo 1, Typical earthen terrace.

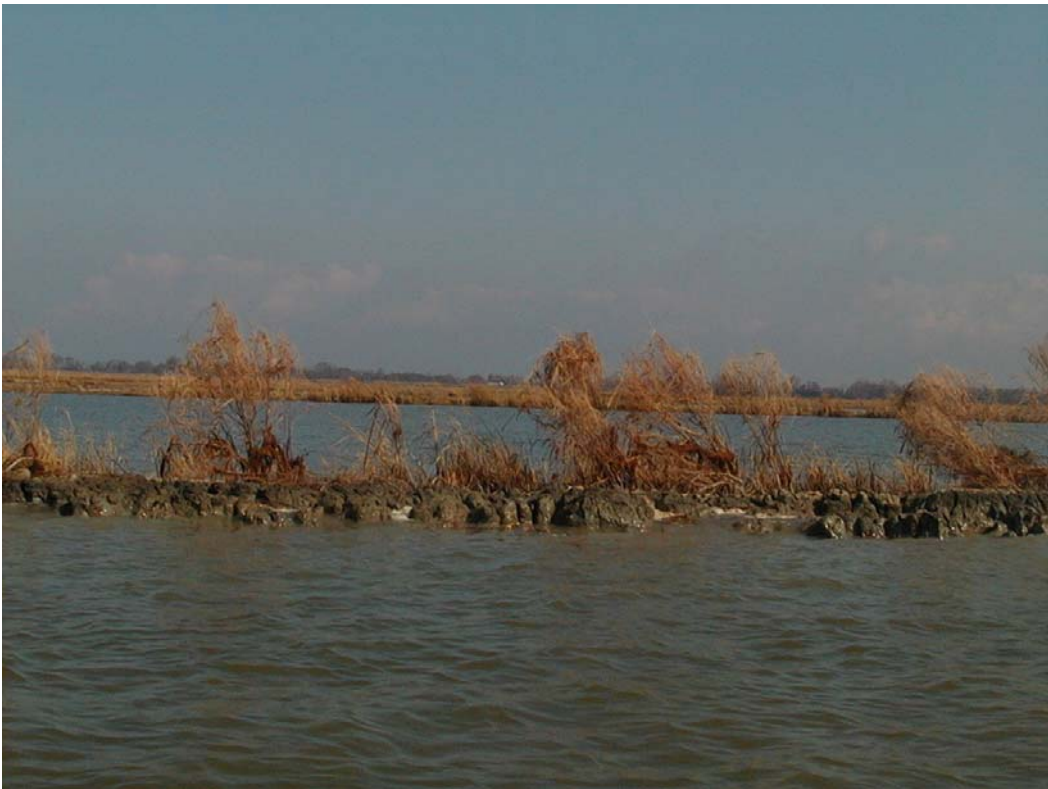
The vegetative plantings on the slopes of the earthen terraces have colonized significantly and are experiencing stress due to salt water inundation and hurricane force winds. On a separate field trip dated October 11, 2005, Monitoring Personnel identified the need for complete replacement of two (2) continuous recorders and two (2) staff gages within the project area. (Photos: Appendix B, Photo 2)

Photo 2, Typical eroded terrace.
