## **2005/2006 Annual Inspection Report**

### **GRAND-WHITE LAKES LANDBRIDGE PROTECTION PROJECT (ME-19)**

State Project Number ME-19  
Priority Project List 10

October 12, 2005  
Cameron Parish

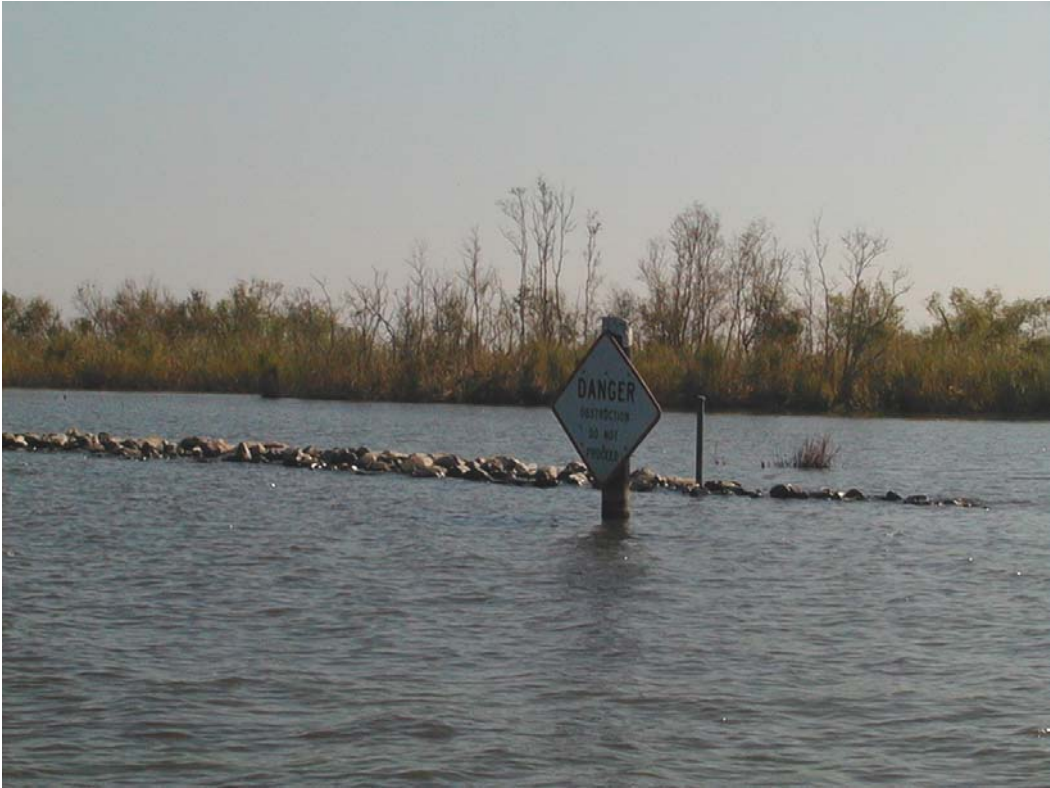
The foreshore rock dike feature is in excellent condition and appears to be in same condition as to what existed prior to Hurricane RITA. No maintenance is required at this time. (Photos: Appendix B, Photos 1 & 2)

Photo 1, Typical rock dike, note high water from Hurricane RITA storm surge.

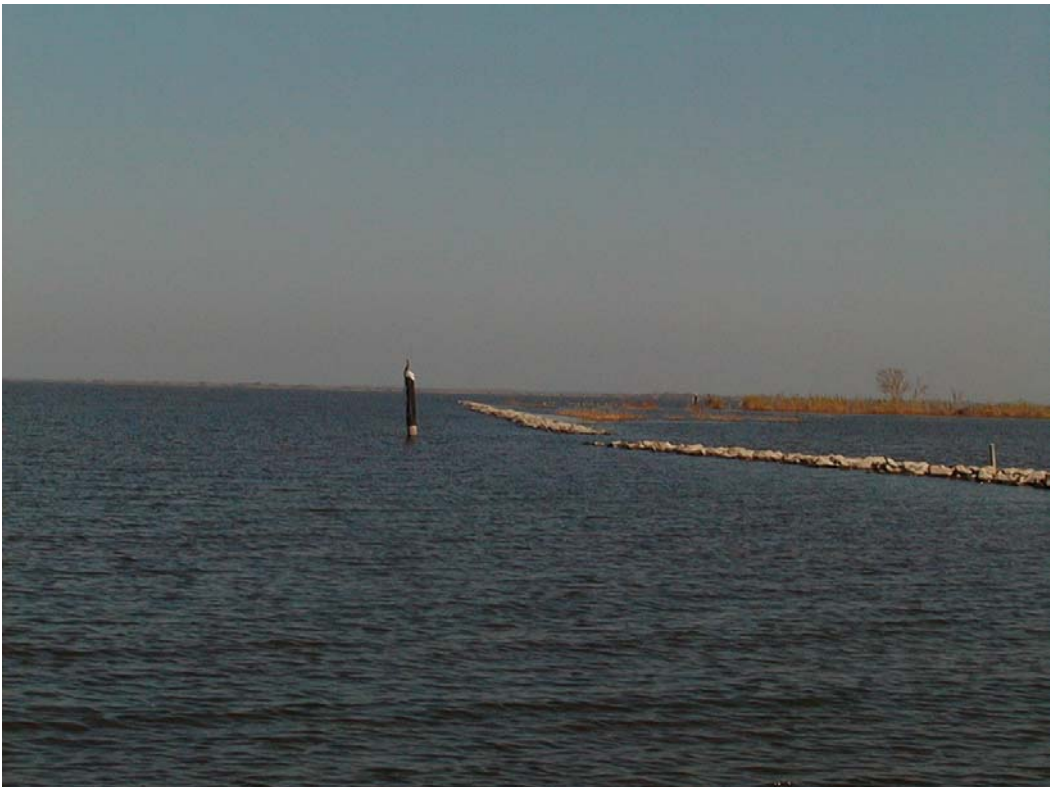
Photo 2, Rock foreshore dike.

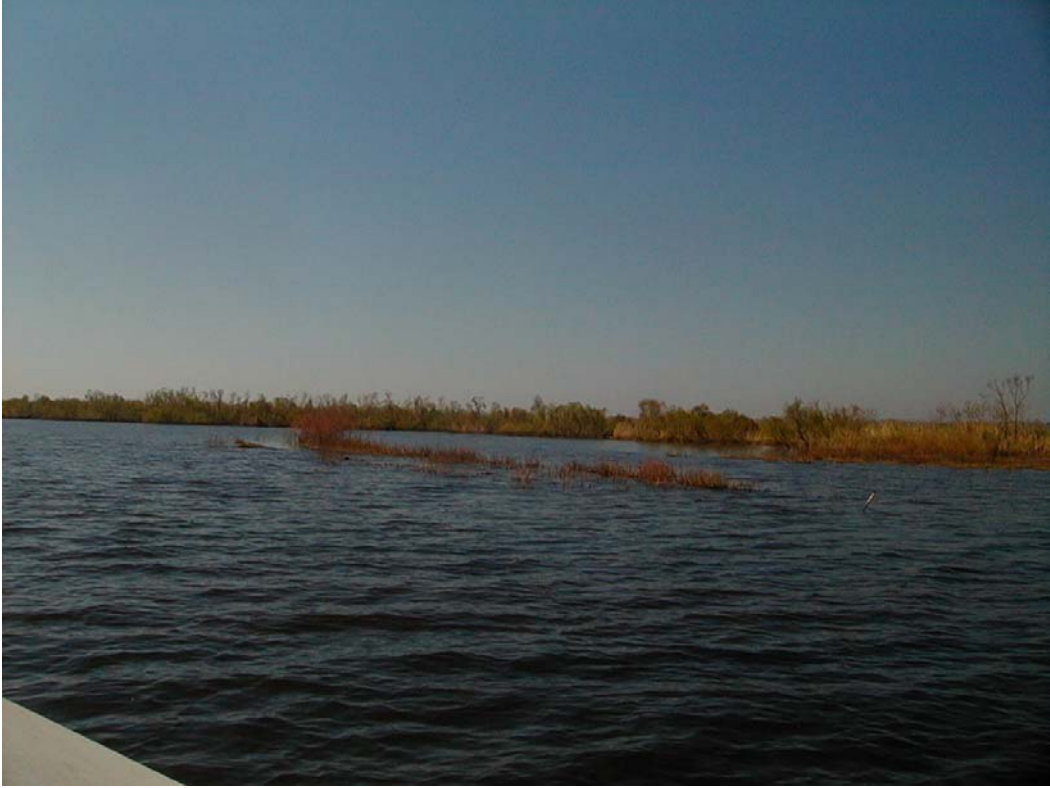
The condition of the shallow water earthen terraces feature of the project was unable to be determined due to the high water conditions. Previous O & M Annual Inspections did

note marsh side and lake side earthen terraces along Collicon Lake having experienced some erosion with the most extensive occurring on the East side of Collicon Lake. Original giant cutgrass plantings along the terraces were visible although appearing stressed. (Photos: Appendix B, Photos 3 & 4)

Photo 3, Earthen terraces submerged by high water.

Overall, the foreshore rock dike feature of the Grand-White Lake Landbridge Project is in excellent condition and is functioning as designed and did not sustain any discernable damage from Hurricane RITA. The earthen terrace feature along Collicon Lake has experienced some erosion and will be monitored in the future to determine if a maintenance or vegetative planting project is needed.

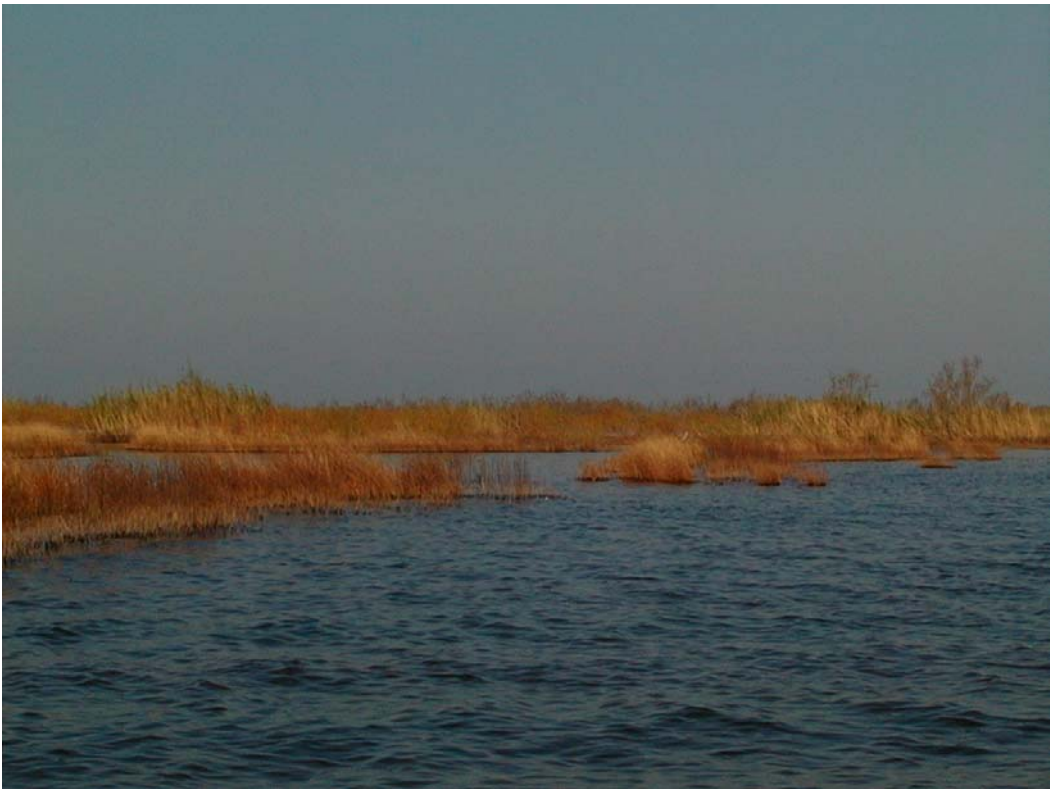
Photo 4, Earthen terraces
