**State of Louisiana  
Department of Natural Resources  
Coastal Engineering Division**

**2005/2006 Annual Inspection  
Report**

**COTE BLANCHE HYDROLOGIC  
RESTORATION PROJECT  
(TV-04)**

October 11, 2005  
St. Mary Parish

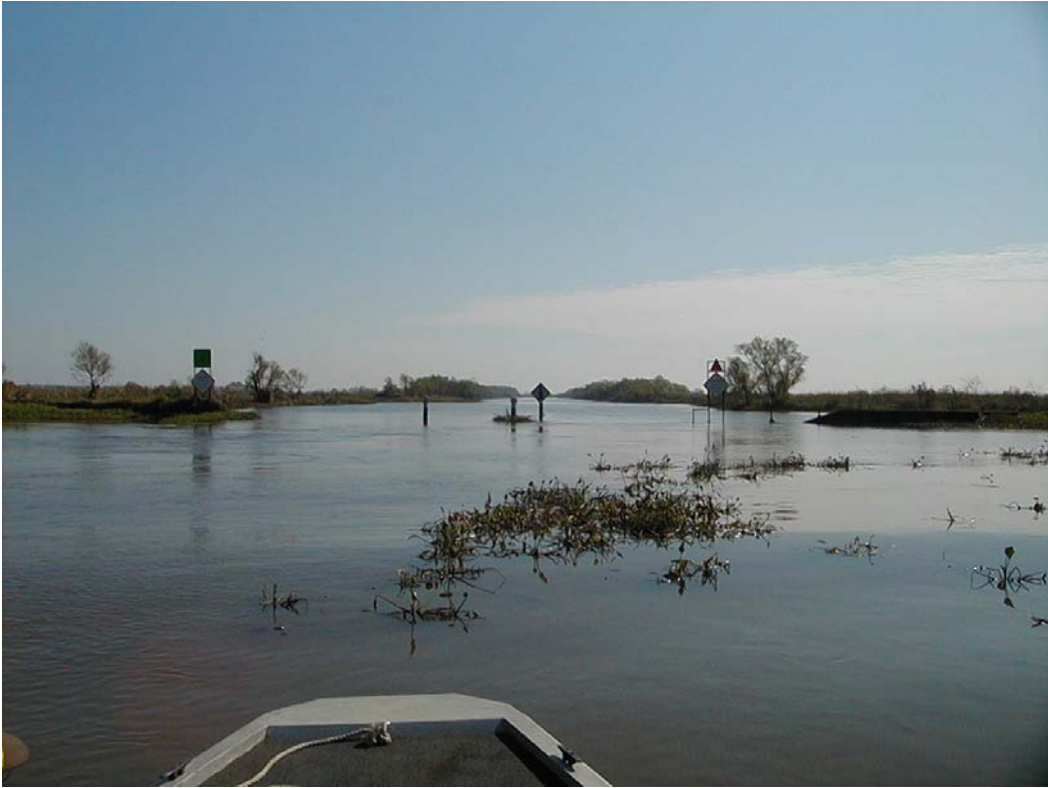
Photo 1, Mud Bayou Structure

Mud Bayou did not experience any damages due to Hurricane RITA. The conditions of the structure are good, though it appears that the old bayou channel that existed to the marsh side of the structure appears somewhat wider. (Photos: Appendix B, Photo 1).

Item	Condition	Physical Damage	Corrosion	Photo #	Observations and Remarks
Steel Bulkhead / Caps	good				It appears the old bayou channel that existed to the marsh side of the structure appears somewhat wider.
Steel Grating	N/A				
Stop Logs	N/A				
Hardware	good				
Timber Piles	good				
Timber Wales	N/A				
Galv. Pile Caps	N/A				
Cables	N/A				
Signage / Supports	good				
Rip Rap (fill)	good				
Eathem Embankment	N/A

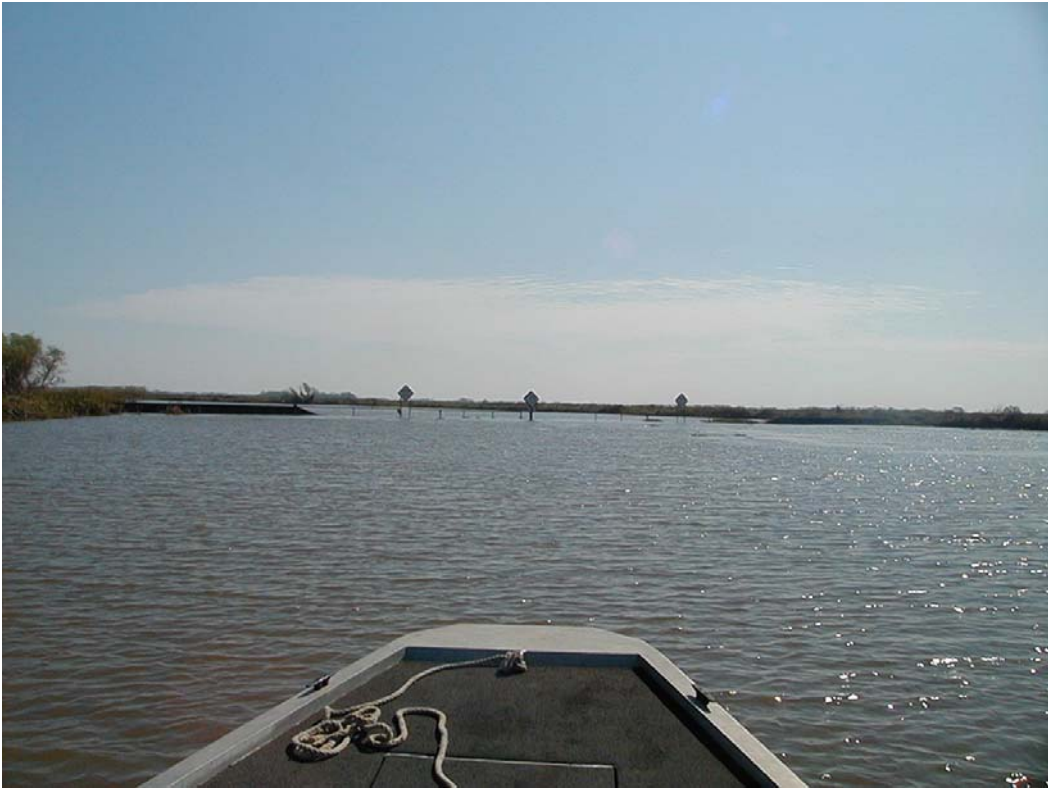
Photo 2, Humble F-Canal Structure

Humble F Canal did not experience any damages due to Hurricane RITA. (Photos: Appendix B, Photo 2).

Item	Condition	Physical Damage	Corrosion	Photo #	Observations and Remarks
Steel Bulkhead / Caps	good				Structure in good condition. Some slight rusting of pile caps. No immediate action necessary
Steel Grating	N/A				
Stop Logs	N/A				
Hardware	good				
Timber Piles	good				
Timber Wales	N/A				
Galv. Pile Caps	N/A				
Cables	N/A				
Signage / Supports	good				
Rip Rap (fill)	good				
Eathern Embankment	N/A

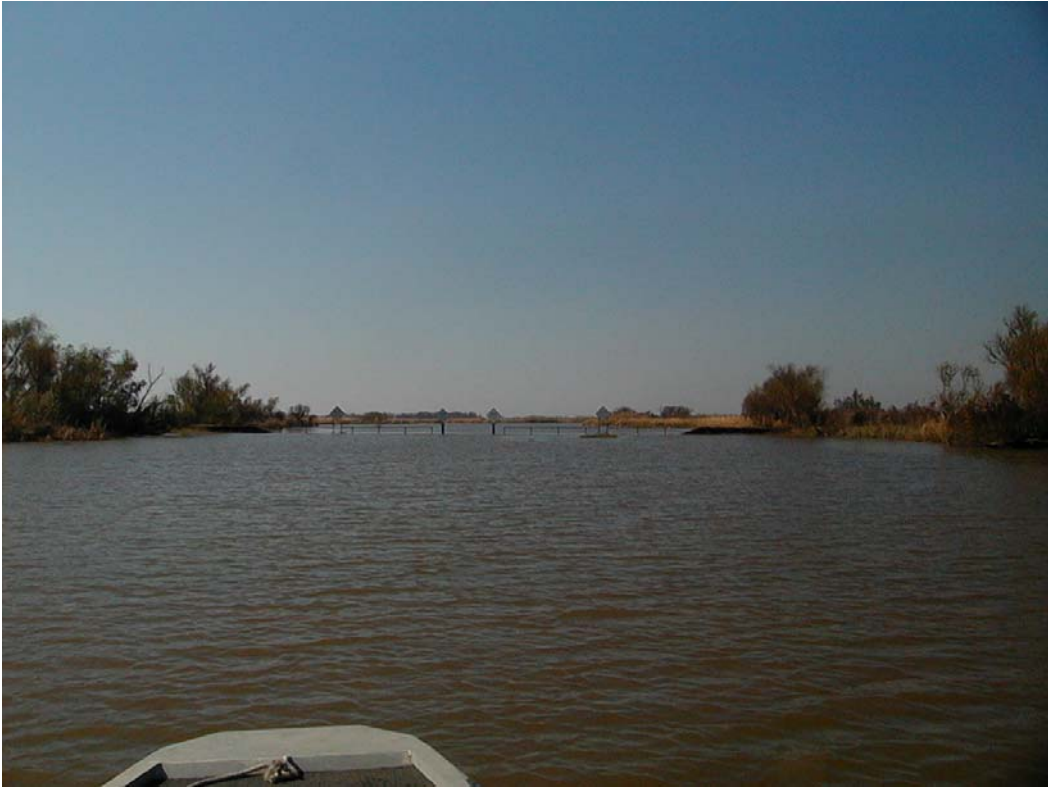
Photo 3, Bayou Long Structure

Bayou Long structure did not receive any damages due to Hurricane RITA. (Photos: Appendix B, Photo 3).

Item	Condition	Physical Damage	Corrosion	Photo #	Observations and Remarks
Steel Bulkhead / Caps	good				Structure in pristine post-construction condition. Some slight rusting of pile caps. No immediate action necessary.
Steel Grating	N/A				
Stop Logs	N/A				
Hardware	good				
Timber Piles	good				
Timber Wales	N/A				
Galv. Pile Caps	N/A				
Cables	N/A				
Signage / Supports	good				
Rip Rap (fill)	N/A				
Eathern Embankment	N/A

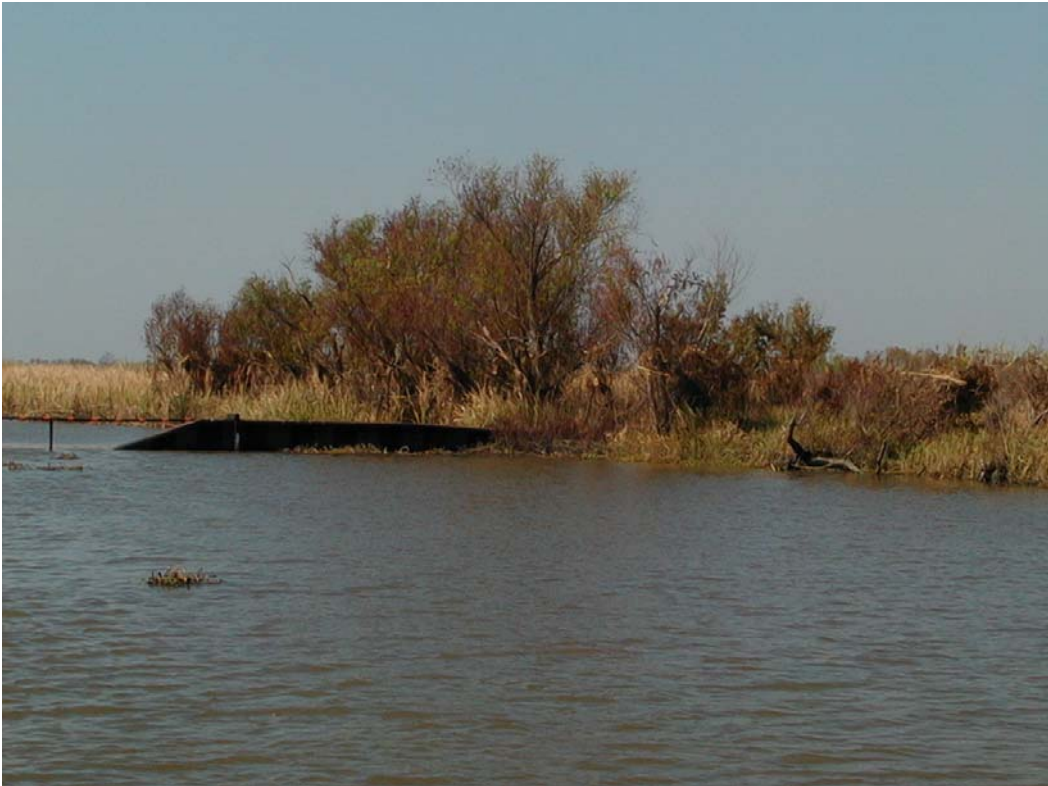
Photo 4, Bayou Carlin Structure

Bayou Carlin structure did not receive any damages due to Hurricane RITA. (Photos: Appendix B, Photo 4).

Item	Condition	Physical Damage	Corrosion	Photo #	Observations and Remarks
Steel Bulkhead / Caps	good				Structure in pristine post-construction condition. Some slight rusting of pile caps. No immediate action necessary.
Steel Grating	N/A				
Stop Logs	N/A				
Hardware	good				
Timber Piles	good				
Timber Wales	N/A				
Galv. Pile Caps	N/A				
Cables	N/A				
Signage / Supports	good				
Rip Rap (fill)	N/A				
Eathern Embankment	N/A

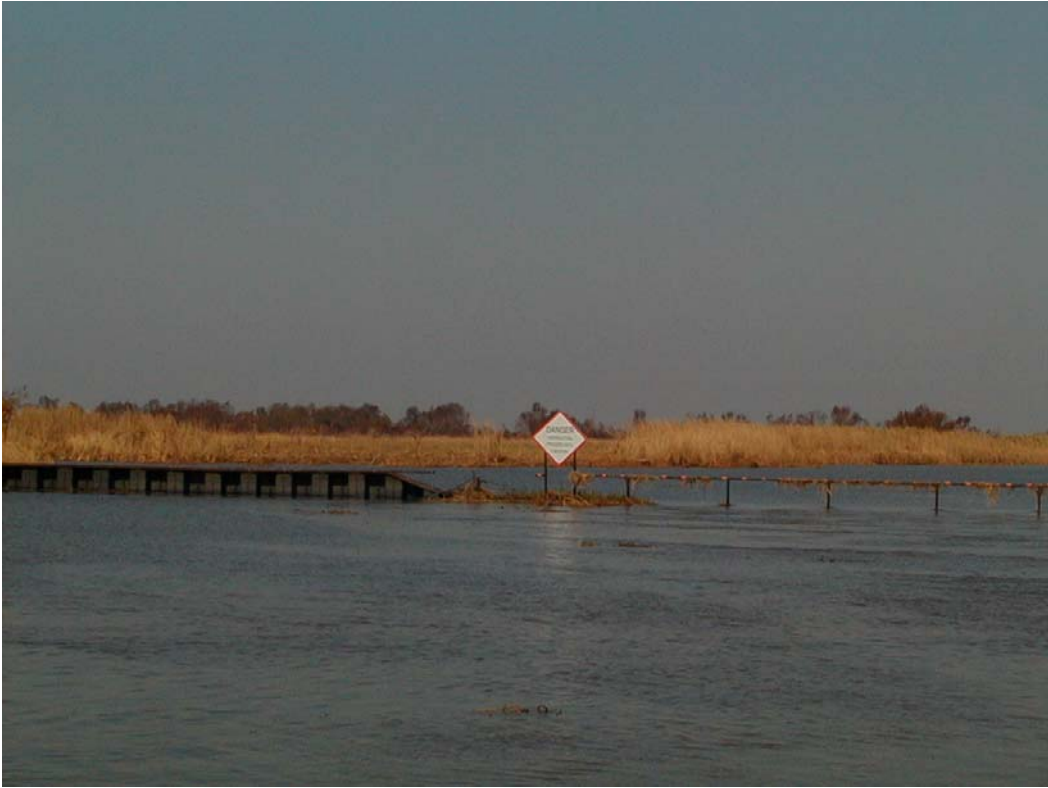
Photo 5, Humble Canal Structure

Humble Canal structure received minor damages as a result of Hurricane RITA. The shoreline at the south end of the rock riprap dike has experienced some erosion and the marsh area remaining is narrow and now subject to being breached allowing water to flow around the weir. The “handrail” on the north side of the barge bay notch, actually a railing of 3 inch pipe that is approximately 2 feet above normal water levels that marks that reach of the sheet pile weir as being non-navigable to boaters, is broken and approximately 8-10 feet of same is missing. The balance of the north “handrail”, approximately 40 feet in length, is slightly bent towards the bay. The cable wraps around the timber pile supports (four timber pile supports total) that support the USCG required Navigation Lights with NAVAid signs are all very loose and now ineffective. The four (4) light assembly apparatuses with the associated solar cells, batteries, battery boxes, etc. for each, will have to be inspected by an authorized firm to determine if they still to light up at night. The storm tidal surge in the area came very high, was of high salinity, and left some “wrack” debris among some of the light assemblies, thus the lighting system may have been adversely impacted. One of the solar cells appears to have been displaced such that it does not face the sun properly to charge the batteries. (Photos: Appendix B, Photo 5).

Item	Condition	Physical Damage	Corrosion	Photo #	Observations and Remarks
Steel Bulkhead / Caps	good				Some initial post construction rusting. No action needed.
Steel Grating	N/A				
Stop Logs	N/A				
Hardware	fair				Handrails need to be replaced and/or repaired.
Timber Piles	N/A				
Timber Wales	N/A				
Galv. Pile Caps	good				
USCG Lights	poor				All light assemblies need to be inspected and repaired if necessary
Signage / Supports	poor				Pile clusters will need to be reinforced/rewrapped with stainless steel cable.
Rip Rap (fill)	fair				Shoreline protection dike on south area of weir needs to be extended and made secure with additional rock.
Eathern Embankment	N/A

Overall, the Cote Blanche Hydrologic Restoration Project is in good condition and functioning as designed with minimal damage sustained from Hurricane RITA, however requests for FEMA claims will be necessary at the Humble Canal Structure. Corrective actions necessary are as follows: (1) By use of 110 pound type rock riprap, the shoreline protection dike on the south area of the weir will need to be extended a short distance and the “tie-in” of the dike to the bank made more secure by construction of a “bank head” of stone. (2) The north “handrail” will need to be repaired by replacement of the portion of the rail that is missing and the other portion that is bent and leaning needs to be again made plumb. (3) The existing cable wraps on the light system support piling clusters ( four timber pile supports total) will need to be removed (cable is of stainless steel and is in very good condition) and re-installed in a tight and secure manner. (4) The four USCG required light assemblies will need to be inspected by a firm that is authorized as qualified by the manufacturer and that will be engaged by DNR by contracting to inspect and repair the systems if necessary.

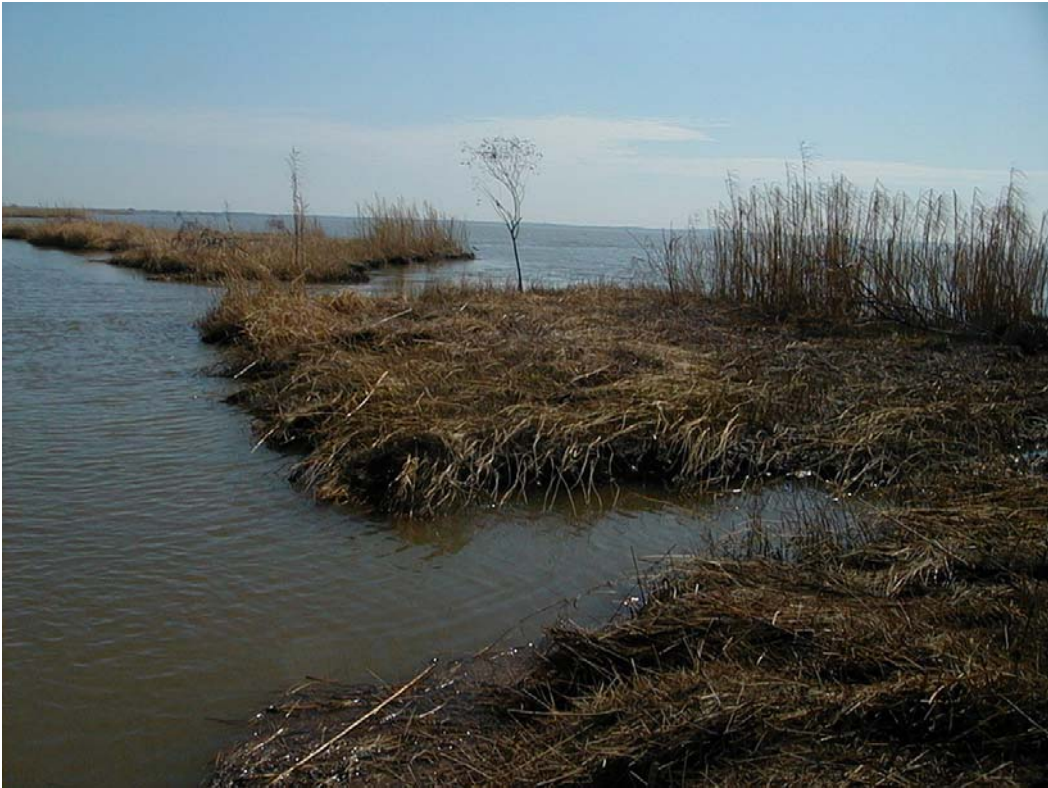
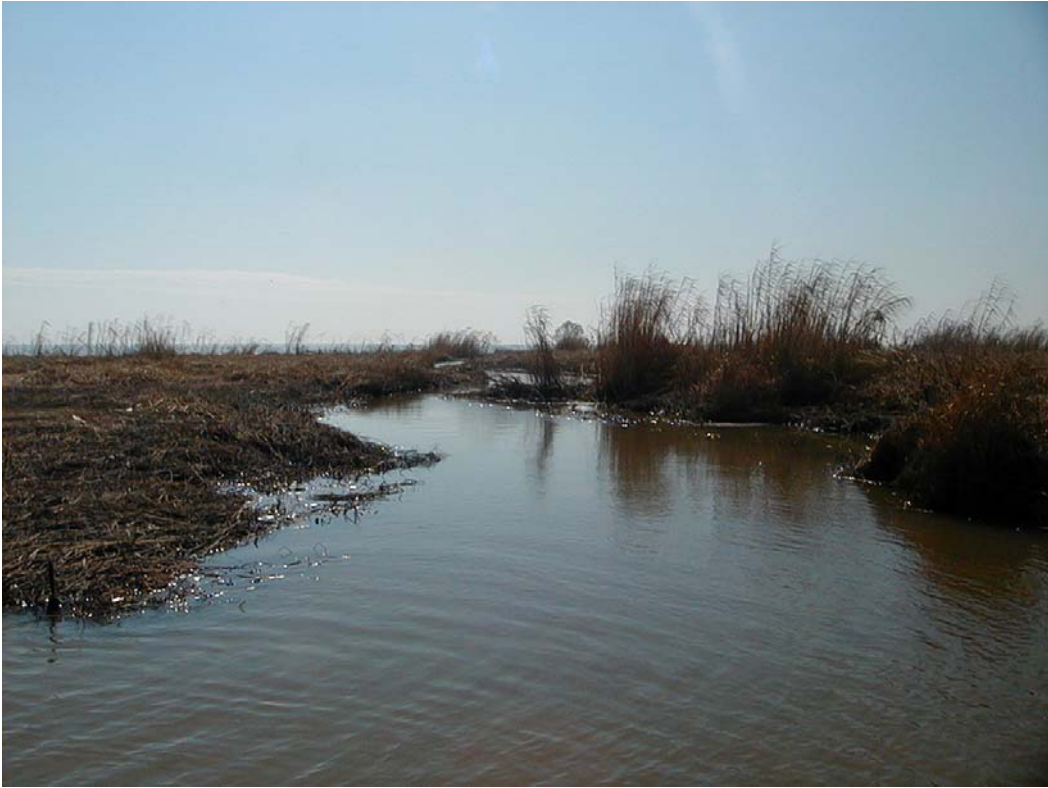
As an aside to inspecting the structural features of this project, we also inspected the School Bus Bayou area to determine the post-RITA conditions of same. We noted that there are now five (5) major breaches between Cote Blanche Bay and the channel proper of School Bus Bayou. During our last pre-RITA inspection approximately two months earlier, only three (3) channel connections had been found. Some of the channel cuts were sounded for depth and found to be approximately 8 feet deep. Each is approximately 10 to 14 feet in width and water was running out to the bay from the marsh. At some other areas, we noted some indications that other minor cuts were developing, but not yet connected to the bay by water. The remaining “land bridge” that still exists between the bay shore and the bayou appears about the same as to what existed pre-RITA. The marsh in the area has suffered severely from the storm tidal surge and it appears as though some areas have been “mowed” as they are bare of any vegetation. (Photos: Appendix B, Photos 6 & 7).

Photo 6, School Bus Bayou Breaches

Photo 7, School Bus Bayou Breaches

On a separate note, although not a component of the TV-04 project, the condition of the breaches between School Bus Bayou and Cote Blanche Bay has worsened and threatens the effectiveness of the Humble Canal structure. Additional O&M monies have been authorized by the CWPPRA Task Force to perform a maintenance project to provide a rock dike shoreline protection along the bay shore on either side of Humble Canal and plugging all of the existing breaches, construct a low level weir along School Bus Bayou on the west side of Humble Canal, and construct a rock plug along School Bus Bayou on the east side of Humble Canal. This project is scheduled for construction during Spring, 2007.

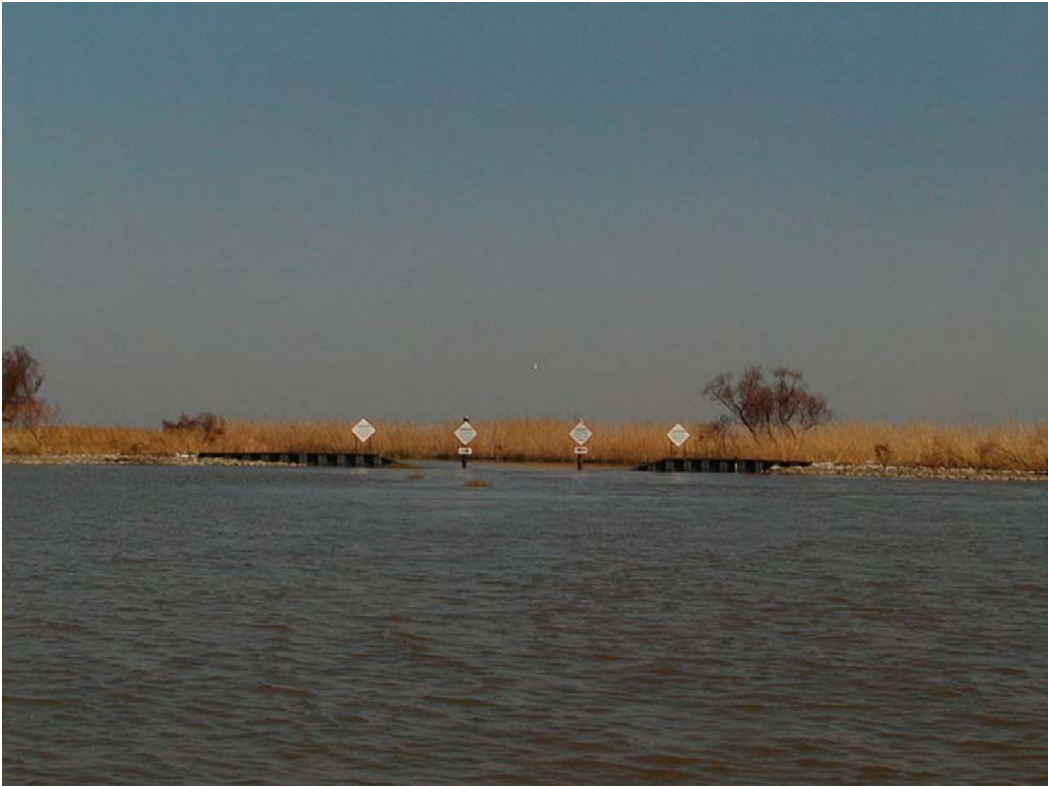
Photo 8, Jackson Bayou Structure

Jackson Bayou structure did not receive any damages due to Hurricane RITA. (Photos: Appendix B, Photo 8).

Item	Condition	Physical Damage	Corrosion	Photo #	Observations and Remarks
Steel Bulkhead / Caps	good				Some slight rusting of pile caps. No immediate action necessary.
Steel Grating	N/A				
Stop Logs	N/A				
Hardware	good				
Timber Piles	poor				
Timber Wales	N/A				
Galv. Pile Caps	N/A				
Cables	N/A				
Signage / Supports	good				
Rip Rap (fill)	N/A				
Eathem Embankment	N/A

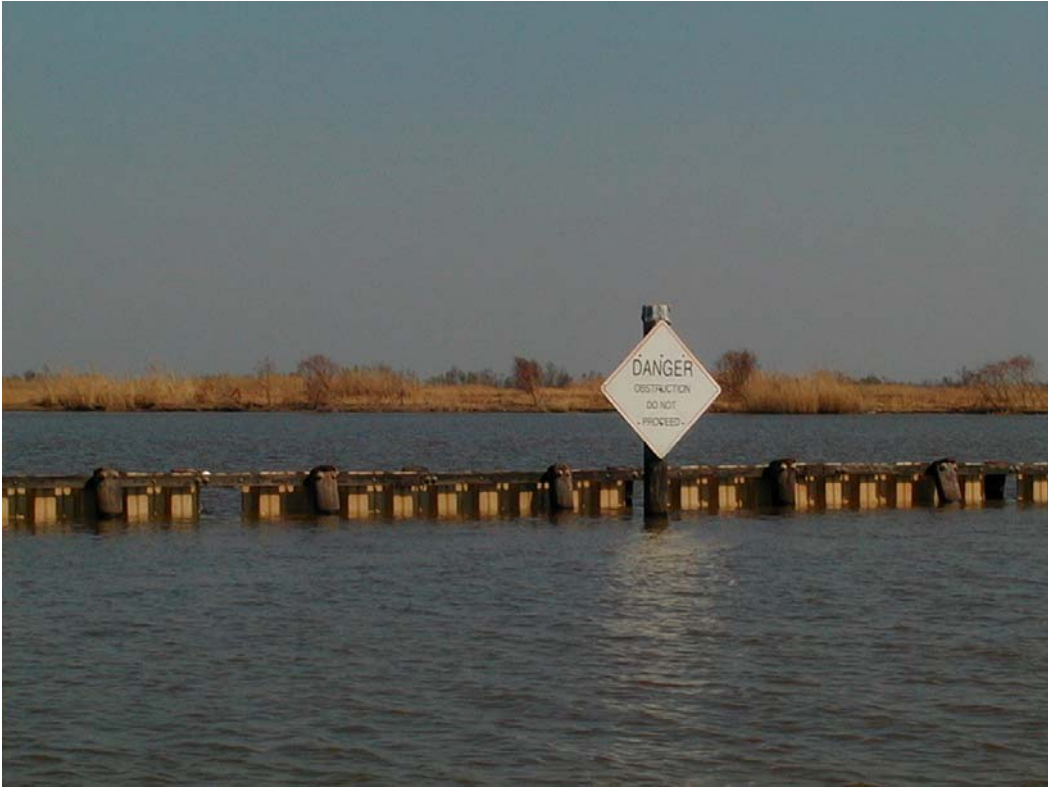
Photo 9, PVC Sheet Pile Wall

The PVC shoreline protection wall did not receive any damages because of Hurricane RITA. There was noted that one large tree trunk was deposited onto the wall, but that is of no consequence. (Photos: Appendix B, Photo 9).

Item	Condition	Physical Damage	Corrosion	Photo #	Observations and Remarks
PVC sheet piling / Caps	fair				PVC wall appears to be in post construction condition and holding up well. There is one large tree trunk deposited onto the wall from Hurricane RITA.
Steel Grating					
Stop Logs					
Hardware	good				
Timber Piles	good				Some pile caps missing again. No immediate action necessary.
Timber Wales	good				
Galv. Pile Caps					
Cables					
Signage / Supports	good				All signs in place and in immediate post construction condition.
Rip Rap (fill)	good				Rock placed along the inside and outside of the PVC wall is still in place and functional. No action necessary.
Earthen Embankment

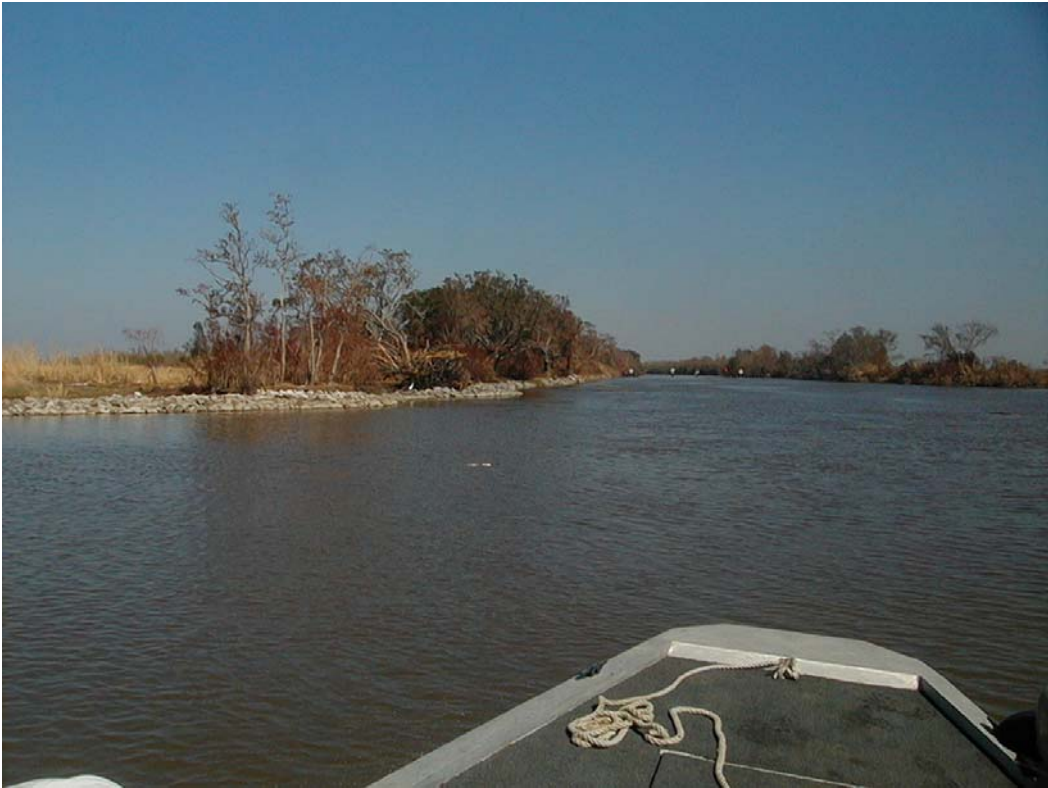
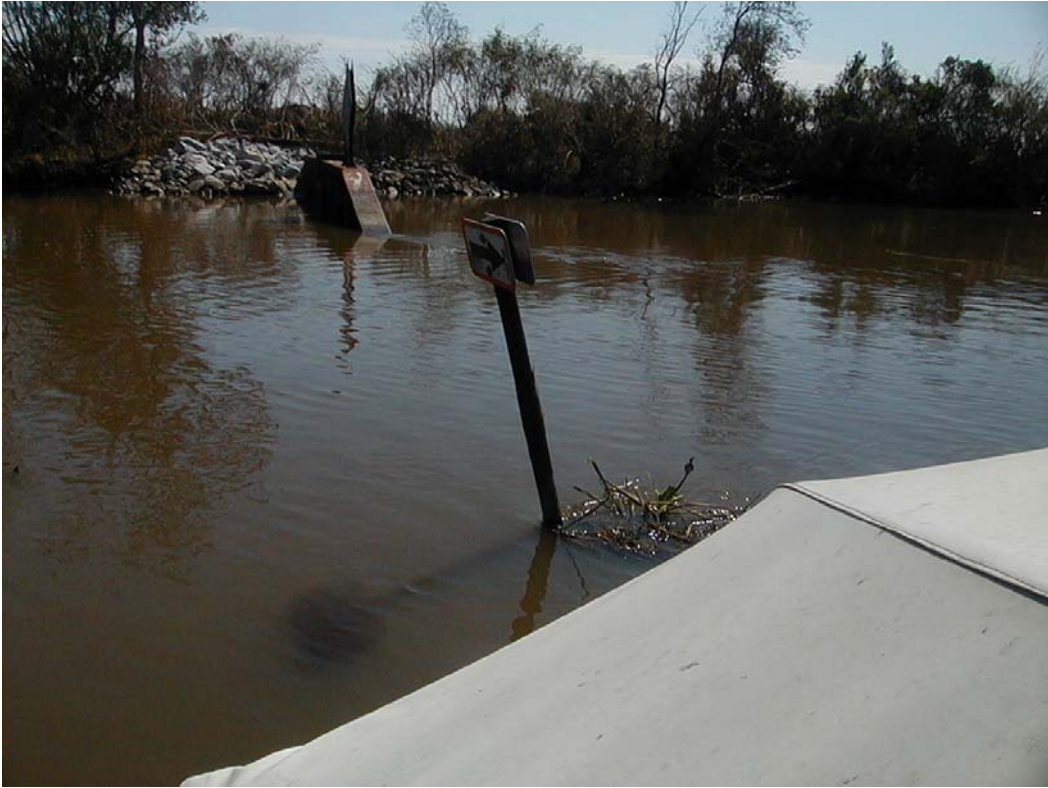
British American Canal did not receive any damages due to Hurricane RITA (Photos: Appendix B, Photos 10 & 11).

Photo 10, British American Canal Structure

Photo 11, British American Canal Structure

Item	Condition	Physical Damage	Corrosion	Photo #	Observations and Remarks
Steel Bulkhead / Caps	good				Some initial post construction rusting. Hasn't gotten any worse. No action needed.
Steel Grating	N/A				
Stop Logs	N/A				
Hardware	good				
Timber Piles	N/A				
Timber Wales	N/A				
Galv. Pile Caps	N/A				
Cables	N/A				
Signage /Supports	good				
Rip Rap (fill)	good				
Eathern Embankment	N/A
