**2005/2006 Annual Inspection  
Report**

**BOSTON CANAL/VERMILION  
BAY SHORE RESTORATION  
PROJECT  
(TV-09)**

State Project Number TV-09  
Priority Project List 2

October 4, 2005  
Vermilion Parish

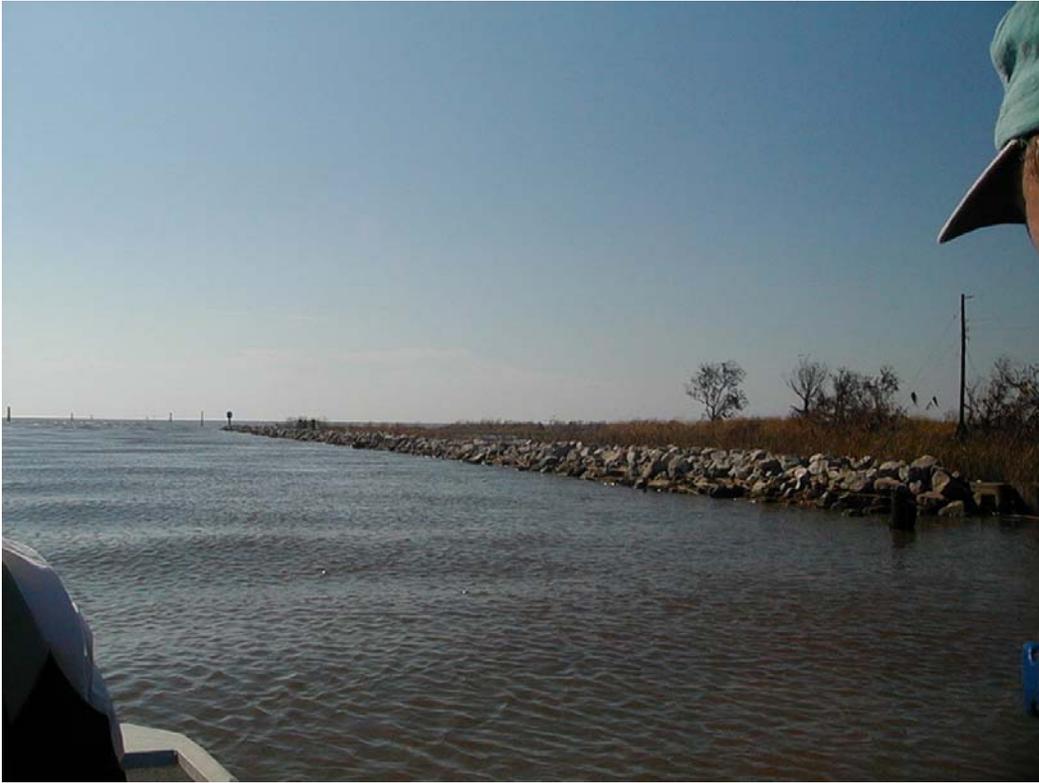
For the most part, the breakwaters are in excellent post construction condition. There is no apparent toe scour or rock displacement. The western end of the dike where it ties into the Vermilion Bay shoreline continues to worsen. A small gap left during original construction appears to have caused this problem. While the situation is similar on the SE tie-in, it is not as severe. No gap was left on this end during construction. Recommendations made to repair these gaps during the O & M inspection of June 2003 have been reconsidered due to costs and logistics associated with such repairs. These areas will be closely monitored, and should the situation significantly worsen, steps will be taken to close/stabilize these areas. Signage and associated pilings are stable and functioning; however some of the signs were slightly bent around the pilings from Hurricane RITA damages. (Photos: Appendix B, Photos 1 - 4)

Photo 1, Rock dike west side of canal

The Boston Canal/Vermilion Bay Shore Restoration Project is in good condition and functioning as intended and suffered no discernable damage from Hurricane RITA. Installation of a staff gauge in the vicinity is recommended. As recommended in previous inspections, the sediment fences installed during construction should be re-evaluated in similar projects in the future. Because survivorship and percent cover of *S. alterniflora* was lessened in established stands of *Phragmites australis*, it is suggested that this planting situation be avoided.

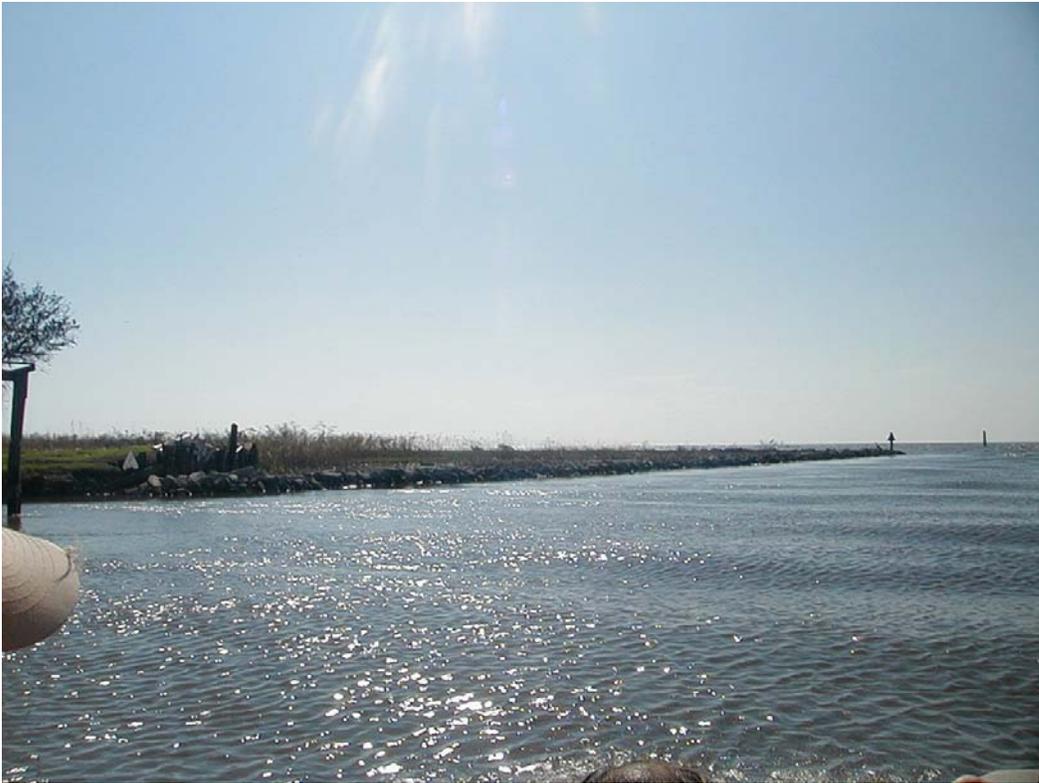
Photo 2, Rock dike, east side canal.

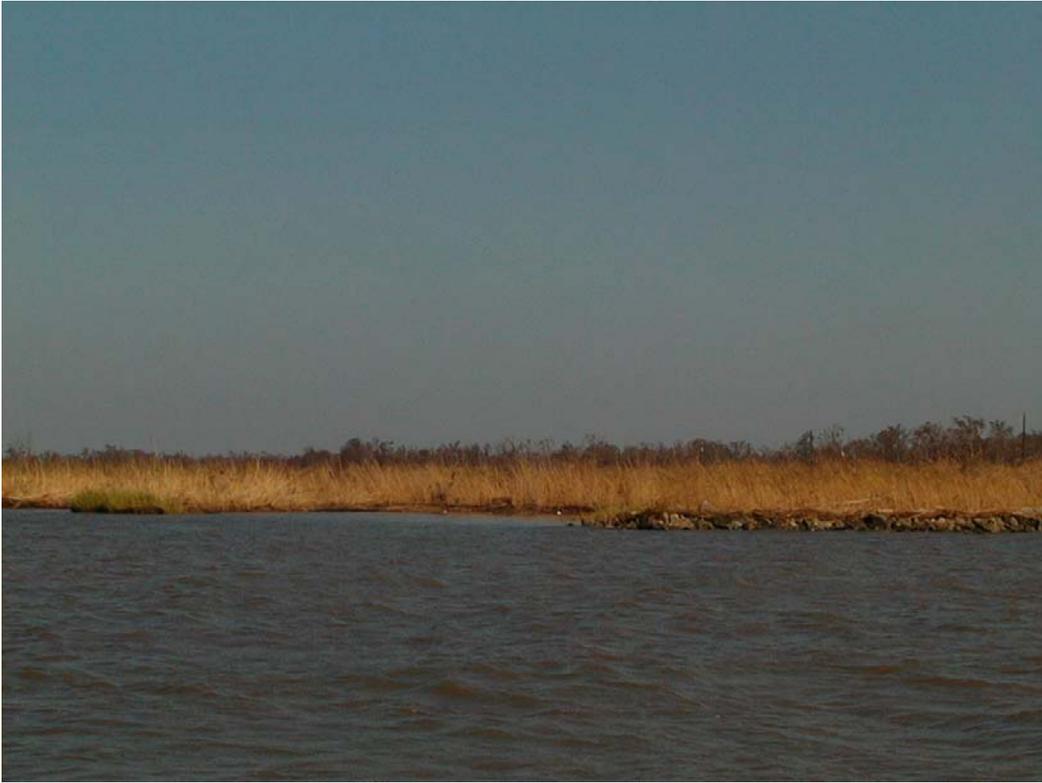
Photo 3, Western tie-in along bayshore.

Item	Condition	Physical Damage	Corrosion	Photo #	Observations and Remarks
Steel Bulkhead / Caps	N/A				
Steel Grating	N/A				
Stop Logs	N/A				
Hardware	N/A				
Timber Piles	N/A				
Timber Wales	N/A				
Galv. Pile Caps	N/A				
Cables	N/A				
Signage / Supports	Good				Some signs slightly bent from Hurricane RITA damages.
Rip Rap (fill)	Good			1,2,3, & 4	Western end of rock dike needs some repair.
Vegetative Plantings	Good			5

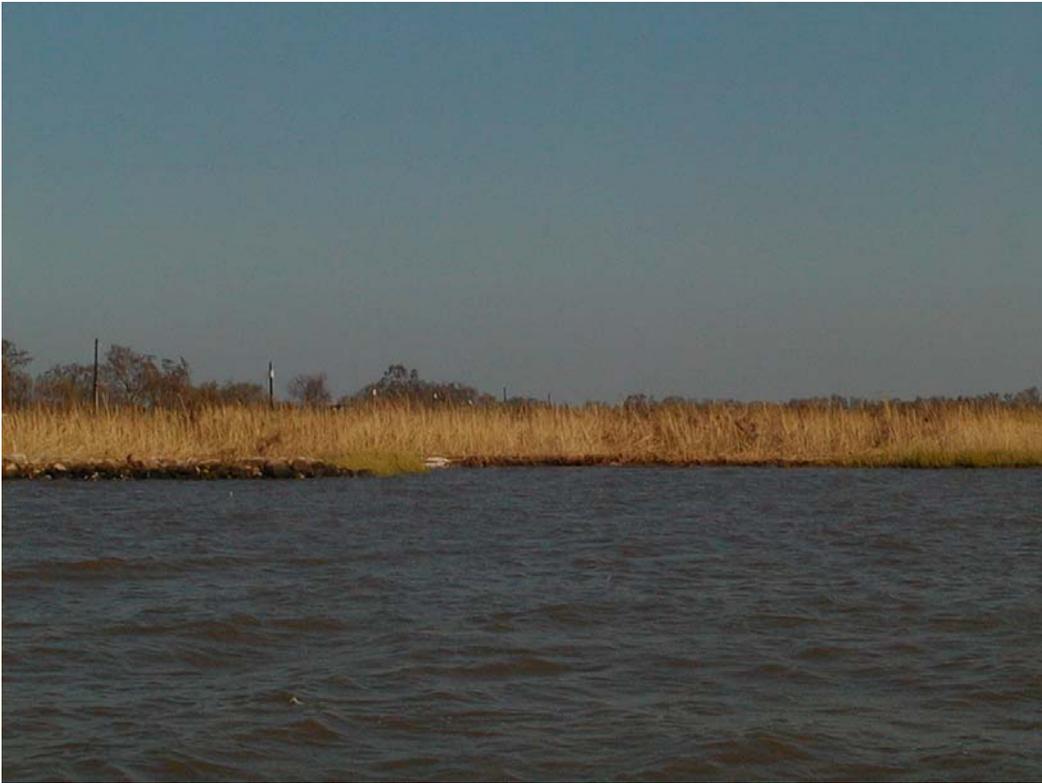
Photo 4, Eastern tie-in along bayshore.

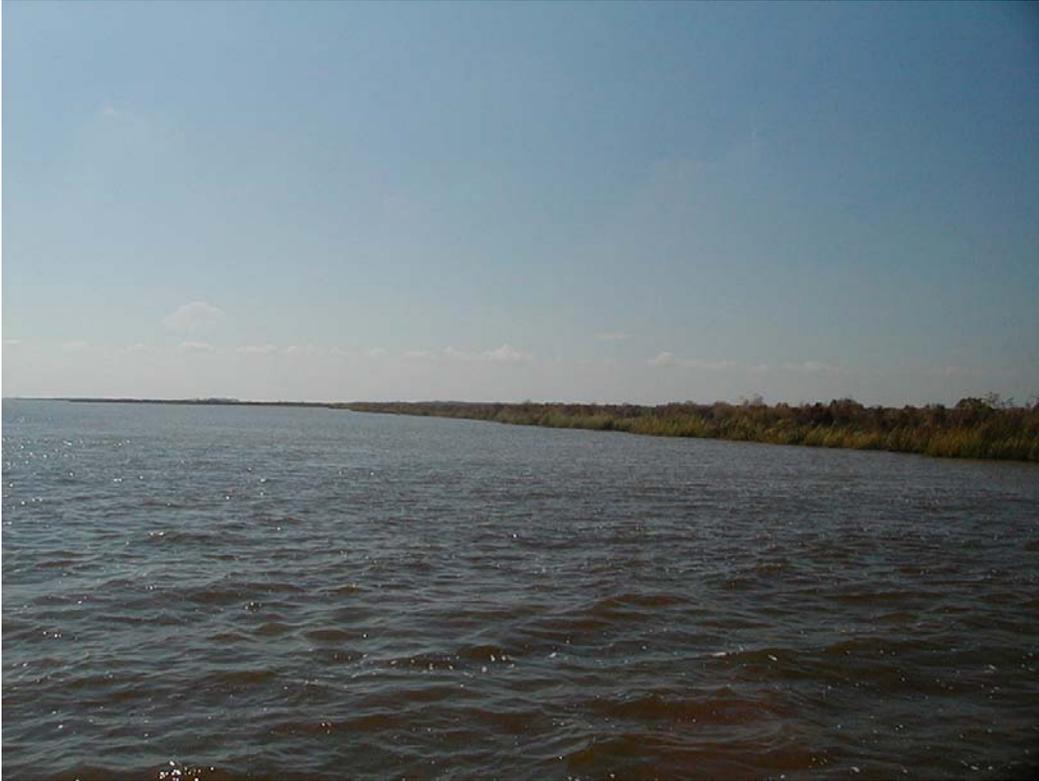
To inspect the shoreline plantings, we only traveled west from Boston Canal to Four Mile Cut along the Vermilion Bay shoreline. Because of time and logistic constraints, we did not inspect the plantings east of Boston Canal or west of Four Mile Cut. The shoreline plantings appear green and relatively unharmed. Areas where the plantings were missing did not appear to have recent storm related erosion and were associated with stands of *Phragmites australis*. The marsh behind the plantings appeared stressed and matted probably due to high water levels and salinity. It is likely, however, that those areas will quickly return to their preexisting conditions. The vegetation within the rock dike was burned by salt water but should survive. Some vegetation stations were visible with plantings still intact and 4 x 4 posts standing in water. (Photos: Appendix B, Photo 5)

Photo 5, Vegetative plantings along bayshore, between Boston Canal and Four Mile Cut.
