**State of Louisiana
Department of Natural Resources
Coastal Engineering Division**

**2005/2006 Annual Inspection
Report**

**LITTLE VERMILION BAY
SEDIMENT TRAPPING
PROJECT**

State Project Number TV-12
Priority Project List 5

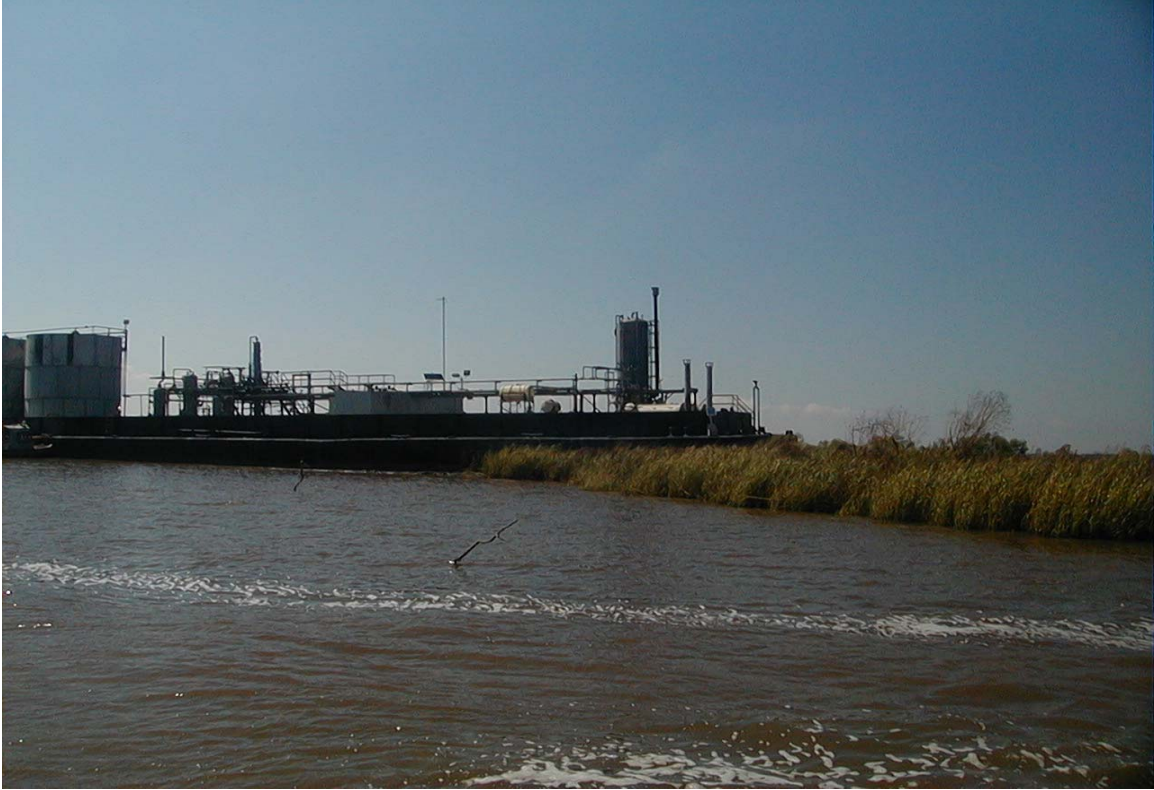
The terraces appear to be in excellent condition. Water elevation taken at a gauge on the Vermilion River Cut-Off was +1.7 NAVD. Some erosion has taken place on the southern most terraces but not nearly as severely as anticipated. The western most terraces have nearly eroded away. Water levels in this borrow canal are still 5-6 feet deep. The berm is still present. A tanker barge that was being used at an oilfield location in the vicinity had broken free as a result of Hurricane Rita and was sitting on the northeast corner of the southwest row of terraces impacting approximately 30 linear feet of terrace. Oilfield crews were working on removing the barge at the time of this inspection. Damage to the terrace from this barge is expected to be minimal. No maintenance needed at this time. (Photos: Appendix B, Photo 1)

Photo 1—oilfield barge on terrace

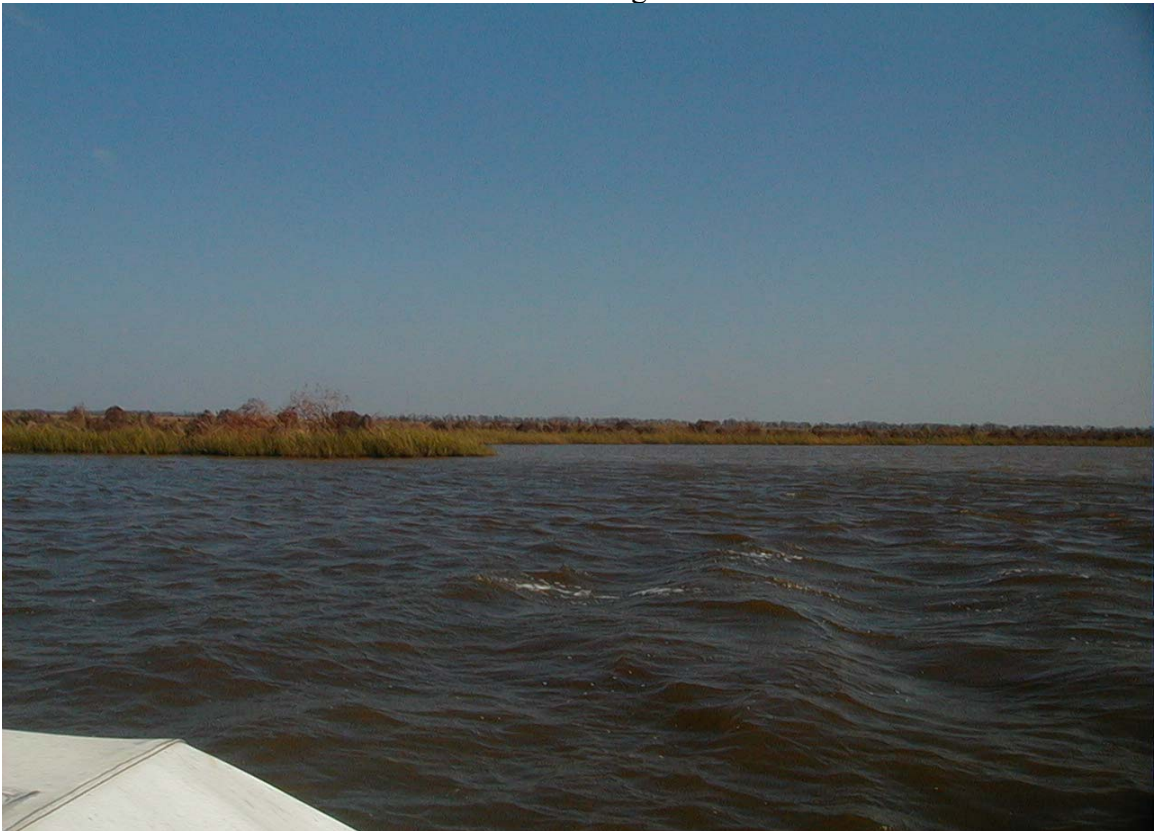
Vegetation planted on the terraces during construction was stressed but is expected to recover. No maintenance needed at this time. (Photos: Appendix B, Photo 2)

Photo 2—typical vegetated terrace
