**State of Louisiana
Department of Natural Resources
Coastal Engineering Division**

**2005/2006 Annual Inspection
Report**

**OAKS/AVERY CANALS
HYDROLOGIC RESTORATION
PROJECT**

State Project Number TV-13a
Priority Project List 6

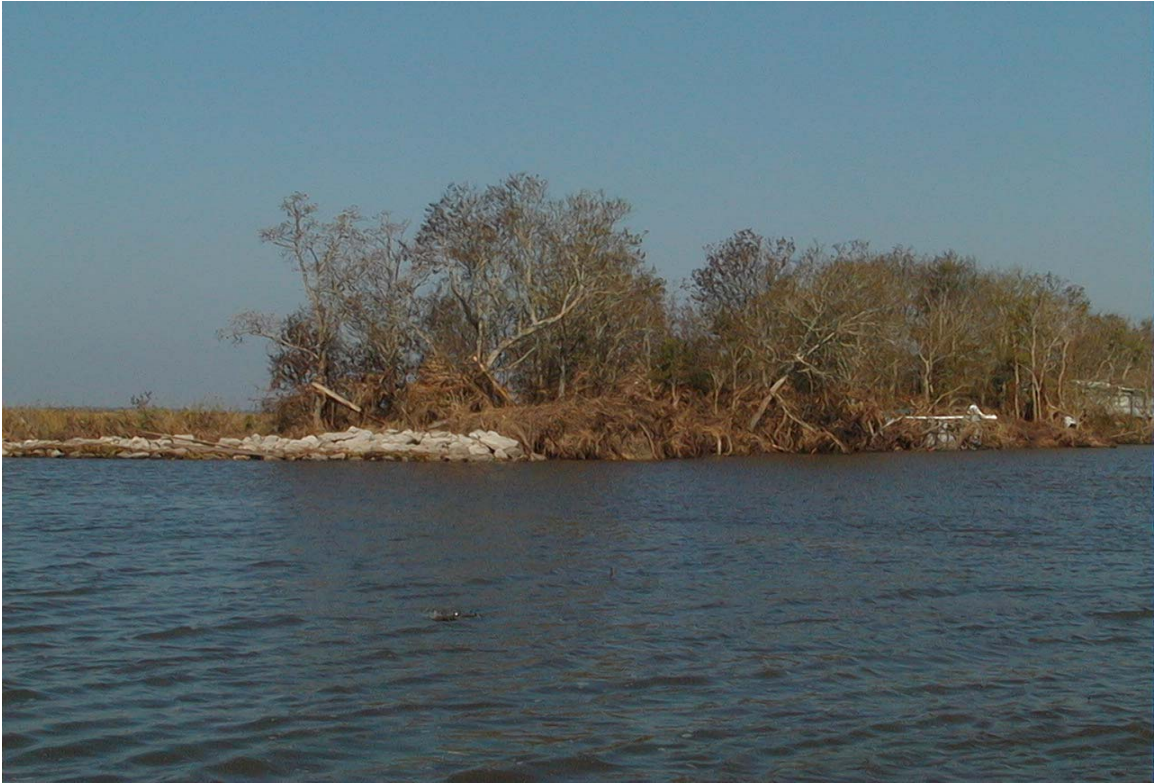
The dike is in excellent condition.. Approximately 60 linear feet on the eastern end at a barge slip has settled slightly but is and in no need of any repairs. East and west tie-ins are stable. (Appendix B; photos 1-3)

Photo 1—eastern tie in of rock dike on northern bank of GIWW

Item	Condition	Physical Damage	Corrosion	Photo #	Observations and Remarks
Steel Bulkhead / Caps					
Steel Grating					
Stop Logs					
Hardware					
Timber Piles					
Timber Wales					
Galv. Pile Caps					
Vegetation					
Signage /Supports					
Rip Rap/dike	Excellent			1-3	Dike is excellent post construction condition.
Eathern Embankment

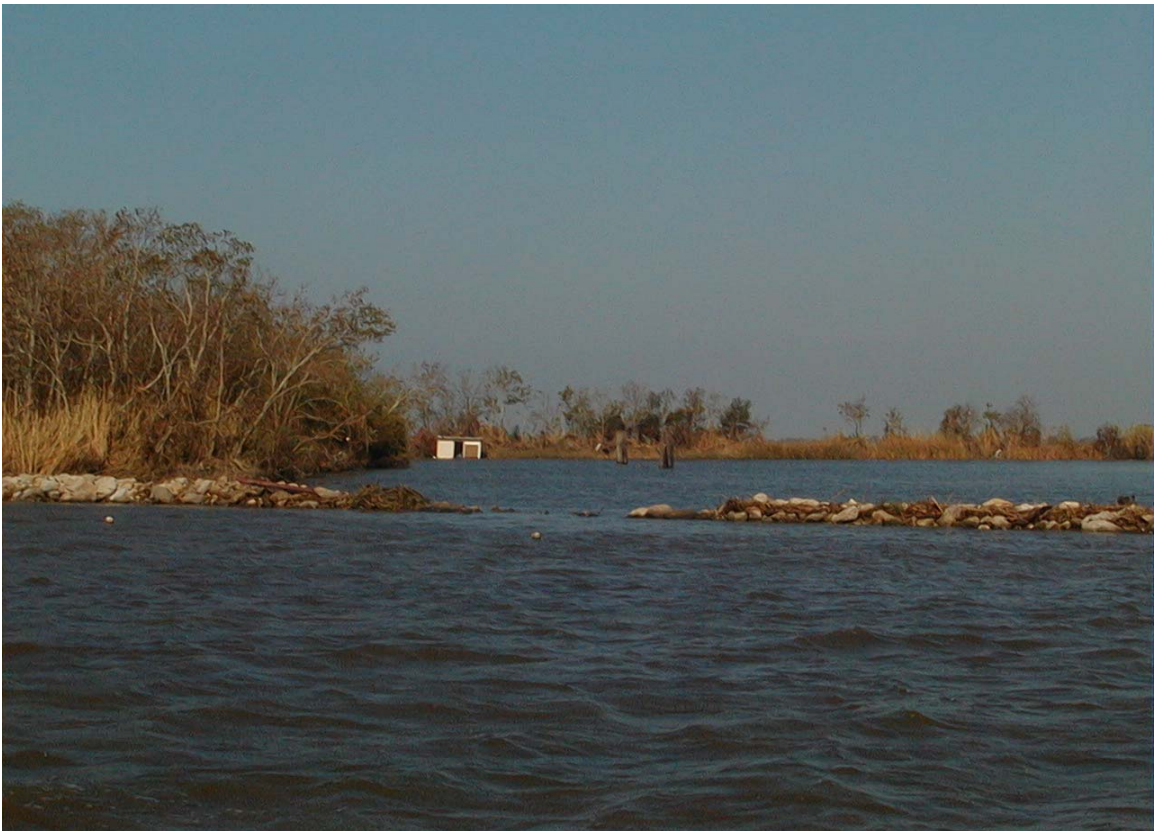
Photo 2—low section at abandoned location on north bank of GIWW

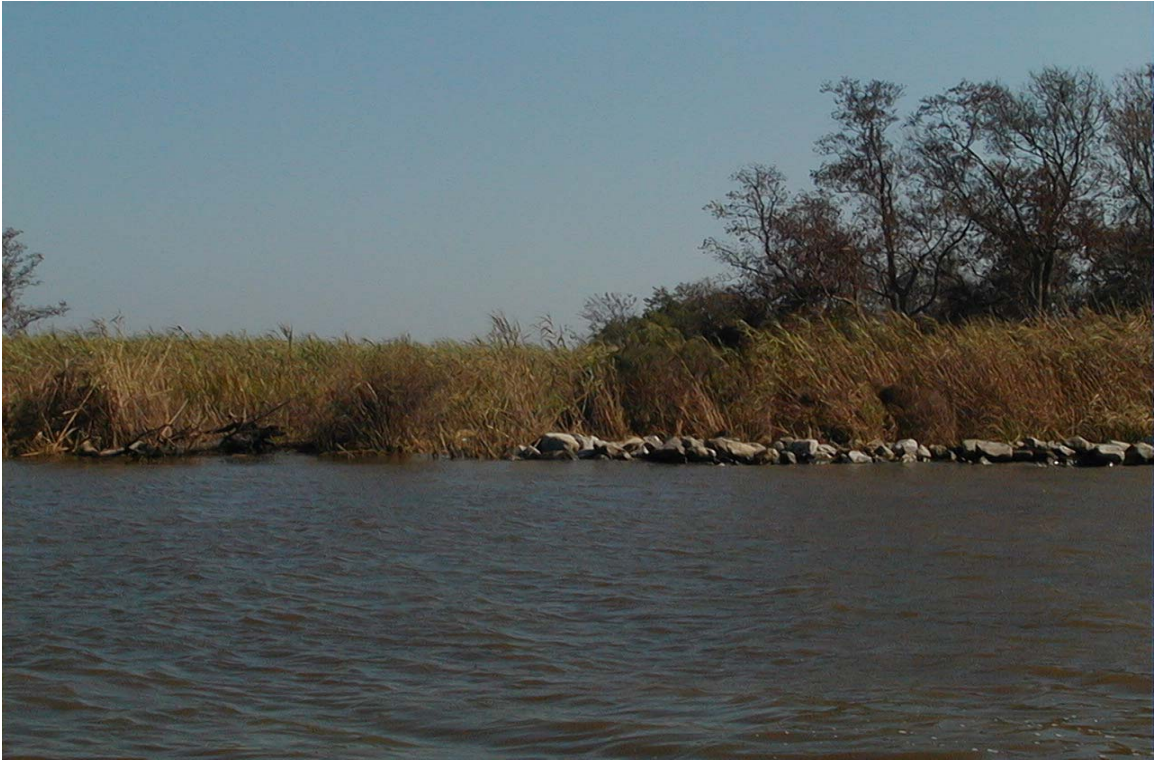
Photo 3—western tie in of rock dike on northern bank of GIWW

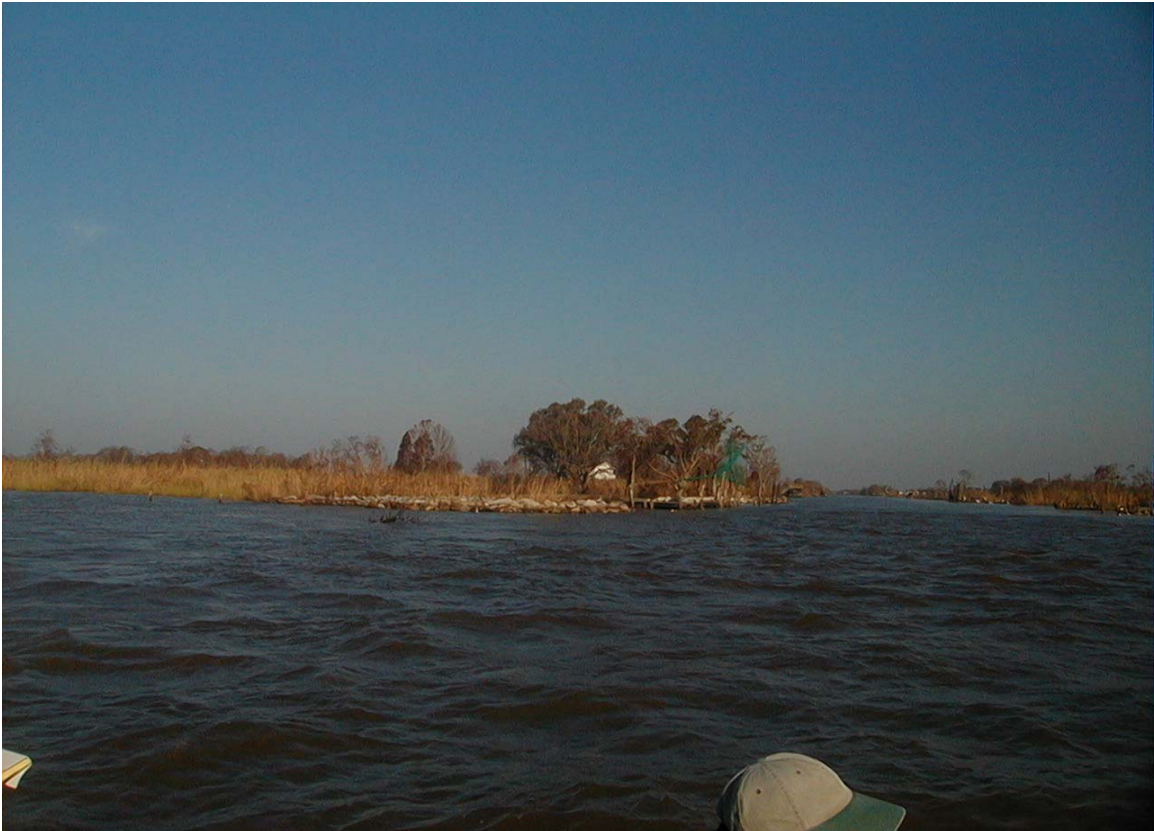
High tides concealed the area along the western bank paving where some rock had apparently slid into the channel. No worsening in this area was evident. The bank between the bay and Bayou Hebert is still only about 6 feet wide and has not gotten any worse. No immediate maintenance required at this time. (Appendix B; photo 4)

Photo 4—rock revetment at mouth of Oaks Canal

Item	Condition	Physical Damage	Corrosion	Photo #	Observations and Remarks
Steel Bulkhead / Caps					
Steel Grating					
Stop Logs					
Hardware					
Timber Piles					
Timber Wales					
Galv. Pile Caps					
Vegetation					
Signage /Supports					
Rip Rap (fill)	Excellent			4	Rock in excellent condition
Eathern Embankment

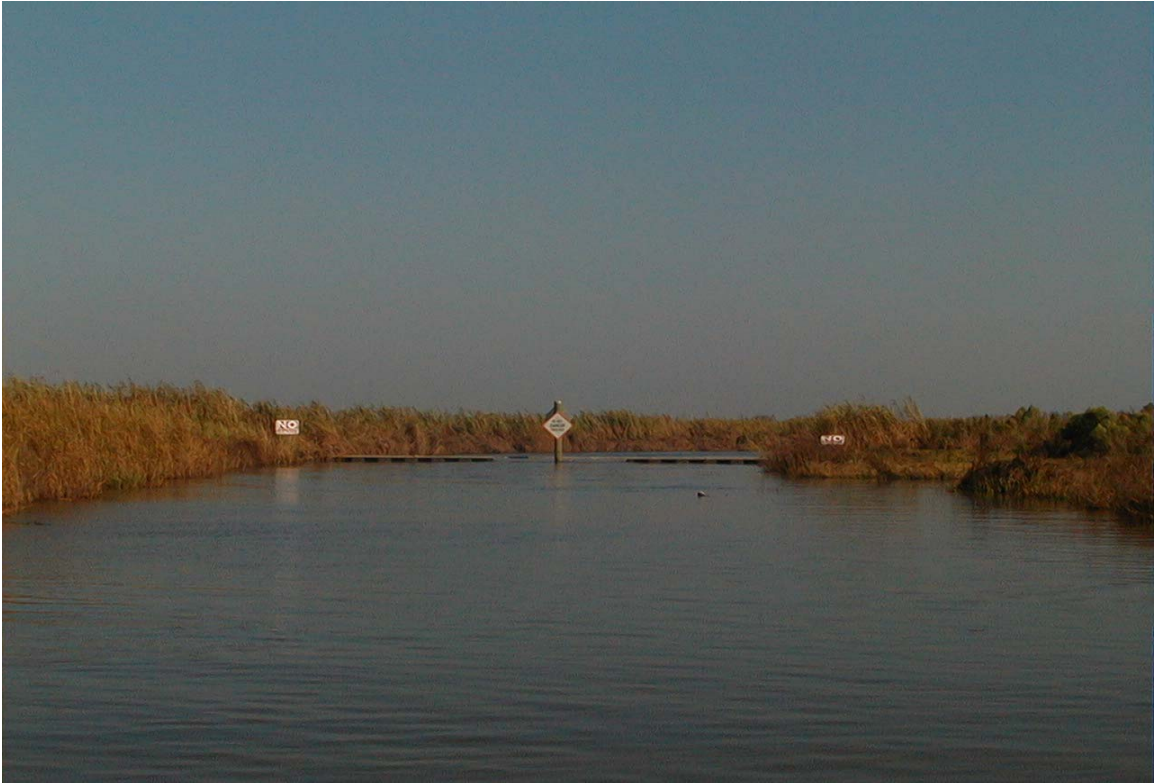
The structure is in excellent shape. Signage is stable. Wingwalls show no signs of any erosion. Three SS bolts are missing from pile cap and will eventually need to be replaced, probably by DNR personnel. The levee from the structure to the GIWW is stable. No maintenance required at this time. (Appendix B; photos 5-7)

Photo 5—Cowpath structure

Item	Condition	Physical Damage	Corrosion	Photo #	Observations and Remarks
Steel Bulkhead / Caps	Excellent				
Steel Grating					
Stop Logs					
Hardware	Good				Three SS bolts missing from pile cap. Not critical.
Timber Piles					
Timber Wales					
Galv. Pile Caps	Excellent				
Vegetation					
Signage /Supports	Excellent			5	
Rip Rap (fill)					
Eathern Embankment	Excellent			6,7

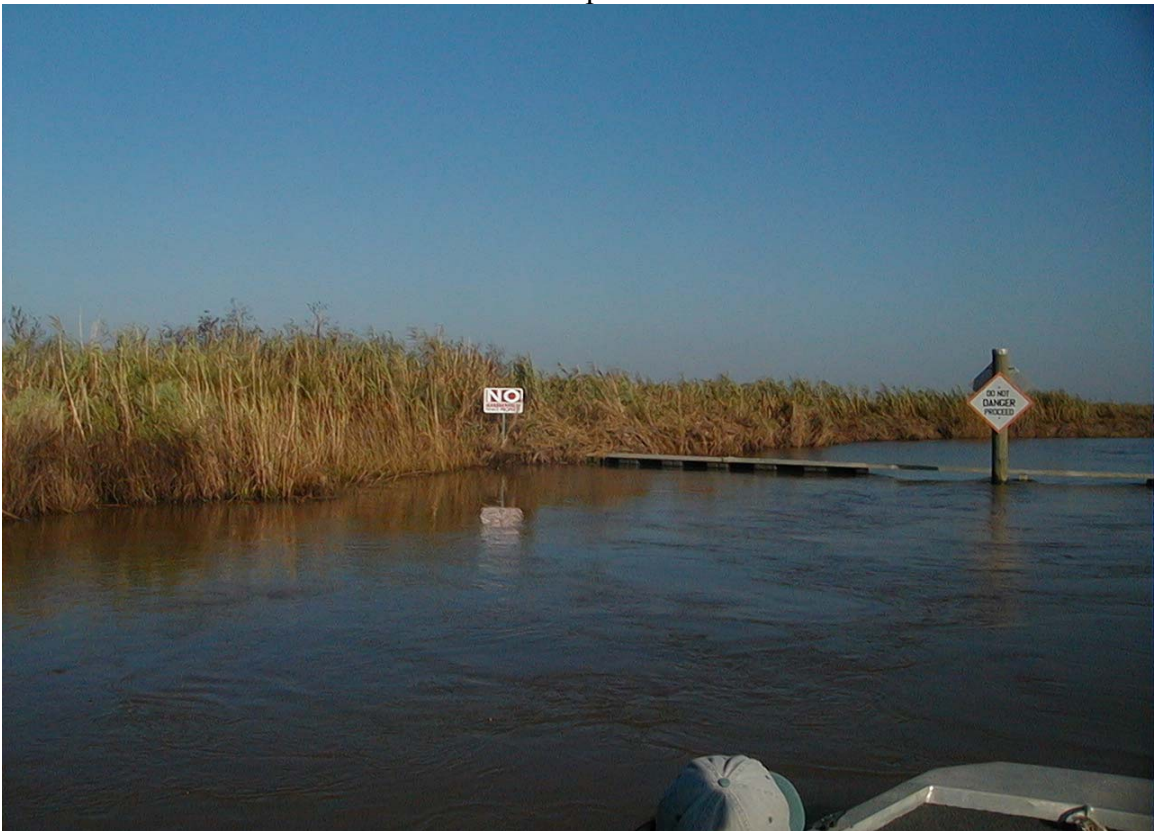
Photo 6—western end of Cowpath structure

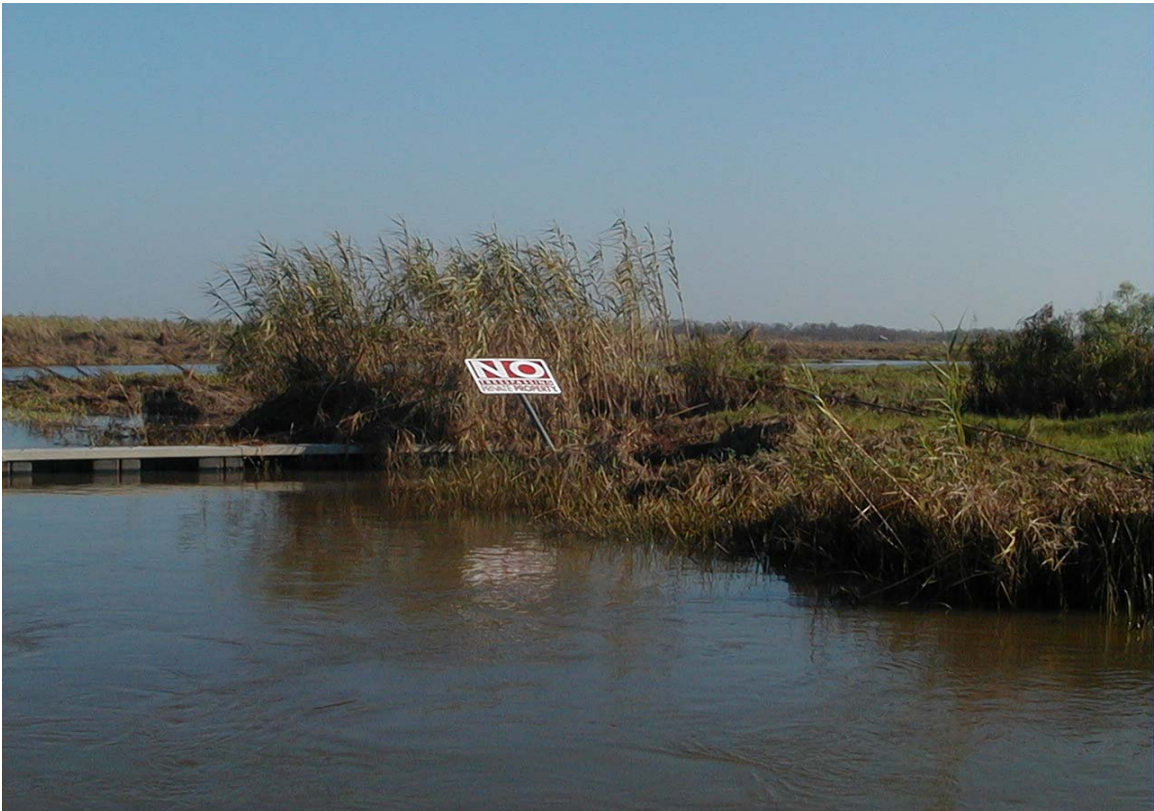
Photo 7—eastern end of Cowpath structure

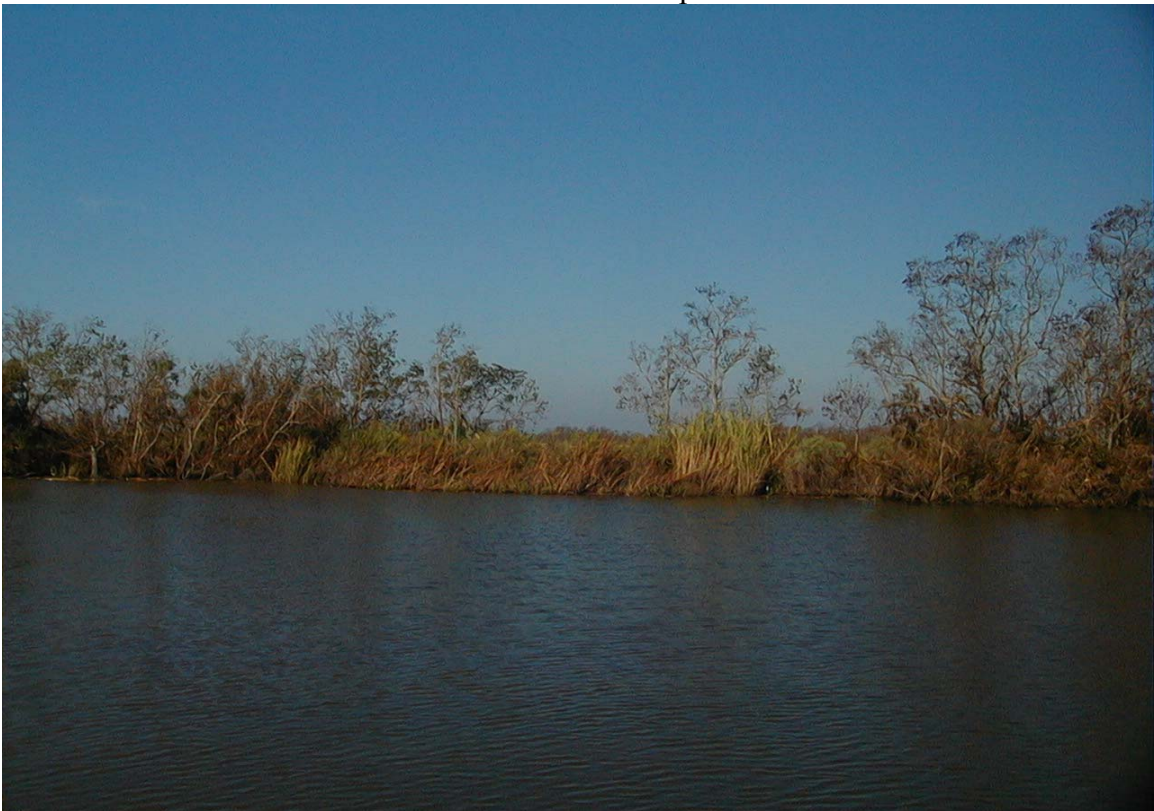
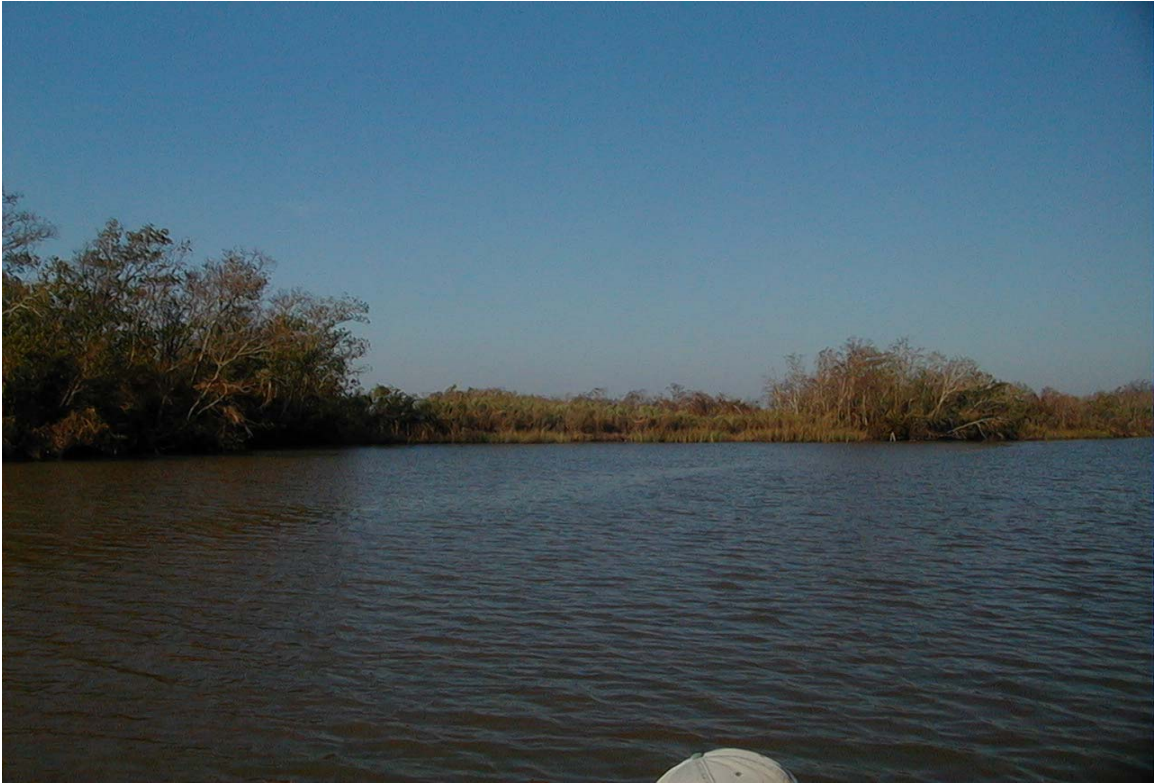
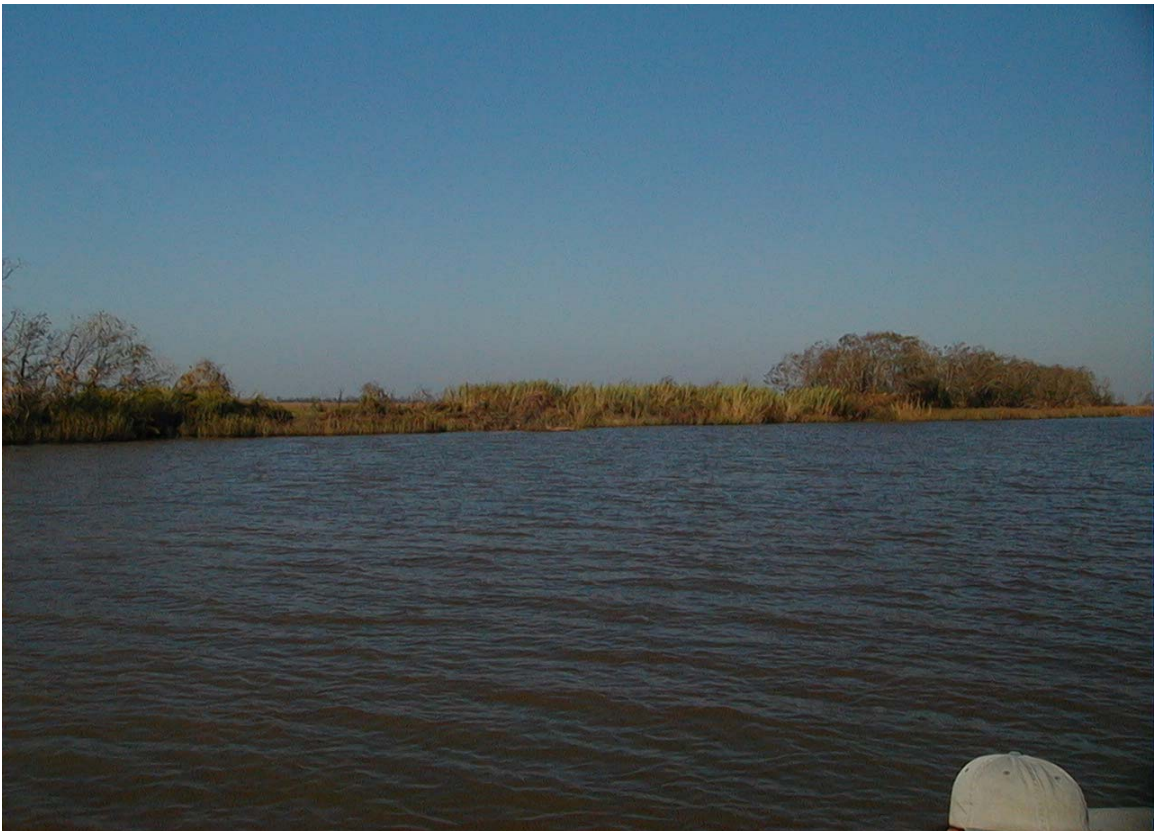
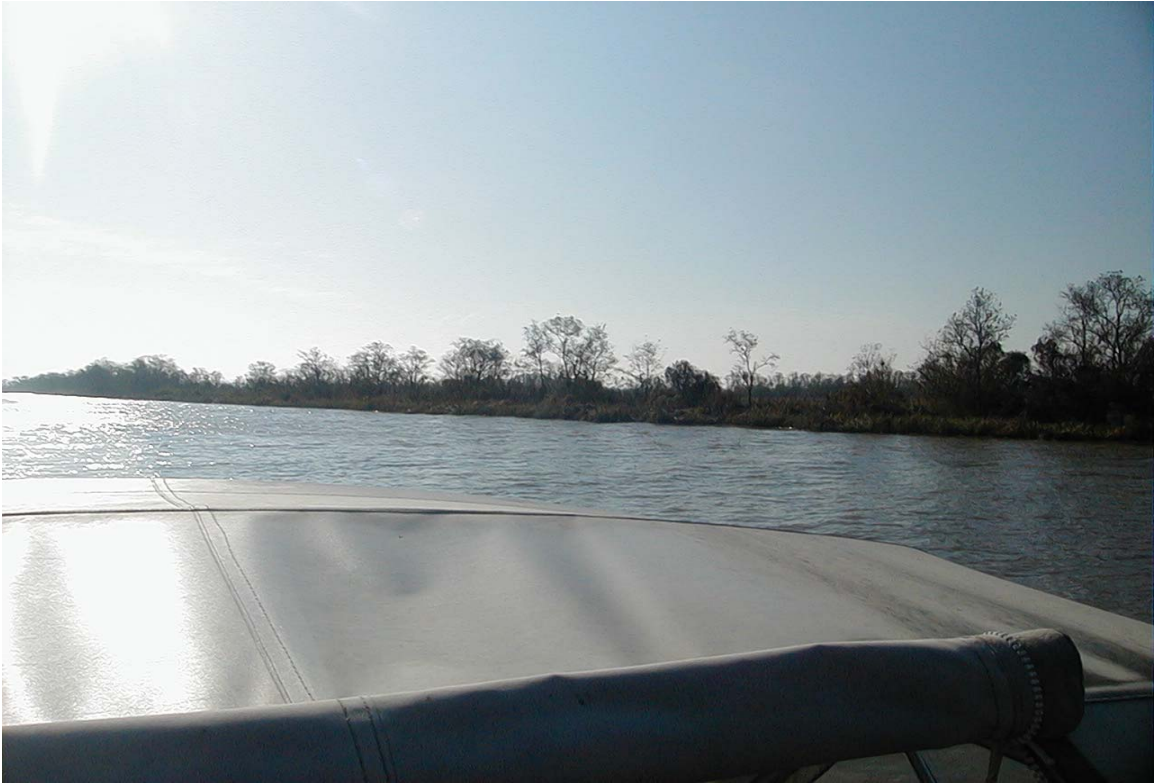
The closures are holding up well. Vegetation has been established. No need for any repairs. (Appendix B; photos 8-11)

Photo 8—earthen closure

Photo 9—earthen closure

Photo 10—earthen closure

Photo 11—earthen closure

Item	Condition	Physical Damage	Corrosion	Photo #	Observations and Remarks
Steel Bulkhead / Caps					
Steel Grating					
Stop Logs					
Hardware					
Timber Piles					
Timber Wales					
Galv. Pile Caps					
Vegetation					
Signage /Supports					
Rip Rap (fill)					
Eathern Embankment	Excellent			8-11

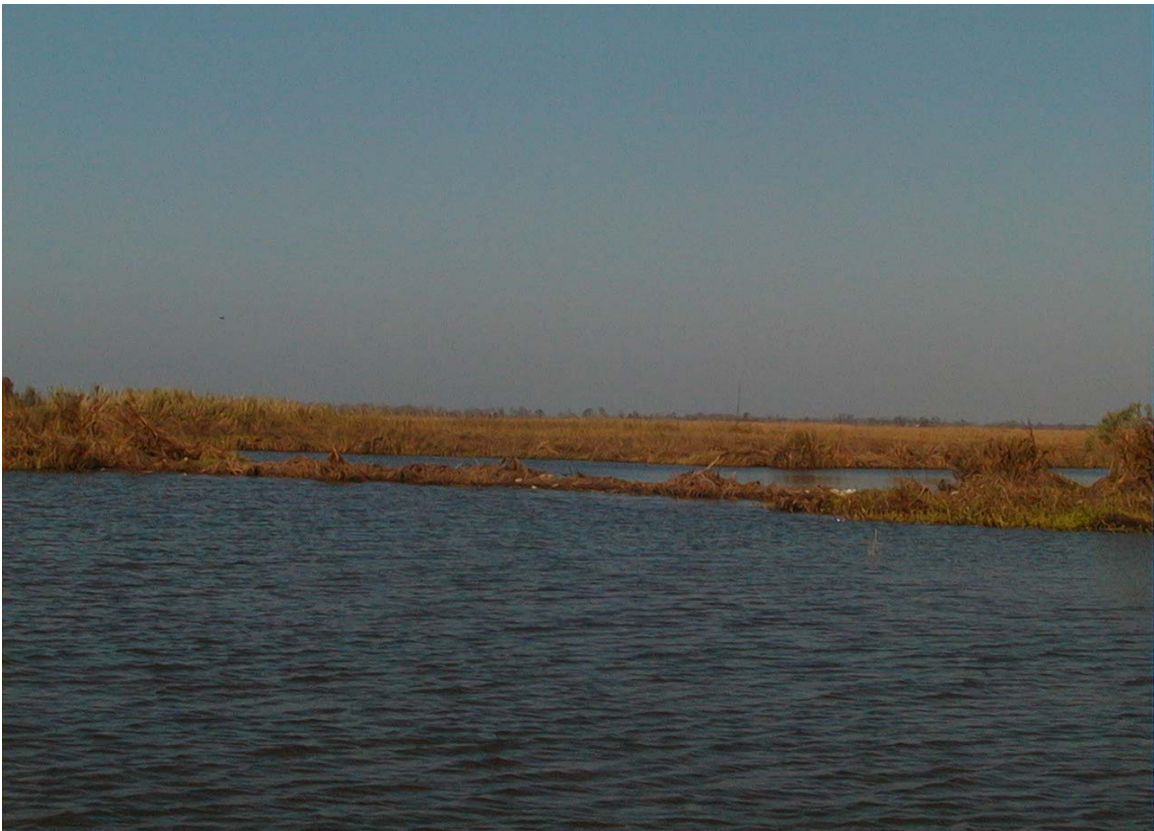
The plug is in excellent condition. No evidence of settling or vandalism. Tie-ins are stable. No need for any repairs. (Appendix B; photo 12)

Photo 12—rock plug

Item	Condition	Physical Damage	Corrosion	Photo #	Observations and Remarks
Steel Bulkhead / Caps					
Steel Grating					
Stop Logs					
Hardware					
Timber Piles					
Timber Wales					
Galv. Pile Caps					
Vegetation					
Signage /Supports					
Rip Rap (fill)	Excellent			12	
Eathern Embankment

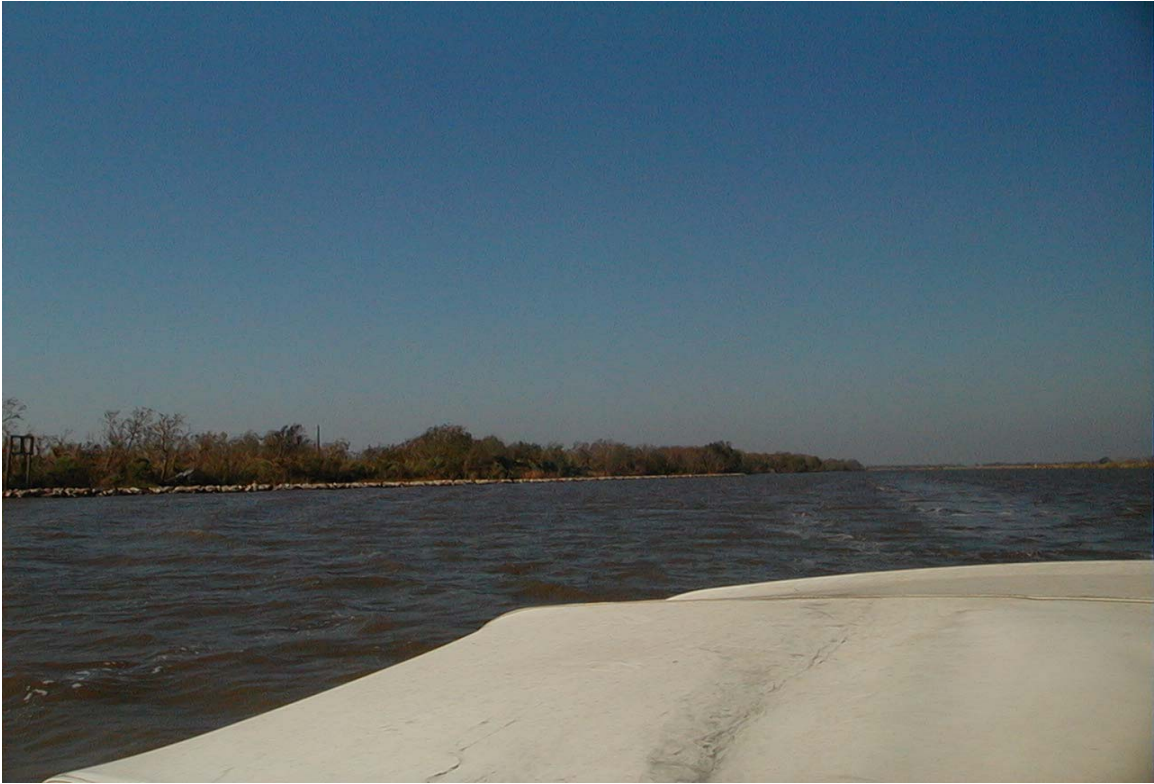
The dike is in immediate post construction condition and in no need of any repairs. (Appendix B; photo 13)

Photo 13—rock dike along southern bank of GIWW

Item	Condition	Physical Damage	Corrosion	Photo #	Observations and Remarks
Steel Bulkhead / Caps					
Steel Grating					
Stop Logs					
Hardware					
Timber Piles					
Timber Wales					
Galv. Pile Caps					
Vegetation					
Signage /Supports					
Rip Rap (fill)	Excellent			13	
Eathern Embankment

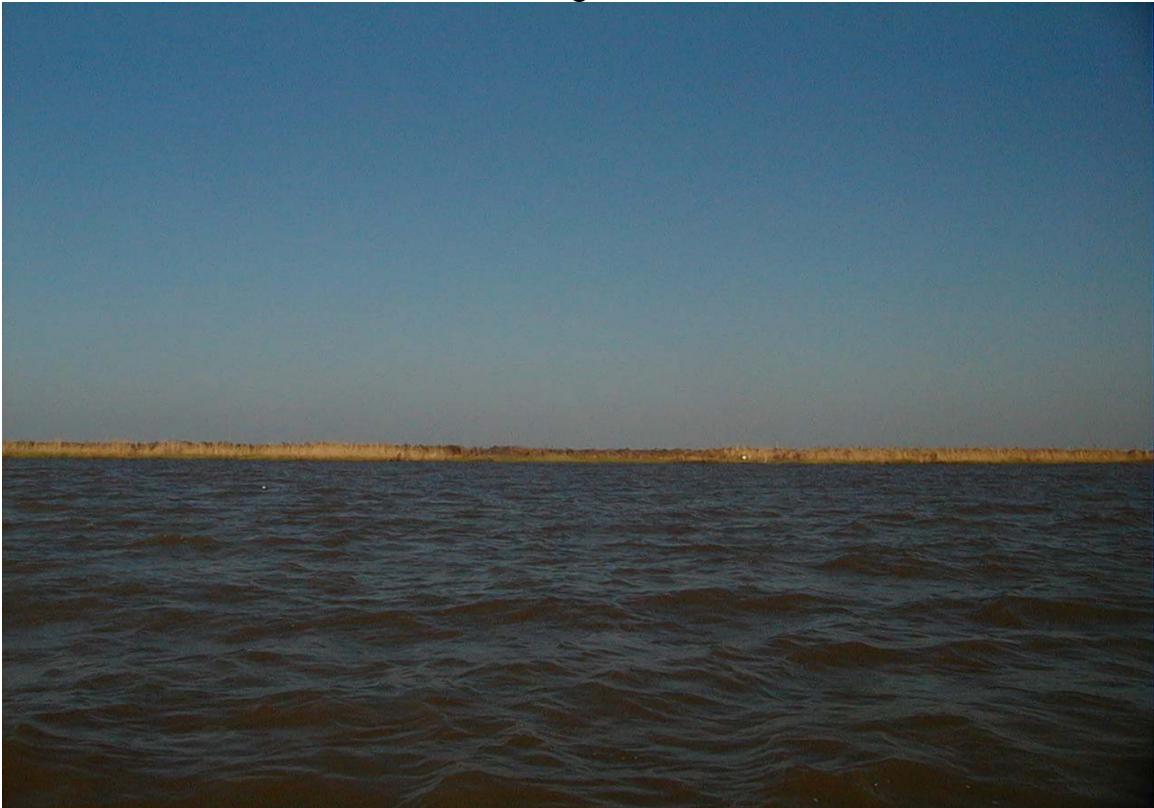
While a close inspection of the plants was not possible due to high water and rough seas, plantings, and the marsh behind them, although stressed due to high salinity water from the hurricane, appeared to be in relatively good condition and in no need of repair. (Appendix B; photo 14)

Photo 14—vegetation along northern bank of Vermilion Bay

Item	Condition	Physical Damage	Corrosion	Photo #	Observations and Remarks
Steel Bulkhead / Caps					
Steel Grating					
Stop Logs					
Hardware					
Timber Piles					
Timber Wales					
Galv. Pile Caps					
Vegetation	Excellent			14	Based on limited inspection, vegetation appeared to have survived Hurricane Rita and is expected to fully recover.
Signage /Supports					
Rip Rap (fill)					
Earthen Embankment
