**State of Louisiana  
Department of Natural Resources  
Coastal Engineering Division**

**2005/2006 Annual Inspection  
Report**

**FOUR MILE CANAL TERRACING  
AND SEDIMENT TRAPPING  
PROJECT**

State Project Number TV-18  
Priority Project List 9

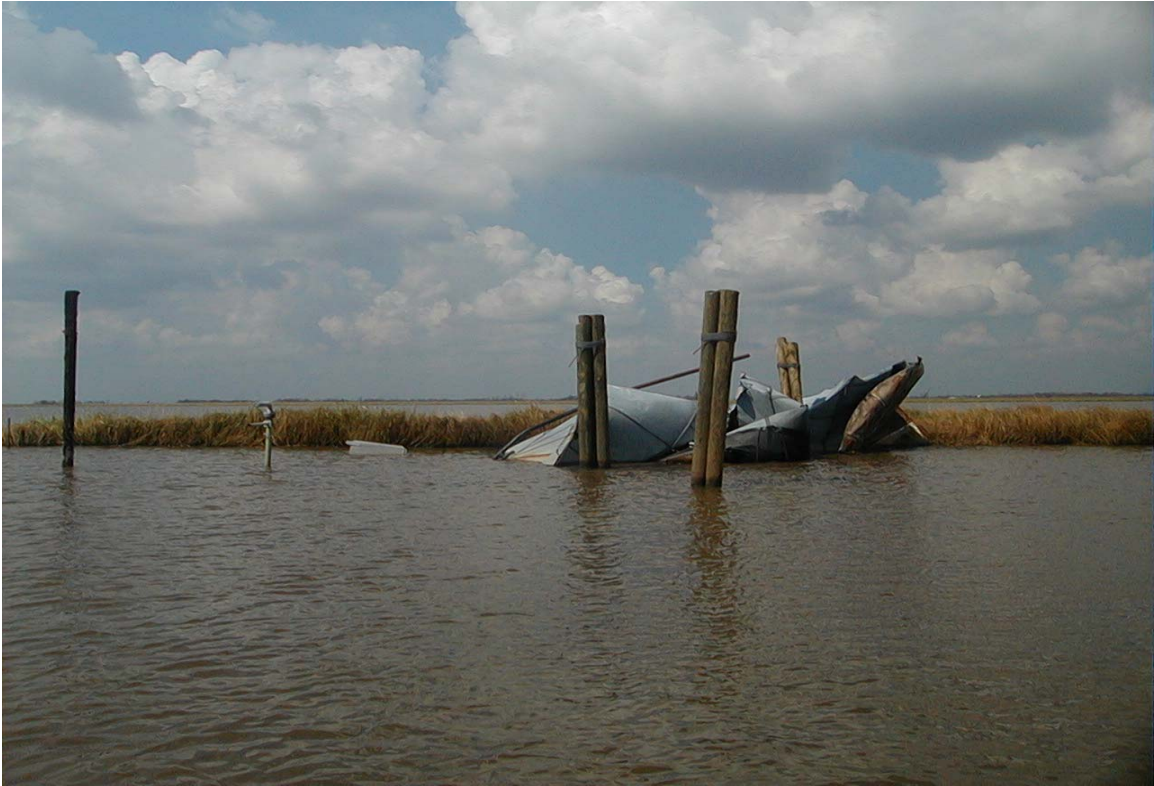
The terraces appear to be in fairly good condition. No excessive erosion has taken place as a result of Hurricane Rita. There was some oilfield trash found on the southwestern most terraces in Little White Lake. On the Little Vermilion Bay portion of the project, some significant erosion is still occurring on the terraces immediately adjacent to the Vermilion River Cut Off. These terraces will continue to be closely monitored. Interior terraces were unable to be closely inspected due to the closures, that were installed in some of the borrow excavations, but appear in excellent condition with substantial growths of the vegetation that was planted. No sections on the excavated channels to determine sediment deposited were taken on this inspection. No maintenance needed at this time. (Photos: Appendix B, Photo 1-2)

Photo 1—Oilfield debris on terrace in Little White Lake

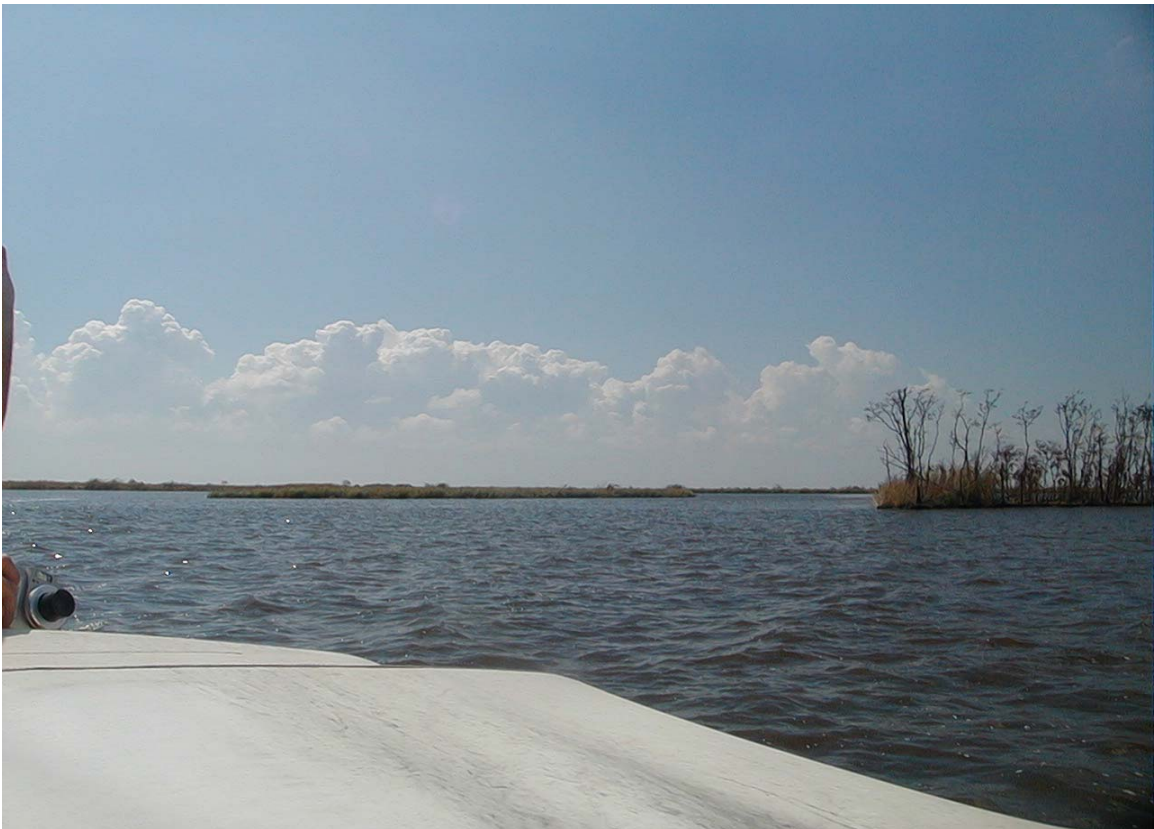
Photo 2—eroded terrace near Vermilion River Cut Off

Item	Condition	Physical Damage	Corrosion	Photo #	Observations and Remarks
Steel Bulkhead / Caps					
Steel Grating					
Stop Logs					
Hardware					
Timber Piles					
Timber Wales					
Galv. Pile Caps					
Vegetation	Good				Stressed due to Hurricane Rita. Recovery expected.
Signage /Supports					
Rip Rap (fill)					
Eathern Embankment Terraces	Good				Expected erosion on sacrificial terraces. Significant erosion on terraces adjacent to Vermilion River Cut Off.
