**State of Louisiana
Department of Natural Resources
Coastal Engineering Division**

2005/2006 Annual Inspection Report

**SWEET LAKE/ WILLOW LAKE
HYDROLOGIC RESTORATION
PROJECT
(CS-11b)**

State Project Number CS-11b
Priority Project List 5

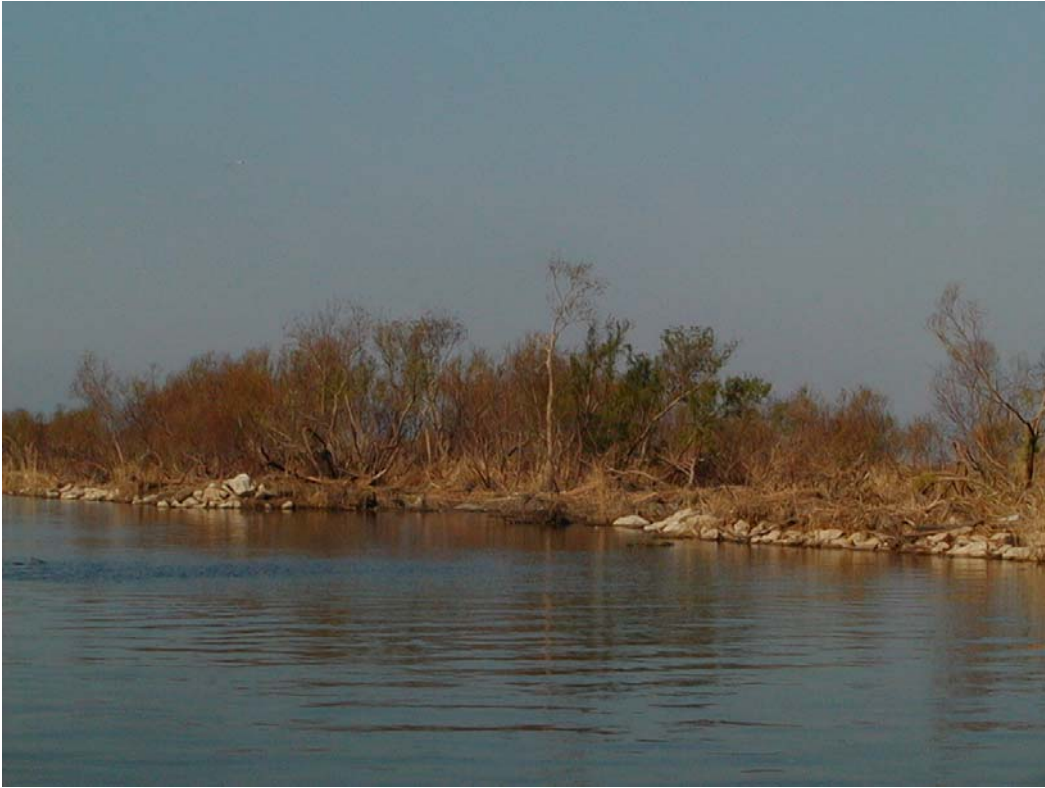
The dikes are in reasonably good condition. There are a few low places along the length of the rock dike with the most significant stretches along the open water areas adjacent to Sweet Lake. There is an area approximately 50 feet wide along the very eastern end of the project area in which the dike appears to have been “pushed back” 10-12 feet apparently by a barge. There is another area approximately 4 feet wide in which the dike appears to have been removed by hunters or fishermen. Several settlement plates are either broken or leaning and are of no use. No gauges were available in the vicinity to determine water levels. The condition of the shallow water terraces feature of the project was unable to be determined due to high water conditions. (Photos: Appendix B, Photos 1, 2 & 3).

Photo No.1, Area of rock dike pushed back by barge.

- The areas mentioned above will be monitored, but as of now are in no need of any immediate repairs.

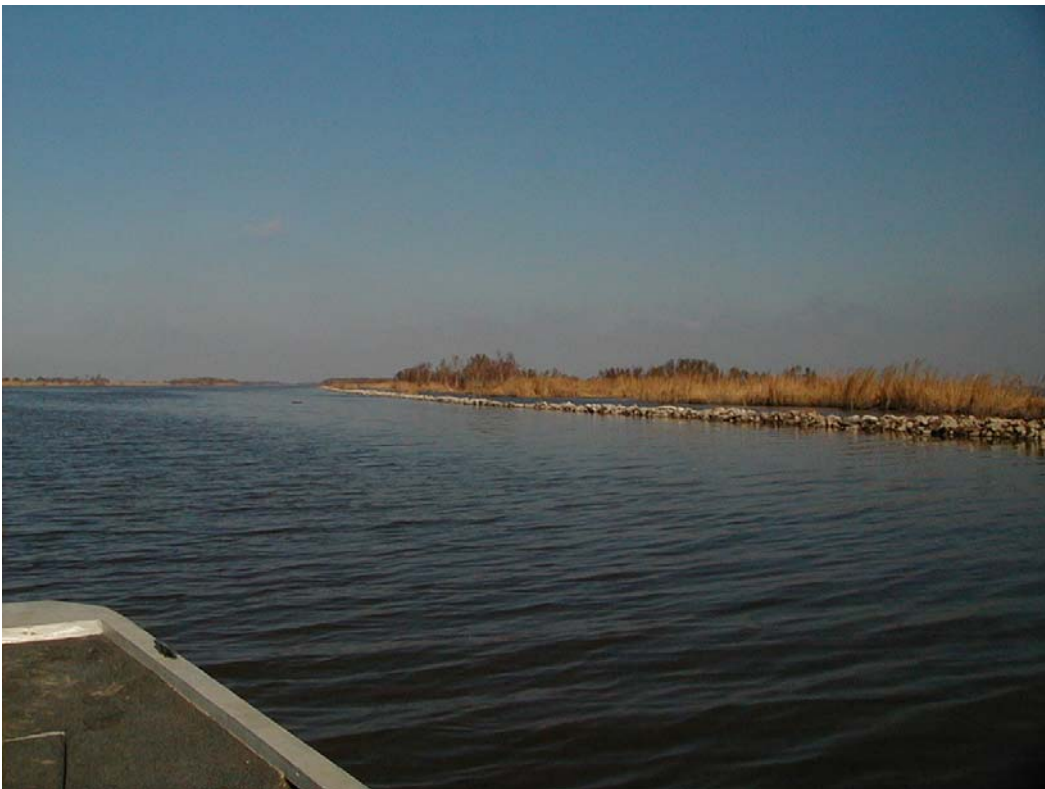
Photo No.2, Typical rock dike section.

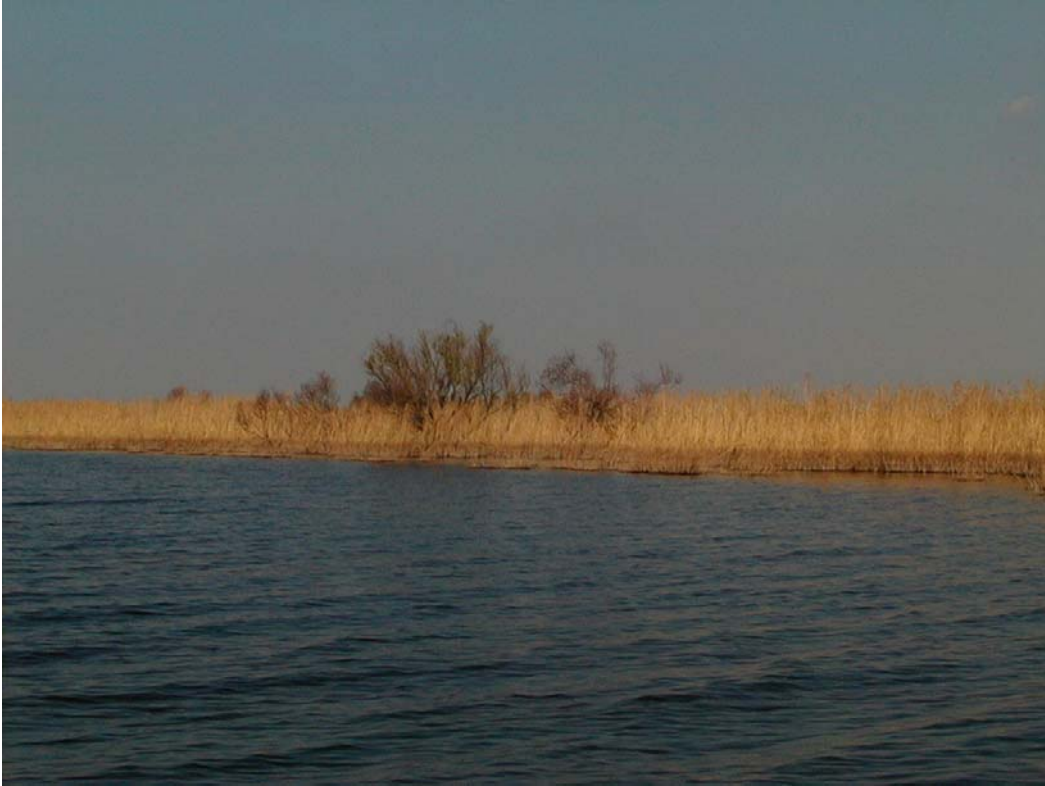
Photo No. 3, Typical shallow water earthen terrace.

Item	Condition	Physical Damage	Corrosion	Photo #	Observations and Remarks
Earthen Terraces	Fair			3	Unable to determine condition of terraces due to high water.
Steel Grating	N/A				
Stop Logs	N/A				
Hardware	N/A				
Timber Piles	N/A				
Timber Wales	N/A				
Galv. Pile Caps	N/A				
Cables	N/A				
Signage/Support	N/A				
Rip Rap(fill)	N/A				
Earthen Embankment	N/A				
Foreshore Dike	Good			1 & 2	300 Linear feet of dike on eastern edge of Willow is low,. Also, there is a 50 foot section of rock dike that has apparently been pushed back. Another 4 foot section is missing in another area.
