**State of Louisiana
Department of Natural Resources
Coastal Engineering Division**

**2005/2006 Annual Inspection
Report**

**CAMERON/CREOLE
WATERSHED HYDROLOGIC
RESTORATION PROJECT
(CS-17)**

October 24, 2005
Cameron Parish

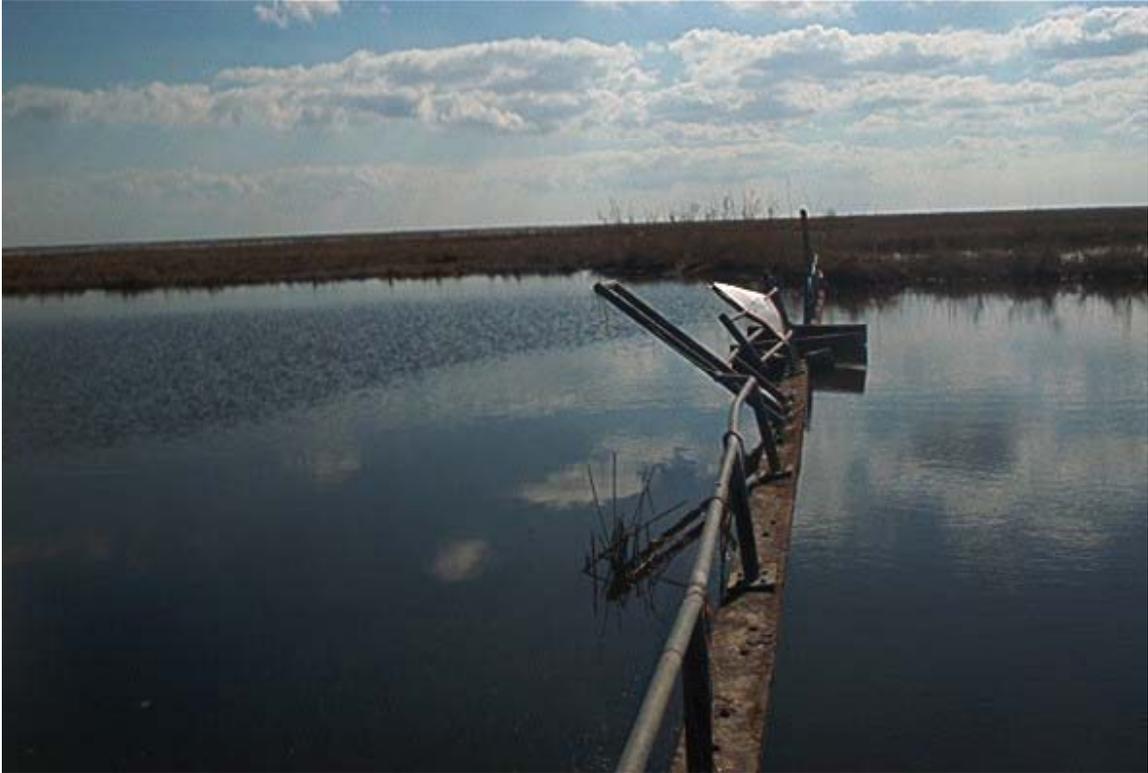
Photo 1, Mangrove Bayou Weir No. 1

The contractor had completed the installation of the rails and boat guides. The storm surge pushed a steel tank approximately 6'Φ x 8' Lg. across the structure in the vicinity of the warning sign bracket on the west side of the boat passage bay. The tank is on the levee near the Mangrove Bayou structure. Twenty four feet of the pile cap is twisted, bent and pulled away from the sheet piling. The railing east of the boat bay is in good condition. There is bank erosion on both ends of the sheet pile wall. (Photos: Appendix B, Photo 1 & 2).

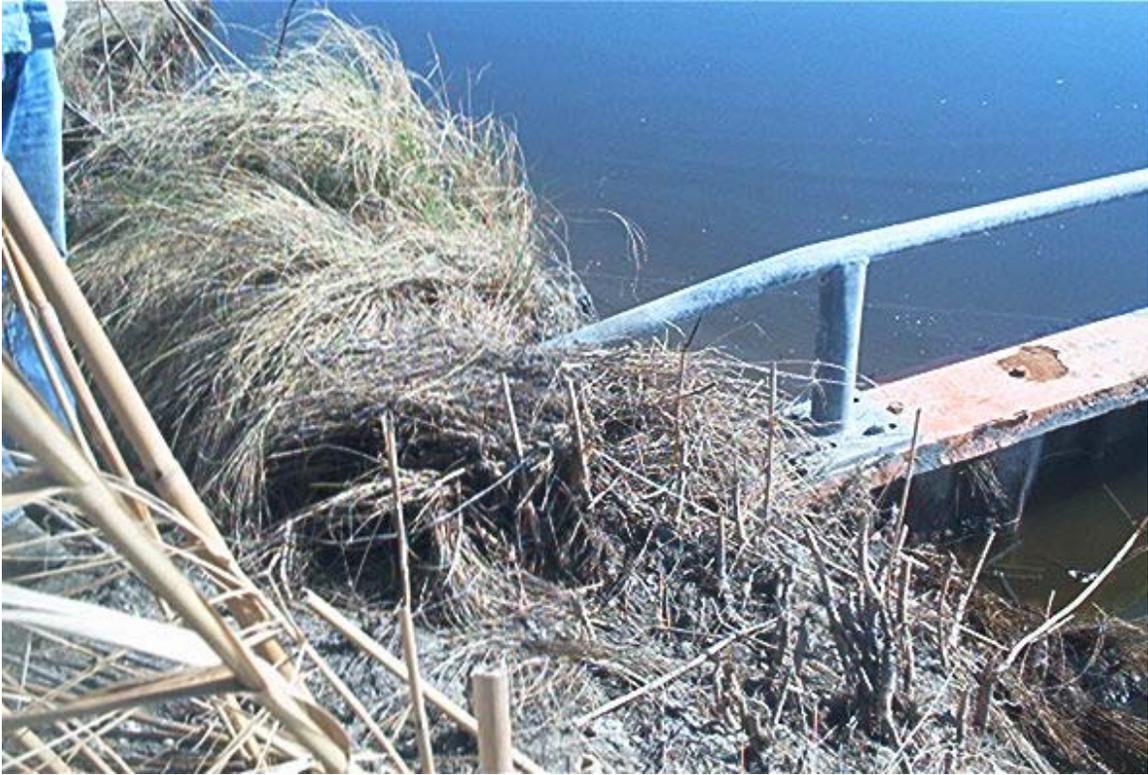
The contractor had removed the existing railing and had his work barge with the new railing moored in the vicinity of the weir. The storm surge broke the barge from its mooring. The barge and material cannot be found. The water level was over the top of the weir. There is bank erosion on both ends of the sheet pile wall. (Photos: Appendix B, Photo 3).

Photo 3, Bank Erosion On Both Ends Of The Weir On Both Structures
