**State of Louisiana  
Department of Natural Resources  
Coastal Engineering Division**

**2005/2006 Annual Inspection  
Report**

**SABINE REFUGE PROTECTION  
PROJECT (CS-18)**

October 27, 2005  
Cameron Parish

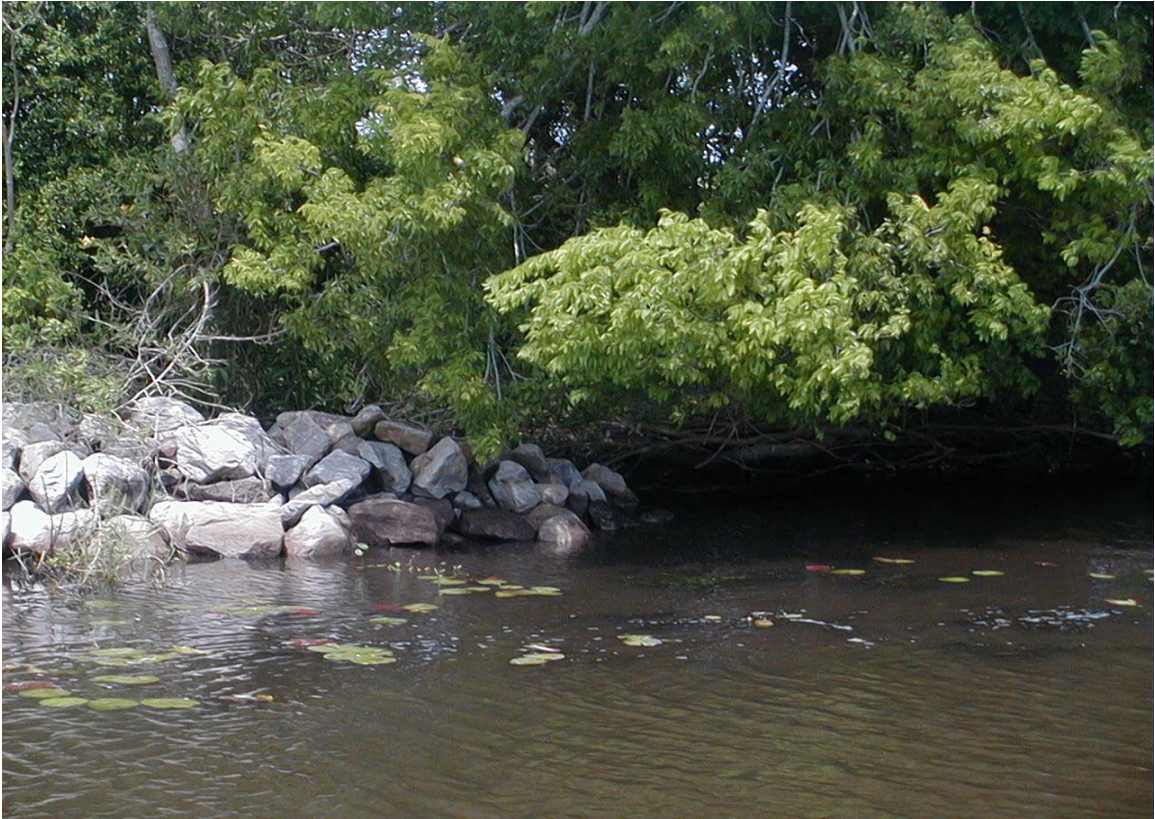
The rock breakwater along the Burton Sutton Canal was the only dike inspected due to Hurricane Rita debris field. The storm surge was estimated to be +7.0 NAVD88. There was some organic material deposited on the rocks. The dike is in excellent post construction condition. No need for any maintenance in the foreseeable future. (Photos: Appendix B, Photos 1 - 2)

Photo 1—southern tie-in on Burton Sutton Canal (April 21, 2005)

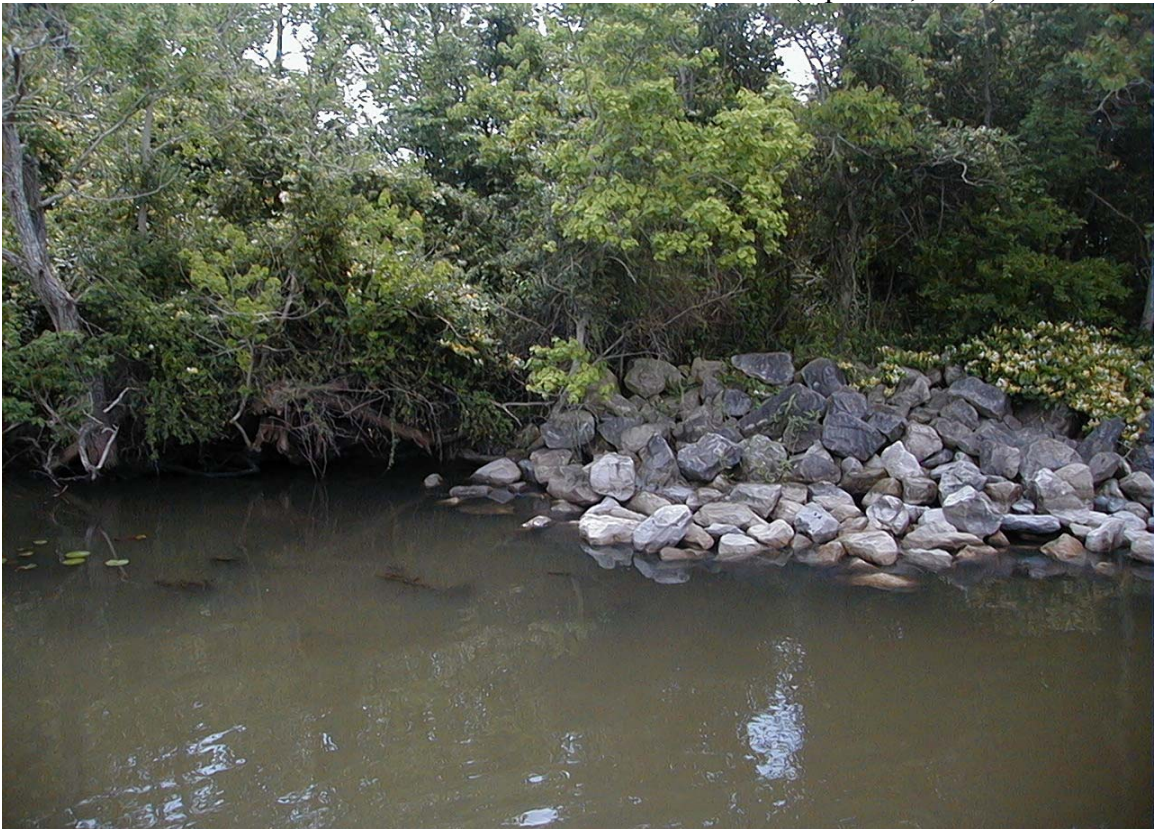
Photo 2—northern tie-in (April 21, 2005)
