**State of Louisiana
Department of Natural Resources
Coastal Engineering Division**

**2005/2006 Annual Inspection
Report**

**EAST MUD LAKE MARSH
MANAGEMENT PROJECT
(CS-20)**

November 3, 2005
Cameron Parish

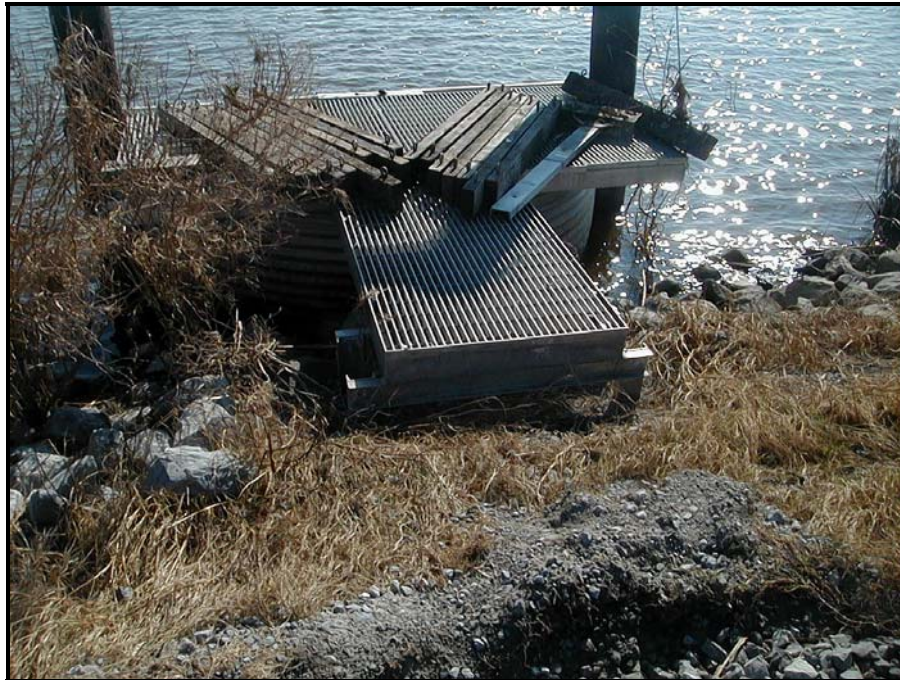
The overall condition of Structure No. 6 appears to be very good. Water level gauges weren't available near the structure but read +1.7 NAVD at Structure No. 7 just east of Structure No. 6. The timber piles, stop logs, grating, etc. are in good condition. Rock placed around the outlet side of the structure has held up well and stabilized the shoreline. Some minor erosion has occurred on the westerly pipe structure near the grating along the road. The end of the outlet pipes are clogged with marsh and other debris. The padlocks on the stop log locking devices have rusted, but since these structures are seldom operated, it was decided not to replace them at this time. As a result of the inspection of Structure No. 6, LDNR and NRCS agree that stone needs to be added around grating near the access roadway, and clean out ends of both outfall pipes of marsh debris. (Photos: Appendix B, Photo 1).

Photo 1, Structure No. 6 showing erosion at end of grating.

Item	Condition	Physical Damage	Corrosion	Photo #	Observations and Remarks
Steel Bulkhead / Caps	N/A				
Steel Grating	Good			1	Some erosion near end of grating along roadside.
Stop Logs	Good				
Hardware	Fair		Yes		Corrosion on padlocks.
Timber Piles	Good				
Timber Wales	Good				
Galv. Pile Caps	Good				
Cables	Good				
Signage / Supports	Fair				General Note: There are no staff gages at this structure.
Outlet Pipes	Fair			1	The ends of both outlet pipes are clogged with marsh debris.
Earthen Embankment	Good

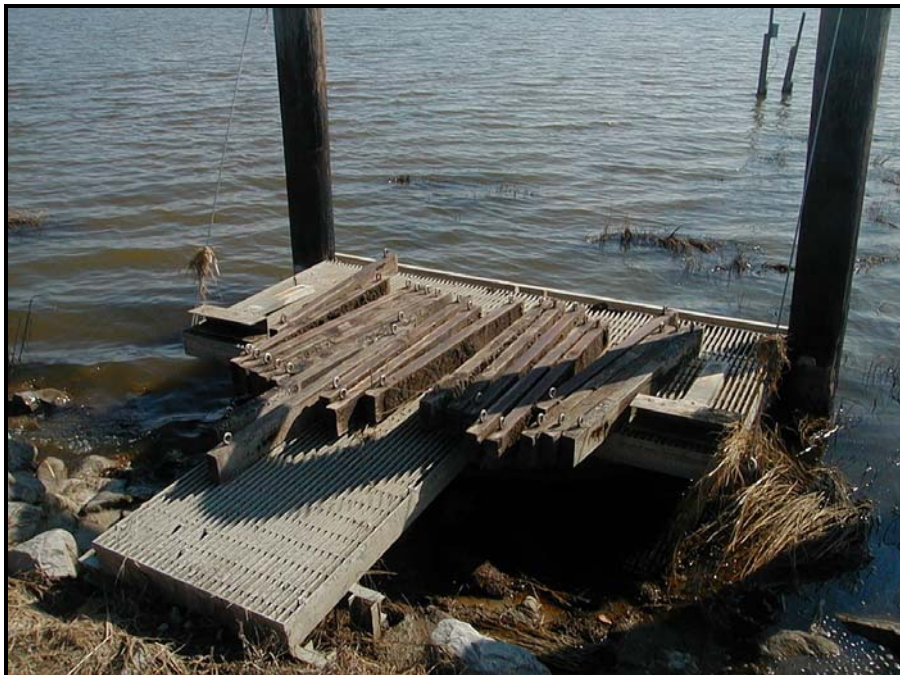
Structure No. 7 appears to be in very good condition. Water level gage on the inside was leaning and not readable and the outside gage was +1.7. Both ends of this structure are clogged with marsh debris and have silted up. Minor erosion also has occurred at the end of the grating along the road. LDNR and NRCS agree that stone needs to be added around grating near access roadway, clean out marsh debris from the inlet and outlet sides of the structure and replace staff gage on the inside of the structure. (Photos: Appendix B, Photo 2).

Photo 2, Structure No.7 showing marsh debris/siltation and minor erosion at grate.

Item	Condition	Physical Damage	Corrosion	Photo #	Observations and Remarks
Steel Bulkhead / Caps	N/A				
Steel Grating	Good				Minor erosion at end of grating along roadside.
Stop Logs	Good				
Hardware	Fair		Yes		Corrosion on padlocks.
Timber Piles	Good				
Timber Wales	Good				
Galv. Pile Caps	Good				
Cables	Good				
Signage / Supports	Good				
Satff Gages	Fair				Inside gage was leaning and not readable.
Inlet/Outlet Pipe	Fair			2	Inlet and outlet pipes are clogged with marsh debris.
Earthen Embankment	Good

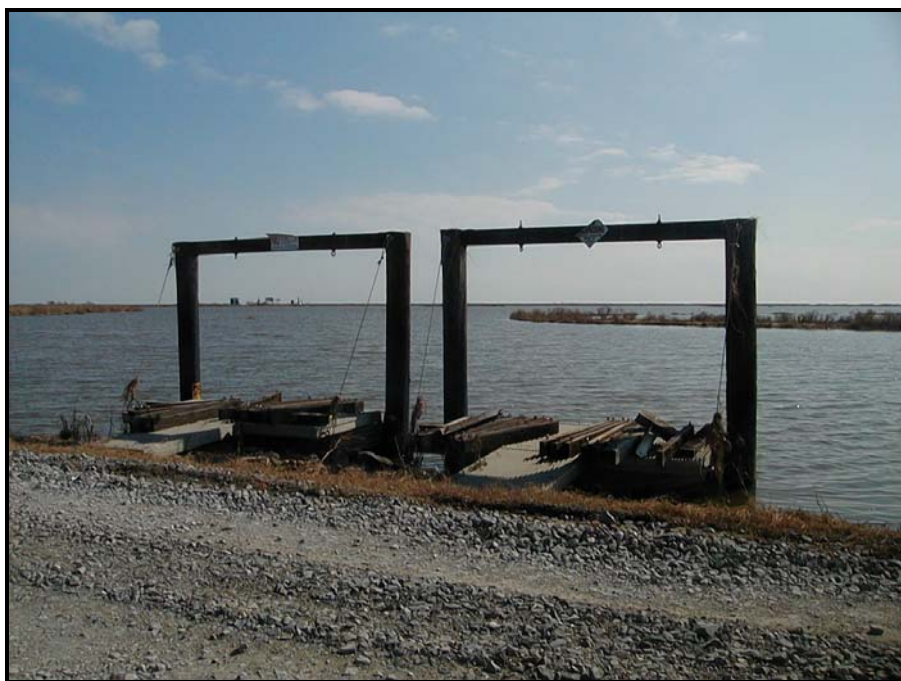
Structure No. 8 appears to be in very good condition. Water level gauges were unavailable. The end of the outlet pipes need to be cleaned out. It appears very little flow is going through the pipes due to washover of the access road rock material into the water. LDNR and NRCS agree that this structure requires clean out of the ends of outlet pipes, and replace staff gages inside and outside of the structure. (Photos: Appendix B, Photos 3).

Photo 3, Structure No.8, view looking south.

Item	Condition	Physical Damage	Corrosion	Photo #	Observations and Remarks
Steel Bulkhead / Caps	N/A				
Steel Grating	Good				
Stop Logs	Good				
Hardware	Fair		Yes		Corrosion on padlocks.
Timber Piles	Good				
Timber Wales	Good				
Galv. Pile Caps	Good				
Cables	Good				
Signage / Supports	Good				
Staff Gages	Poor				Staff gages inside and outside of the structure are missing.
Inlet/Outlet Pipe	Fair			3	Very little flow through pipes, clogged with washover of rock from roadway.
Earthen Embankment	Good

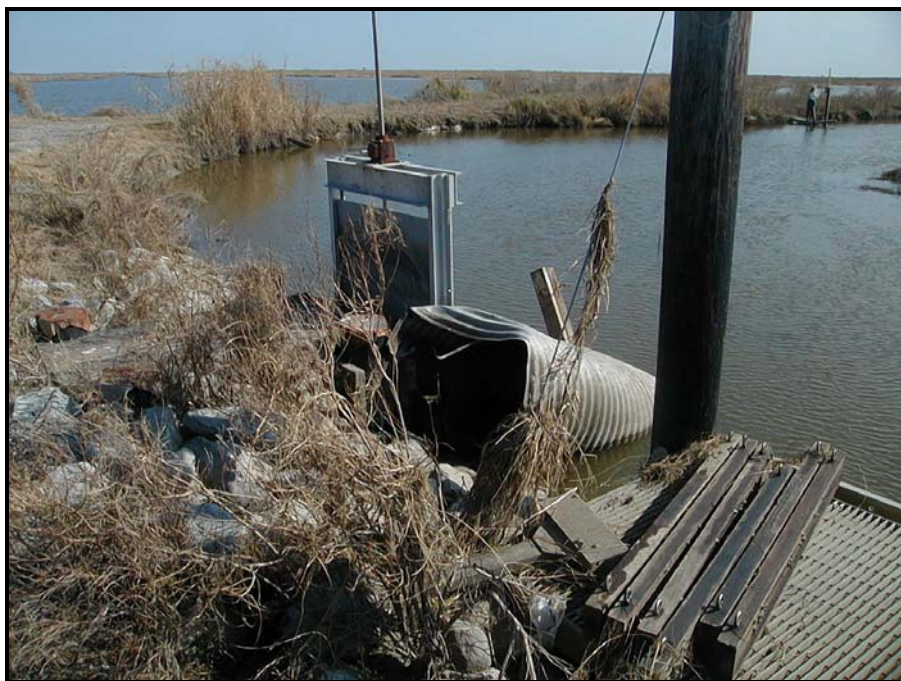
Structure No. 9a is in good condition. The staff gage on the inside was leaning and not readable and the gage on the outside was +1.1 NAVD. Salinity on the inside was 20.8 ppt and 25.0 ppt on the outside. A section of corrugated metal culvert debris has been lodged up against this structure. The handle on the outlet pipe flapgate has been broken off. Upon visual inspection, we noticed that there was slight erosion on the earthen wing-walls of the structure. LDNR and NRCS agree that this structure requires removal of the metal pipe and repair of the flapgate handle. (Photos: Appendix B, Photos 4 & 5).

Structure No. 9b is in good condition. The staff gage on the inside was leaning and not readable and the gage on the outside was +1.1 NAVD. Salinity on the inside was 20.8 ppt and 25.0 ppt on the outside. A section of corrugated metal culvert debris has been lodged up against this structure. The handle on the outlet pipe flapgate has been broken off. The gear box on the sluice gate is showing signs of rust and the stem cover is missing. Apache personnel have reported that it, so far, is not a problem; however it will probably need to be addressed. LDNR and NRCS agree that this structure is in operable condition and minor maintenance will be required to sandblast, clean up, paint the gearbox and replace the plastic stem cover, and repair flapgate handle. (Photos: Appendix B, Photos 4 & 5).

Photo 4, Structure 9a & 9b, showing metal culvert debris lodged on structures.

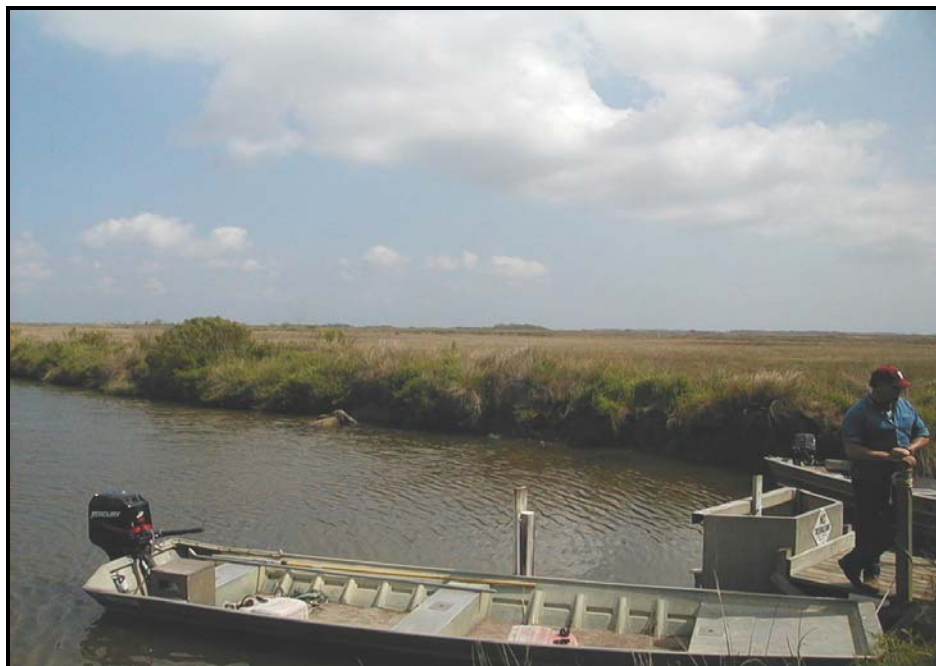
This is also a pre-existing structure that was incorporated into the CS-20 Project. The walkways on the outside and the inside of the structure are missing. The structure is silted up with marsh debris and the stop logs could not be pulled. The bank, however, is showing signs of some erosion and will require approximately 270 tons of man-size rip rap for reinforcement. The bank has additional erosion occurring from the storm. The staff gage on the outside of the structure is missing. LDNR and NRCS agree that maintenance work is required to add rip rap, clean out debris, replace walkway, and replace staff gage. (Photos: Appendix B, Photos 10, 11 & 12).

Photo 10, Structure No.3, March – 2005, showing bankline erosion.

Photo 11, Structure No. 3, November – 2005, showing additional erosion along structure and eastern levee.

Photo 12, Structure No. 3, showing marsh debris/siltation in and around the structure.

Item	Condition	Physical Damage	Corrosion	Photo #	Observations and Remarks
Steel Bulkhead / Caps	N/A				
Steel Grating	Good				
Stop Logs	Good				
Hardware	Fair		Yes		Corrosion on padlocks.
Timber Piles/ Walkway	Fair				Walkways on the inside and outside of the structure are missing.
Timber Wales	Good				
Galv. Pile Caps	Good				
Cables	Good				
Signage /Supports	Fair				Replace staff gage on inside and outside of the structure.
Rip Rap (fill)	N/A				
Earthen Embankment	Fair	Yes		10, 11	Bank erosion on inside of structure, 75 feet on left side and 25 feet on right .
Channel	Poor			10, 11 12	Bank erosion on outside of structure, 20 feet (Approximately 270 tons of rock total). Inlet side of the structure is silted up with marsh debris.

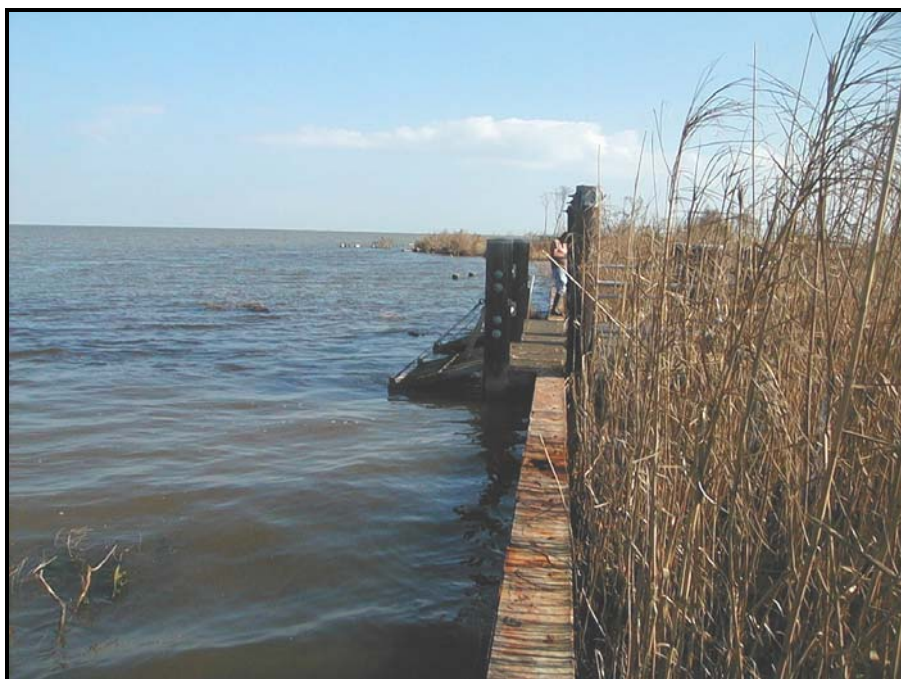
Water was flowing into this structure from First Bayou. The warning sign is missing as well as the staff gauge inside. Staff gauge reading outside was +1.67NAVD88. Salinity inside the marsh was 25.0 ppt and 21.5 ppt on the outside. Remaining project features are in same condition as pre-storm. LDNR and NRCS agree that minor maintenance is required to replace the warning sign. (Photos: Appendix B, Photo 15).

Photo 15, Structure No. 13, view looking south, flap gates open.

Item	Condition	Physical Damage	Corrosion	Photo #	Observations and Remarks
Steel Bulkhead / Caps	Fair			15	Some rusting of pile cap is present.
Steel Grating	Good				
Stop Logs	Good				Note: Water was flowing into project from First Bayou.
Hardware	Good				
Timber Piles	Good				
Timber Wales	Good				
Galv. Pile Caps	Good				
Cables					
Signage / Supports	Fair				Warning sign is missing.
Staff Gage	Fair				Staff gage inside is missing.
Rip Rap (fill)					
Earthen Embankment

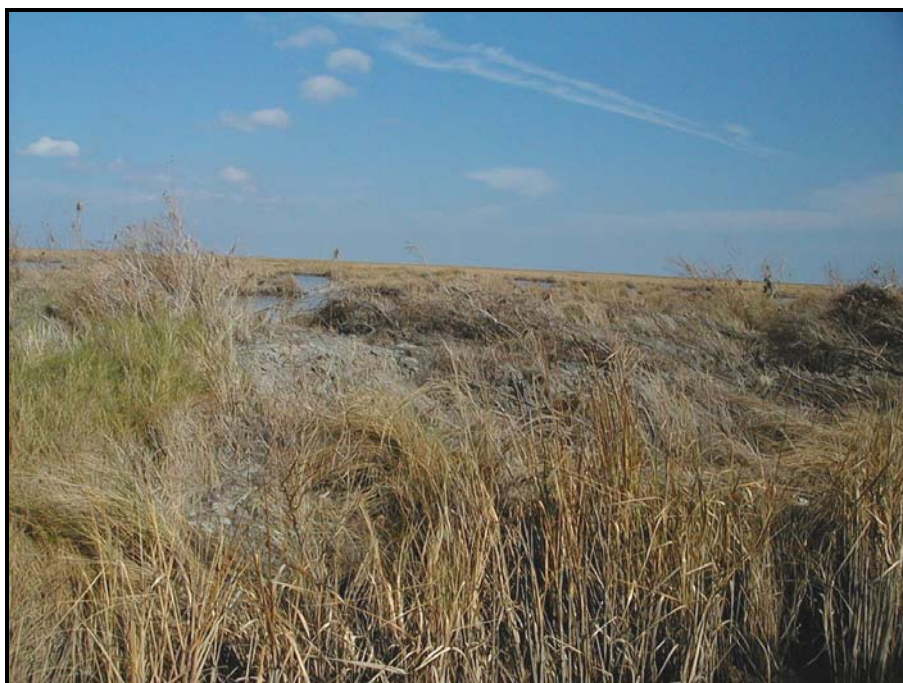
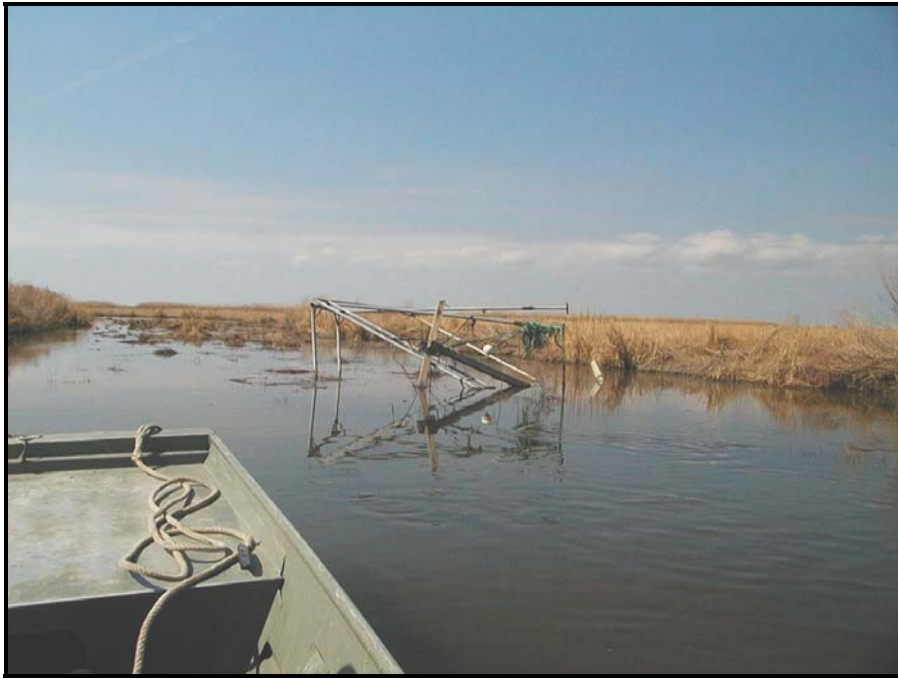
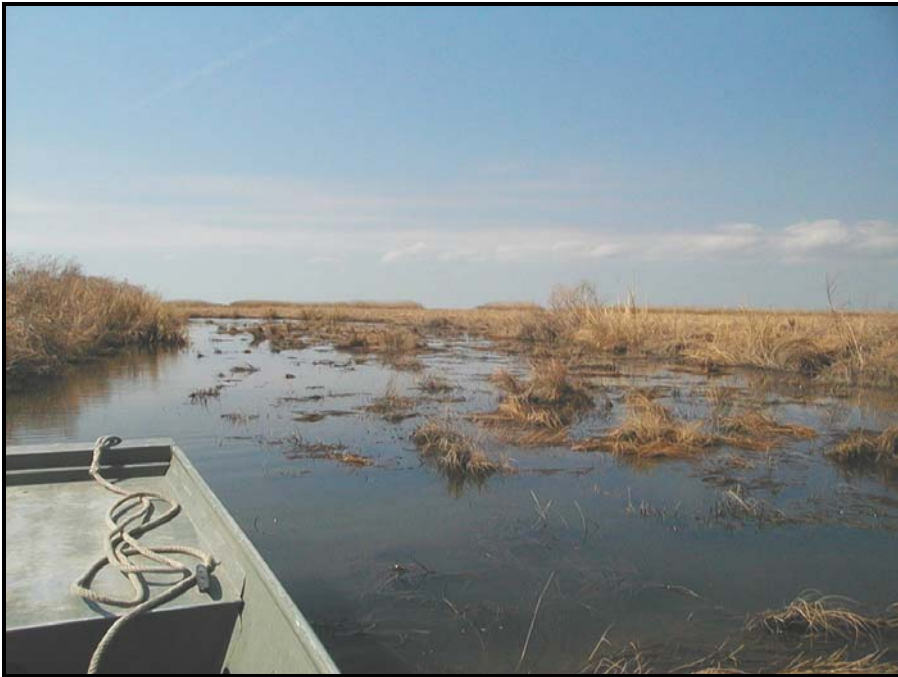
The inspection of the earthen levee consisted of a visual inspection of the entire length of levee along the Step Canal. In addition to the erosion noted at Structures No. 5 and 3, the storm surge has eroded portions of the levee in various locations. In addition the storm surge has placed large amounts of marsh and other debris into the east-west sections of the Step Canal. In these areas of the canal, the water depth was very shallow. The north-south sections appear to be relatively free of any obstructions. LDNR and NRCS agree that maintenance is required to repair the levees and remove trash from the canal. (Photos: Appendix B, Photos 16, 17 & 18).

Photo 16, North Levee, looking east, showing washout of top portion of levee.

Photo 17, Step Canal, view looking west, showing marsh/siltation and other debris in the canal.

Photo 18, Step Canal, view looking west, again showing heavy marsh siltation in the canal.
