**State of Louisiana
Department of Natural Resources
Coastal Engineering Division**

**2005/2006 Annual Inspection
Report**

**HWY. 384 HYDROLOGIC
RESTORATION PROJECT
(CS-21)**

October 24, 2005
Cameron Parish

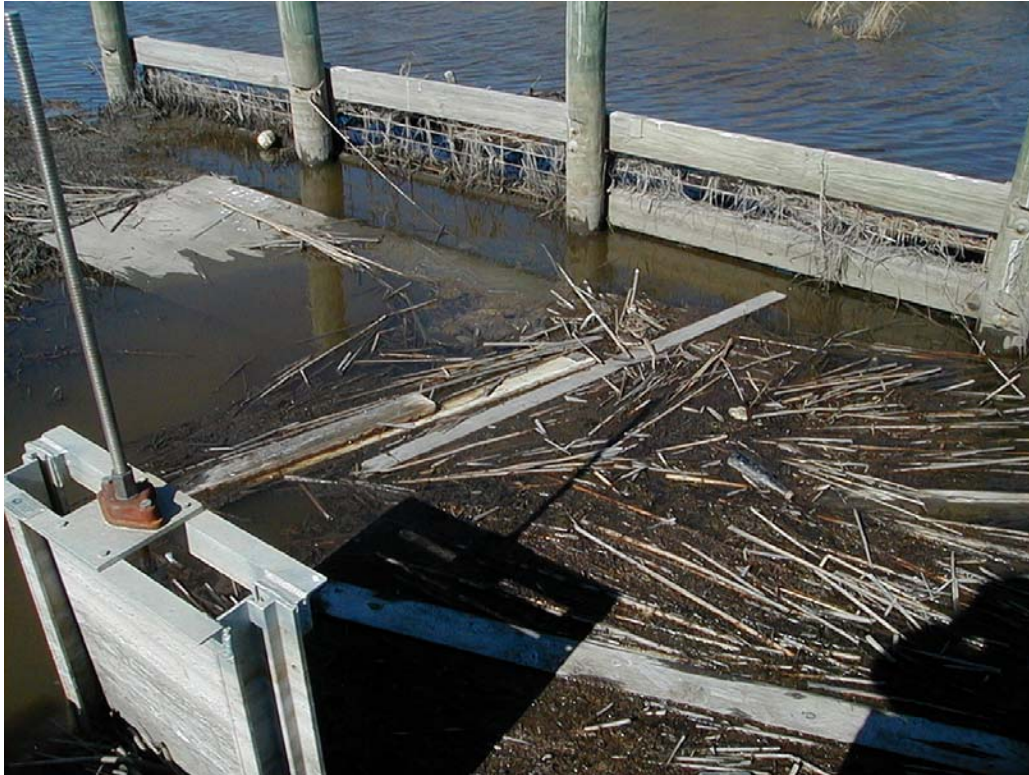
The structure is in good condition. Water levels could not be determined because the staff gages are missing. Rock placed on the bank during the maintenance event of June 2002 is stable and in no need of repair. The hyacinth fence is in good condition; however there is trash from Hurricane Rita that is between the fence and the sluice gates. The bearings on the sluice gate lifting device went under the storm surge waters and will need to be changed. The road/levee leading up to the structure shows areas where scouring is occurring from water over topping the roadway. A maintenance event is required at this site. (Photos: Appendix B, Photos 1-3)

Photo 1, View showing hyacinth fence and sluice gate at structure No.1

Overall, the Hwy. 384 Hydrologic Restoration Project is in good condition and functioning as designed with only minor problems noted. The hyacinth fence that was installed during the maintenance project of June 2002 as well as the rock reinforcement of the bankline is performing well and should be incorporated into all structures of this type in the future. A maintenance event is planned for spring of 2006 to raise the road to original constructed elevations.

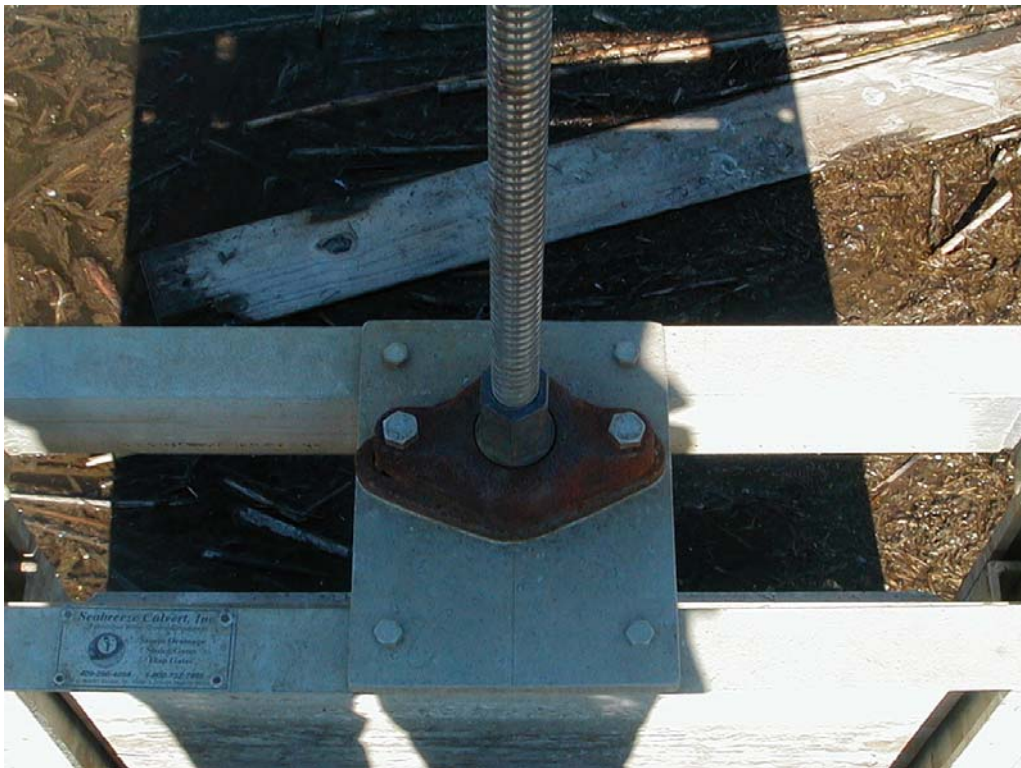
Photo 2, View showing lifting device and stem at structure No. 1.

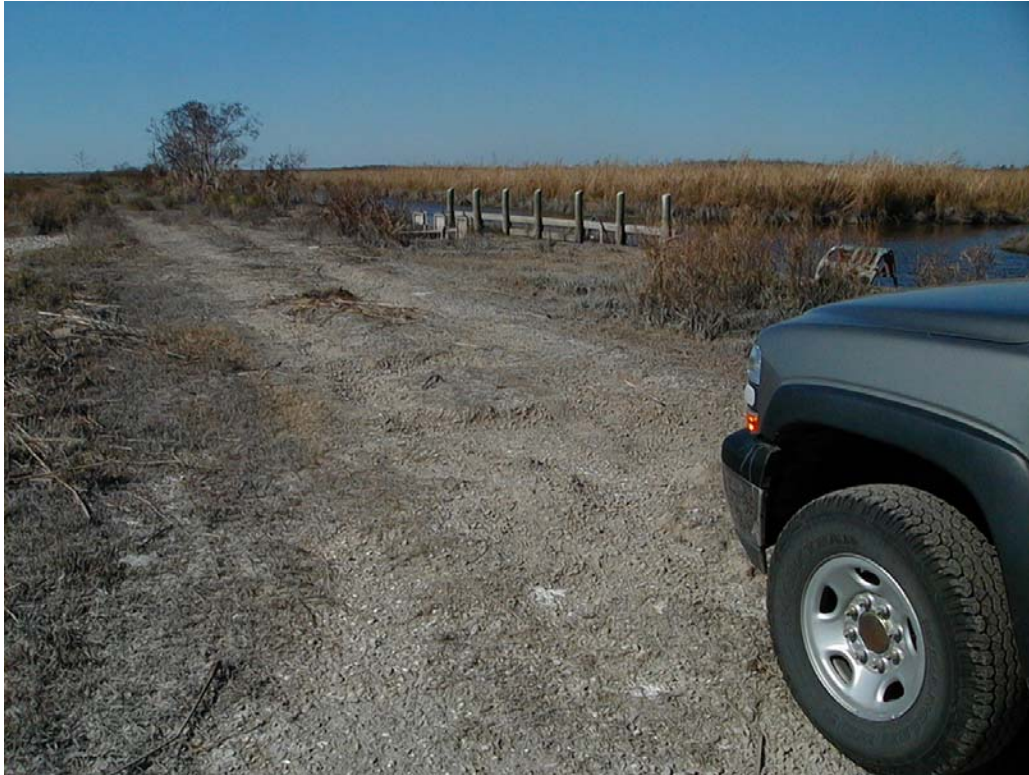
Photo 3, View of roadway approaching structure No. 1.

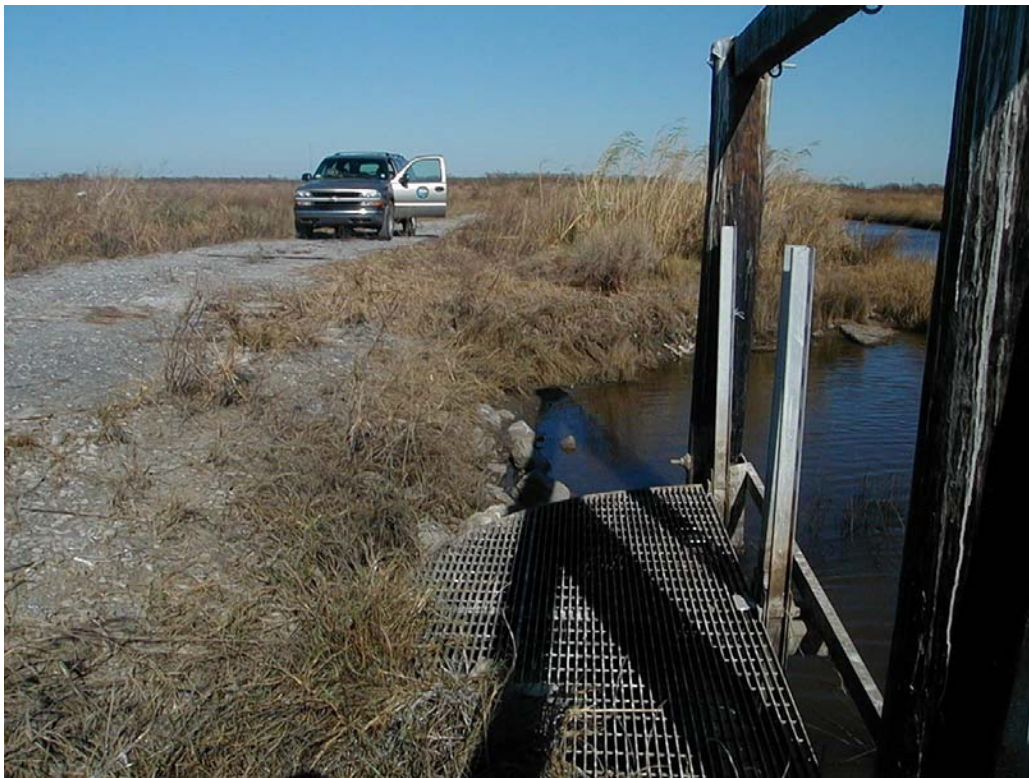
The structure is in good shape. Water levels could not be determined because the staff gages are missing. There are slight depressions in the road approximately 200 feet east of the structure. These depressions are the result of water flow over the road. Pile caps on the inlet side and the padlocks on the stop log locking devices have rusted and will eventually need to be replaced. Rock that was placed during the maintenance of Nov. 2000 is stable. A maintenance event is required at this time. (Photos: Appendix B, Photos 4-6).

Photo 4, Inlet side of structure No. 12.

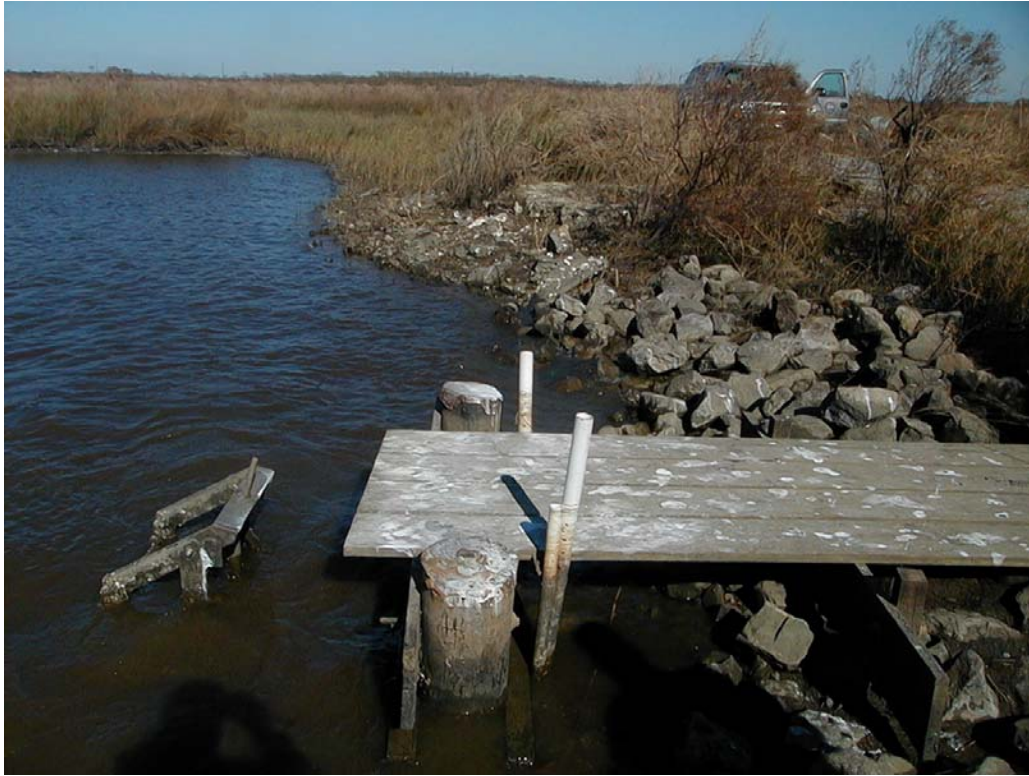
Photo 5, Outlet side of structure No. 12.

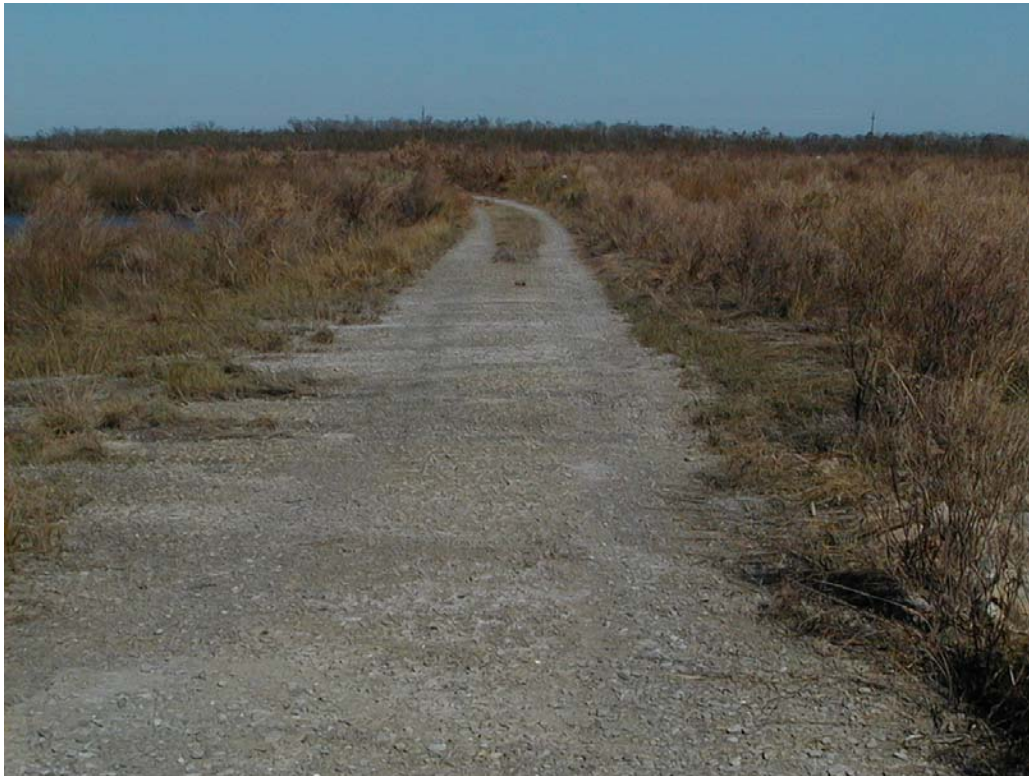
Photo 6, View of access road just east of structure No. 12 showing washout of roadway.

05/06 Description: Restore Access Road to Constructed Elevation

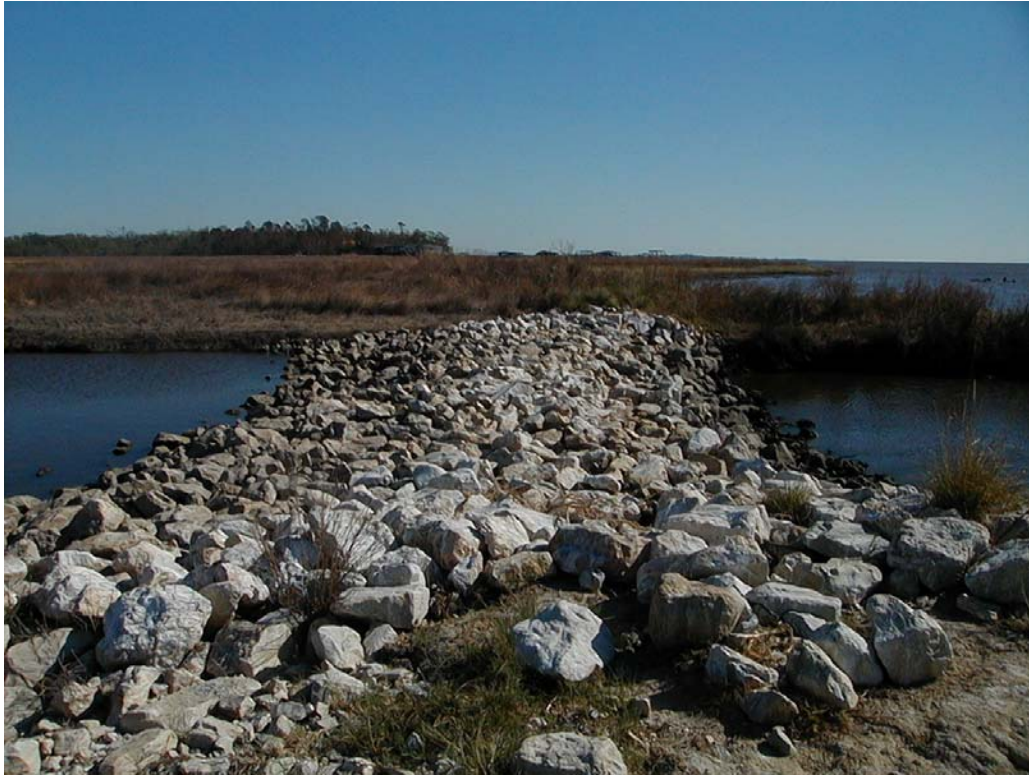
Water levels could not be determined because the staff gages are missing. The rock plug is in good condition and no damage was noted from Hurricane Rita at this structure. The recently completed maintenance work to repair the plug from vandalism held up well under the high storm surge waters. (Photos: Appendix B, Photo7)

Photo 7, Rock plug at structure No. 8, view looking south.
