**2005/2006 Annual Inspection  
Report**

**SABINE REFUGE STRUCTURE  
REPLACEMENT PROJECT  
(CS-23)**

State Project Number CS-23  
Priority Project List 3

October 13, 2005  
Cameron Parish

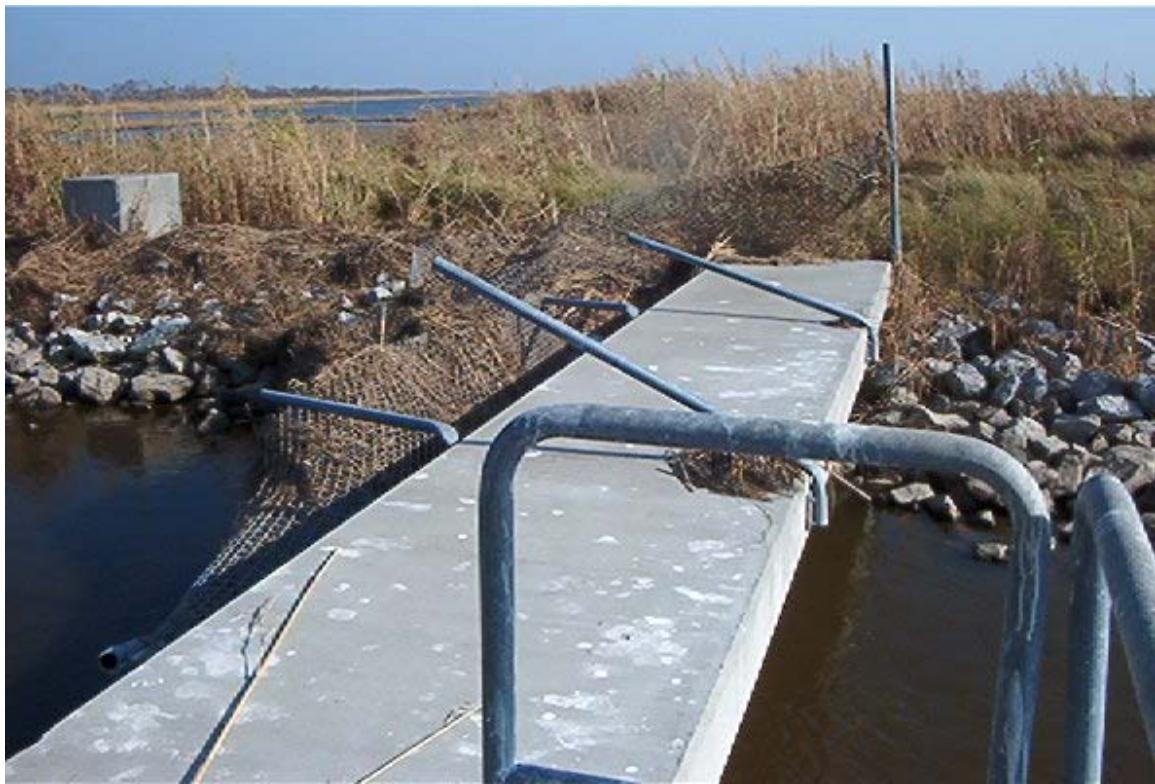
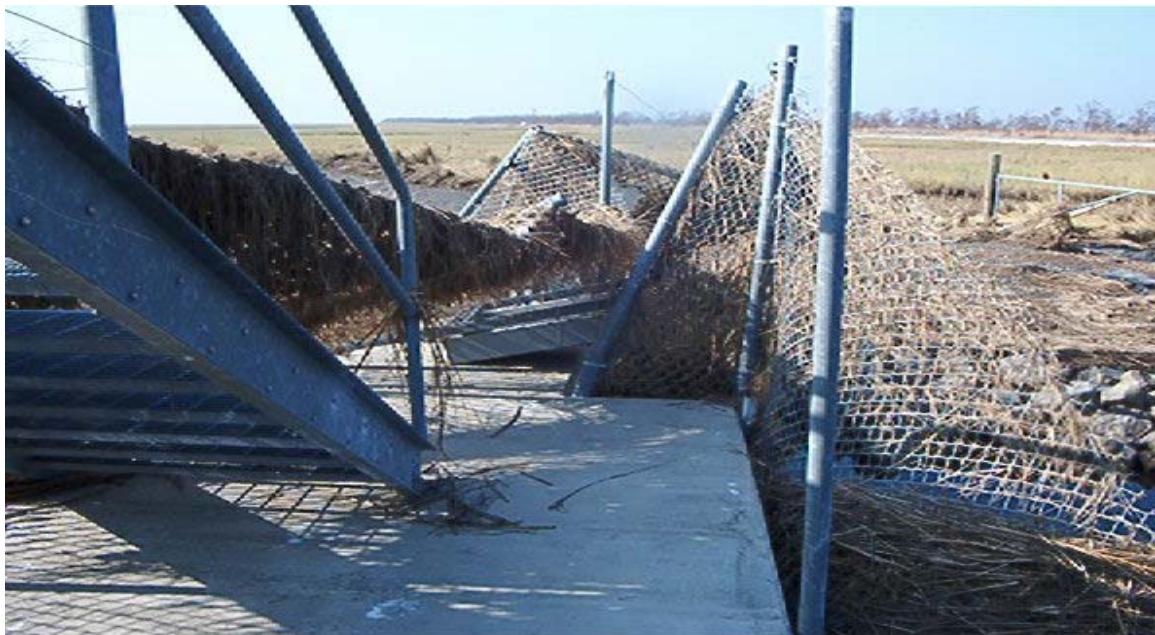
The chain link security fence was demolished on both the north and south sides of the structure. The posts were bent and can be unbolted from the structure and new posts installed. The mesh has to be replaced.

The aluminum brace bolted between the gate guides and the concrete structure was bent, which indicates the gates were twisted. The braces should be replaced and stems realigned with the gate and operating nut. This may require that the pedestal flanges be machined to make sure that the two flanges are parallel. (Photos: Appendix B, Photos 1 - 2)

Photo 1, North Walkway On Hog Island Gully Structure

Photo 2, South Walkway On Hog Island Gully Structure

Item	Condition	Physical Damage	Corrosion	Photo #	Observations and Remarks
Steel Bulkhead / Caps	N/A				
Steel Grating	Good				
Gates Electrical	Fair Poor	Yes Yes			Alignment problems. All electrical components demolished.
Hardware Fencing	Poor	Yes		1 & 2	Chain link fence and posts demolished.
Timber Piles	Good				
Timber Wales	N/A				
Actuators	Fair				All actuators will have to be taken apart and serviced.
Cables	Good				
Signage /Supports	Good				
Rip Rap Rock Dike W.W. Reinf.	Good				
Earthen Embankment	N/A

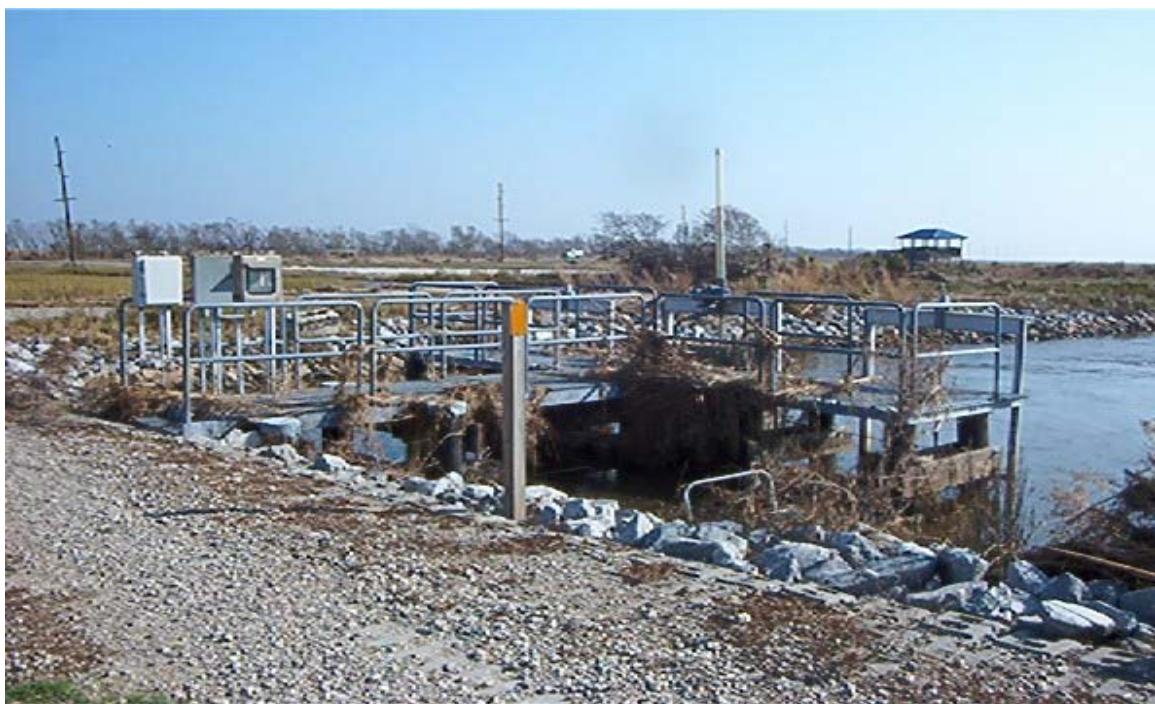
This structure was completely submerged. The electrical power panel had grass debris and water inside. It will have to be changed and should be installed at a higher elevation. The cover on the electronic actuator controller was removed and there was an indication of moisture inside. The actuator will have to be dismantled to determine if it can be salvaged. Walkways, platforms and structures were all in good condition. (Photos: Appendix B, Photos 3-4).

Photo 3, Headquarters' Canal Structure

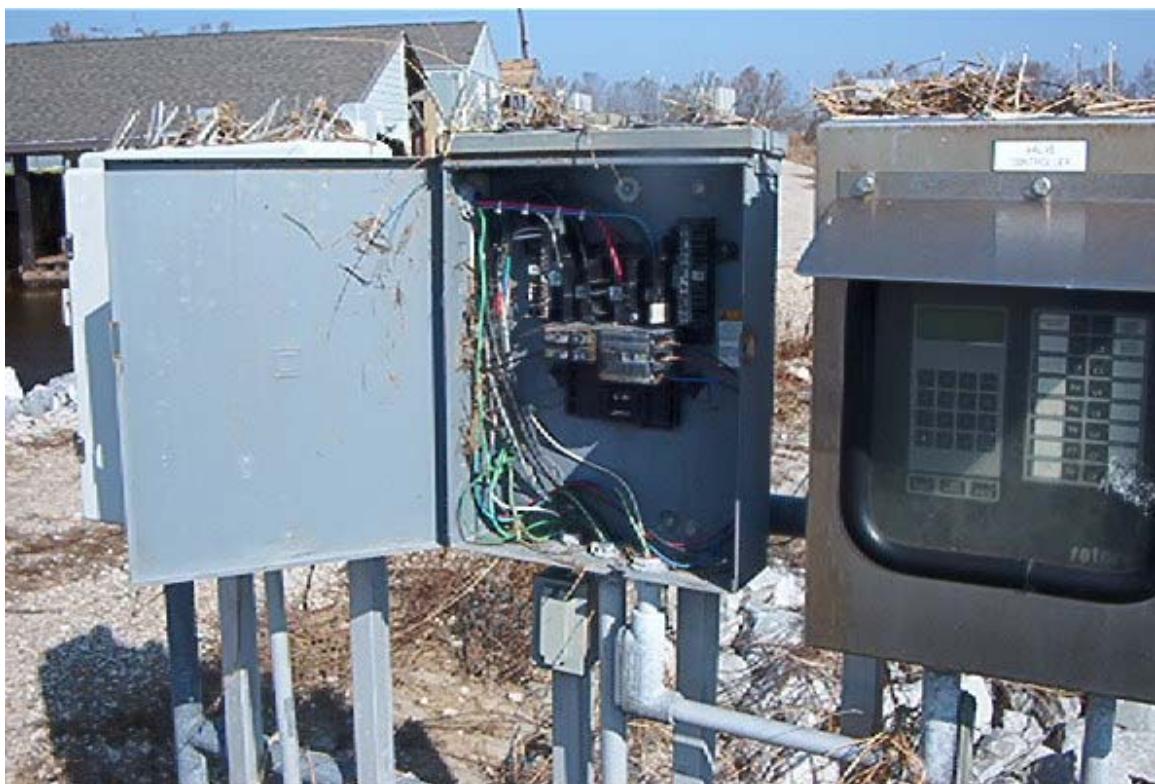
Photo 4, Grass and Water Inside Panel Box Headquarters' Canal Structure

Item	Condition	Physical Damage	Corrosion	Photo #	Observations and Remarks
Steel Bulkhead / Caps	N/A				
Steel Grating	Good				
Gates Electrical	Fair Poor	Probable Yes		3 4	Possible alignment problems with gates and/or stems. All electrical components demolished.
Hardware	Good				
Timber Piles	Good				
Timber Wales	Good				
Actuators	Fair	Yes			The actuator will have to be taken apart and serviced.
Cables	N/A				
Signage /Supports	N/A				
Rip Rap Rock Dike W.W. Reinf.	Good				
Earthen Embankment	N/A

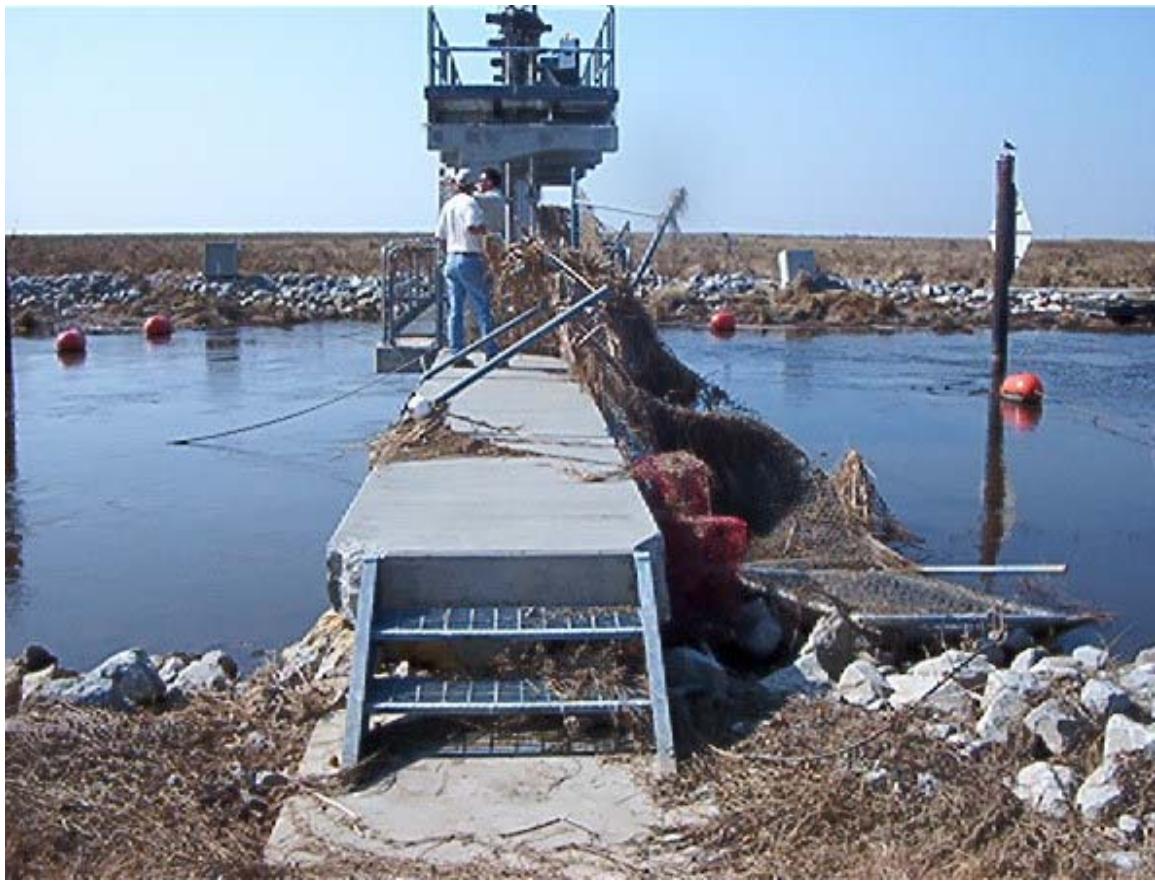
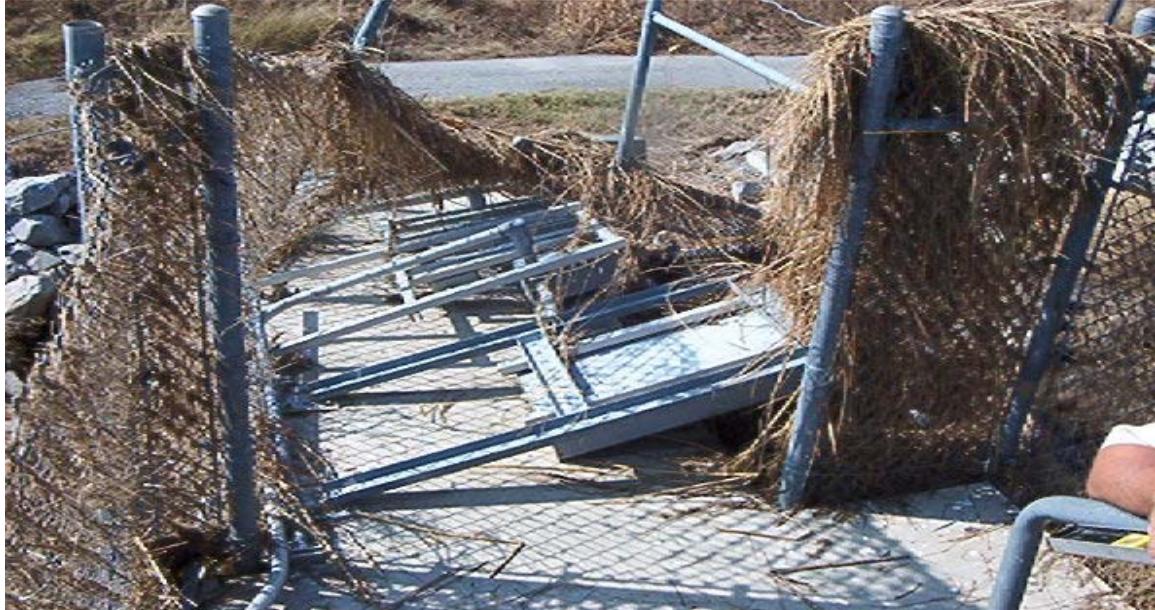
The chain link security fence was demolished on both the north and south sides of the structure. The posts were bent and can be unbolted from the structure and new posts installed. The mesh has to be replaced.

Alignment of the stem with the gate and operating nut should be checked. Realignment may require that the pedestal flanges be machined to make sure that the two are parallel. There is no damage to the fishing piers or boat launches. (Photos: Appendix B, Photos 5-8).

Photo 5, North Walkway On West Cove Canal Structure

Photo 6, South Walkway On West Cove Canal Structure

Item	Condition	Physical Damage	Corrosion	Photo #	Observations and Remarks
Steel Bulkhead / Caps	N/A				
Steel Grating	Good				
Gates Electrical	Fair Poor	Yes Yes		6 & 7	Alignment problems. All electrical components demolished.
Hardware/Stairs Fencing	Good Poor	No Yes		8 5 & 6	Trash and debris to top of structure. Chain link fence and posts demolished.
Timber Piles	Good				
Timber Wales	N/A				
Actuators	Fair				All actuators will have to be taken apart and serviced.
Cables	Good				
Signage /Supports	Good				
Rip Rap Rock Dike W.W. Reinf.	Good				
Earthen Embankment	N/A

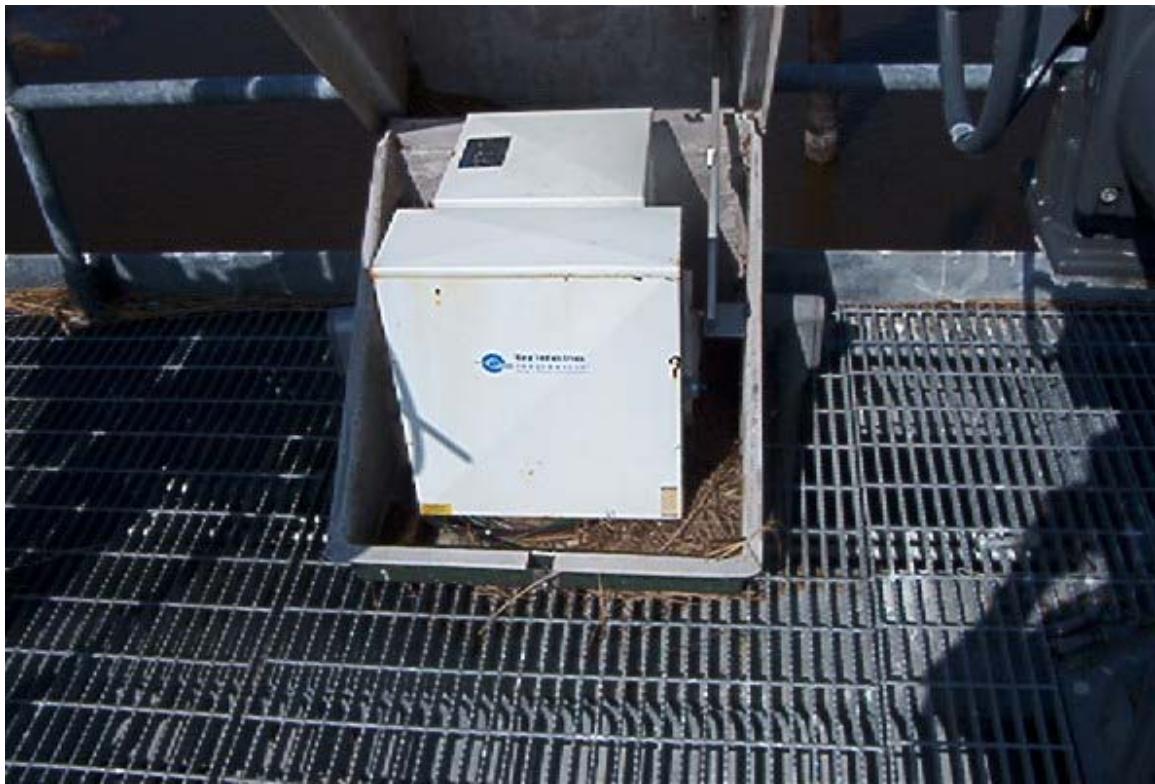
The electrical power panels were completely submerged and will have to be changed. These panels should be relocated to the top of the platform. The variable frequency drive enclosure had grass debris inside of it indicating it had been under water, so it will have to be replaced. A cover on an electronic actuator controller was removed and there was an indication of moisture inside. The bottom drain plug was removed and a considerable quantity of water drained out. All of the actuators will have to be taken apart and determined if they can be salvaged.

Photo 7, Grass And Debris Inside Variable Frequency Drive Enclosure West Cove Canal Structure

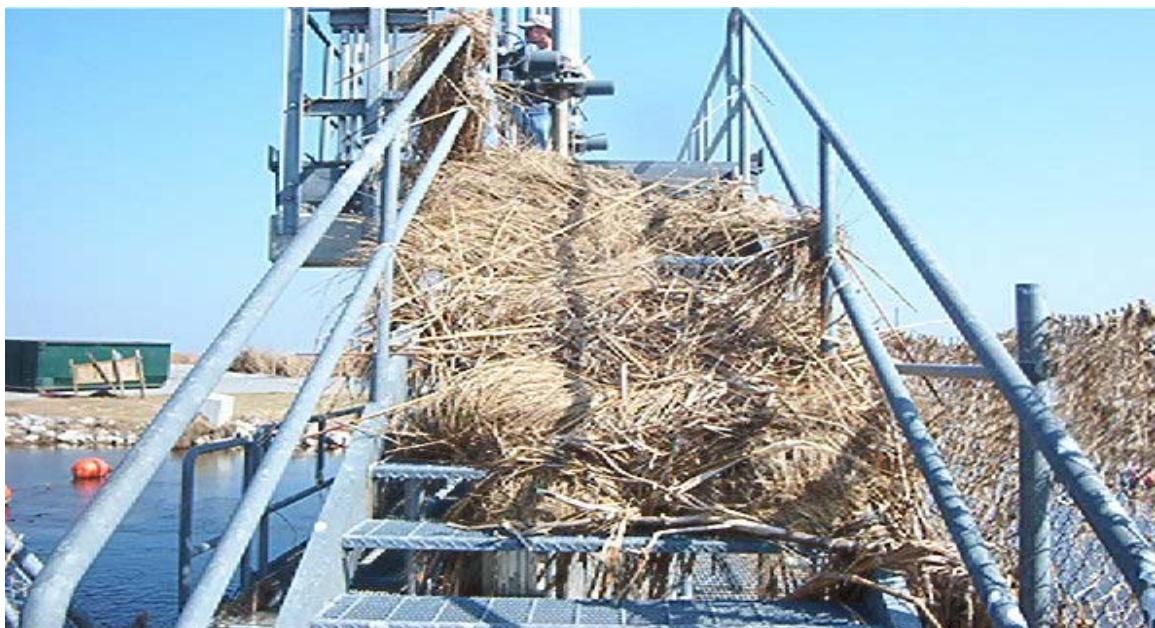
Photo 8, Storm Surge Topped The Top Platform At West Cove Canal Structure
