# 2005/2006 Annual Inspection Report

# PERRY RIDGE SHORELINE PROTECTION PROJECT (CS-24)

State Project Number CS-24 Priority Project List 4

October 6, 2005 Calcasieu Parish

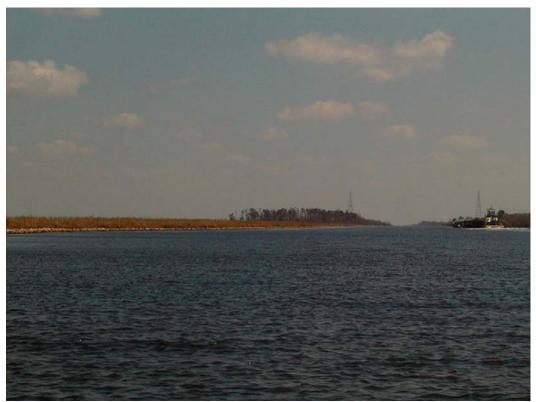
The dike is in good condition and appears to be in the same condition as to what existed prior to the storm and did not sustain any discernable damage from the storm. No maintenance is recommended at this time. (Photos: Appendix B, Photos 1 & 2)

Photo 1, Typical rock dike.

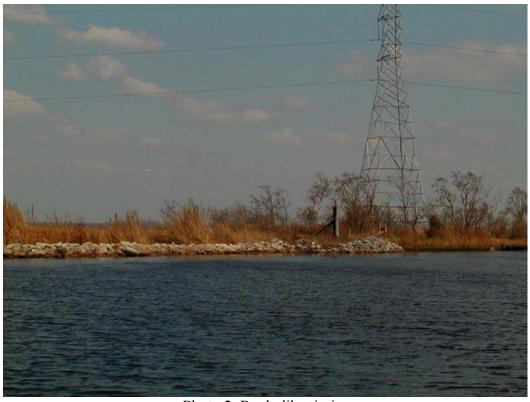
Photo 2, Rock dike tie-in.
