**2005/2006 Annual Inspection
Report**

**BLACK BAYOU HYDROLOGIC
RESTORATION PROJECT
(CS-27)**

State Project Number CS-27
Priority Project List 6

October 6, 2005
Calcasieu and Cameron Parishes

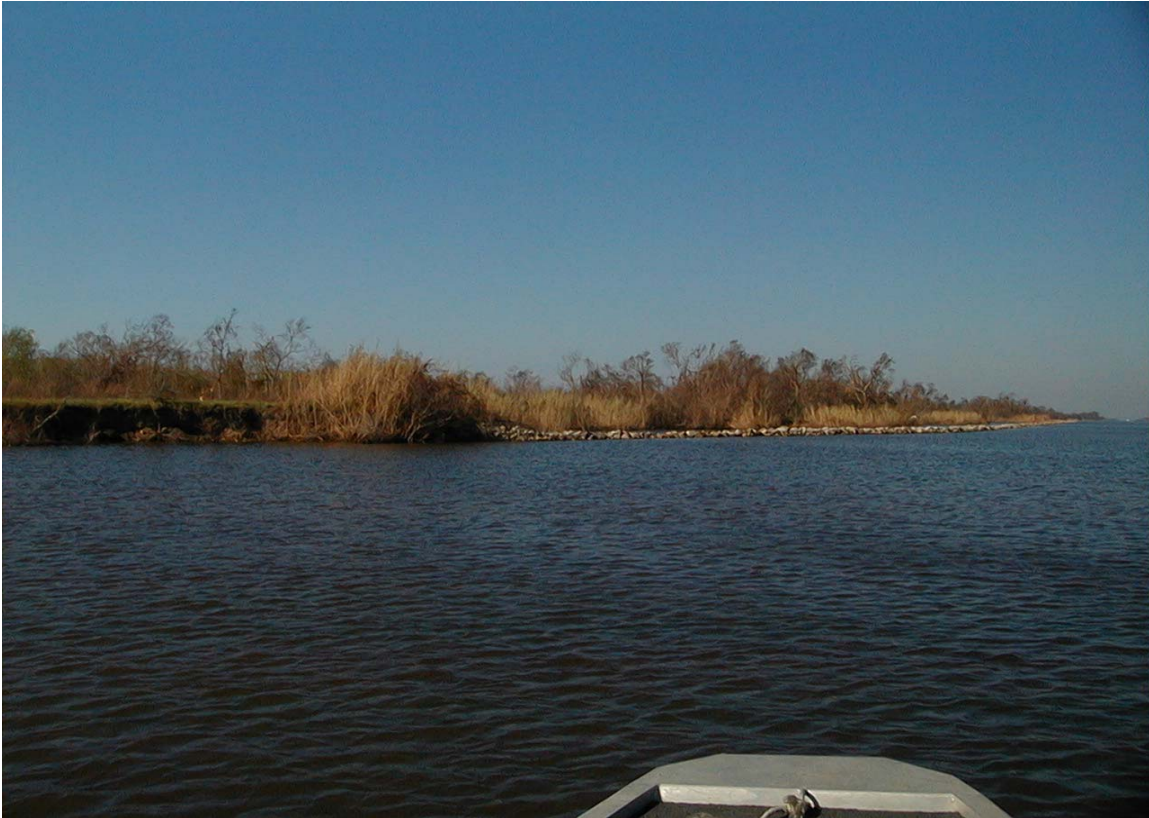
Tie-ins on both the east and west end of the dike are stable. Several random spots along the dike were checked and no apparent toe scour is occurring. There is one section approximately 10 feet in length near the eastern most plug where the rock dike is slightly low in elevation. Near the first pine ridge from the Vinton Canal, along an approximately 50' section, rock has been displaced apparently by being hit by a barge. On the western end of the second plug from the west, an alligator crossing has developed and will need to be monitored. The warning signs at the Vinton Canal and at Black Bayou have been stolen. The piling for the sign at Black Bayou was cut with a chain saw. Replacement of these signs may not be necessary. The other situations mentioned in this section are considered minor and not requiring repair at this time. (Photos: Appendix B, Photos 1 - 6)

Photo 1—eastern tie-in of rock dike

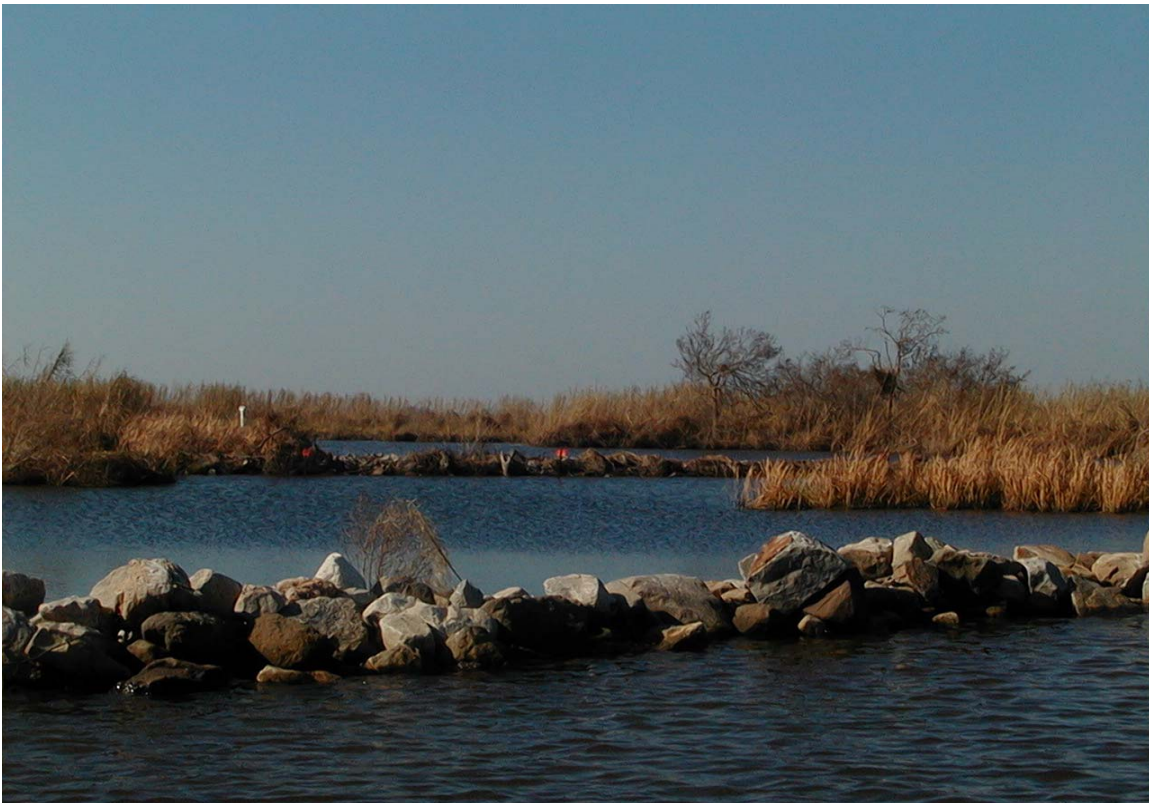
Photo 2—plug behind dike

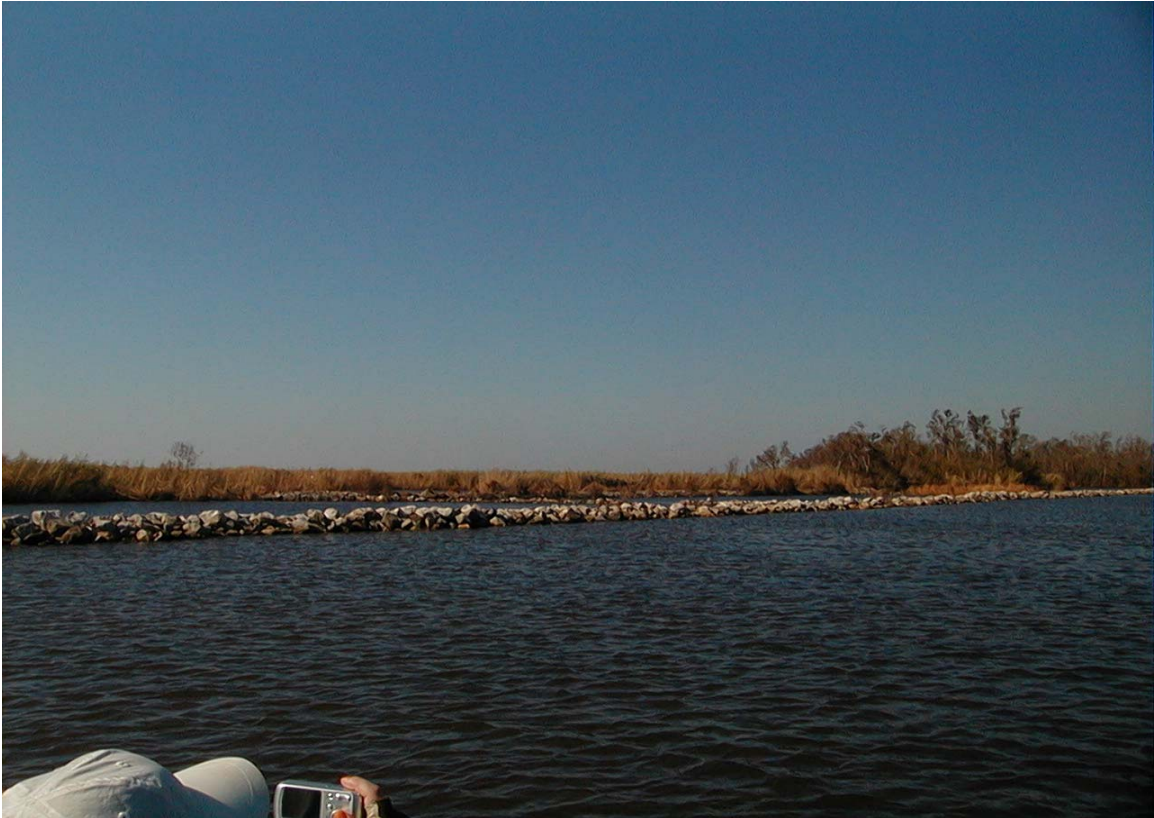
Photo 3--plug behind dike

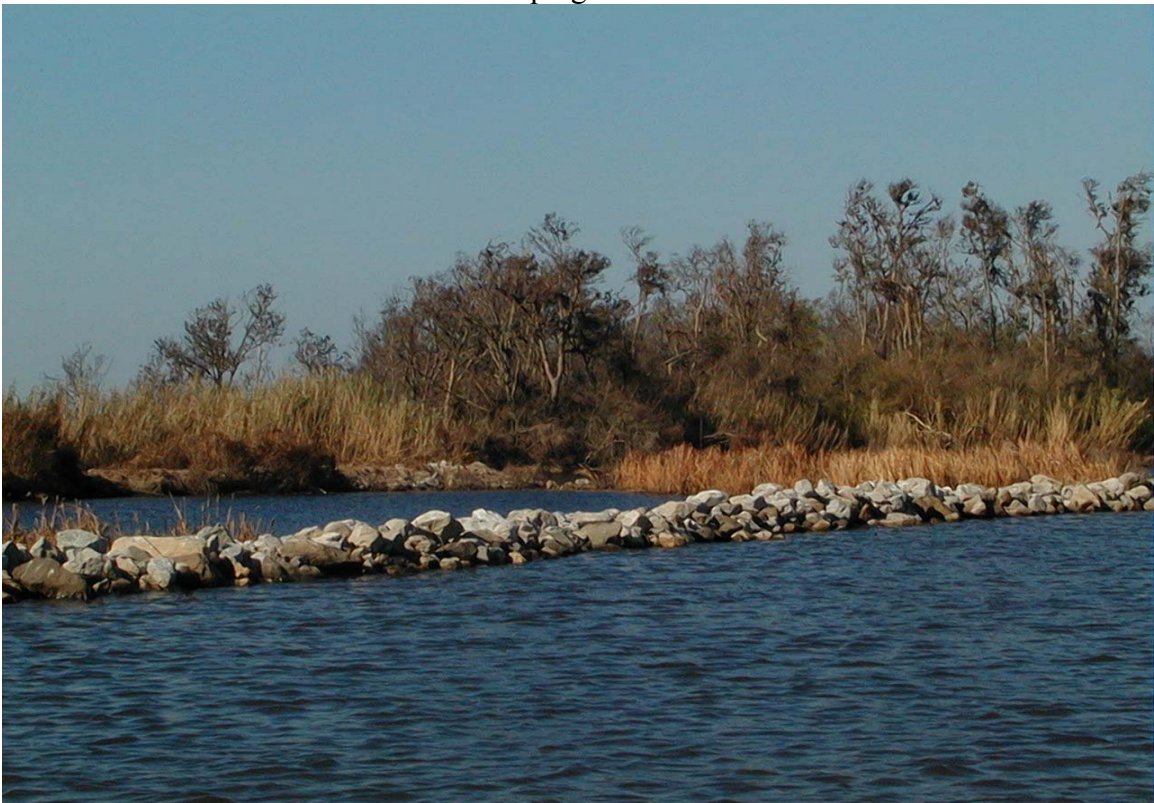
Photo 4--plug behind dike

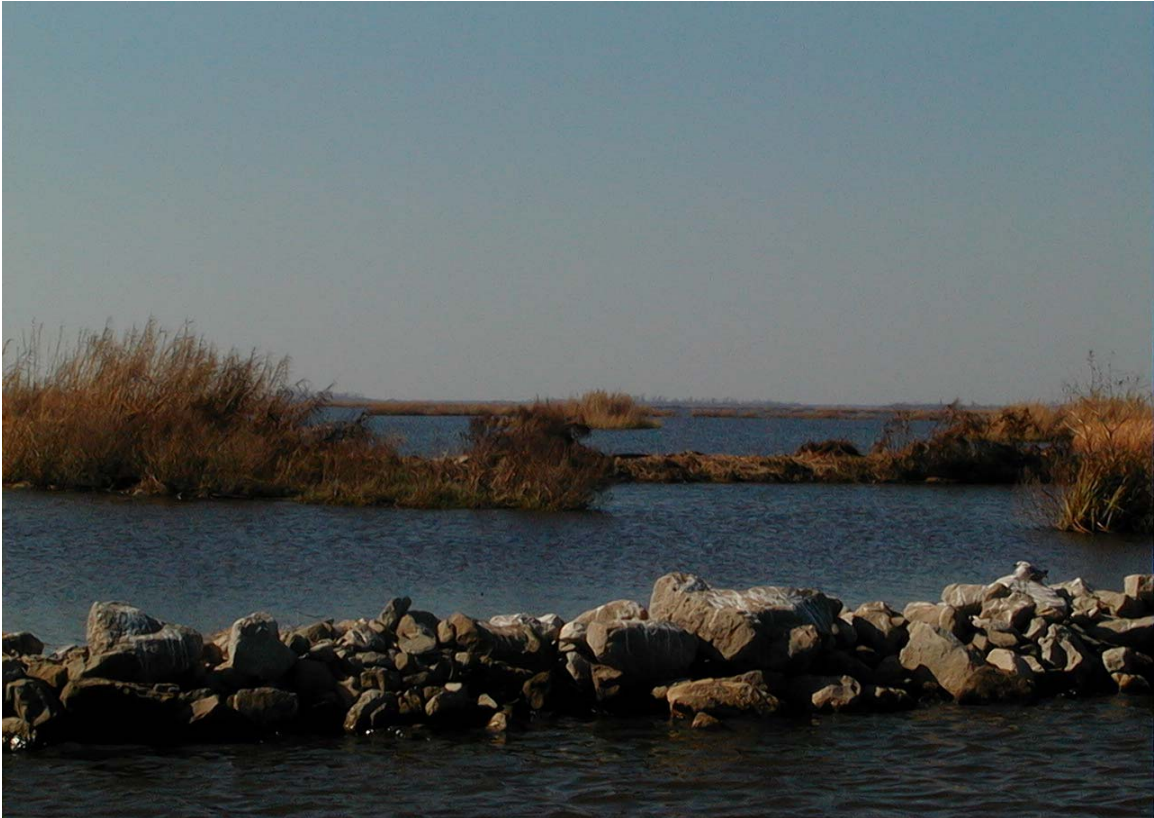
Photo 5-- plug behind dike

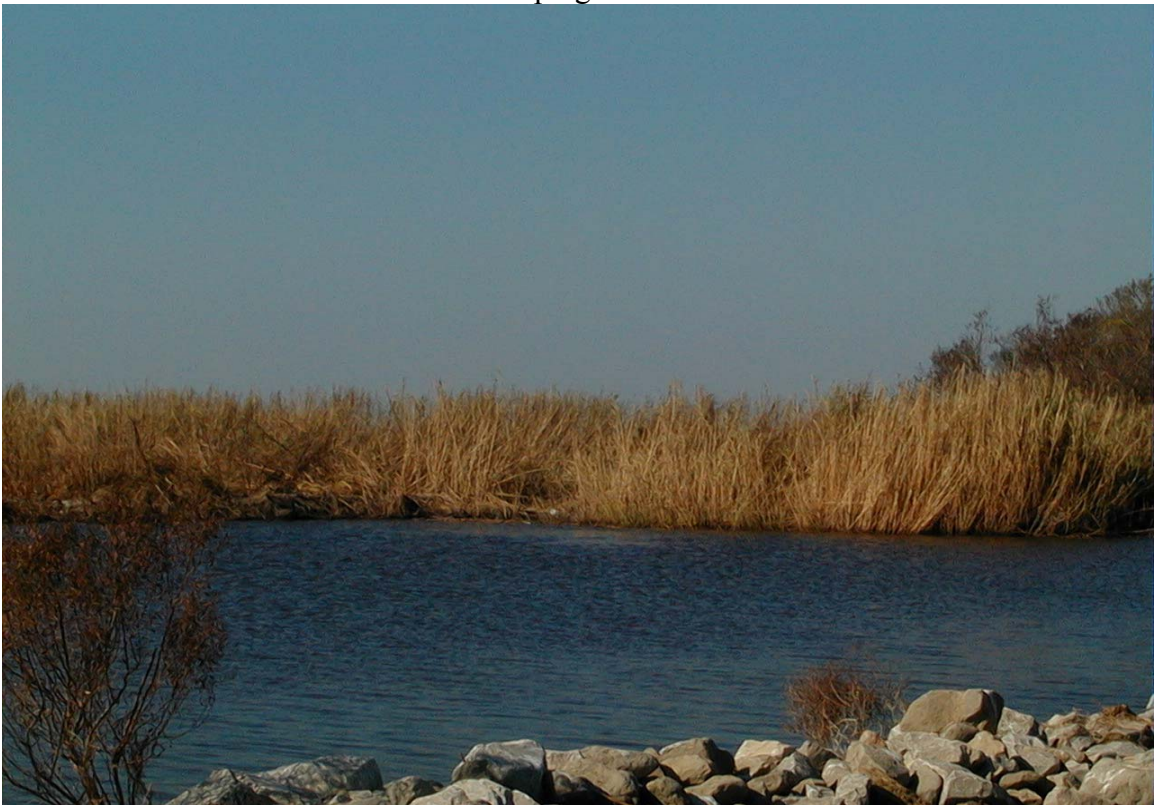
Photo 6—Area of potential problem around rock

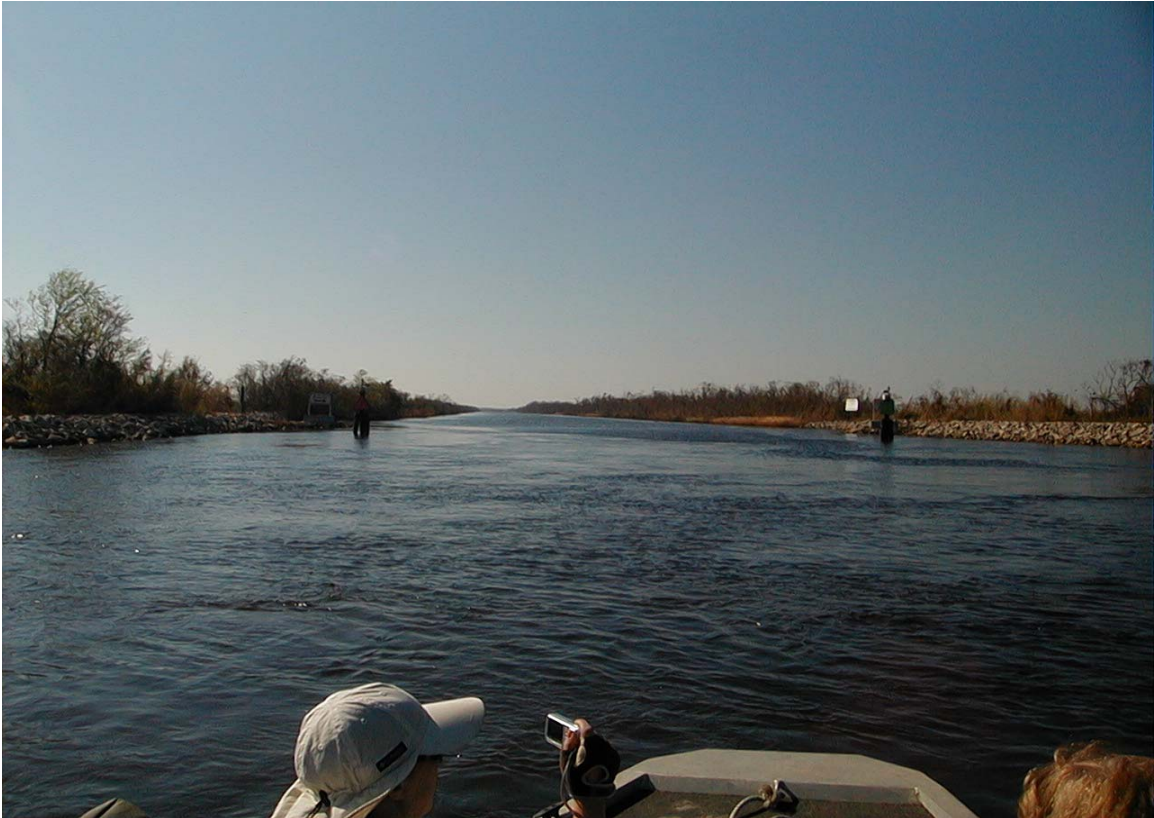
This component is in immediate post construction condition. No need for maintenance at this time. Conditions of the Navigational Aid Lights will have to be evaluated at a later date by trained personnel. (Photos: Appendix B, Photo 7)

Photo 7—Black Lake Cut-Off Structure

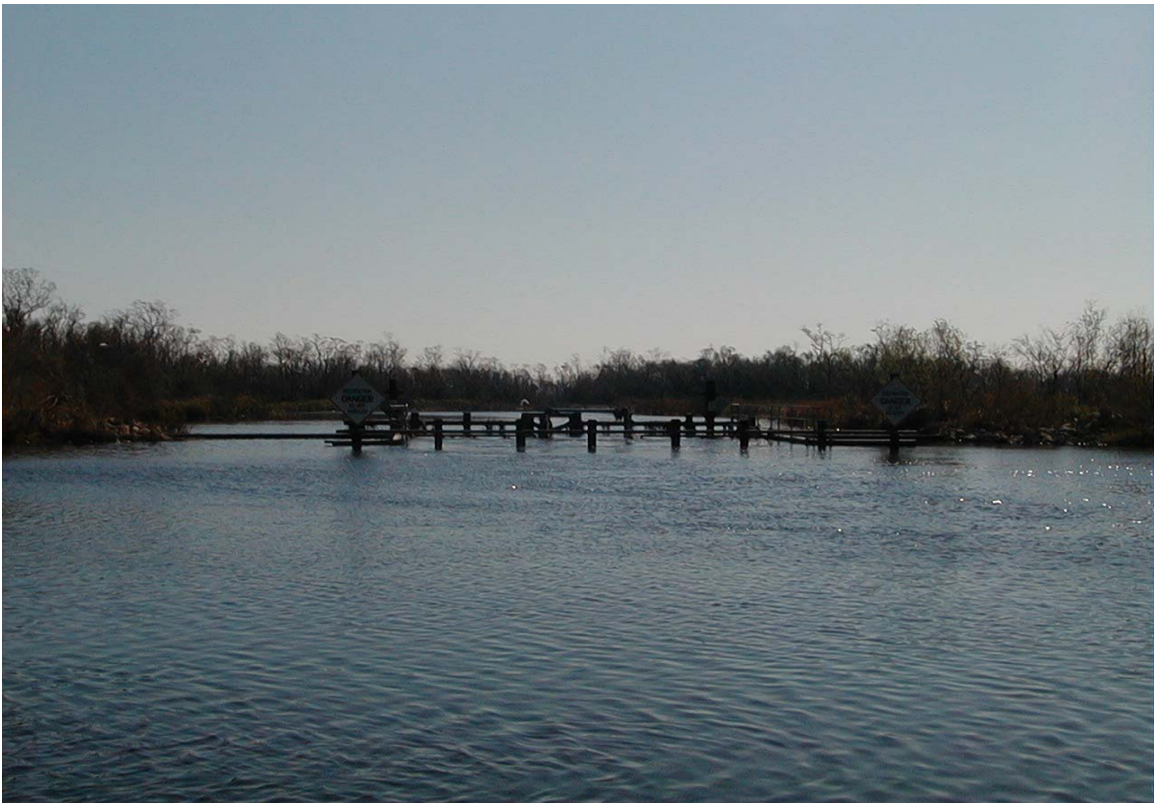
The structure is in excellent condition. Signage, railings, wingwalls, etc. in as-built condition. No need for maintenance other than that which is underway at this time. (Photos: Appendix B, Photos 8-9)

Photo 8—SRT Gate

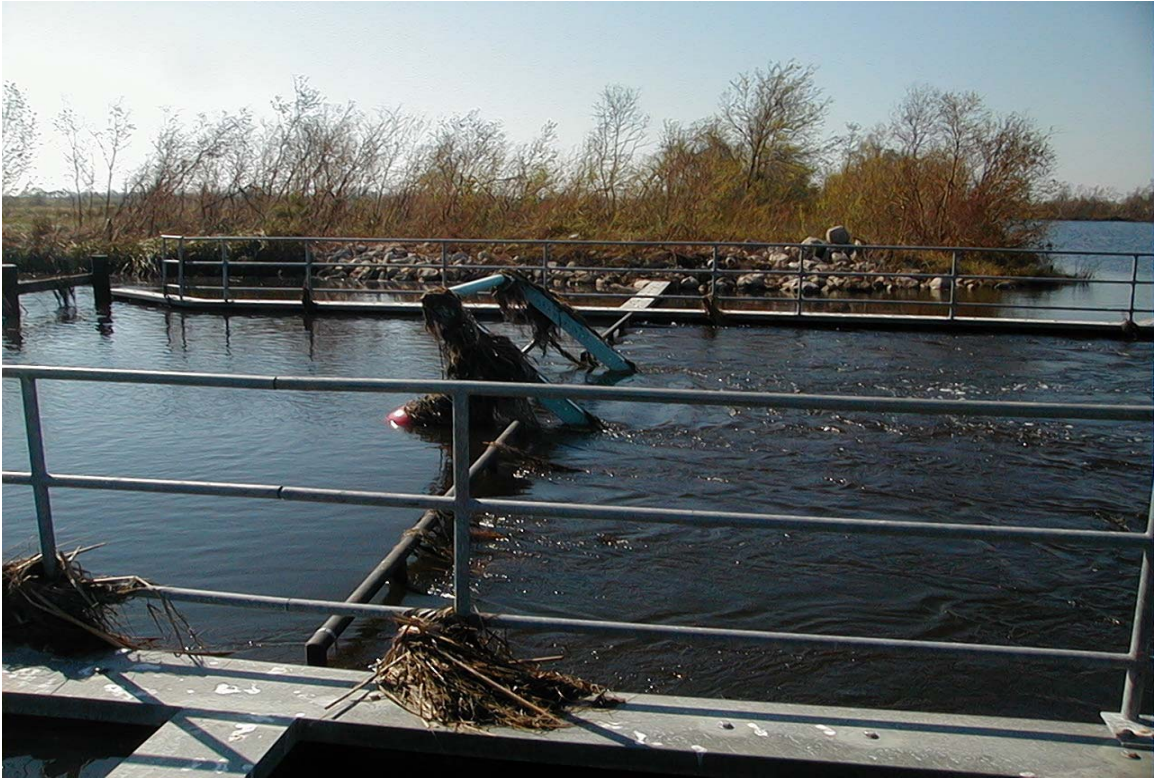
Photo 9—SRT Structure

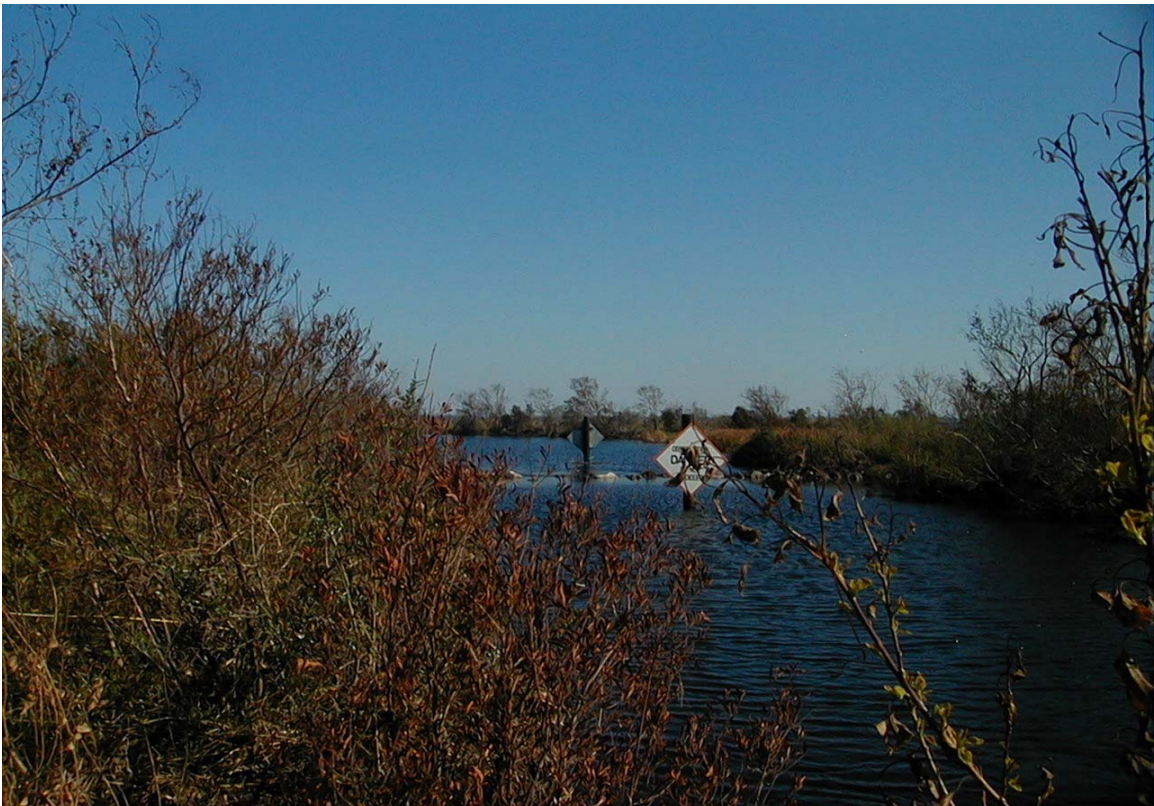
The plug is excellent condition and in no need of maintenance. (Photos: Appendix B, Photo 10)

Photo 10—Rock plug near SRT

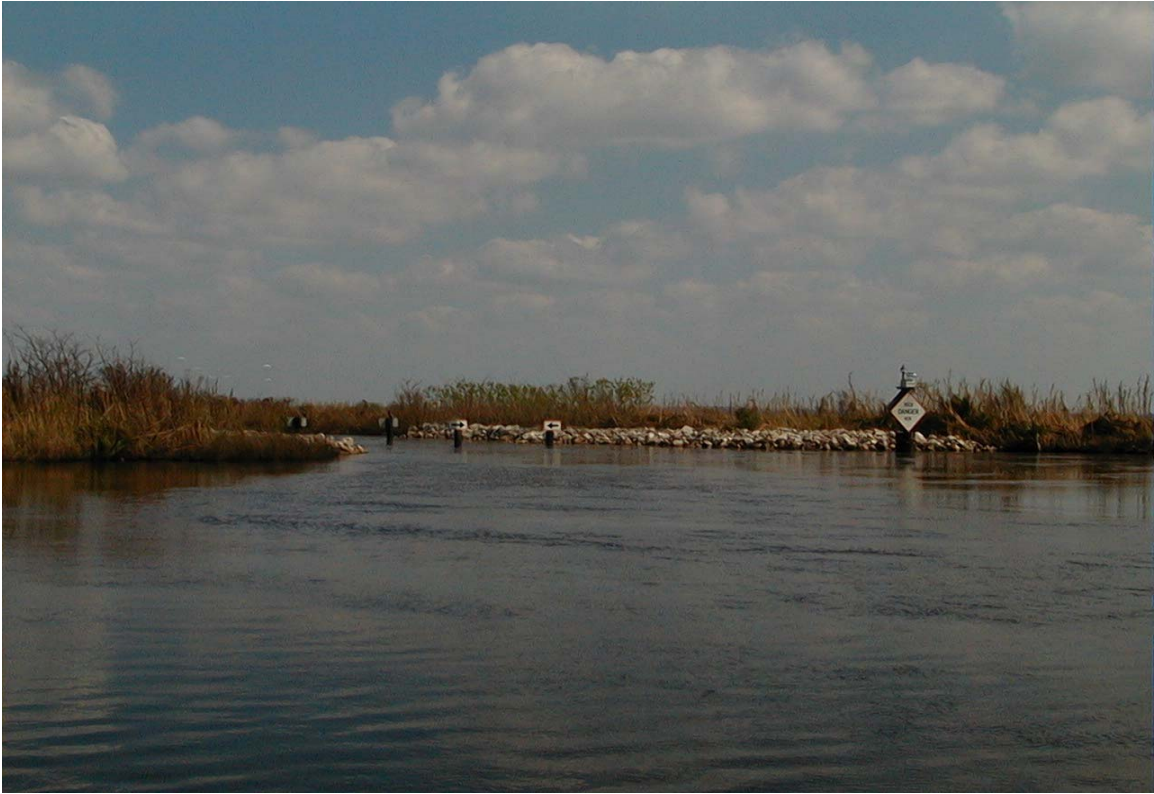
The rock weir is in excellent condition. Signage is stable. No need for maintenance at this time. Conditions of the Navigational Aid Lights will have to be evaluated at a later date by trained personnel. (Photos: Appendix B, Photo 11)

Photo 11—Block's Creek Structure

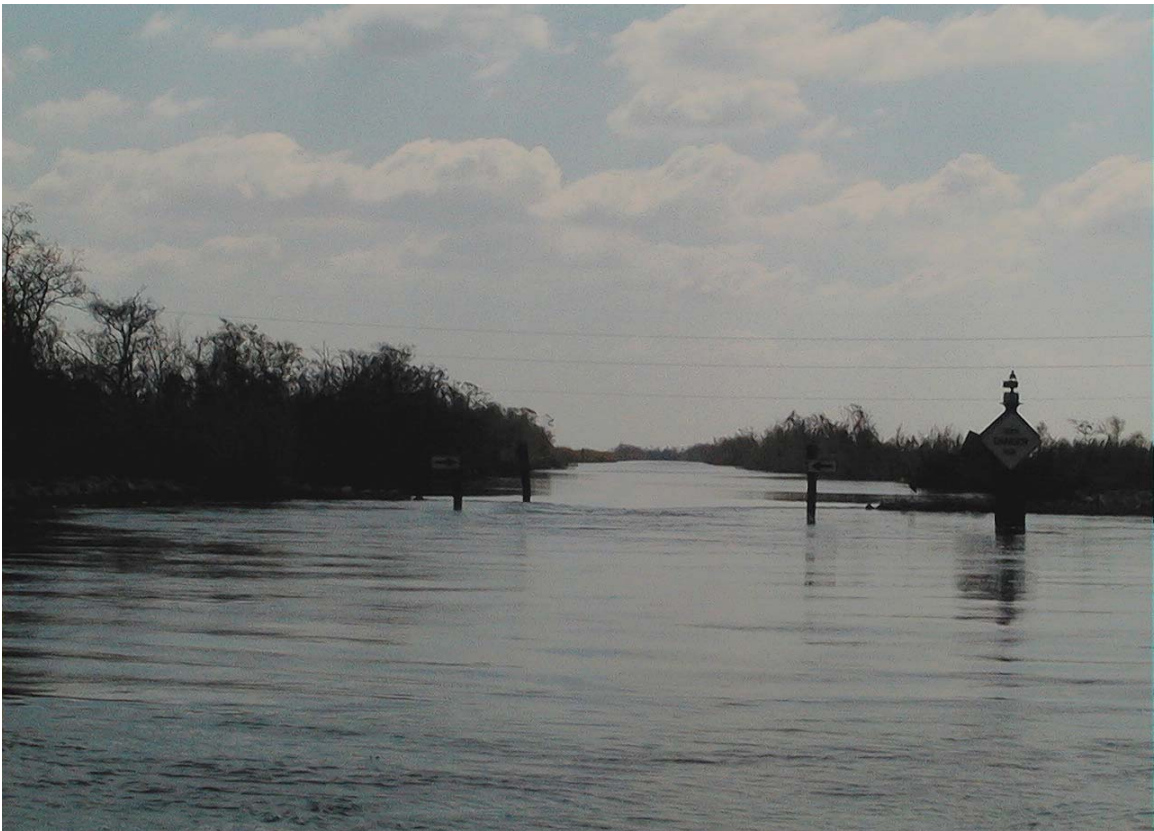
The weir is in good condition. There is some minor scouring along the canal banks inside of the weir at the end of the dike that will be monitored. Severe current through the weir has caused problems for boaters in the area. The pilings with the arrow signs are fairly close together and pose a collision hazard. As a result of this inspection, it is recommended that these pilings be removed and warning signs similar to the ones on the Black Bayou Cut-Off canal be used. Conditions of the Navigational Aid Lights will have to be evaluated at a later date by trained personnel. (Photos: Appendix B, Photo 12)

Photo 12—Burton Canal Structure

The Black Bayou Hydrologic Restoration Project is in good condition and functioning as intended. Project features survived Hurricane Rita basically intact. Installation of staff gauges in convenient locations within the project area is recommended. Warning signs in areas of severe current caused by installation of rock or sheet pile weirs should always include warning signs. These signs should be installed in concrete blocks out of the way of traffic since this has proven to be very effective. Also, railings or fences around water control structures should be considered.

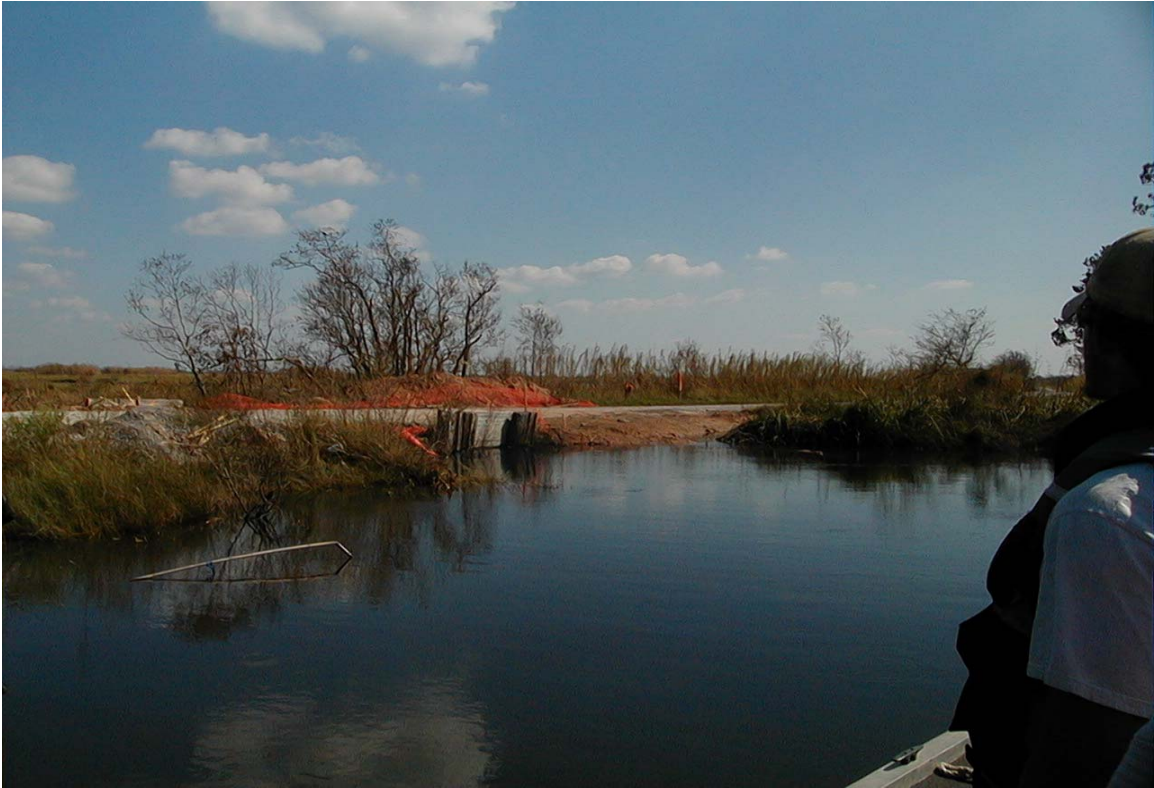
Culvert 1: This is the easternmost culvert site that will be installed on the southern boundary road of the project area and will be included in future annual inspections. (Photos: Appendix B, Photo 13)

Photo 13—Site of Culvert #1

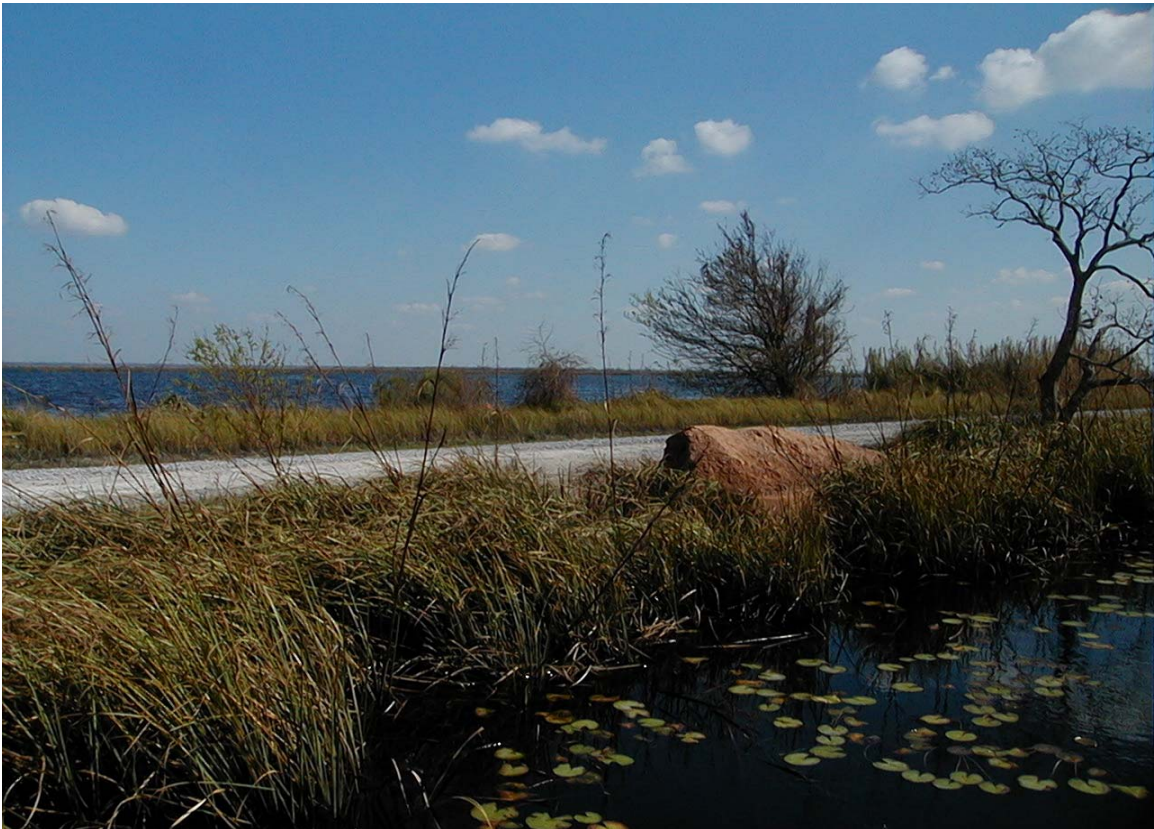
Culvert 2: This is the westernmost culvert site that will be installed on the southern boundary road of the project area and will be included in future annual inspections. (Photos: Appendix B, Photo 14)

Photo 14—Site of Culvert #2
