**2005/2006 Annual Inspection
Report**

**GIWW BANK STABILIZATION
PROJECT (PERRY RIDGE TO
TEXAS (CS-30))**

State Project Number CS-30
Priority Project List 9

October 6, 2005
Calcasieu Parish

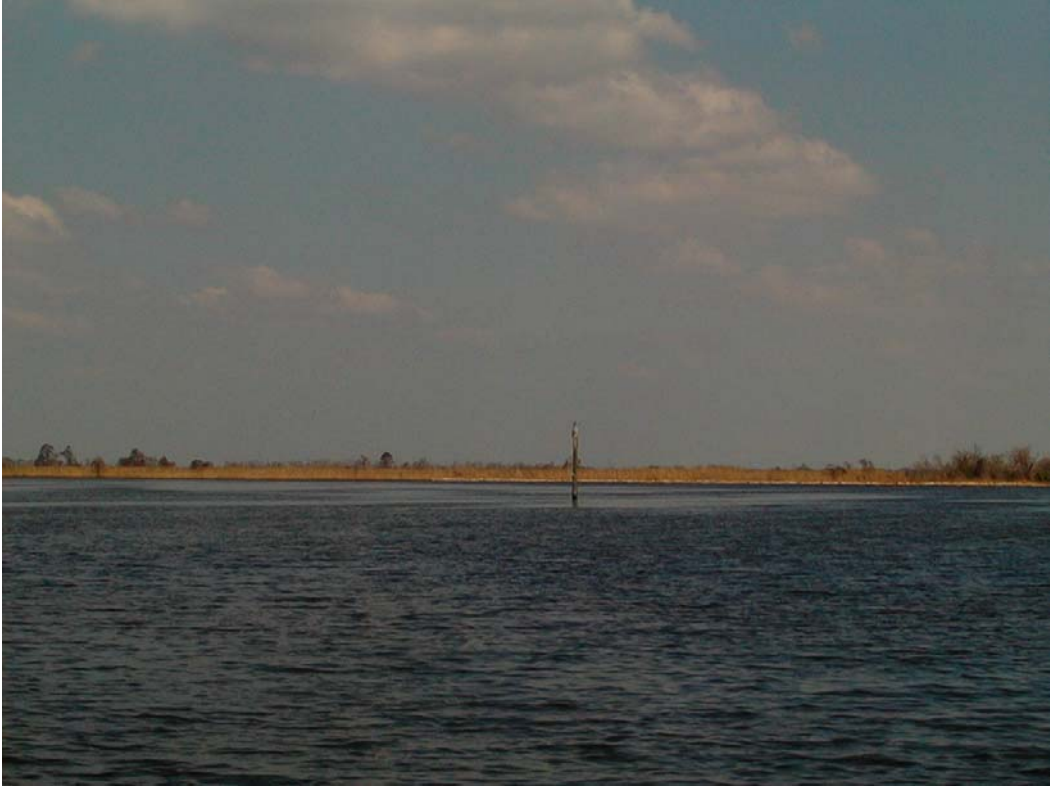
The dike is in good condition and appears to be in the same condition as to what existed prior to the storm and did not sustain any discernable damage from the storm. No maintenance is recommended at this time. (Photos: Appendix B, Photos 1 & 2)

Photo 1, Typical rock dike.

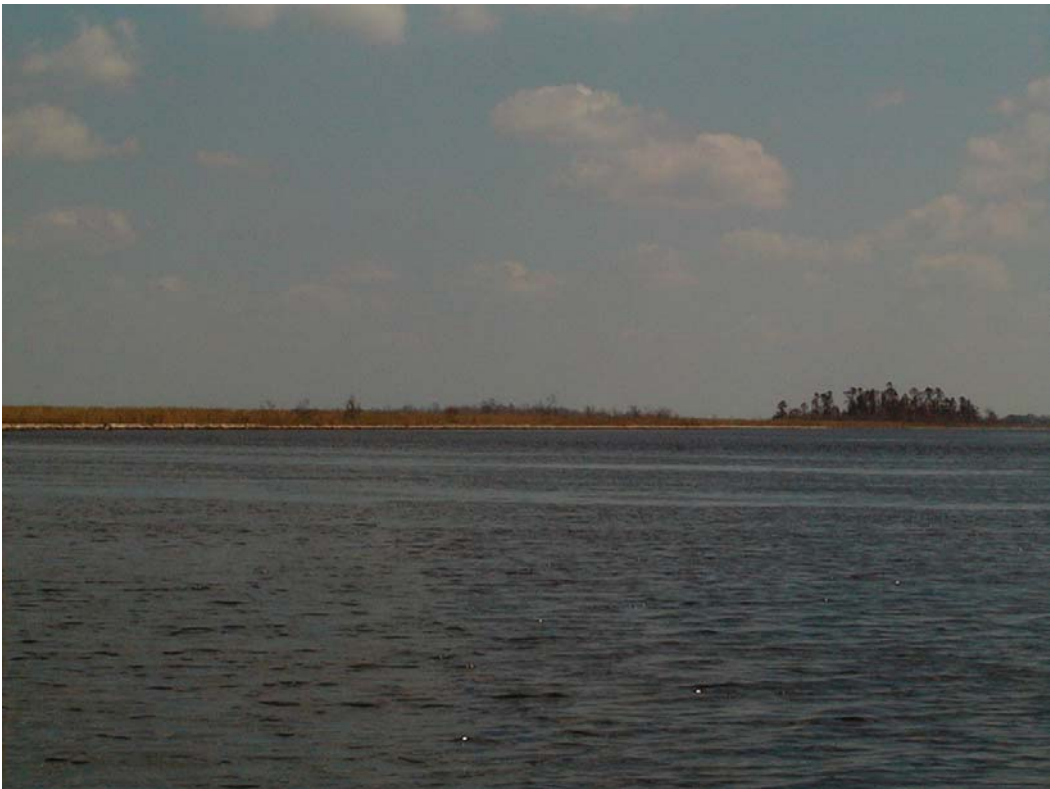
Photo 2, Rock dike, view looking north.
