**State of Louisiana  
Department of Natural Resources  
Coastal Engineering Division**

**2005/2006 Annual Inspection  
Report**

**HOLLY BEACH SAND  
MANAGEMENT PROJECT  
(CS-31)**

October 24, 2005  
Cameron Parish

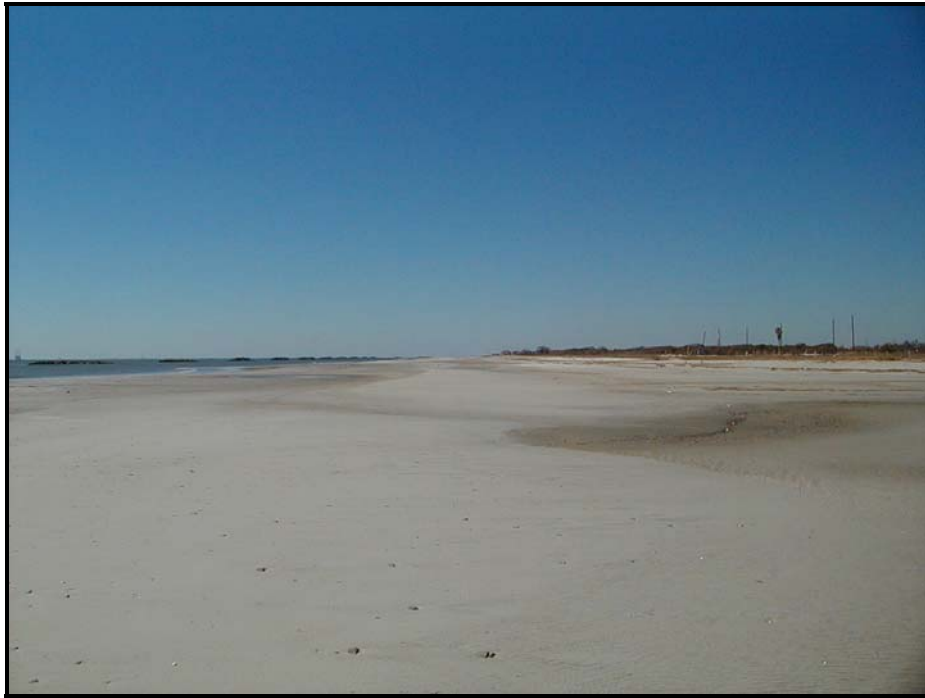
The entire reach of the 28,000 linear feet of the beach fill area appeared very clean and was without significant areas of scattered debris. The sand fill was judged to be in excellent shape, considering the severity of the storm, with the majority of the “plateau area” that was initially constructed still in place. The top of the posts for the anchoring of the sand fencing was originally installed 4 feet out of the constructed beach sandfill or to Elevation +9.0 feet NAVD88. Some unbroken or undisturbed fence posts were still standing and observed to be 5 feet tall from the existing sand elevation. This observation allows a general conclusion to be made that approximately one foot of the sand fill that had been placed to Elevation +5.0 NAVD88 had been eroded from the action of the waves and tidal surge of the storm. On the western end of the project, we observed that some significant amounts of sand material had been deposited onto overbank areas of the beach. On the eastern portion of the project of the project, we observed that a minor amount of sand had been deposited across the highway to the north. All of the camps and residences in Holly Beach that existed prior to the storm have been completely destroyed. There is debris from these structures over much of the overbank areas of the beach, but none on the beach proper. The “vegetative plantings” portion of the project were severely impacted. Many of the plantings that were installed in areas where the

sand dunes had developed have been lost because the erosion of the dunes allowed the plants to be carried away by the tidal surge. Some scattered plants, however, remain and they are starting to “green” up. (Photos: Appendix B, Photos 1, 2 & 5).

Photo 1, View of sand enhancement project, looking west.

Item	Condition	Physical Damage	Corrosion	Photo #	Observations and Remarks
Steel Bulkhead / Caps	N/A				
Steel Grating	N/A				
Stop Logs	N/A				
Hardware	N/A				
Timber Piles	N/A				
Timber Wales	N/A				
Galv. Pile Caps	N/A				
Sand Fencing	Poor			3,4	Fencing is completely destroyed from Hurricane Rita.
Signage /Supports	N/A				
Sand (fill)	Good			1,2,5	Approximately one foot of sand fill eroded from the storm.
Earthen Embankment	N/A

Overall, the Holly Beach Sand Management Project is in good condition and functioning as designed with problems as noted above. Recommendations are as follows for remedial work to restore the Holly Beach Sand Enhancement Project: (1) The Sand Fencing feature, approximately 50,000 linear feet in length, should be replaced, and the remaining but broken 4X4 posts should be removed by “pulling same from the beach fill” with a chain choker and equipment. The broken posts present a major hazard to the general public as the broken lumber with its many splinters, etc., can cause serious injury. The shifting sands may cover or expose the tops of the posts, but the hazards of tripping or encountering splinters will always remain. The foregoing will be the basis for a FEMA claim. (2) A limited cross-section survey of the project beach portion will be made and compared to a survey recently accomplished immediately pre-Hurricane Rita. This survey will provide much data concerning the damage to the sand fill that was caused by the storm. The quantity of sand that was eroded can also be computed and provide information to reviewers to determine if the sand needs to be replaced. This survey will be paid for by an existing NOAA Grant. (3) A FEMA claim has been submitted for damages of the sand fencing described in (1) above and also for replacement of the sand fill that was eroded by the storm.

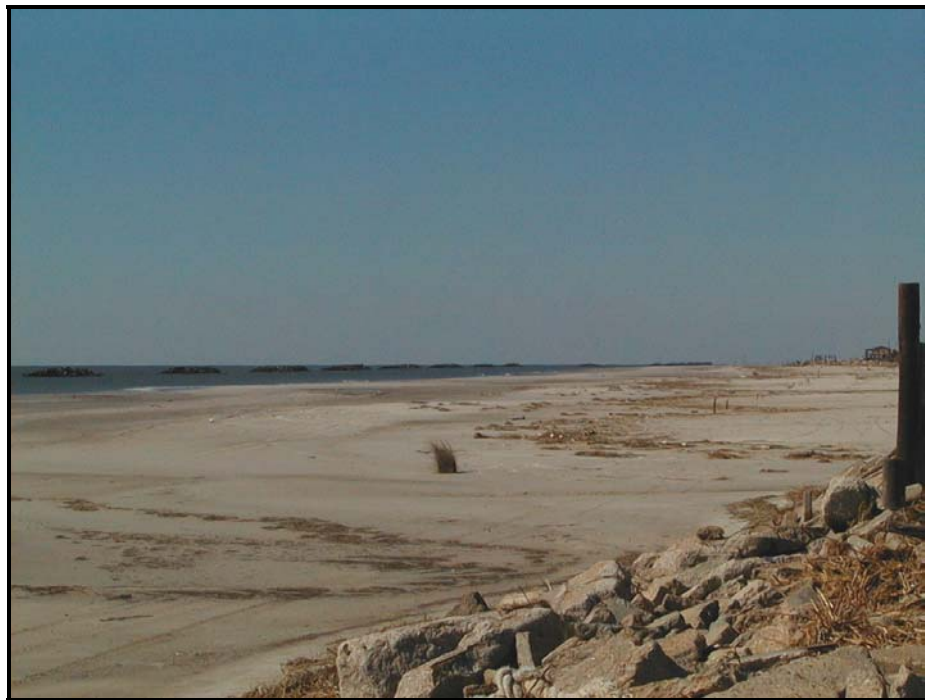
All of the previously constructed “sand fencing”, consisting of approximately 50,000 linear feet of 4 foot tall snow fencing attached to 4X4 inch treated posts was destroyed by Hurricane Rita. Many posts were just pulled out or broken off at or just above ground level and the fencing stripped off and deposited to the north of the beach across the highway or into adjacent marsh. The sand “dunes” that had accumulated adjacent to the sand fences to heights of approximately 2-4 feet were eroded such that it was not apparent that there had ever been dunes in the area. Some pieces of the fence portion of the sand fencing feature were discovered approximately 8-12 feet up in some trees north of Hwy LA 82. At several locations, some unbroken or undisturbed fence posts were still standing and observed to be 5 feet tall from the existing sand elevation. (Photos: Appendix B, Photos 2 & 3).

Photo 2, Close up view of beach head with rock breakwaters in the background.

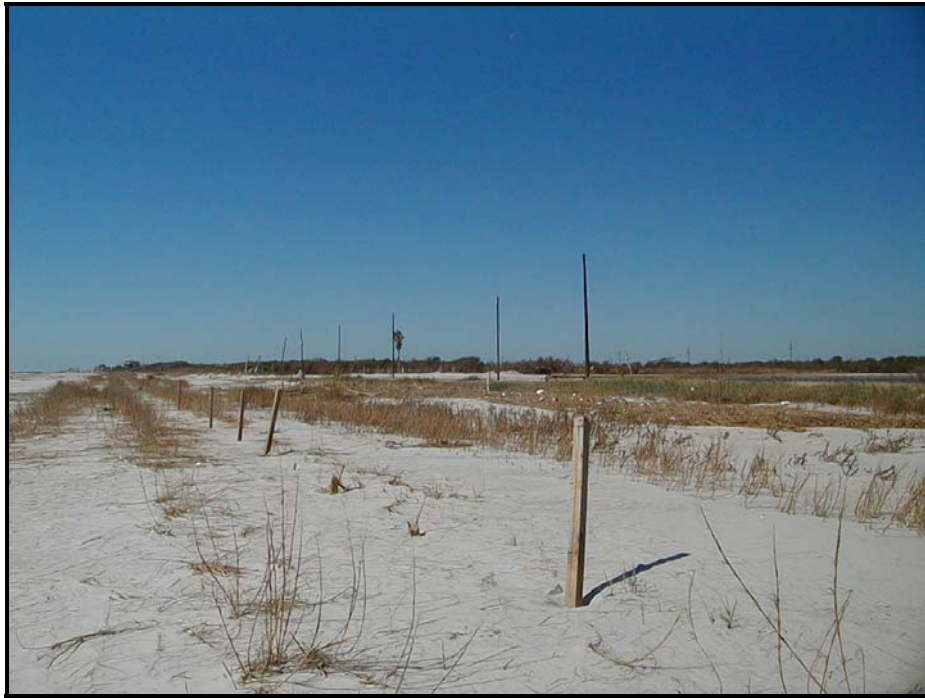
Photo 3, View of missing sand fencing between few remaining posts and vegetative plantings.

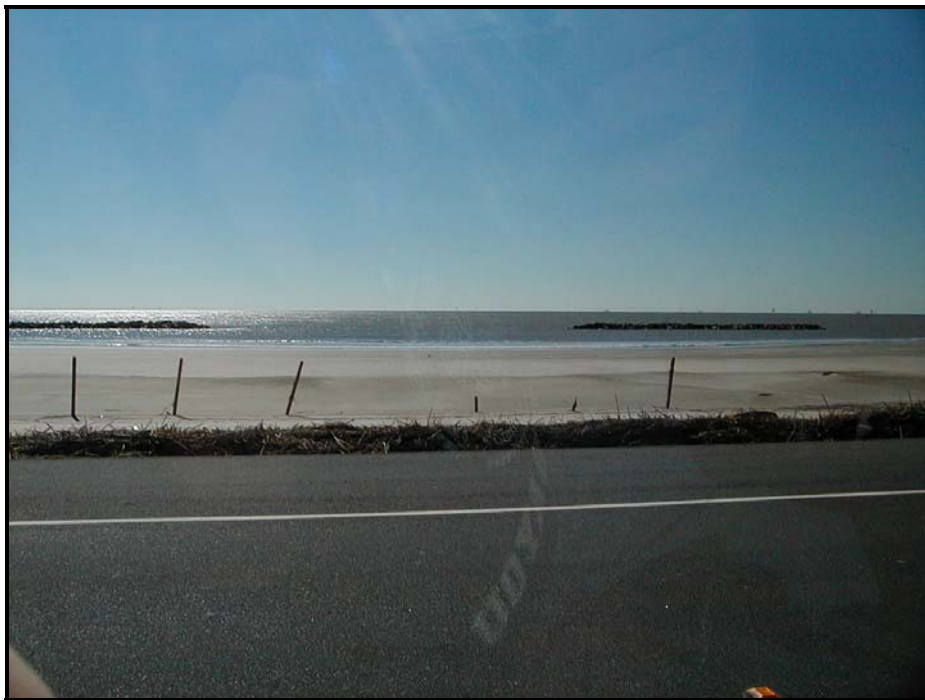
Photo 4, East end of project showing few fence posts that remain, cleanliness of beach, and lack of vegetation.

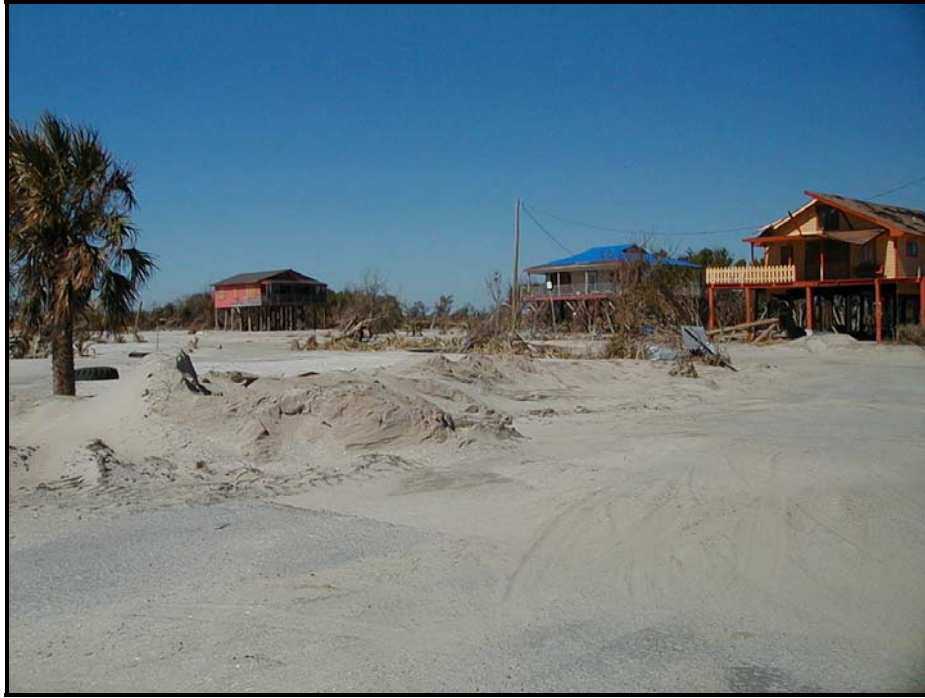
Photo 5, View of sand accumulation near campsites on west end of project.
