2008/2009 Annual Inspection Report

SWEET LAKE/ WILLOW LAKE HYDROLOGIC RESTORATION PROJECT (CS-11b)

State Project Number CS-11b
Priority Project List 5

October 1, 2008
Calcasieu Parish

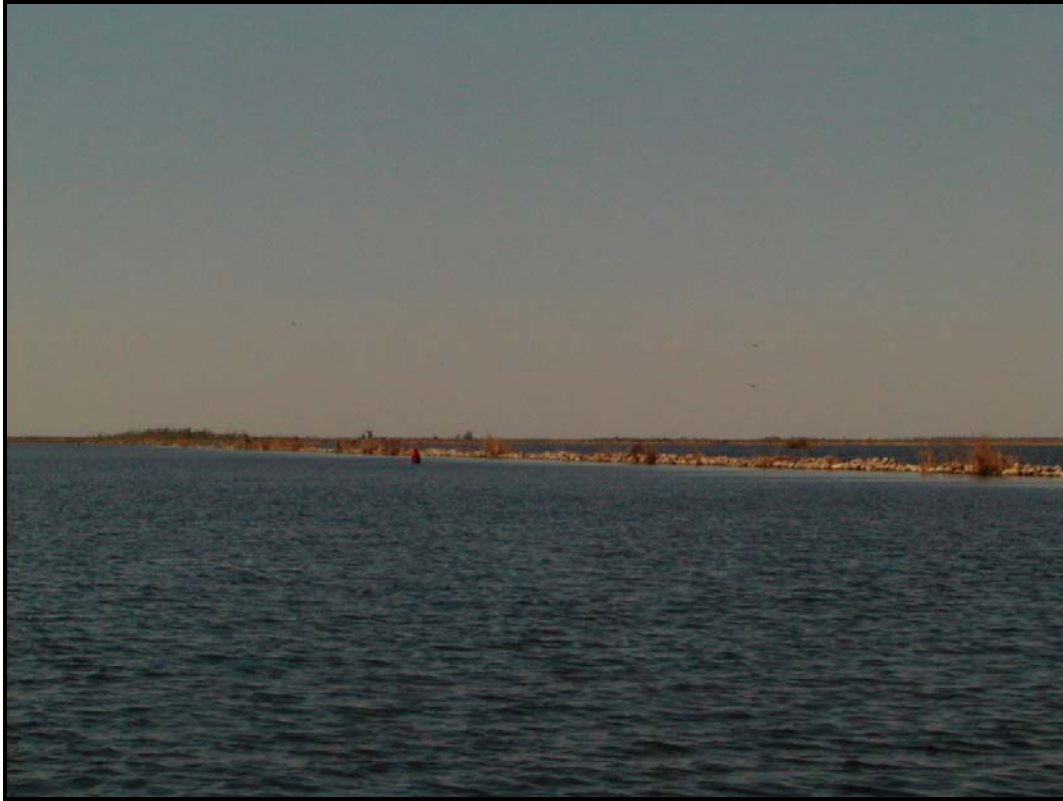
The dikes are in reasonably good condition and do not appear to have suffered any damage from Hurricane Ike. There are a few low places along the length of the rock dike with the most significant stretches along the open water areas adjacent to Sweet Lake along with an area approximately 50 feet wide along the very eastern end of the project area in which the dike appears to have been “pushed back” 10-12 feet apparently by a barge. There is another area approximately 4 feet wide in which the dike appears to have been removed by hunters or fishermen. Several settlement plates are either broken or leaning and are of no use. No gauges were available in the vicinity to determine water levels. The condition of the shallow water terraces feature of the project was unable to be determined due to high water conditions in Sweet Lake and Willow Lake. (Photos: Appendix B, Photo 1).

Photo No. 1, Typical rock dike

The foreshore rock dike feature of the Sweet Lake/Willow Lake Hydrologic Restoration Project is in good condition and functioning as designed. The areas along the foreshore rock dike identified as being below constructed height were noted in previous inspections and will continue to be monitored to determine the need for a maintenance event.
