**2008/2009 Annual Inspection  
Report**

**GIWW BANK STABILIZATION  
PROJECT (PERRY RIDGE TO  
TEXAS  
(CS-30)**

State Project Number CS-30  
Priority Project List 9

October 2, 2008  
Calcasieu Parish

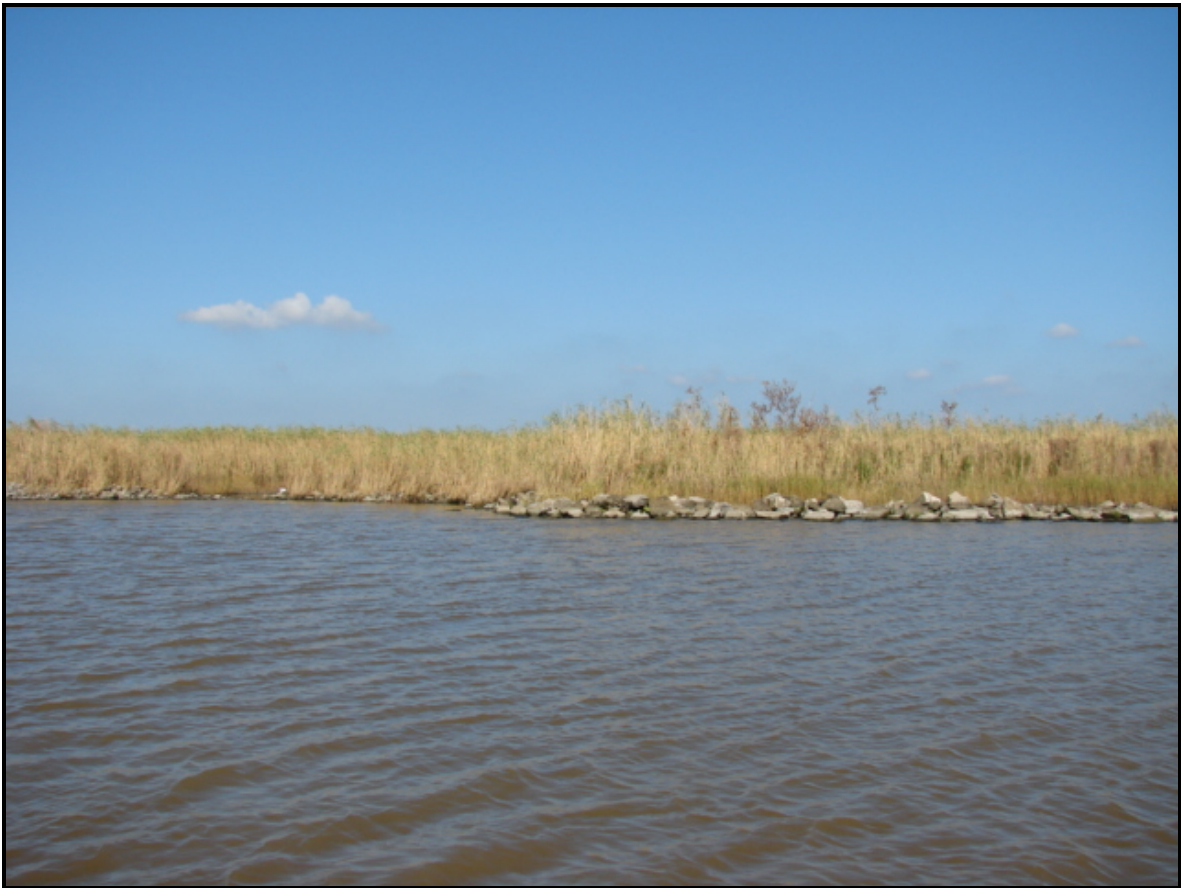
The dike is in very good condition with one small area apparently displaced by a barge noted as being below the constructed height. No maintenance is recommended at this time. (Photos: Appendix B, Photo 1)

**Photo No. 1,** Typical rock dike
