**2007/2008 Annual Inspection
Report**

**FRESHWATER BAYOU CANAL
BANK STABILIZATION
PROJECT (ME-13)**

State Project Number ME-13
Priority Project List 5

April 24, 2008
Vermilion Parish

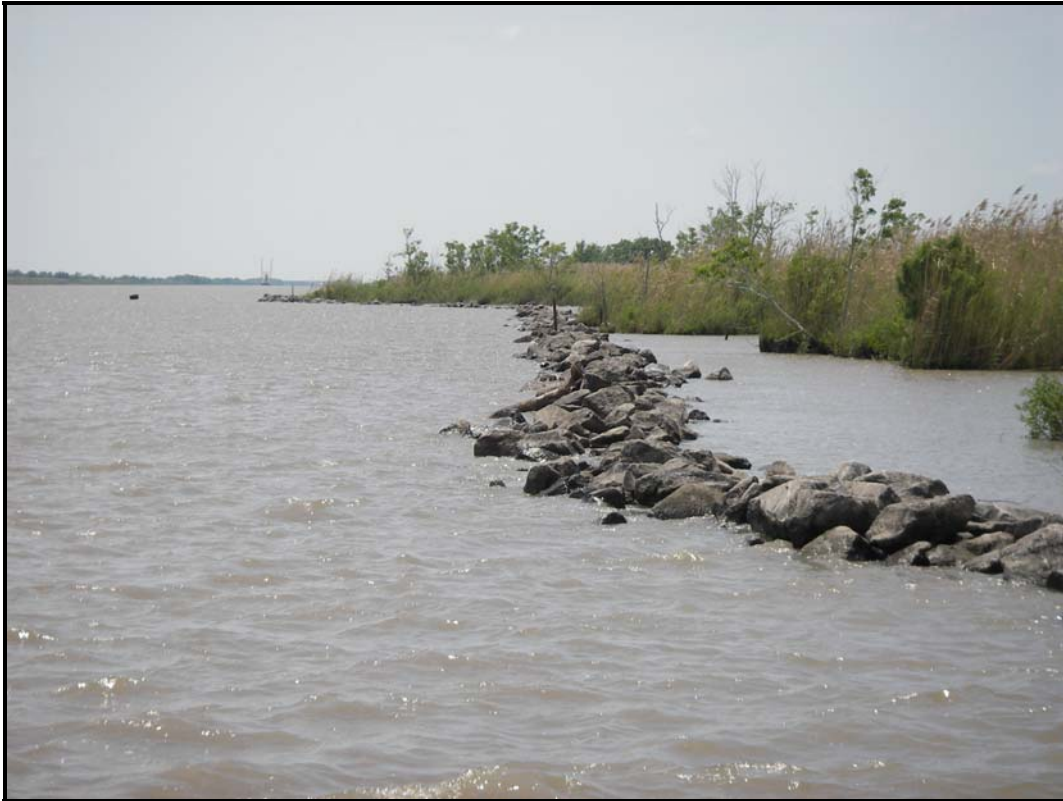
The inspection revealed the 9,130 linear feet of foreshore rock dike repaired in the 2005 maintenance project is in good condition. The additional 7,000 linear feet of foreshore rock dike identified in the 2003/2004 O&M inspection as being below elevation 4.0' NAVD but above elevation 2.0' NAVD, which was not addressed due to budget limitations has not deteriorated further.(Photos: Appendix B, Photos 1 & 2)

Photo 1, rock dike northern tie-in

Item	Condition	Physical Damage	Corrosion	Photo #	Observations and Remarks
Steel Bulkhead / Caps	N/A				
Steel Grating	N/A				
Stop Logs	N/A				
Hardware	N/A				
Timber Piles	N/A				
Timber Wales	N/A				
Galv. Pile Caps	N/A				
Cables	N/A				
Signage / Supports	N/A				
Rip Rap (fill) (foreshore dike)	Good			1 & 2	Recent maintenance work to restore dike to constructed elevation is still in good condition.
Earthen Embankment	N/A

Overall the Freshwater Bayou Canal Bank Stabilization Project is in good condition and appears to have stabilized the erosion of the Freshwater Bayou Canal Bankline. The above mentioned 7,000 linear feet of foreshore rock will continue to be monitored for deterioration in future O & M Inspections.

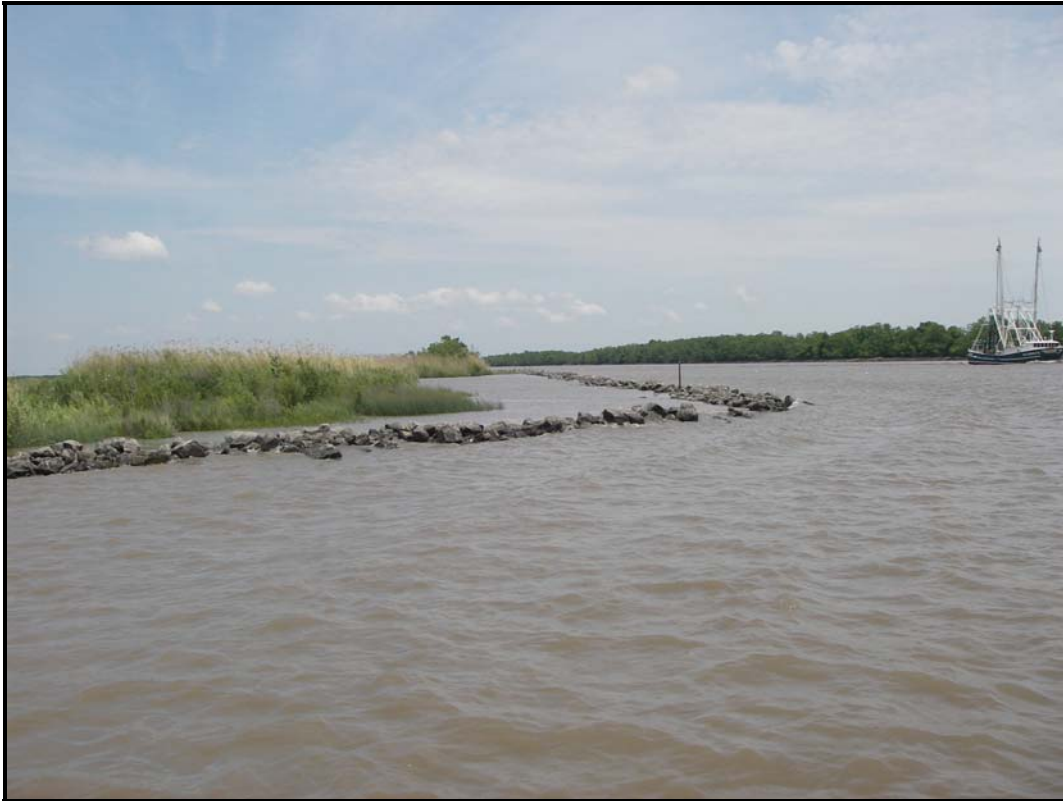
Photo 2, rock dike southern tie-in
