**Coastal Protection and Restoration
Authority of Louisiana**

**2007/2008 Annual Inspection
Report**

**PECAN ISLAND TERRACING
PROJECT
(ME-14)**

State Project Number ME-14
Priority Project List 7

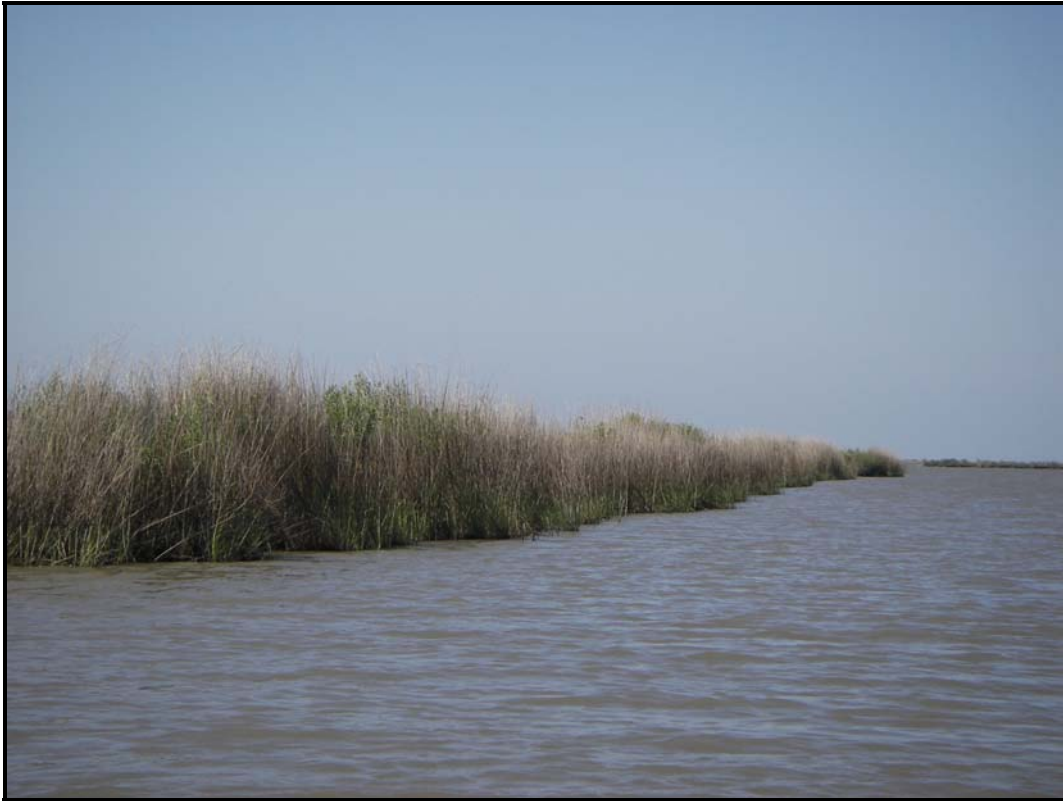
The earthen terraces are in good condition. Previously noted erosion in past O&M Inspections of the southern sacrificial terraces has worsened. The southern sacrificial terraces are providing less protection for the interior earthen terraces than in previous years. (Photos: Appendix B, Photo 1)

Photo 1, Typical earthen terrace.

Overall, the Pecan Island Terracing Project (ME-14) is functioning as designed and in good condition. The erosion of the southern sacrificial terraces will continued to be monitored. Installation of a staff gauge in the vicinity is recommended. Maintenance items to be addressed in CY 2008:

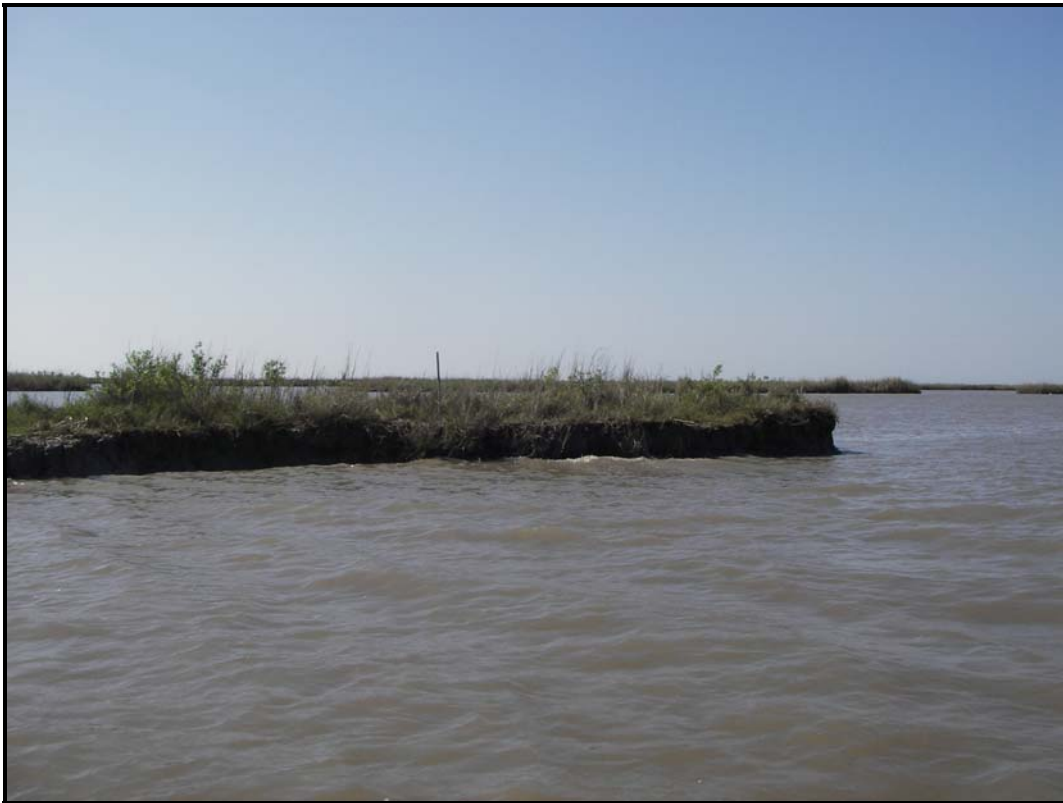
The tops of the terraces are approximately 50 per cent covered with vegetation. Species noted include *Spartina alterniflora*, *Juncus*, *Baccharis*, and *Spartina patens*. (Photos: Appendix B, Photo 2)

Photo 2, Typical eroded terrace.
