2005/2006 Annual Inspection Report

POINT AU FER ISLAND HYDROLOGIC RESTORATION (TE-22)

State Project Number TE-22
Priority Project List 2

August 17, 2006
Terrebonne Parish

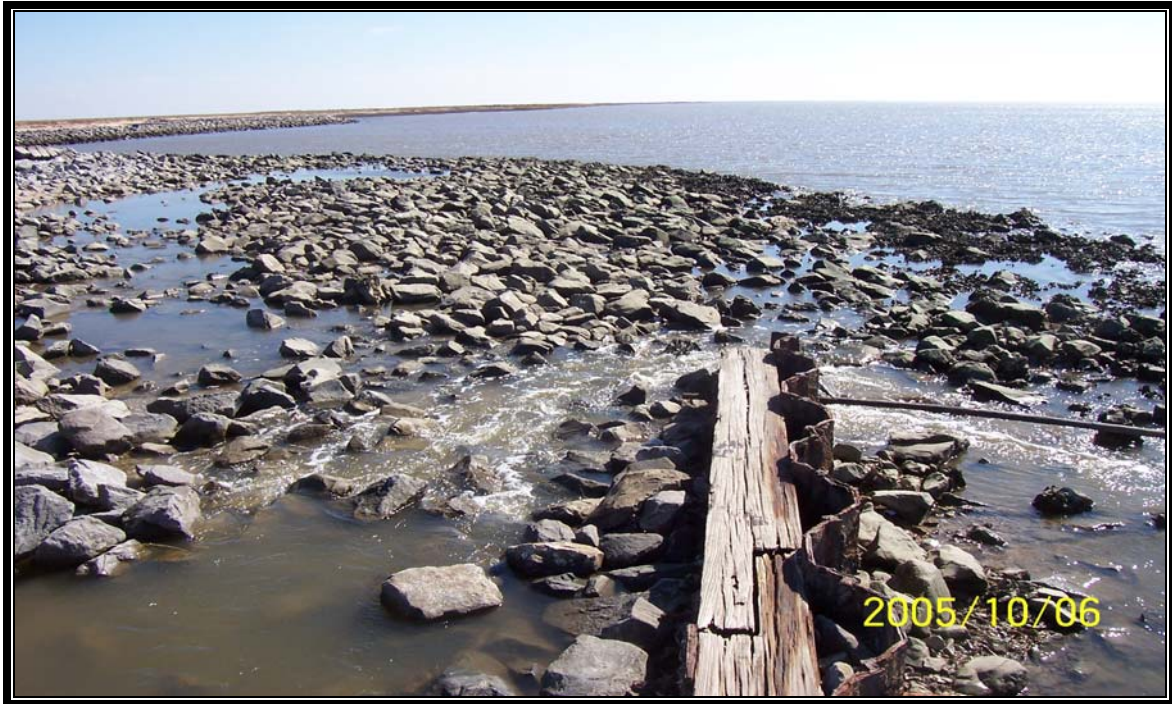
TE-22 – steel sheetpile bulkhead and rock dike located at the end of Transco Canal along the Gulf of Mexico.

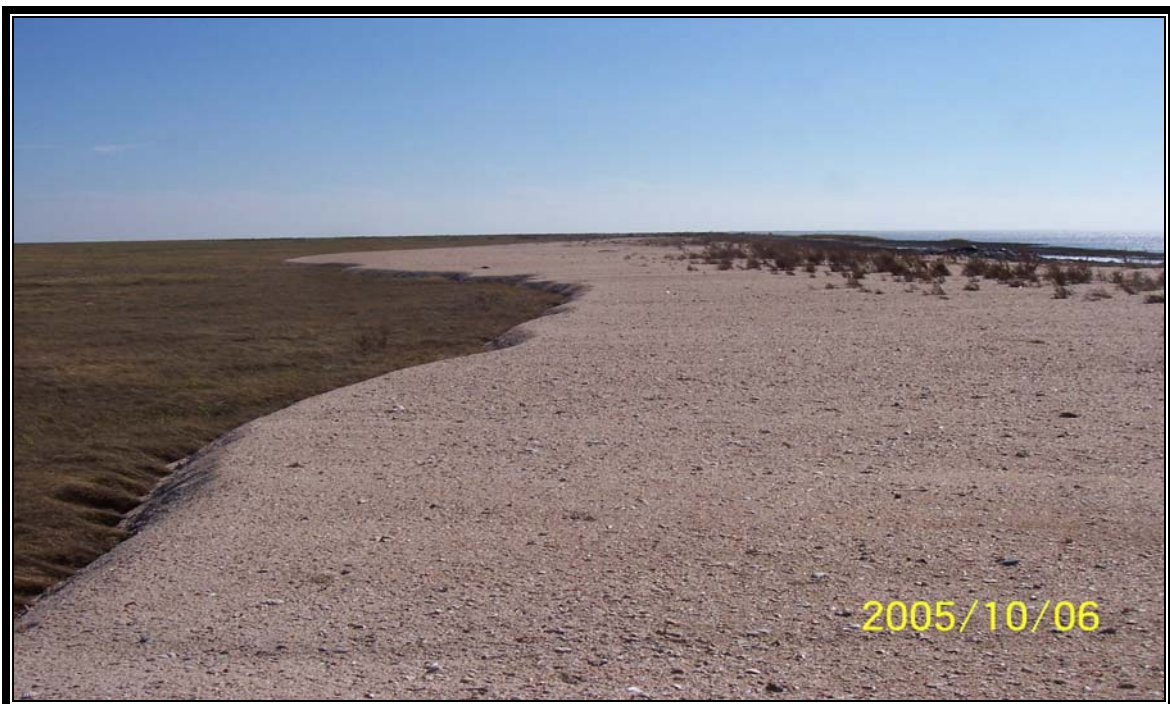
TE-22 – photo of accumulation of sand material behind the rock dike along the Gulf of Mexico adjacent to the rock plug at the end of Transco Pipeline Canal.

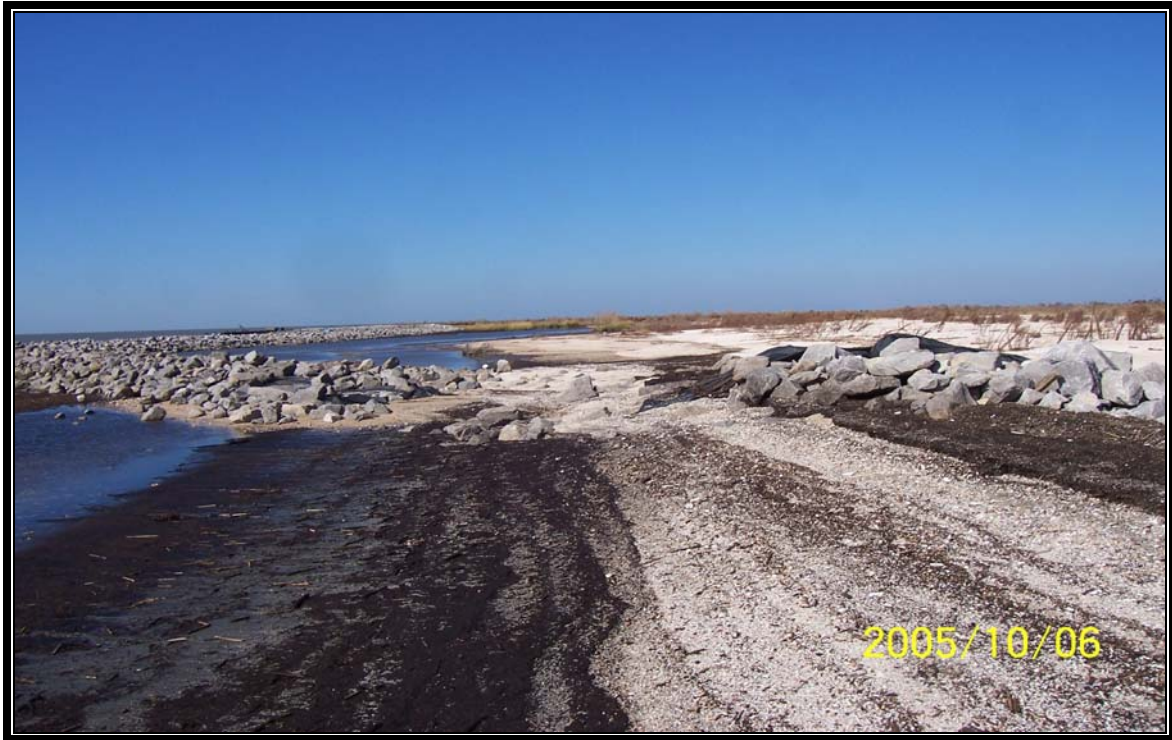
TE-22 –Photo of displaced rock rip rap along rock dike located on the east side of the steel sheetpile bulkhead at the end of Transco Canal along the Gulf of Mexico.

From visual observation of the existing project features, we found minor displacement of the rock riprap, mainly on recently constructed rock breach repairs completed in 2005. Since these damages are considered minor and do not adversely affect the project as a whole, we do not recommend any further actions at this time. No FEMA claims are warranted.

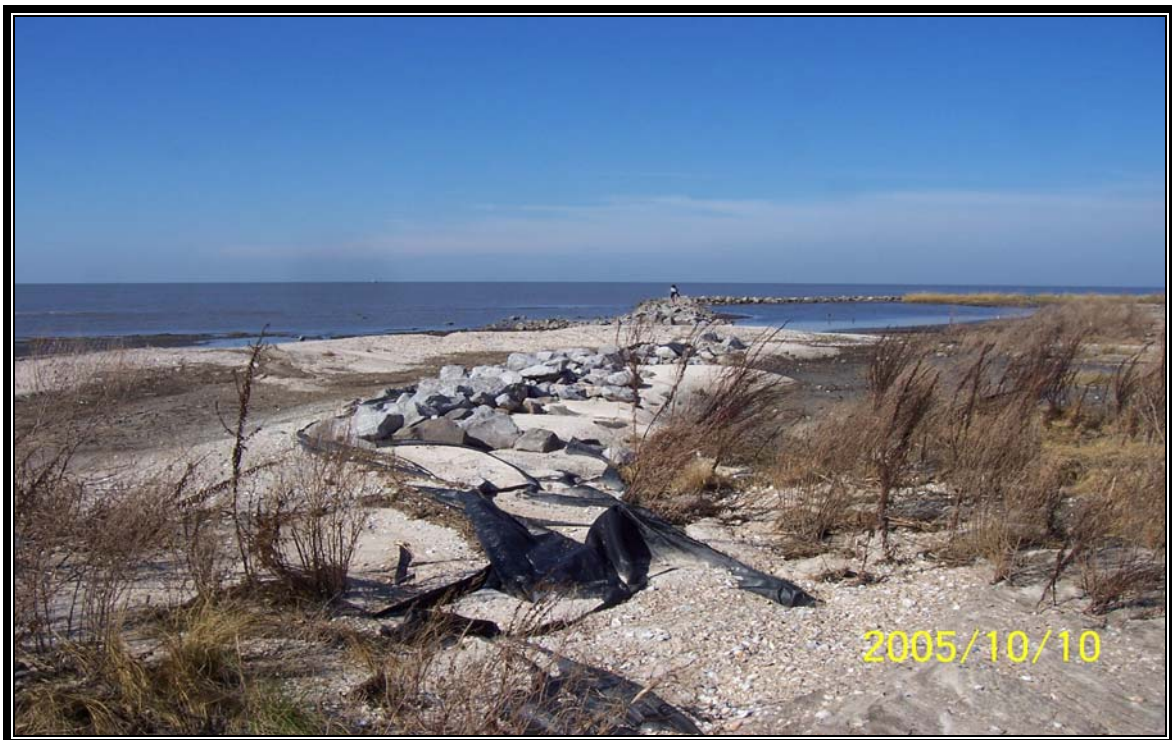
TE-22 –Photo of displaced rock rip rap along rock dike located adjacent to the east end of Mobile Canal along the Gulf of Mexico.
