**State of Louisiana
Department of Natural Resources
Coastal Engineering Division**

**2005/2006 Annual Inspection
Report**

**LAKE CHAPEAU HYDROLOGIC
RESTORATION**

State Project Number TE-26
Priority Project List 2

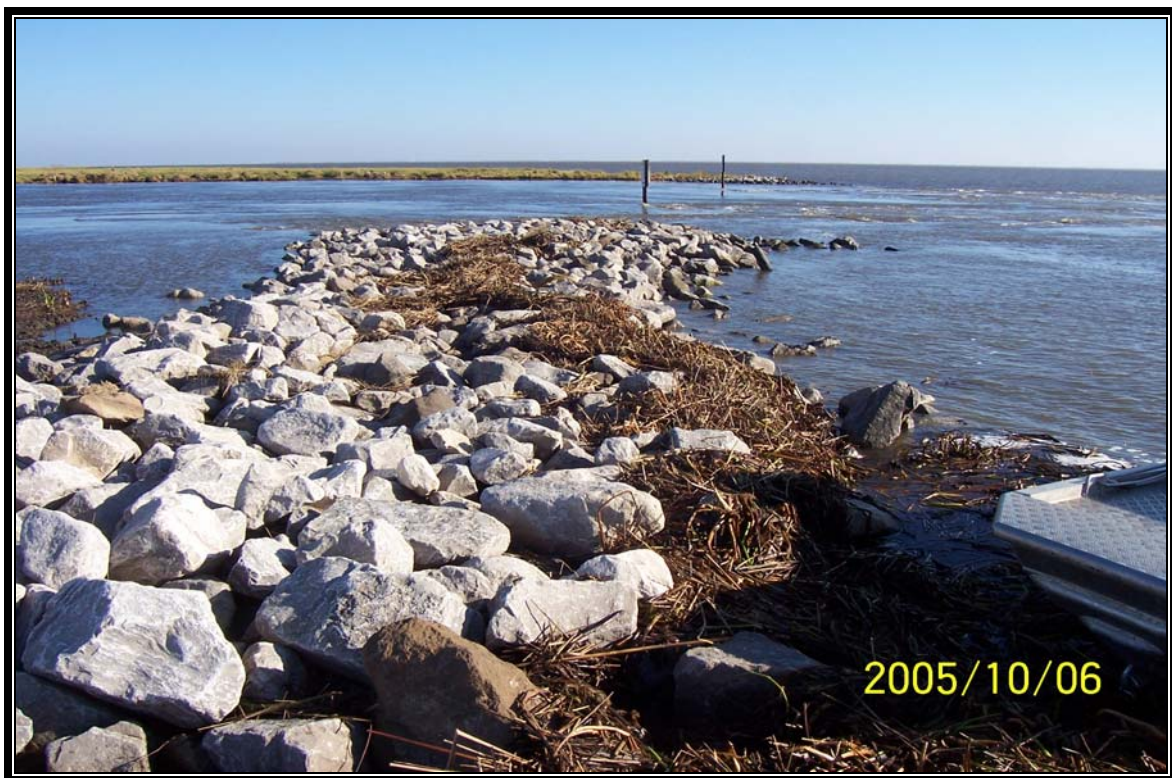
A visual inspection of the rock weirs and previous breach repairs indicated that the project features of the Lake Chapeau Project had sustained very little damage. The rock rip rap structures were in good condition with no signs of displacement or settlement from storm surges brought on by Hurricane Rita. However, we did observe significant erosion adjacent to structure #3 located on the southwest bank of Four League Bay. The marsh on the north side the structure had eroded exposing the rock dike to potential breaching. We anticipate that the southwest bank of the structure will be breached within the next year and require maintenance to extend the rock weir to the nearest stable marsh. (See photos below)

TE-26 – Structure No.3 – rock riprap weir with boat bay located along the southwest bank of Four League Bay looking north.

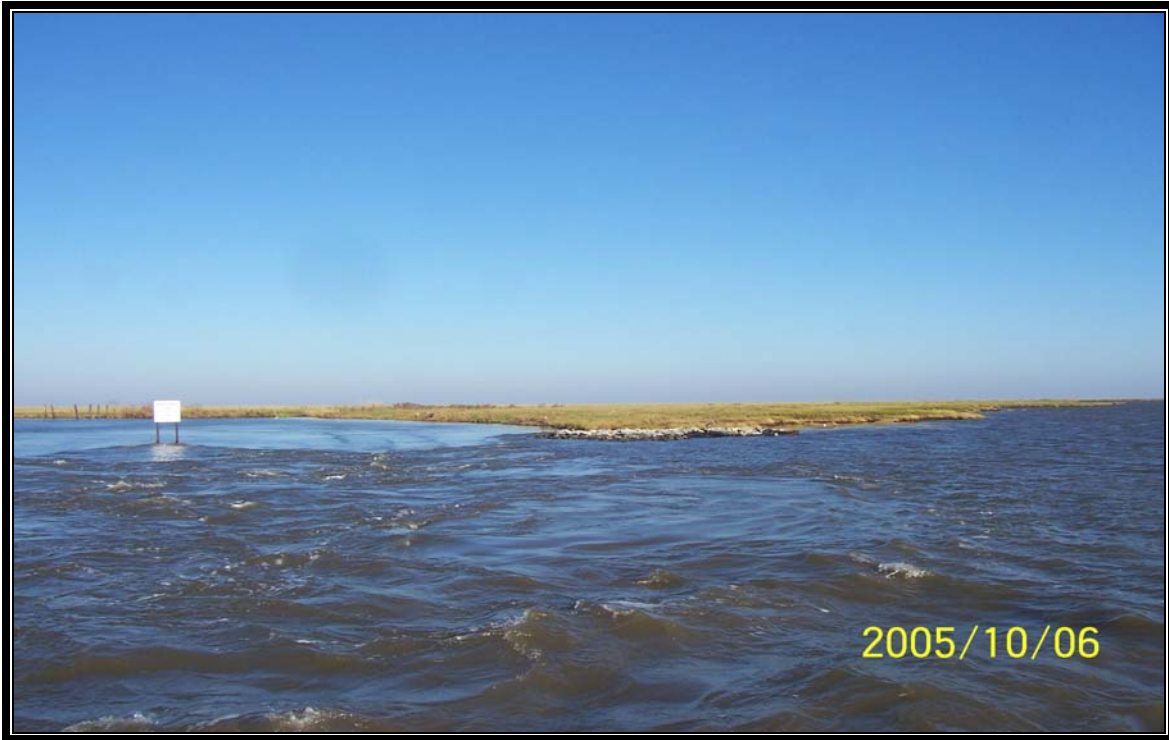
TE-26 – Structure No.3 – photo showing erosion along the shoreline north of rock rip rap weir looking west.

From visual observation of the existing project features, we found significant erosion along the shoreline on the north side of structure no.3. Although erosion in this area was evident, the structure has not breached and no negative impacts are expected in the immediate future. As the bank line erodes in this area, the rock weir connection to the marsh will become breached and repairs will be required. At this time, we do not recommend any corrective actions. No FEMA claims are warranted.

Repair breach along existing marsh adjacent to Structure No.3. Estimated quantity of rock for maintenance repairs is 1,370 tons.

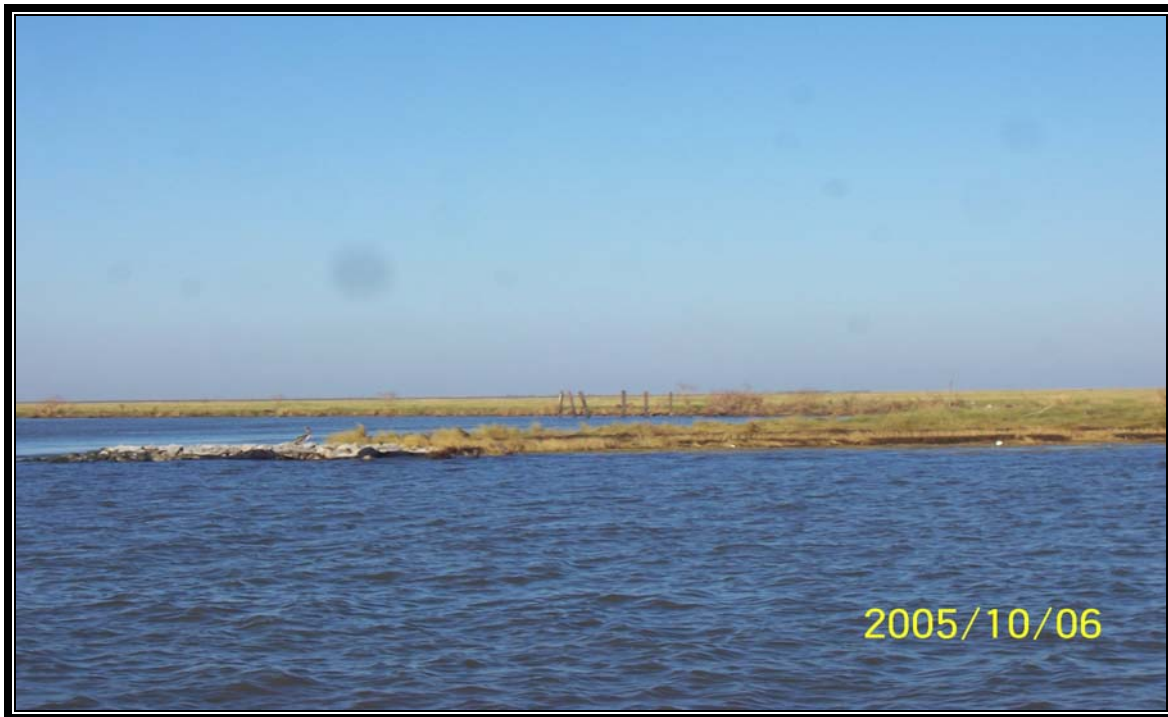
TE-26 – Structure No.3 – photo showing erosion along the shoreline on the north side of structure looking southwest.

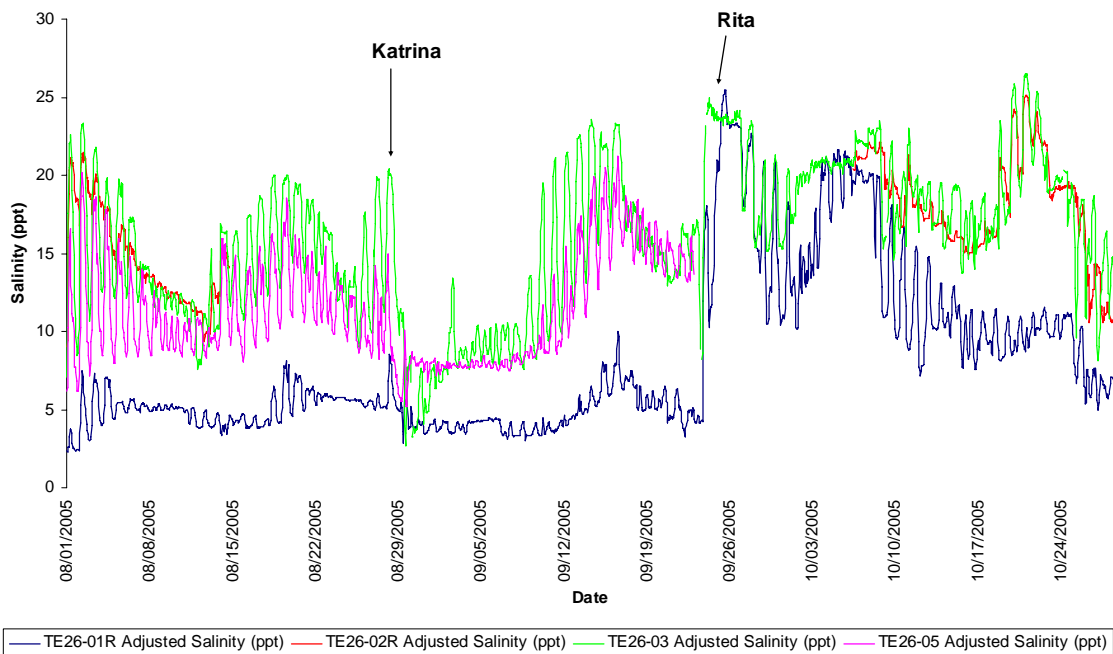
During Hurricanes Katrina and Rita, four continuous recorders remained in place and captured the effects of the hurricanes with respect to the salinity and water levels. Figure 1 illustrates the location of the four continuous recorders. Figures 2 and 3 illustrate the salinity and water level response as a result of the passing of the hurricanes.

Figure 2: Salinity comparison of the four continuous recorders associated with the project.

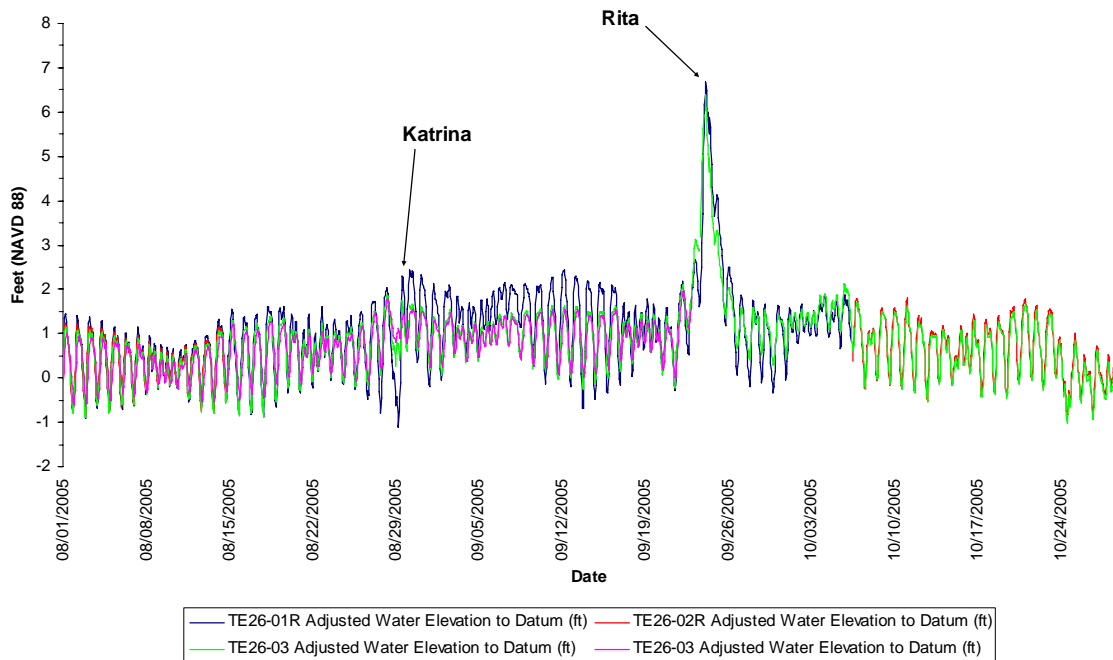
Figure 3: Water level comparison of the four continuous recorders associated with the project.
