**State of Louisiana
Department of Natural Resources
Coastal Engineering Division**

**2006/2007 Annual Inspection
Report**

**SWEET LAKE/ WILLOW LAKE
HYDROLOGIC RESTORATION
PROJECT
(CS-11b)**

State Project Number CS-11b
Priority Project List 5

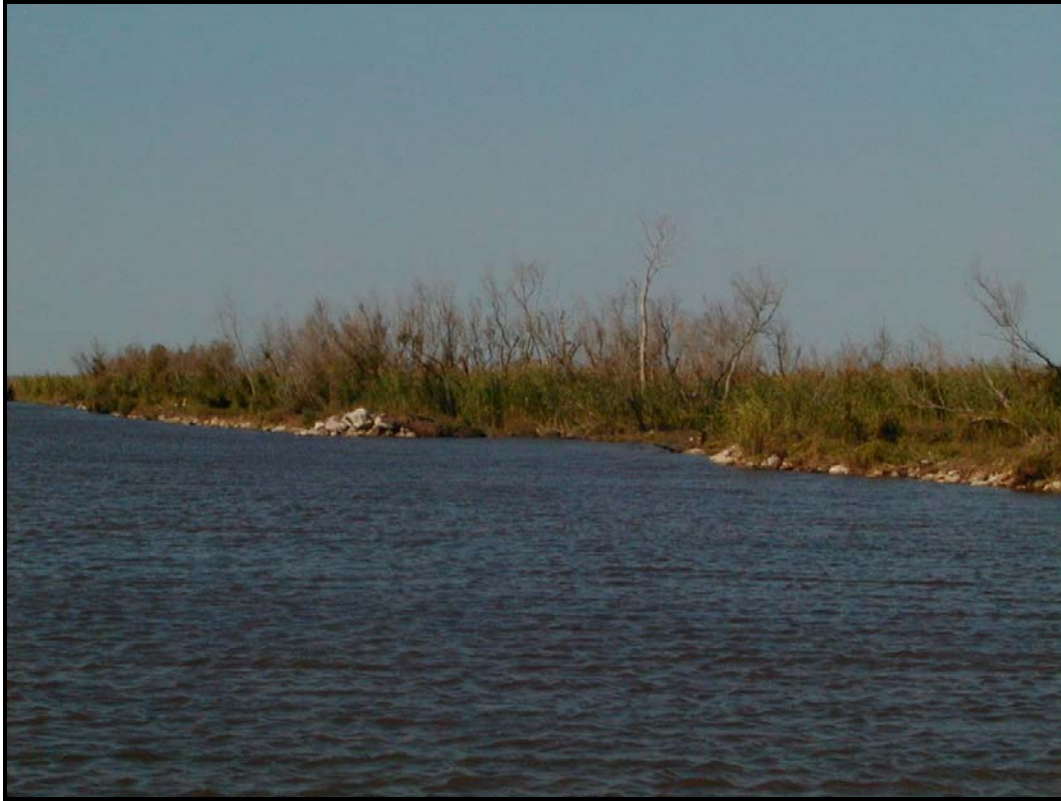
The dikes are in reasonably good condition. There are a few low places along the length of the rock dike with the most significant stretches along the open water areas adjacent to Sweet Lake along with an area approximately 50 feet wide along the very eastern end of the project area in which the dike appears to have been “pushed back” 10-12 feet apparently by a barge. There is another area approximately 4 feet wide in which the dike appears to have been removed by hunters or fishermen. Several settlement plates are either broken or leaning and are of no use. No gauges were available in the vicinity to determine water levels. The condition of the shallow water terraces feature of the project was unable to be determined due to high water conditions in Sweet Lake and Willow Lake. (Photos: Appendix B, Photos 1 & 2).

Photo No.1, Area of rock dike pushed back by barge.

- The areas mentioned above will continue to be monitored. As of now, there is no need of any immediate repairs.

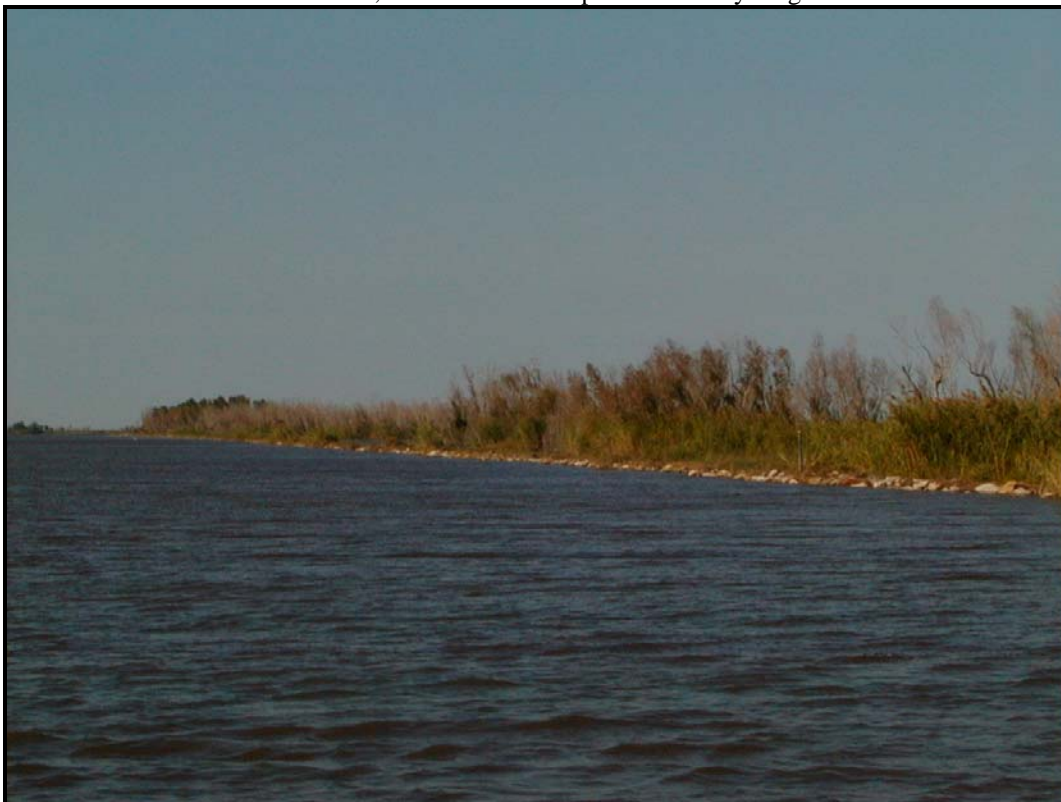
Photo No.2, Typical rock dike section.
