**State of Louisiana  
Department of Natural Resources  
Coastal Engineering Division**

**2006/2007 Annual Inspection  
Report**

**GIWW BANK STABILIZATION  
PROJECT (PERRY RIDGE TO  
TEXAS (CS-30))**

June 20, 2007  
Calcasieu Parish

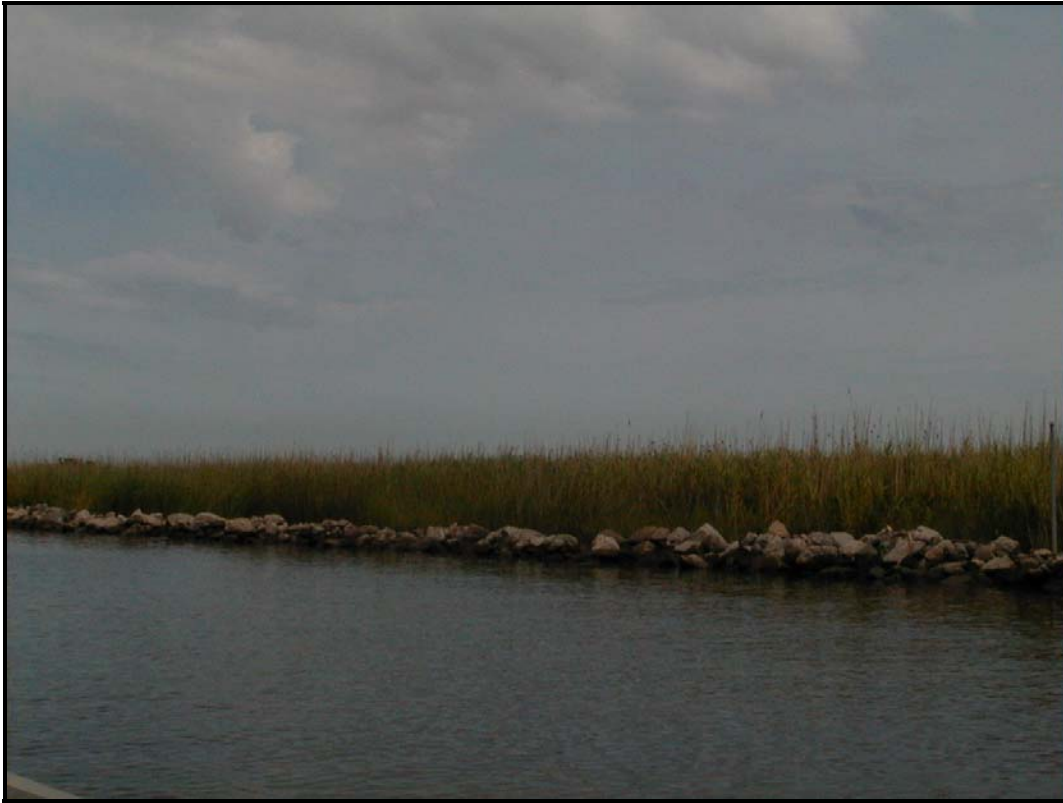
The dike is in very good condition with one small area apparently displaced by a barge noted as being below the constructed height. No maintenance is recommended at this time. (Photos: Appendix B, Photos 1 & 2)

Photo 1, Typical rock dike.

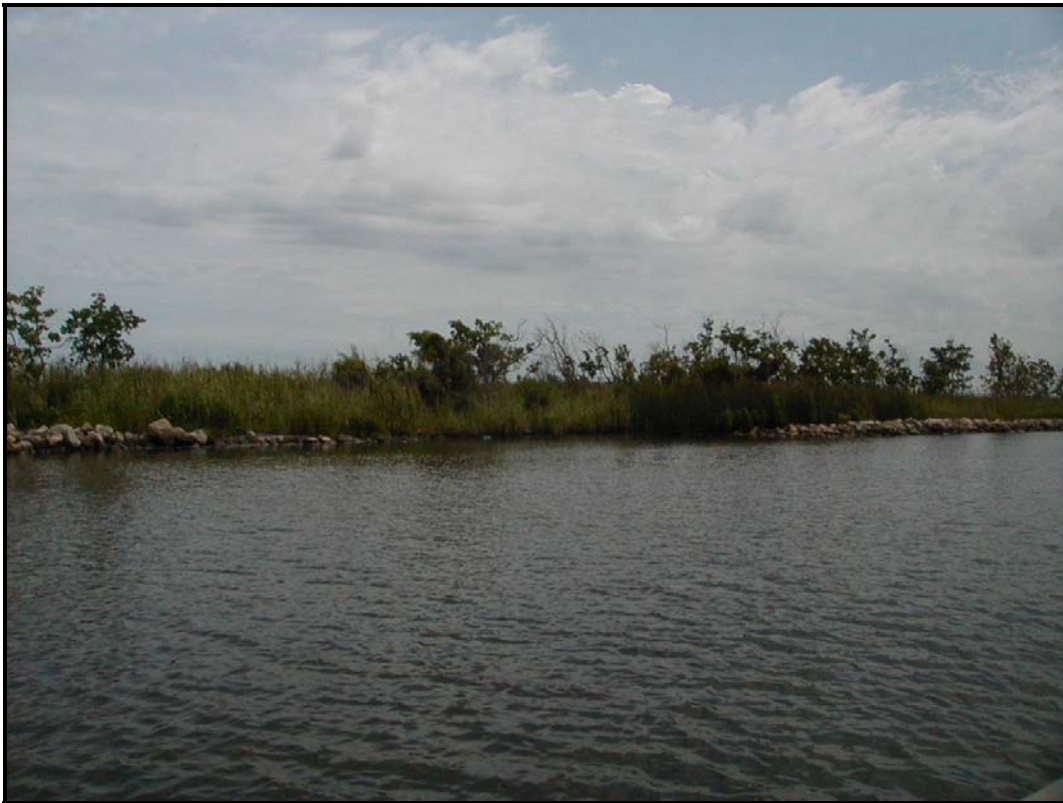
Photo 2, Rock dike, view showing low area hit by barge.

Item	Condition	Physical Damage	Corrosion	Photo #	Observations and Remarks
Steel Bulkhead / Caps	N/A				
Steel Grating	N/A				
Stop Logs	N/A				
Hardware	N/A				
Timber Piles	N/A				
Timber Wales	N/A				
Galv. Pile Caps	N/A				
Cables	N/A				
Signage /Supports	N/A				
Rip Rap (fill) (foreshore dike)	Good			1 & 2	One area slightly damaged by apparent barge tow.
Earthen Terraces	Good				
Vegetative Plantings	Good

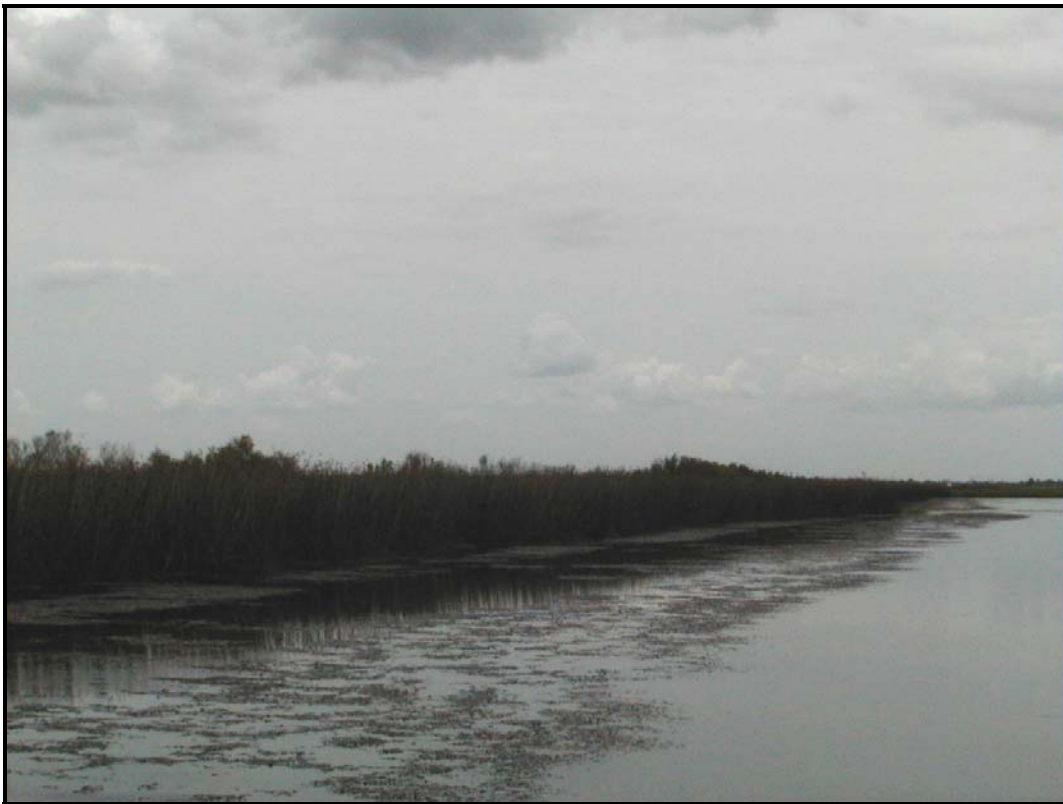
The earthen terraces and vegetative plantings are in very good condition. No maintenance is recommended at this time. (Photos: Appendix B, Photo 3)

Photo 3, Typical terrace feature.
