**State of Louisiana
Department of Natural Resources
Coastal Engineering Division**

**2006/2007 Annual Inspection
Report**

**FRESHWATER BAYOU CANAL
BANK STABILIZATION
PROJECT (ME-13)**

May 01, 2007
Vermilion Parish

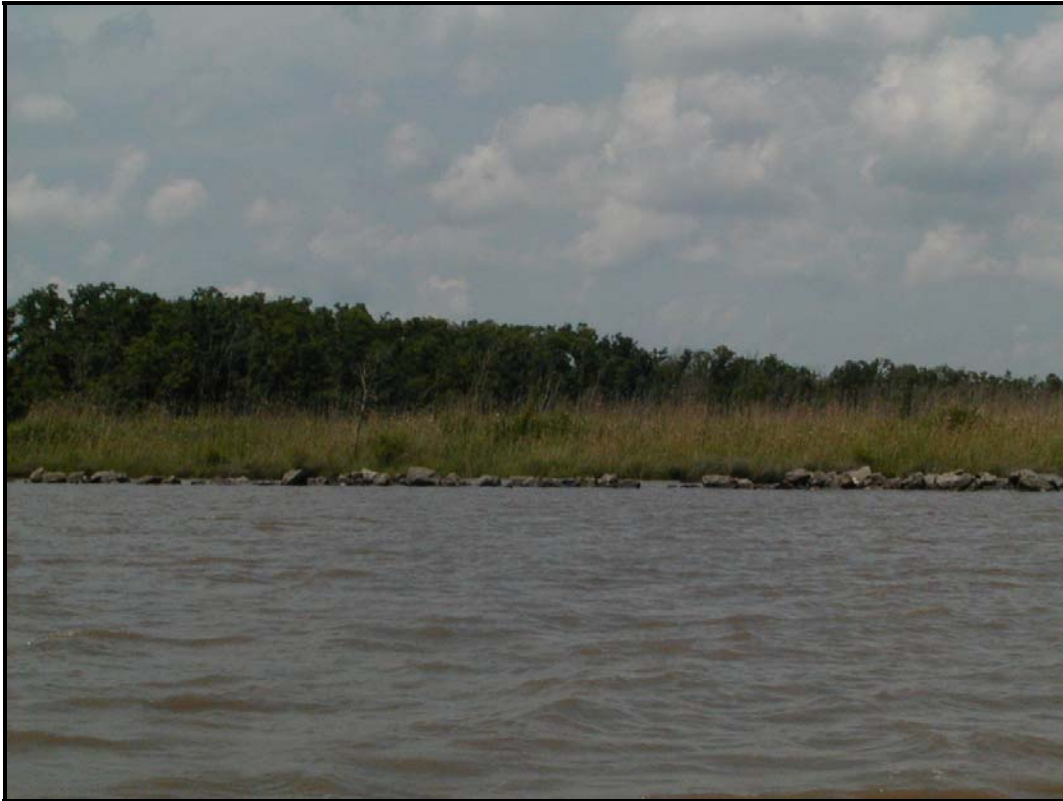
The inspection revealed the 9,130 linear feet of foreshore rock dike repaired in the 2005 maintenance project is in good condition. The additional 7,000 linear feet of foreshore rock dike identified in the 2003/2004 O&M inspection as being below elevation 4.0' NAVD but above elevation 2.0' NAVD, which was not addressed due to budget limitations has not deteriorated further.(Photos: Appendix B, Photos 1 & 2)

Photo 1, Typical rock dike

Item	Condition	Physical Damage	Corrosion	Photo #	Observations and Remarks
Steel Bulkhead / Caps	N/A				
Steel Grating	N/A				
Stop Logs	N/A				
Hardware	N/A				
Timber Piles	N/A				
Timber Wales	N/A				
Galv. Pile Caps	N/A				
Cables	N/A				
Signage / Supports	N/A				
Rip Rap (fill) (foreshore dike)	Good			1 & 2	Recent maintenance work to restore dike to constructed elevation is still in good condition.
Earthen Embankment	N/A

Overall the Freshwater Bayou Canal Bank Stabilization Project is in good condition and appears to have stabilized the erosion of the Freshwater Bayou Canal Bankline. The above mentioned 7,000 linear feet of foreshore rock will continue to be monitored for deterioration in future O & M Inspections.

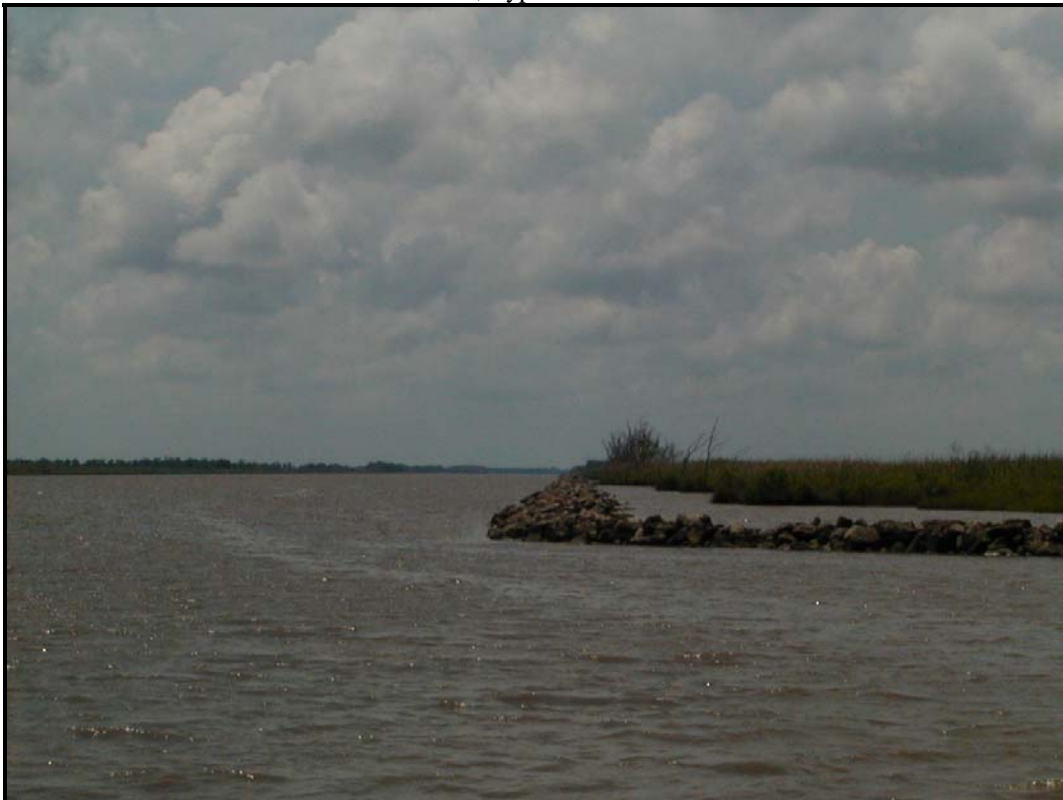
Photo 2, Typical rock dike.
