**State of Louisiana  
Department of Natural Resources  
Coastal Engineering Division**

**2006/2007 Annual Inspection  
Report**

**COTE BLANCHE HYDROLOGIC  
RESTORATION PROJECT  
(TV-04)**

June 22, 2007  
St. Mary Parish

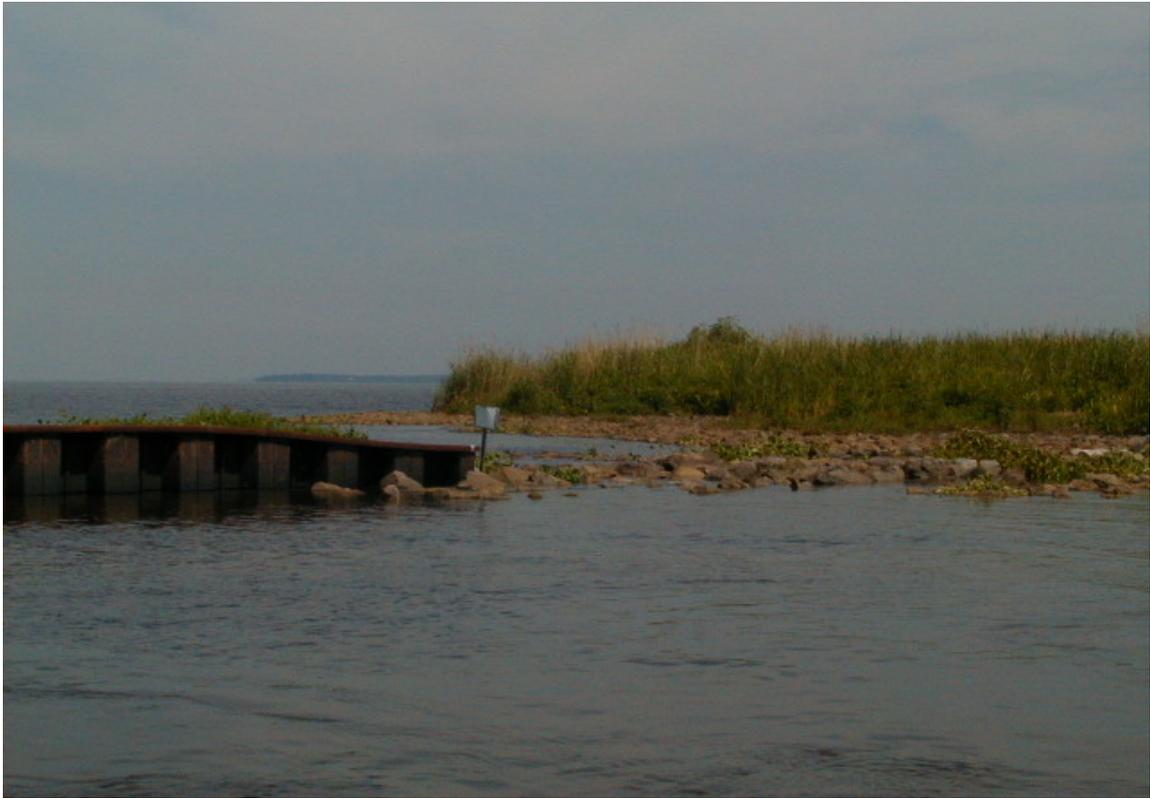
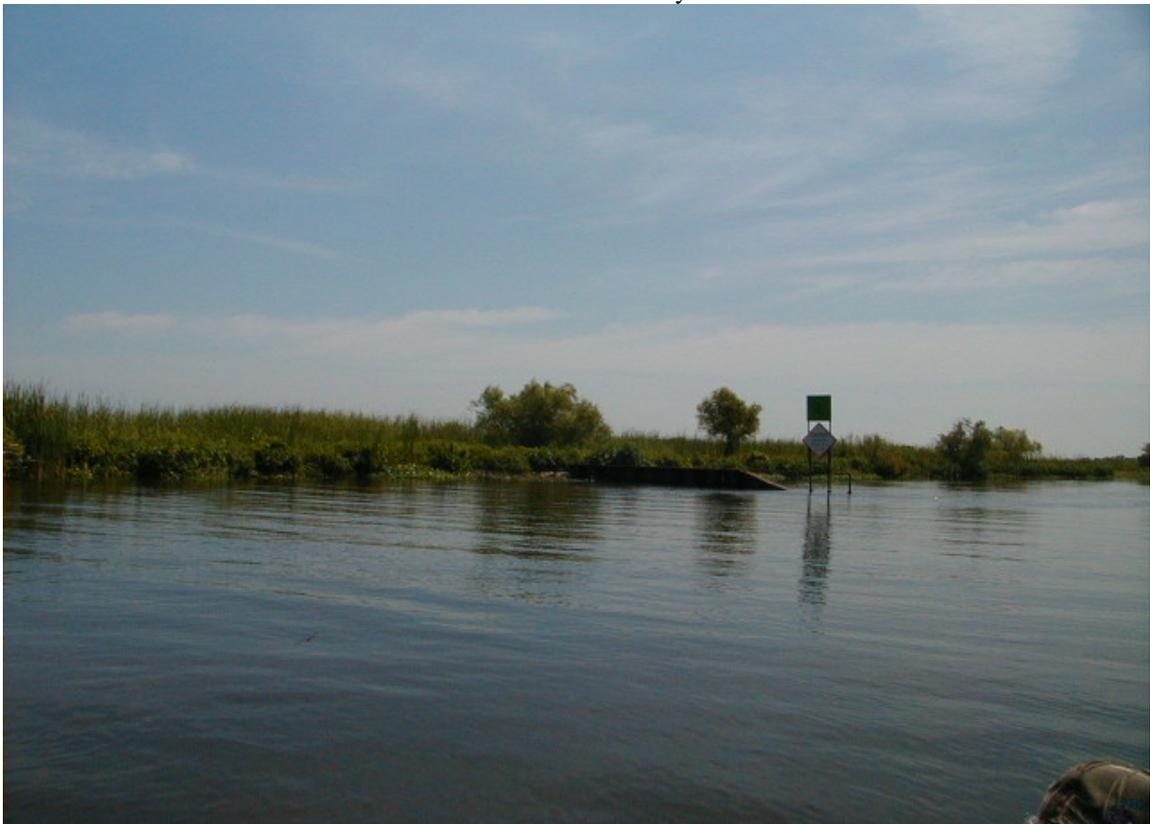
The Mud Bayou structure appears to be holding up fairly well. The coating on the sheet piles is peeling. The steel is beginning to show signs of rust and will need to be monitored. Signage is ok. (Photos: Appendix B, Photos 1-2).

**Photo 1**—north side of Mud Bayou Structure

**Photo 2**—south side of Mud Bayou structure

Item	Condition	Physical Damage	Corrosion	Photo #	Observations and Remarks
Steel Bulkhead / Caps	good				It appears the old bayou channel that existed to the marsh side of the structure appears somewhat wider.
Steel Grating	N/A				
Stop Logs	N/A				
Hardware	good				
Timber Piles	good				
Timber Wales	N/A				
Galv. Pile Caps	N/A				
Cables	N/A				
Signage / Supports	good				
Rip Rap (fill)	good				
Eathern Embankment	N/A

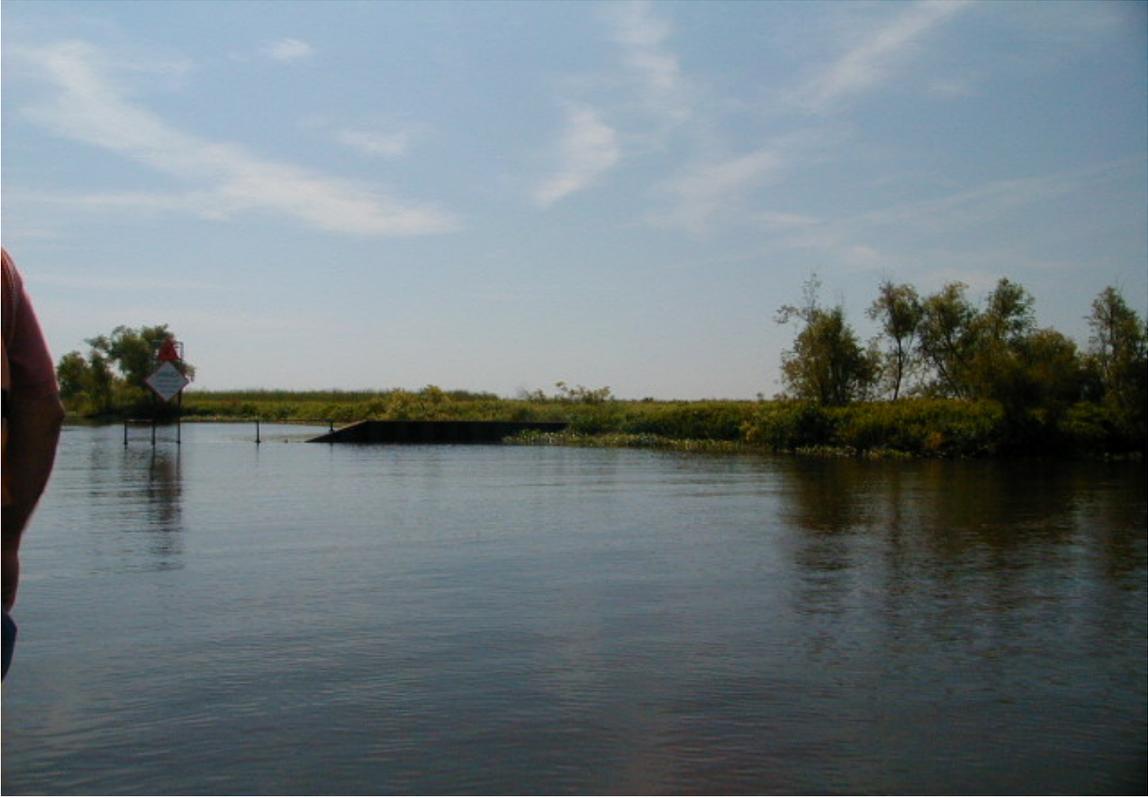
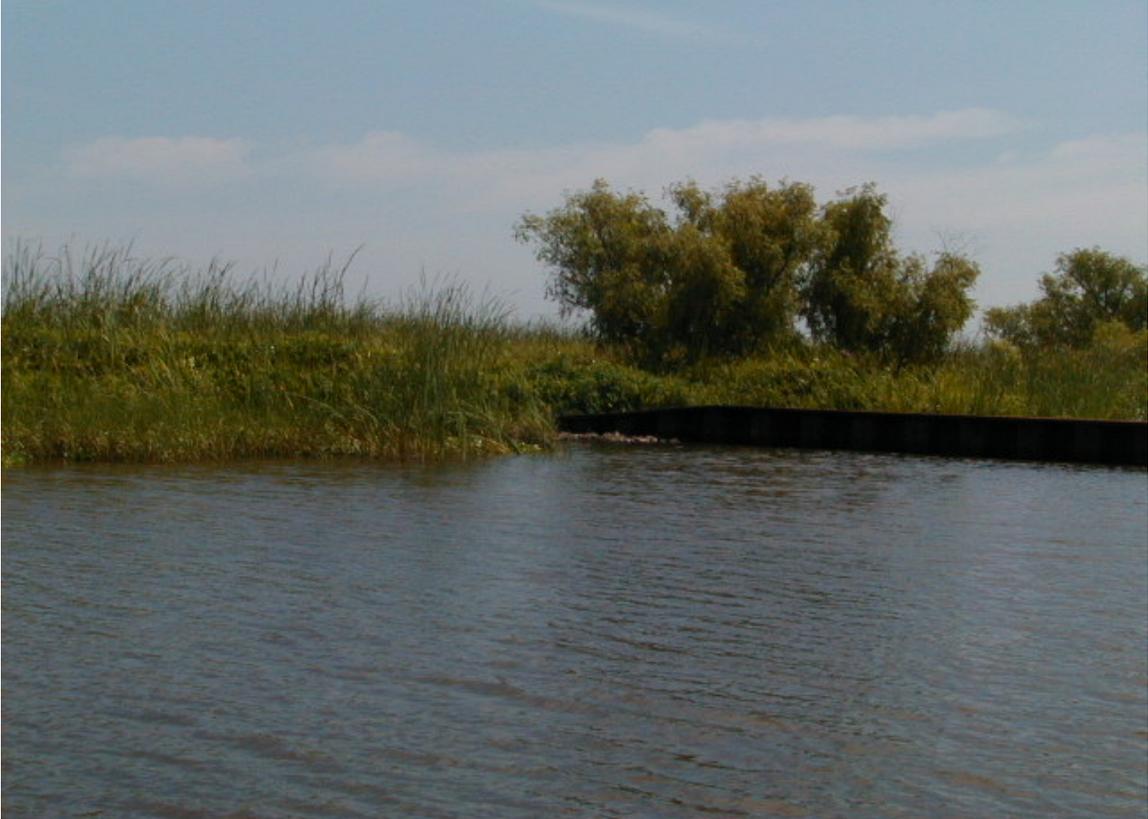
The Humble F Canal structure and signage are stable. The coating on the sheet piles is rusting on this structure and will be monitored as well. (Photos: Appendix B, Photos 3-4).

**Photo 3**—south side of Humble F Canal

**Photo 4**—north side of Humble F Canal

Item	Condition	Physical Damage	Corrosion	Photo #	Observations and Remarks
Steel Bulkhead / Caps	good				Structure in good condition. Some slight rusting of pile caps. No immediate action necessary
Steel Grating	N/A				
Stop Logs	N/A				
Hardware	good				
Timber Piles	good				
Timber Wales	N/A				
Galv. Pile Caps	N/A				
Cables	N/A				
Signage / Supports	good				
Rip Rap (fill)	good				
Eathern Embankment	N/A

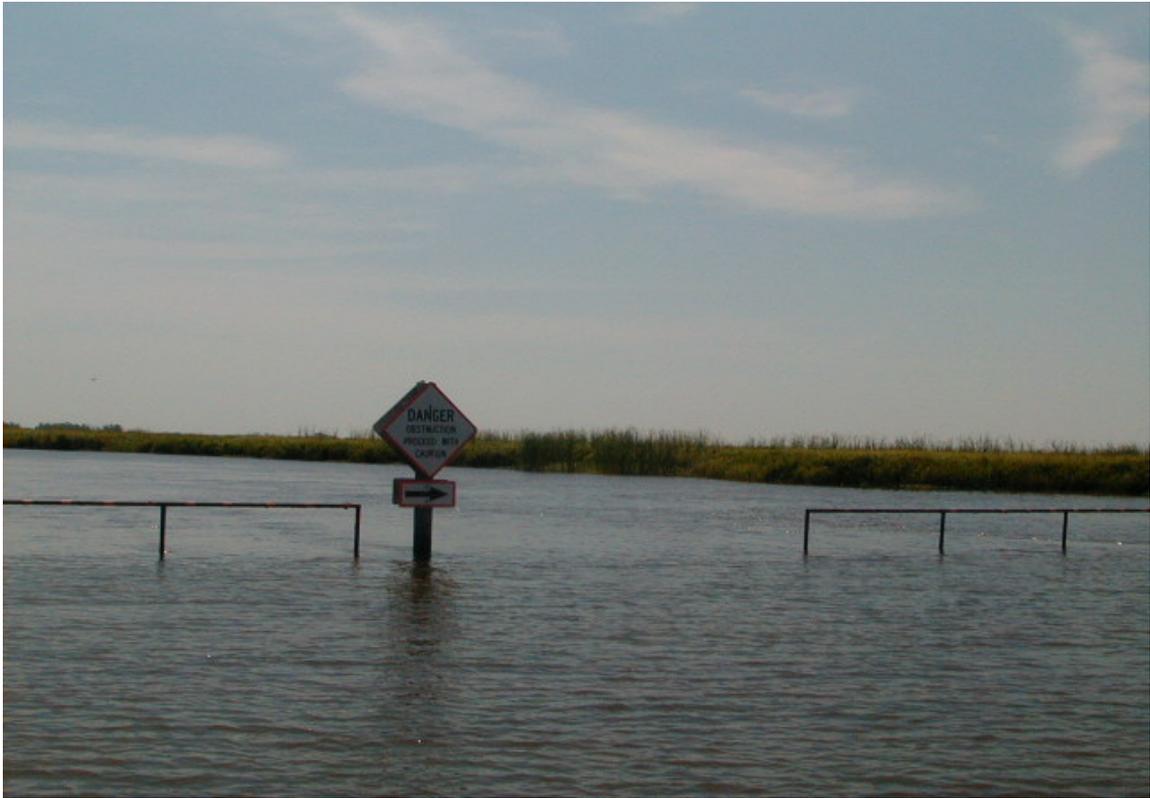
The Bayou Long structure and signage are stable. The coating on the sheet piles is rusting on this structure and will be monitored as well. (Photos: Appendix B, Photo 5)

**Photo 5**—missing sign at Bayou Long Structure

Item	Condition	Physical Damage	Corrosion	Photo #	Observations and Remarks
Steel Bulkhead / Caps	good				Structure in pristine post-construction condition. Some slight rusting of pile caps. No immediate action necessary.
Steel Grating	N/A				
Stop Logs	N/A				
Hardware	good				
Timber Piles	good				
Timber Wales	N/A				
Galv. Pile Caps	N/A				
Cables	N/A				
Signage / Supports	good				
Rip Rap (fill)	N/A				
Eathern Embankment	N/A

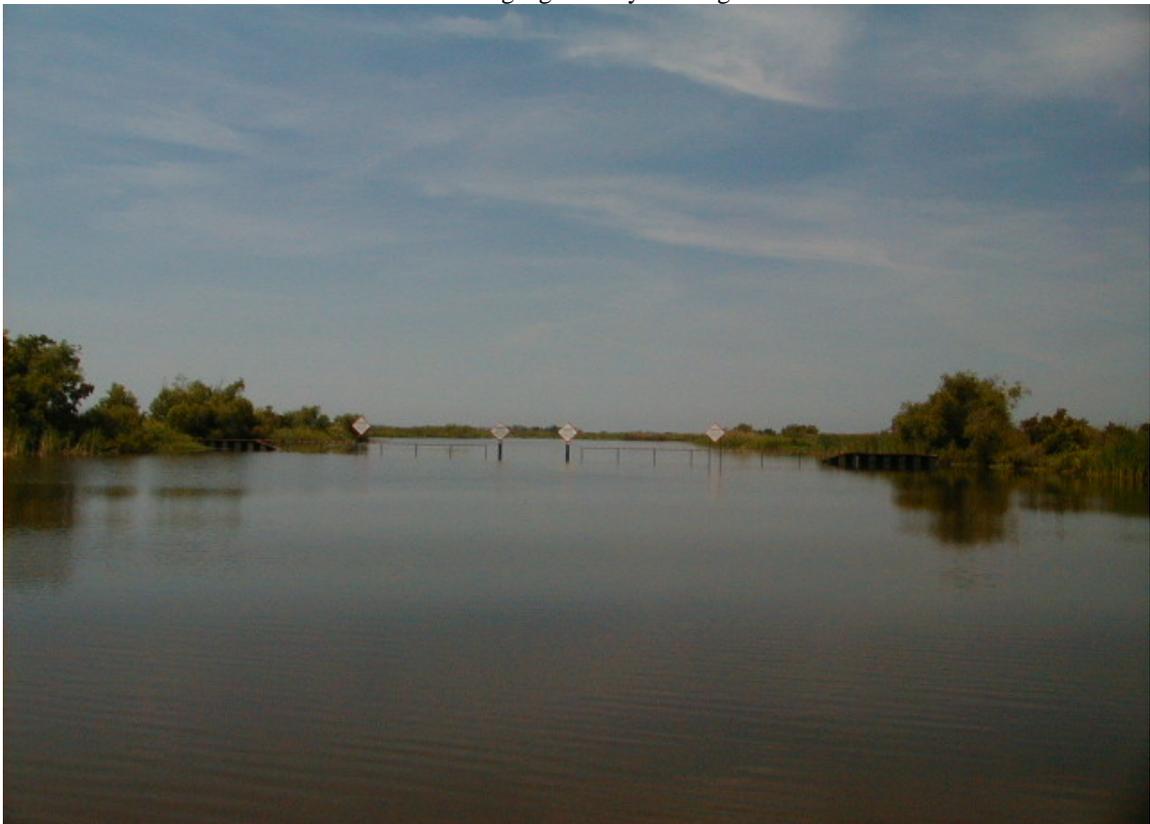
The Bayou Carlin structure and signage are stable. The coating on the sheet piles is rusting on this structure and will be monitored as well. (Photos: Appendix B, Photo 6)

**Photo 6**—Bayou Carlin Structure

Item	Condition	Physical Damage	Corrosion	Photo #	Observations and Remarks
Steel Bulkhead / Caps	good				Structure in pristine post-construction condition. Some slight rusting of pile caps. No immediate action necessary.
Steel Grating	N/A				
Stop Logs	N/A				
Hardware	good				
Timber Piles	good				
Timber Wales	N/A				
Galv. Pile Caps	N/A				
Cables	N/A				
Signage / Supports	good				
Rip Rap (fill)	N/A				
Eathern Embankment	N/A

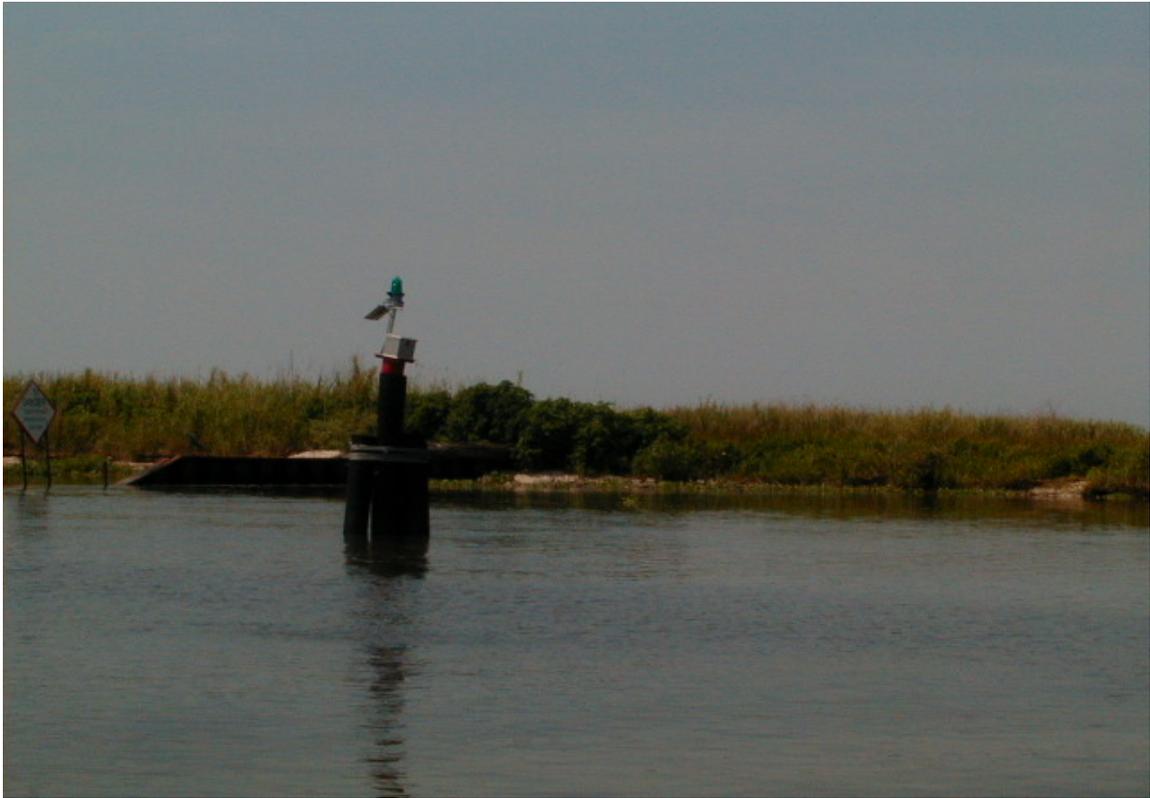
The Humble Canal structure has some minor damages that will be addressed as part of the School Bus Bayou repairs beginning in the summer of 2007. The shoreline at the south end of the rock riprap dike has experienced some erosion and the marsh area remaining is narrow and now subject to being breached allowing water to flow around the weir. Budget limitations will not allow this area to be addressed; however, Miami Corporation has proposed to address this area with mitigation dollars in the future. In the meantime, it will continue to be monitored. The “handrail” on the west side of the barge bay notch, actually a railing of 3 inch pipe that is approximately 2 feet above normal water levels that marks that reach of the sheet pile weir as being non-navigable to boaters, is broken and approximately 8-10 feet of same is missing. The balance of the north “handrail”, approximately 40 feet in length, is slightly bent towards the bay. The NW nav-aid sign is missing and will need to be replaced. (Photos: Appendix B, Photos 7-8).

**Photo 7**—Missing nav-aid and damaged rail at Humble Canal Structure

Item	Condition	Physical Damage	Corrosion	Photo #	Observations and Remarks
Steel Bulkhead / Caps	good				Some initial post construction rusting. No action needed.
Steel Grating	N/A				
Stop Logs	N/A				
Hardware	fair				Handrail on western side of structure is damaged.
Timber Piles	N/A				
Timber Wales	N/A				
Galv. Pile Caps	good				
USCG Lights	poor				NW nav-aid sign is missing and needs replacement.
Signage / Supports	poor				
Rip Rap (fill)	fair				
Eathern Embankment	N/A

- Repair School Bus Bayou
- Replace Coast Guard sign at Humble Canal
- Verify staff gauges in the area

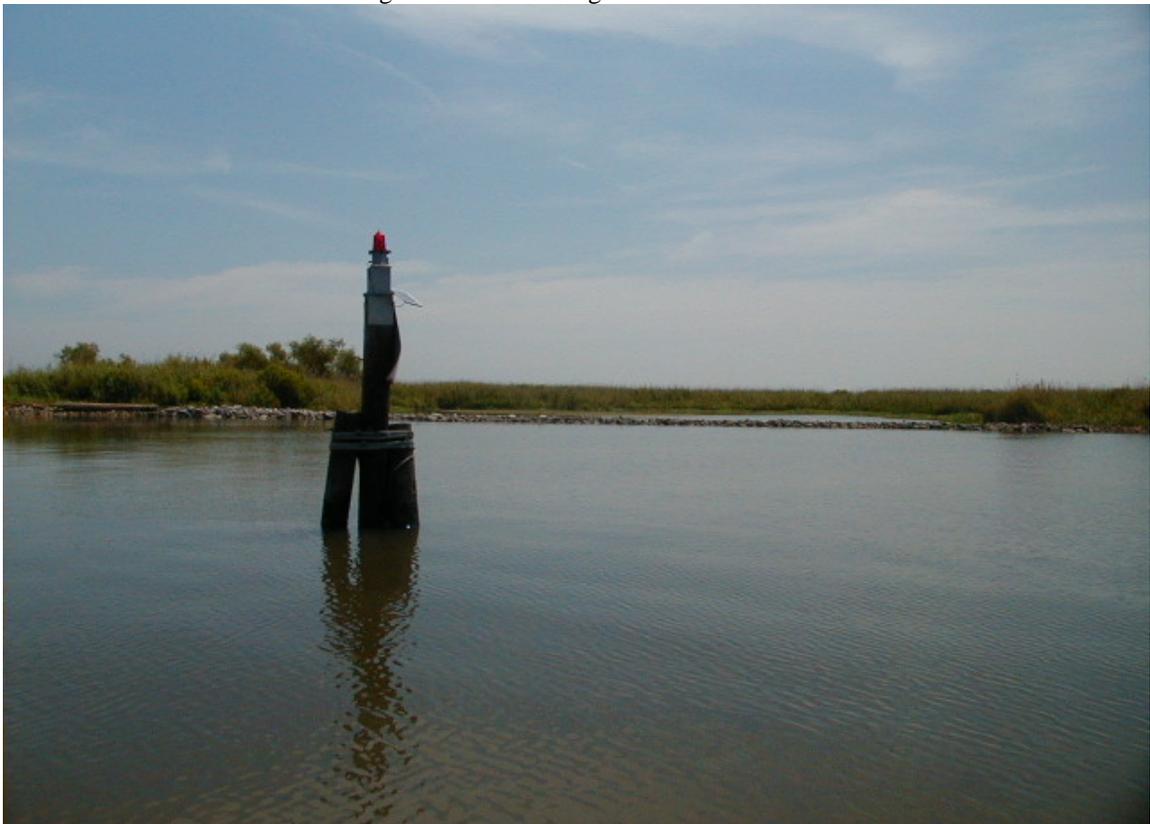
**Photo 8**—rock dike near Humble Canal

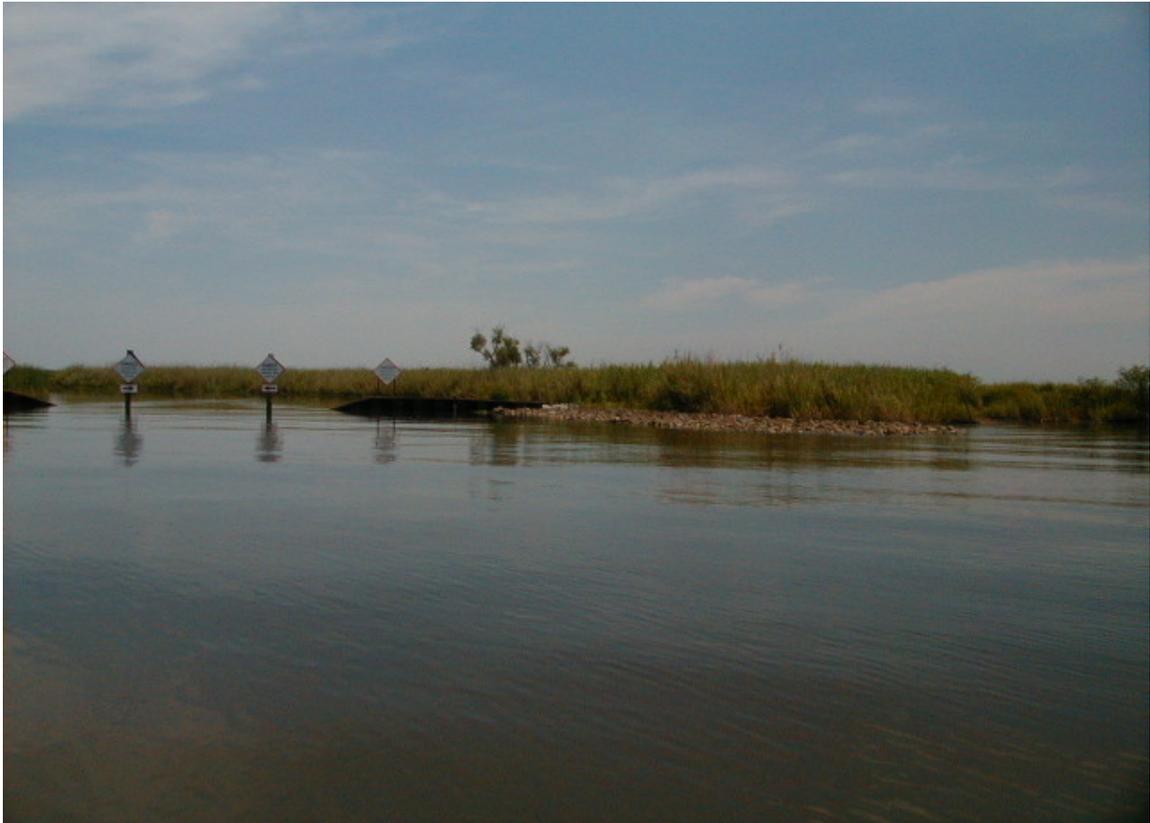
The Jackson Bayou structure and signage are stable. The coating on the sheet piles is rusting on this structure and will be monitored as well. (Photos: Appendix B, Photo 9).

**Photo 9**—east side of Jackson Bayou Structure

Item	Condition	Physical Damage	Corrosion	Photo #	Observations and Remarks
Steel Bulkhead / Caps	good				Some slight rusting of pile caps. No immediate action necessary.
Steel Grating	N/A				
Stop Logs	N/A				
Hardware	good				
Timber Piles	poor				
Timber Wales	N/A				
Galv. Pile Caps	N/A				
Cables	N/A				
Signage / Supports	good				
Rip Rap (fill)	N/A				
Eathern Embankment	N/A

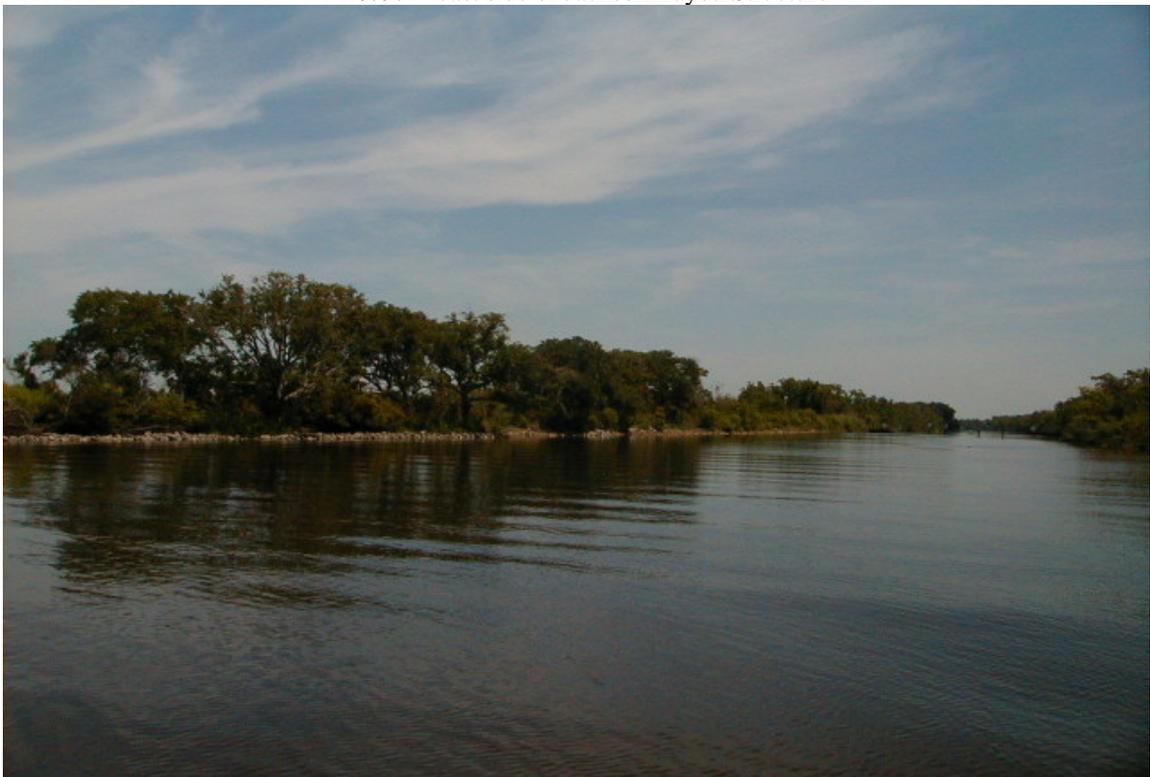
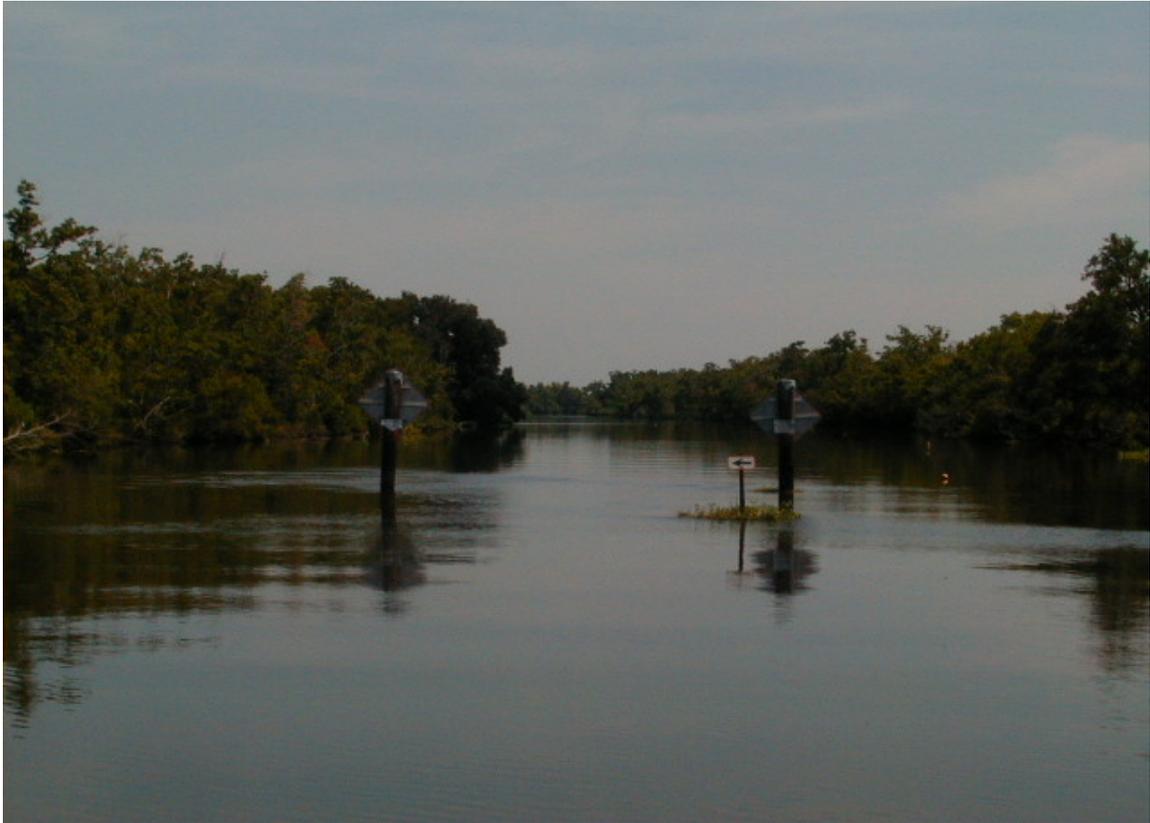
The British American Canal and signage are stable. The coating on the sheet piles is rusting on this structure and will be monitored as well. One of the directional arrows is missing, but may not need to be replaced at this time. (Photos: Appendix B, Photos 10 & 11).

**Photo 10**—rock along British American canal

**Photo 11**—missing arrow sign at British American canal

Item	Condition	Physical Damage	Corrosion	Photo #	Observations and Remarks
Steel Bulkhead / Caps	good				Some initial post construction rusting. No action needed.
Steel Grating	N/A				
Stop Logs	N/A				
Hardware	good				
Timber Piles	N/A				
Timber Wales	N/A				
Galv. Pile Caps	N/A				
Cables	N/A				
Signage / Supports	good				
Rip Rap (fill)	good				
Eathern Embankment	N/A

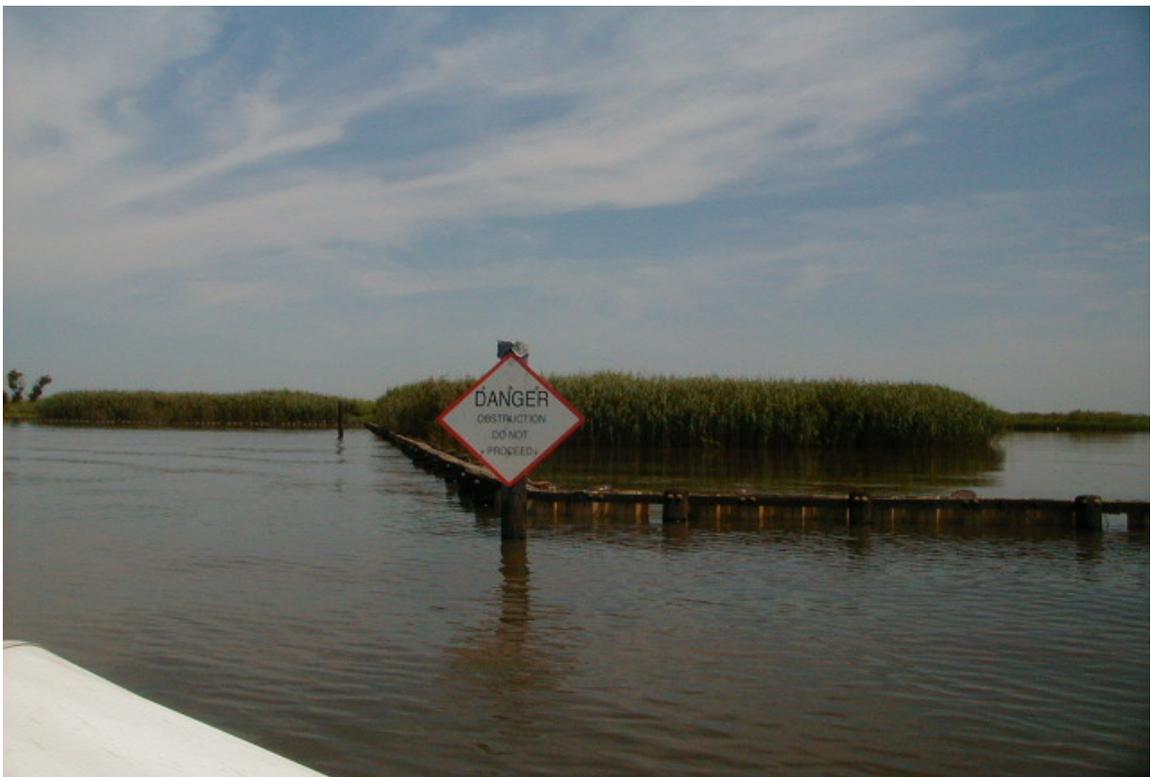
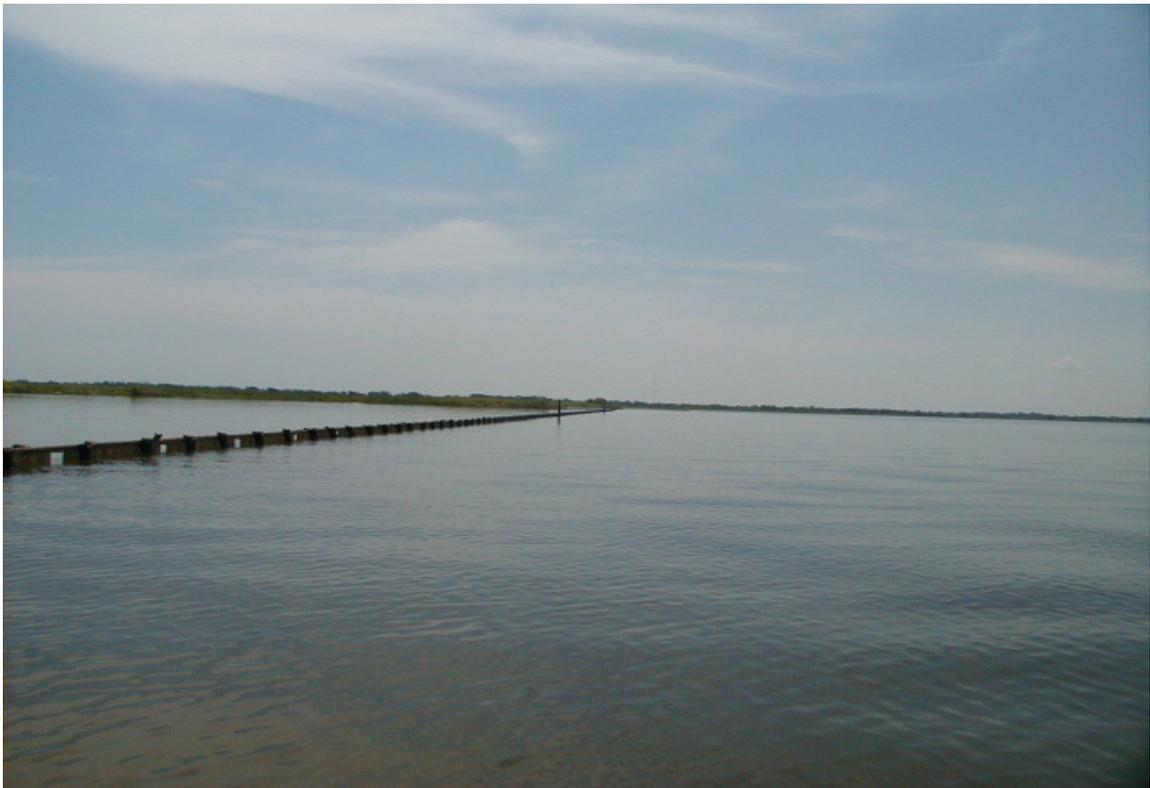
The PVC shoreline protection wall and signage are stable. Several pile caps are missing but no damage to the timber piles was noticed. Previous attempts to replace these pile caps have been unsuccessful. The piles will be monitored and should the need arise, will be painted or coated for protection. (Photos: Appendix B, Photos 12-13).

**Photo 12**—signage along PVC Wall

**Photo 13**—typical section of PVC wall

Item	Condition	Physical Damage	Corrosion	Photo #	Observations and Remarks
PVC sheet piling / Caps	fair				PVC wall appears to be in post construction condition and holding up well.
Steel Grating					
Stop Logs					
Hardware	good				
Timber Piles	good				Some pile caps missing again. No immediate action necessary.
Timber Wales	good				
Galv. Pile Caps					
Cables					
Signage / Supports	good				All signs in place and in immediate post construction condition.
Rip Rap (fill)	good				Rock placed along the inside and outside of the PVC wall is still in place and functional. No action necessary.
Earthen Embankment

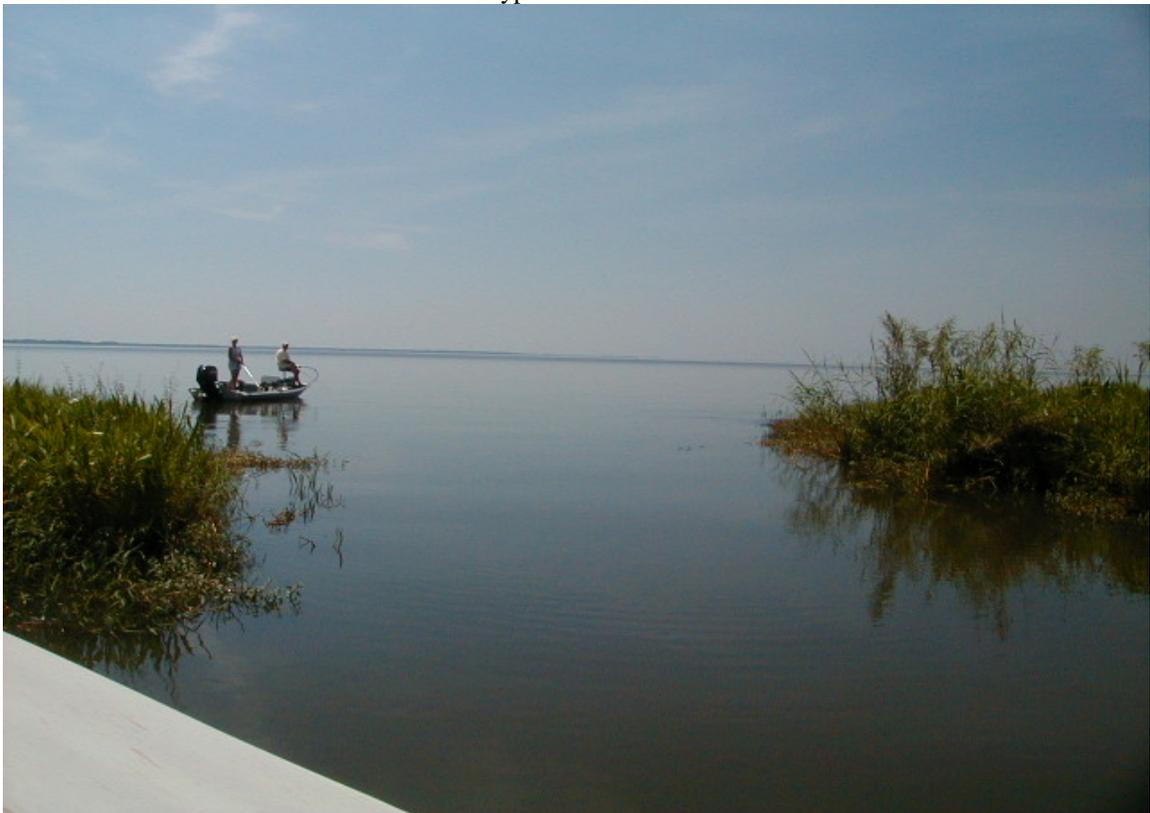
As an aside to inspecting the structural features of this project, the situation at School Bus Bayou was inspected. Luhr Bros. has been awarded the construction contract in the amount of \$1,500,000. Construction should begin during the end of summer 2007. (Photos: Appendix B, Photo 14).

**Photo14**—largest breach in School Bus Bayou
