**State of Louisiana
Department of Natural Resources
Coastal Restoration Division and
Coastal Engineering Division**

**2007 Operations, Maintenance,
and Monitoring Report**

Cameron Creole Plugs Project

State Project Number CS-17
Priority Project List 1

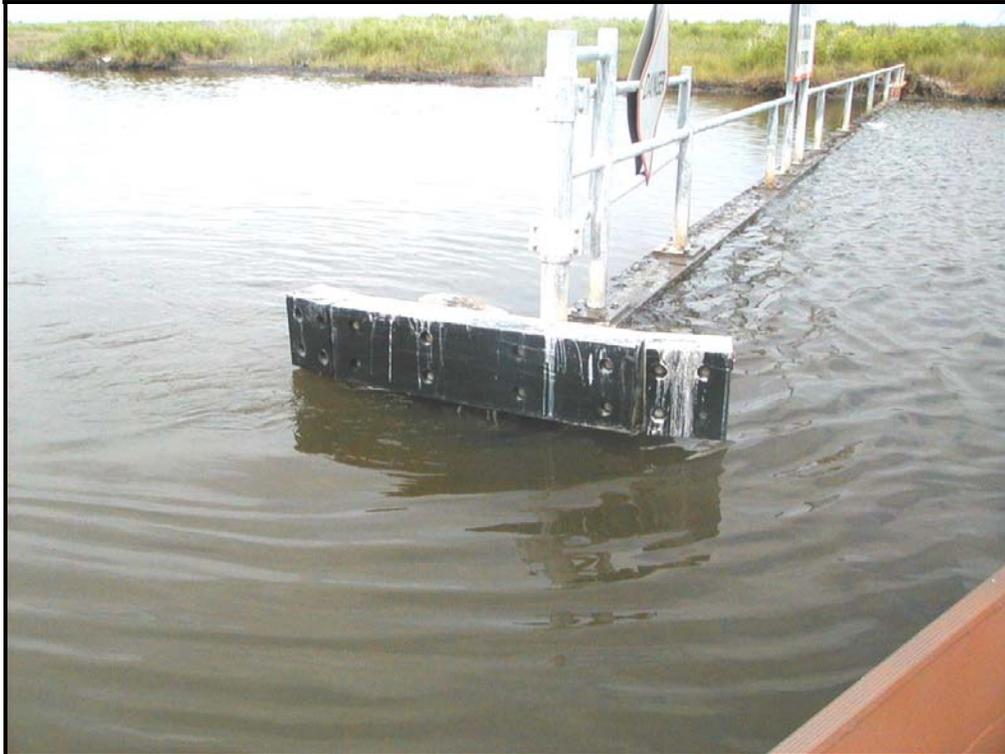
The structure is in good condition since the maintenance repair project in 2005; however, there is bank erosion on both ends of the sheet pile wall which will need to be addressed with rock rip rap. (Photos: Appendix B, Photos 1 & 2).

Photo 1, Partial view of boat bay and sheet pile wall at Grand Bayou Structure (April 17, 2007).

Repair bank erosion at each end of the sheet pile wall at both structures and replace boat guide timbers as described above.

- Grand Bayou structure – repair bank erosion with rock rip rap.

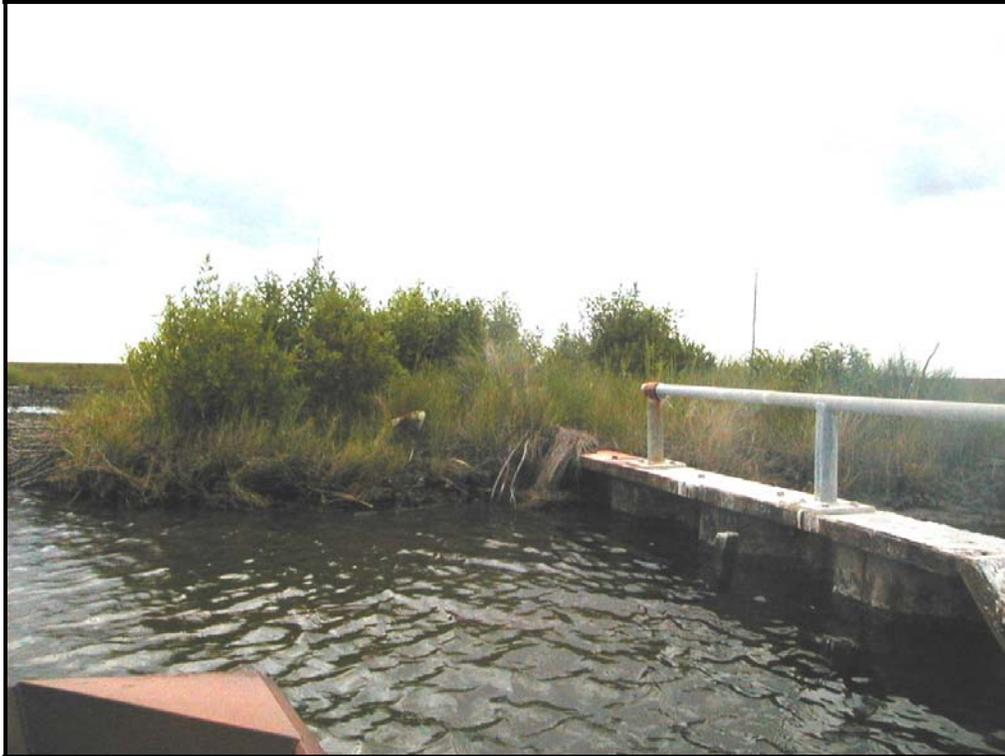
Photo 2, View of erosion occurring at each end of sheet pile wall at Grand Bayou Structure (April 17, 2007).

Item	Condition	Physical Damage	Corrosion	Photo #	Observations and Remarks
Steel Bulkhead / Caps	Good			1	
Steel Grating	N/A				
Stop Logs	N/A				
Hardware	Good				
Timber Piles	N/A				
Timber Wales	N/A				
Galv. Pile Caps	Good				
Cables	N/A				
Signage / Supports	Good			1	
Rip Rap (fill)	N/A				
Eathern Embankment	Poor			2	Erosion occuring on both ends of the sheet pile wall.

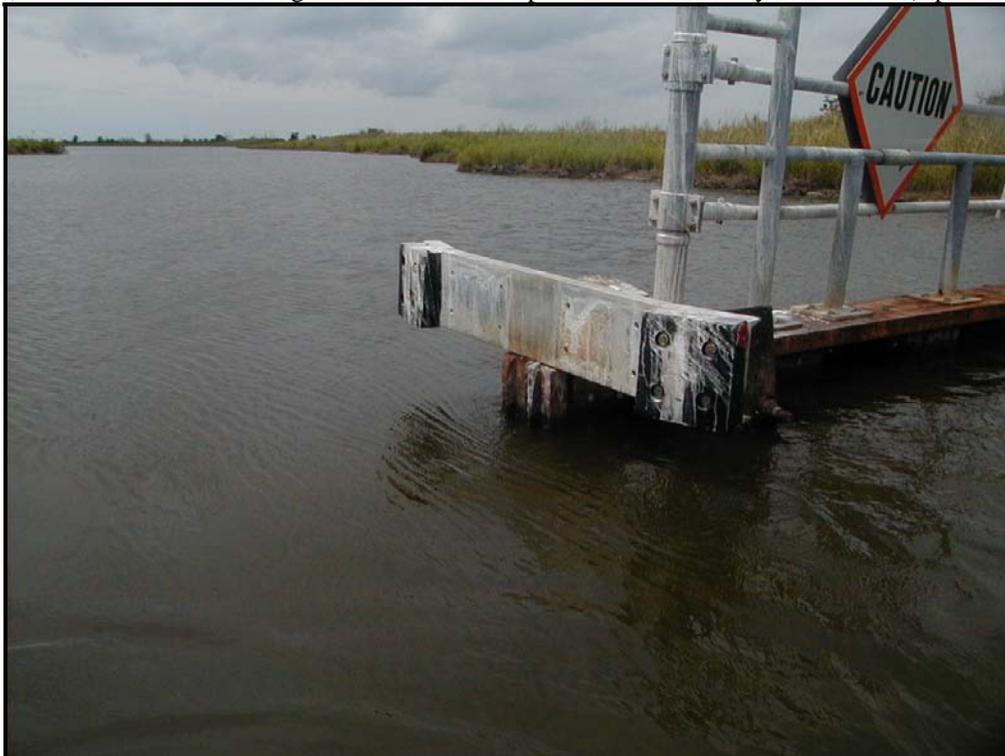
This structure is also in good condition, but has been vandalized. Two (2) sections of 8” x 12” Seatimber Composite Marine Timber have been removed from the boat guide and need to be replaced along with the stainless steel hardware. There is bank erosion on both ends of the sheet pile wall which will need to be addressed with rock rip rap. (Photos: Appendix B, Photos 3 & 4).

Photo 3, View showing missing composite timbers on boat guide at Mangrove Structure (April 17, 2007).

- Mangrove Bayou structure – repair bank erosion with rock rip rap; replace boat guide marine timber.

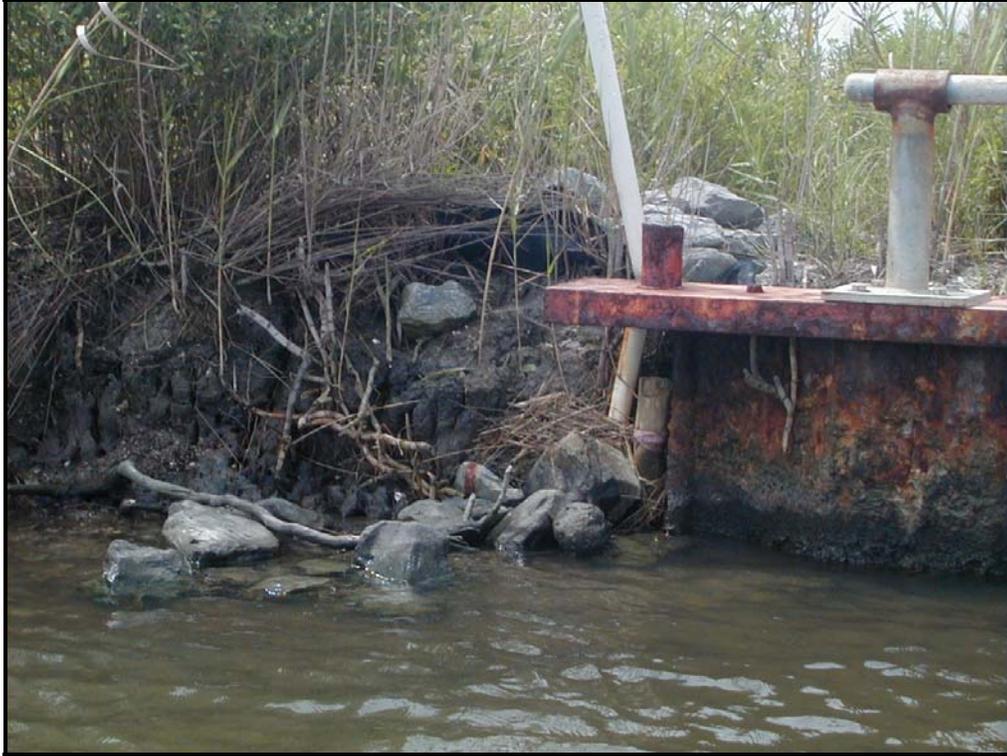
Photo 4, View of erosion at ends of sheet pile wall at Mangrove Structure (April 17, 2007).

Item	Condition	Physical Damage	Corrosion	Photo #	Observations and Remarks
Steel Bulkhead / Caps	Good			3	
Steel Grating	N/A				
Stop Logs	N/A				
Hardware	Fair				
Timber Piles	N/A				
Timber Wales	N/A				
Galv. Pile Caps	Good				
Cables	N/A				
Signage / Supports	Good			3	
Rip Rap (fill)	N/A				
Eathern Embankment	Poor			4	Erosion occuring at both ends of sheetpile wall.
