**2007 Operations, Maintenance,
and Monitoring Report**

**Humble Canal Hydrologic
Restoration**

State Project Number ME-11
Priority Project List 8

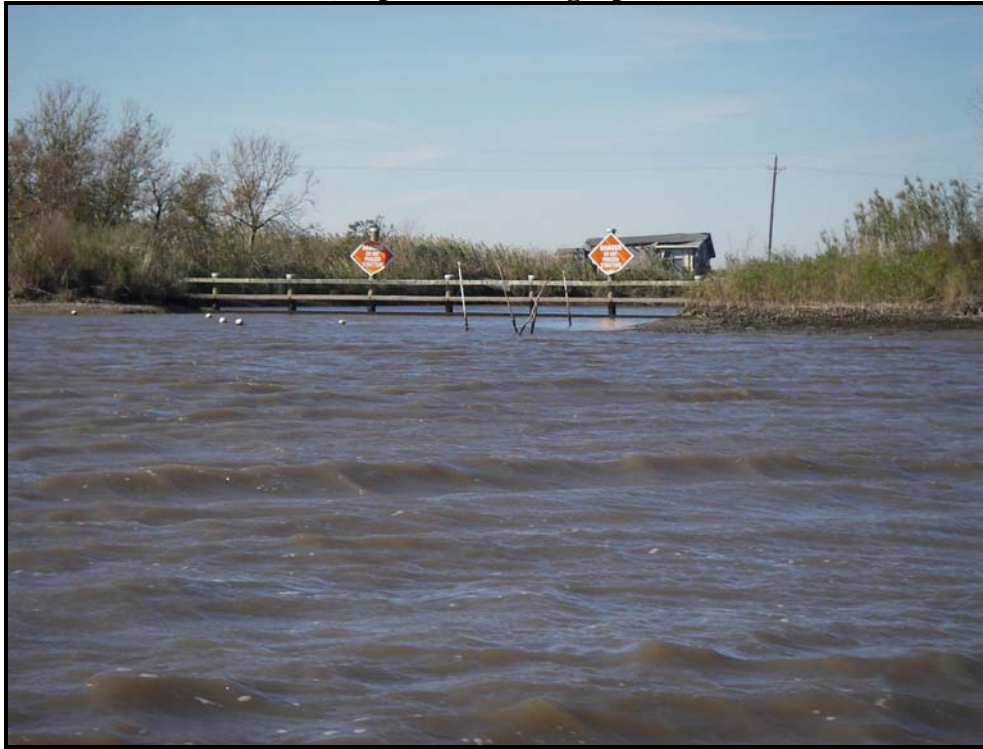
The structure is in excellent condition. Some shrinkage of the sign lettering has occurred and the signs are slightly bent from Hurricane Rita damage. Bank tie-ins, pile caps, hardware, etc. are in excellent condition. No maintenance is required at this time. (Photos: Appendix B, Photo 1)

Photo 1, Marine barrier with signage.

Item	Condition	Physical Damage	Corrosion	Photo #	Observations and Remarks
Steel Bulkhead / Caps	good				
Steel Grating					
Stop Logs	N/A				
Hardware	good				
Timber Piles	good				
Timber Wales	good				
Galv. Pile Caps	good				
Cables	N/A				
Signage /Supports	good			1	Some odd shrinkage of the lettering on the warning signs. Still no cause for concern. Signs slightly bent from Hurricane RITA damage.
Rip Rap (fill)	N/A				
Eathern Embankment	N/A

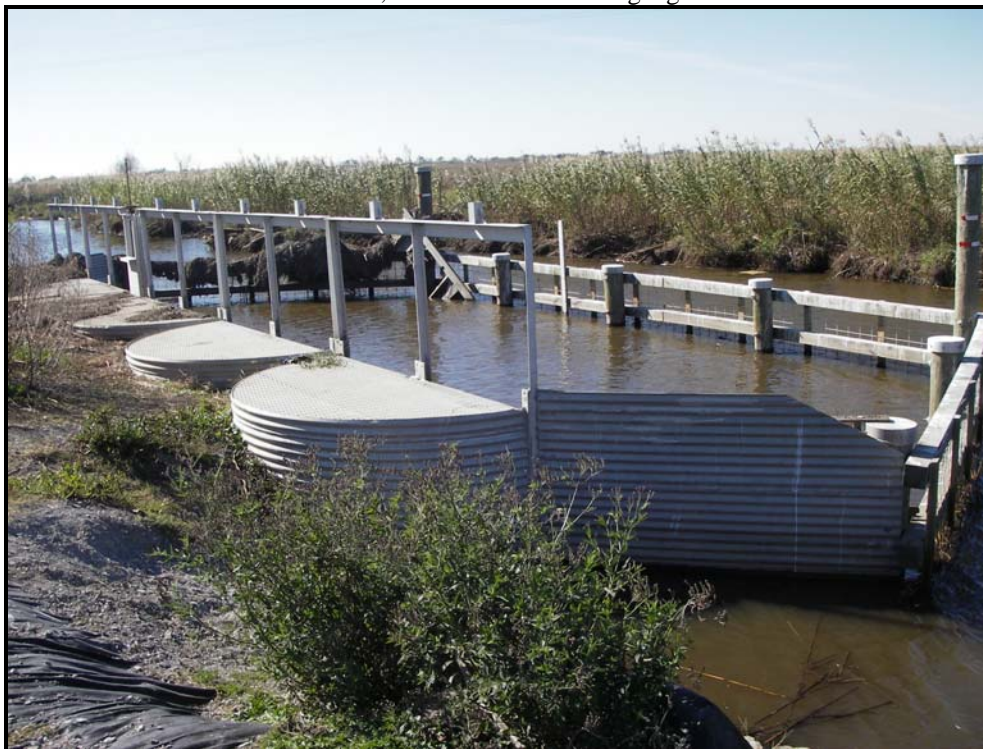
This feature is in good condition. There is a small amount of debris and wrack material clogging the hyacinth guard. Maintenance to remove the debris is needed. (Photos: Appendix B, Photo 2)

Photo 2, Inlet side showing hyacinth fence in background covered with debris, as well as embankment of structure.

Item	Condition	Physical Damage	Corrosion	Photo #	Observations and Remarks
Steel Bulkhead / Caps	good				
Steel Grating	N/A				
Stop Logs	N/A				
Hardware	fair			4	Hyacinth fence is covered with wrack and debris.
Timber Piles	good				
Timber Wales	good				
Galv. Pile Caps	good				
Cables	N/A				
Signage /Supports	N/A				
Rip Rap (fill)	N/A				
Earthen Embankment	N/A

Repair structure hardware, clean wrack and debris, provide additional aggregate on top of structure.

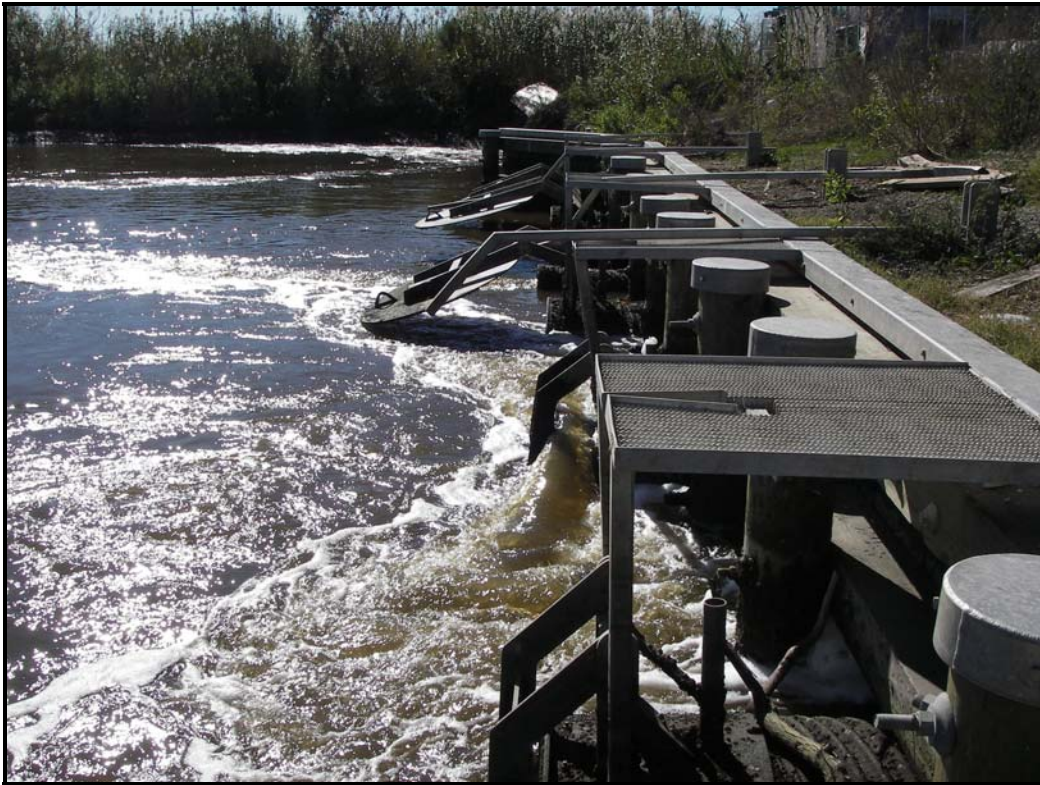
Overall, the structure is in good post-construction condition. The inspection noted the erosion of the structure embankment behind each wing wall and over the structure identified in the 2005/2006 O & M Inspection. Miscellaneous structure maintenance such as replacement of bolts and flap gate locking arms will be required. The camp building identified in the 2005/2006 O & M Inspections has not been removed by the owner. (Photos: Appendix B, Photos 3, 4, 5, and 6)

Photo 3, Outlet side of structure.

Item	Condition	Physical Damage	Corrosion	Photo #	Observations and Remarks
Steel Bulkhead / Caps	good				
Steel Grating	good				
Stop Logs	good				Stoplogs on this structure are made of aluminum and should last practically forever.
Hardware	fair			3	Some of the hardware needs to be replaced or repaired.
Timber Piles	good				
Timber Wales	good				
Galv. Pile Caps	good				
Cables/ lifting device	good				
Signage /Supports	good				
Rip Rap (fill) (foreshore dike)	good				
Eathern Embankment	good			4	Erosion has occurred behind each wingwall and over the structure.
Inlet Channel/Plug				4	A camp building has been deposited on the southern end of the structure.
				5 & 6	Inlet channel completely cleared of wrack & debris, earthen plug replaced by Cameron Parish GDD.

- Repair and/or replace miscellaneous hardware.
- Add crushed stone on top of structure.
- Clean wrack and debris from structure.

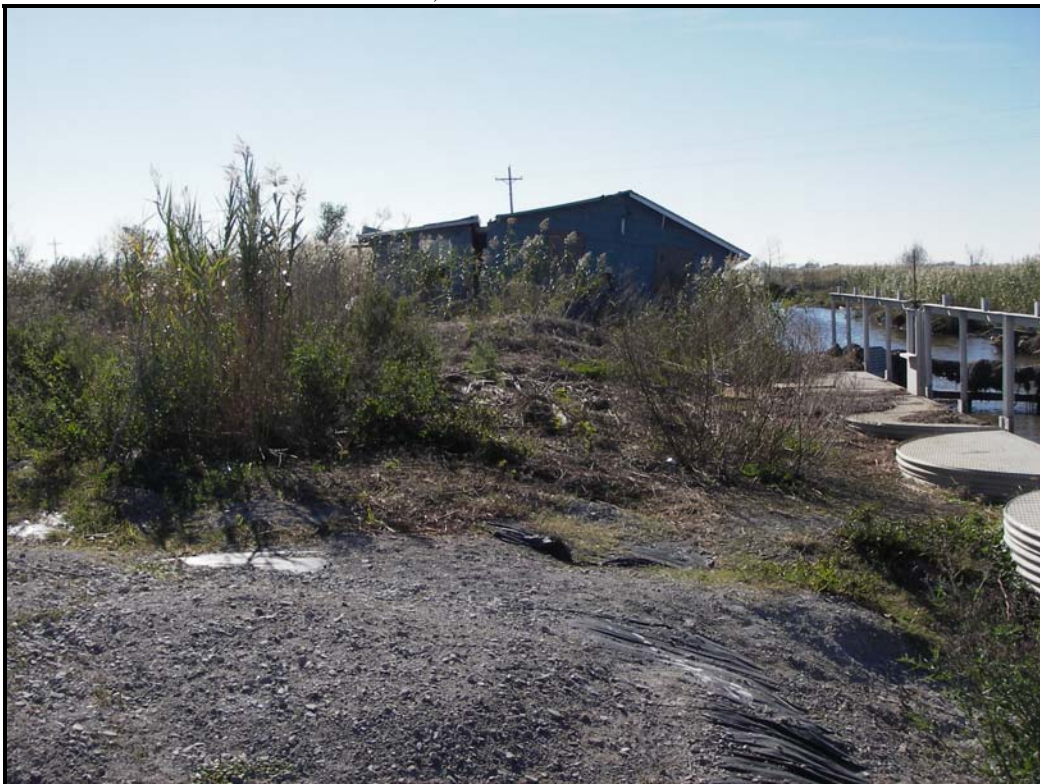
Photo 4, Showing camp on southern end of structure and erosion on embankment.

Overall, the Humble Canal Hydrologic Restoration Project structural components are in good condition and are functioning as designed; however, some maintenance is required as listed below. Plans and specifications will be prepared to address these issues. A Federal Emergency Management Agency (FEMA) claim has been submitted for a portion of the repair work needed on the structure. Miami Corporation will continue efforts to identify the owner of the camp building and options for removal.

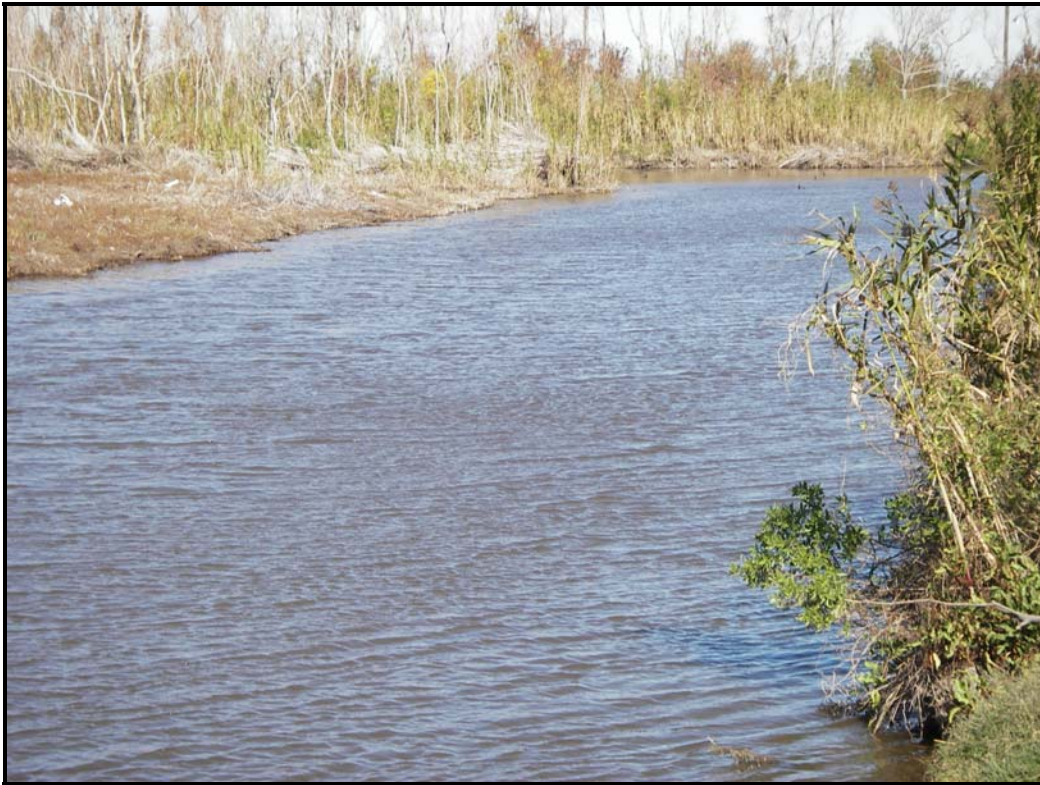
Photo 5, Showing inlet channel, view looking north.

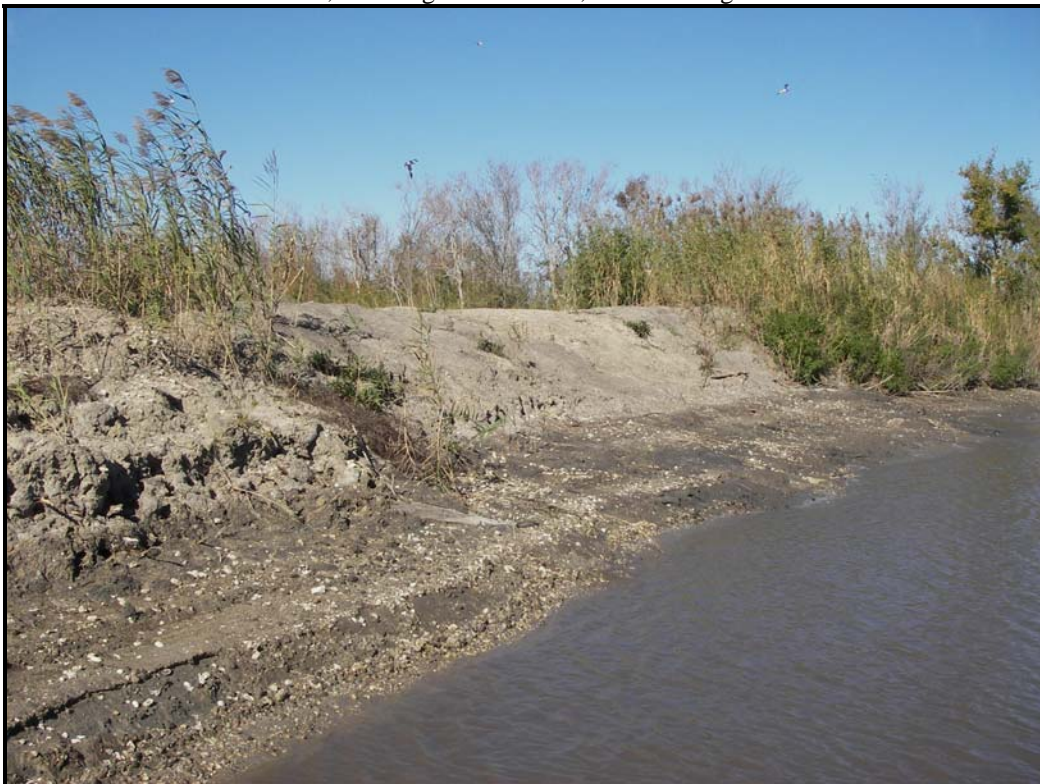
Photo 6, Earthen plug replaced by Cameron Parish Gravity District after high water levels receded.
