**2007 Operations, Maintenance,  
and Monitoring Report**

**Grand-White Lakes Landbridge  
Protection**

State Project Number ME-19  
Priority Project List 10

August 2007  
Vermilion Parish

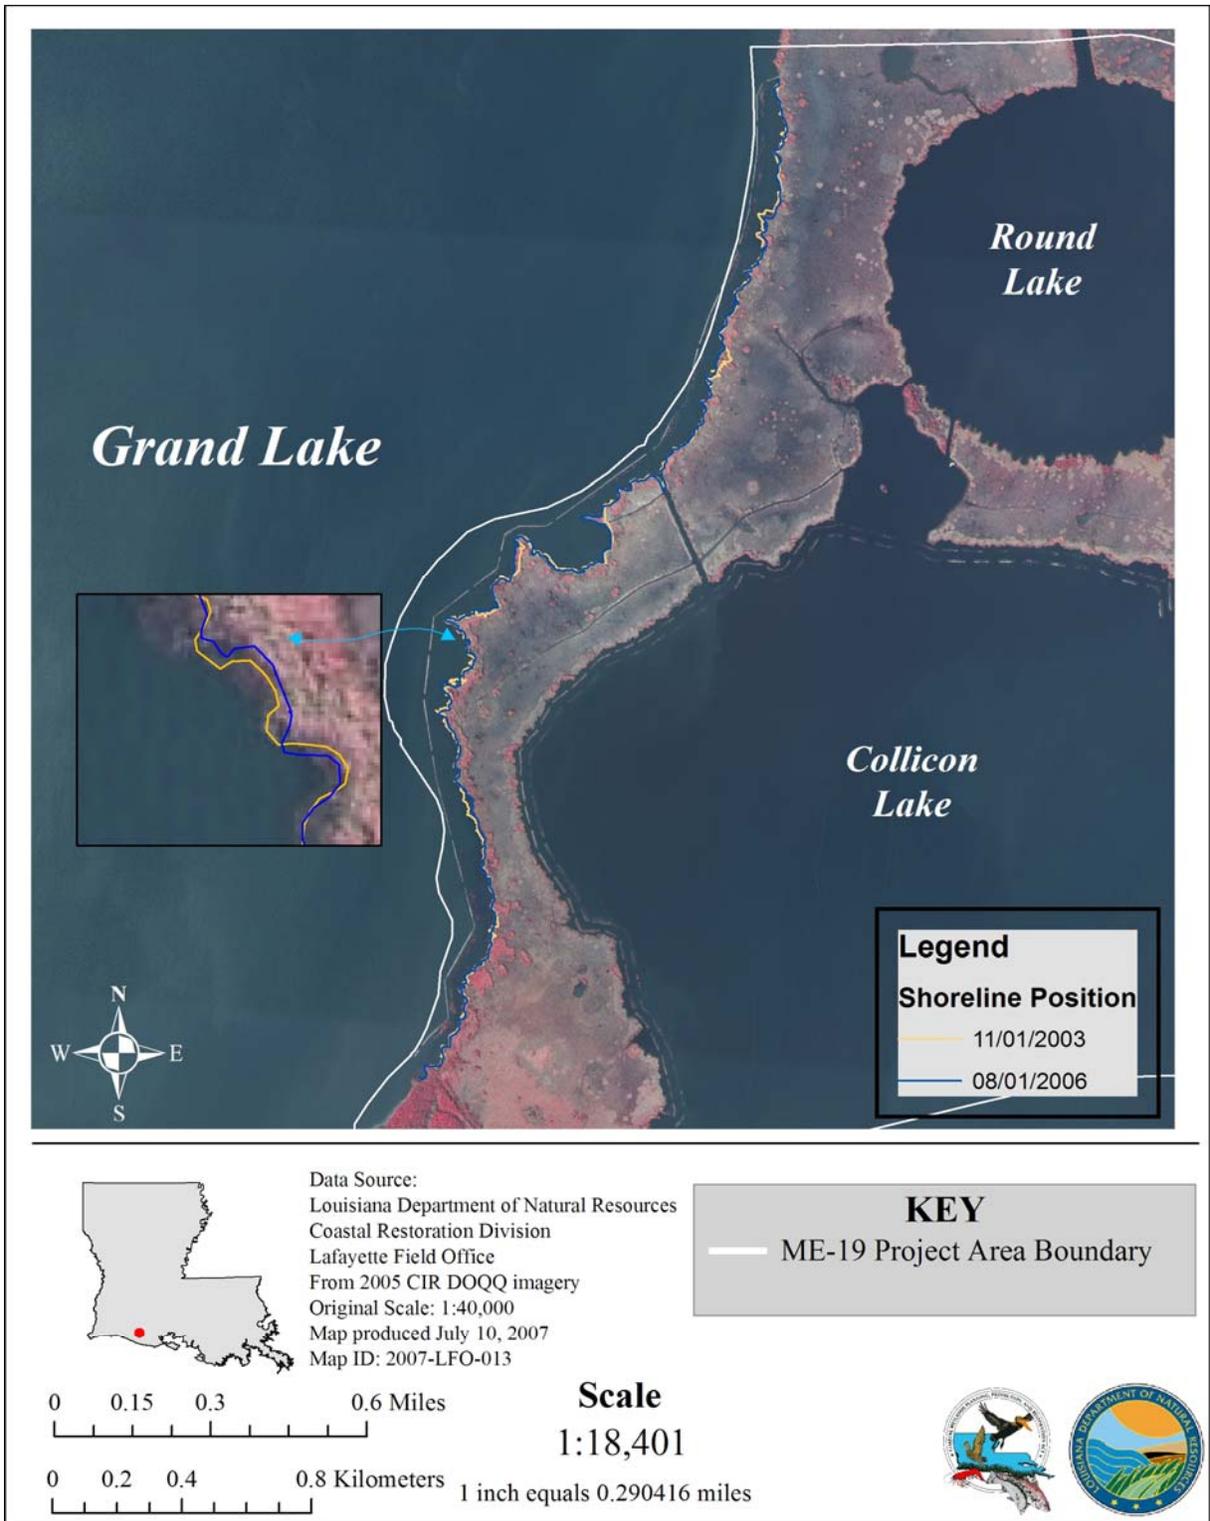
Analysis of as built Differential GPS (DGPS) sampled on November 11, 2003, was compared to post-construction DGPS sampled August 30, 2006, to evaluate the shoreline behind the foreshore dike. Change rates were calculated in m/yr for the length of the project area and the reference area along transects spaced 20 m apart (figures 3 and 4). Change rates were determined and averaged from each transect along the shoreline. The rate of change behind the foreshore dike indicated an average loss of -0.54 m/yr. The rate of change on the reference area is an average loss of -0.24 m/yr. DGPS of the as built shoreline behind the terraces and its reference area was taken on October 9, 2004. Analysis of this area will be determined after the next DGPS scheduled in 2007.

**Figure 3.** Shoreline change map of the Grand-White Lakes Landbridge Protection (ME-19) project for the period of record of November 11, 2003, to August 30, 2006.

The shoreline behind the foreshore rock dike experienced a slightly greater average loss per year than the reference area. Because the shoreline survey was conducted one year after Hurricane Rita, this loss could be attributed to storm impacts. The shoreline behind the terraces will be evaluated after the next sampling date. Visual inspection of the lakeside terraces indicates heavy erosion. The *Zizaniopsis miliacea* plantings on the terrace slopes were impacted by sloughing of the soils. There was no evidence of *Echinochloa crus-galli*, that had been seeded on the terraces. It is difficult to attribute the response of the planted and seeded vegetation to the project features, instead, due to storm impacts.

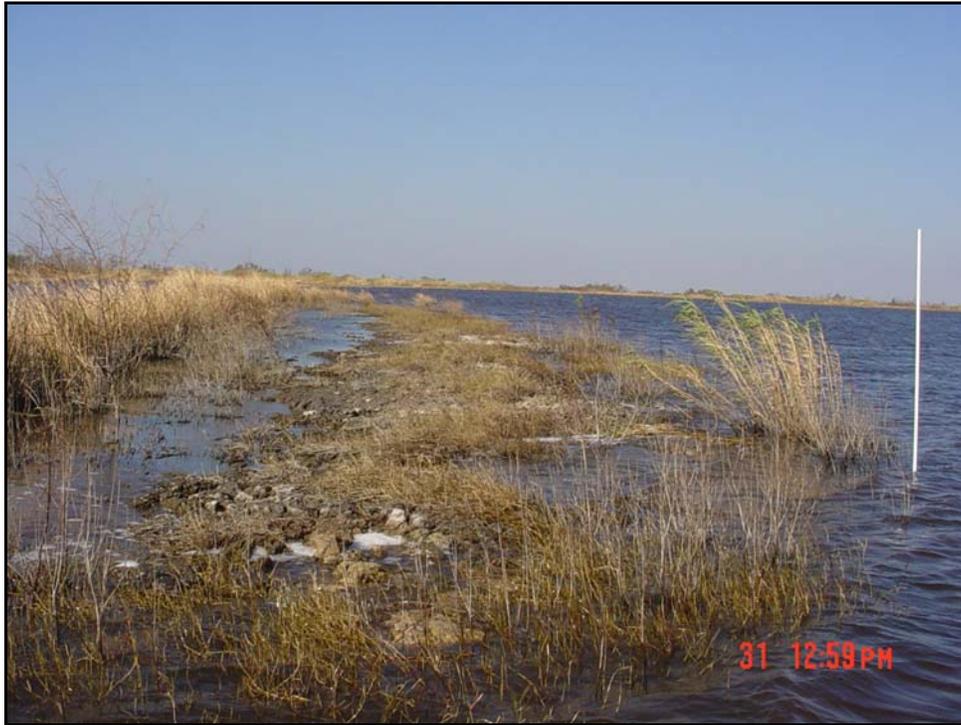
Species occurrence on terraces between years were plotted in figure 7. *Zizaniopsis miliacea*, which was planted on the terrace slopes, decreased in occurrence from 2004 to 2005. *Paspalum vaginatum*, which was planted on the terrace crowns, increased in occurrence over time. Weifenbach and Sharp (2006) reported an increase in *Paspalum* species in all marsh types in southwestern Louisiana post-Hurricane Rita. *Echinochloa crus-galli*, which had been seeded on the crown, did not occur in the 2005 sampling. The overall appearance and health of all species present at the 2005 sampling were considered to be stressed and adversely affected by Hurricane Rita (figures 8 and 9).

**Figure 8.** Photo of monitored terrace; taken October 31, 2005.

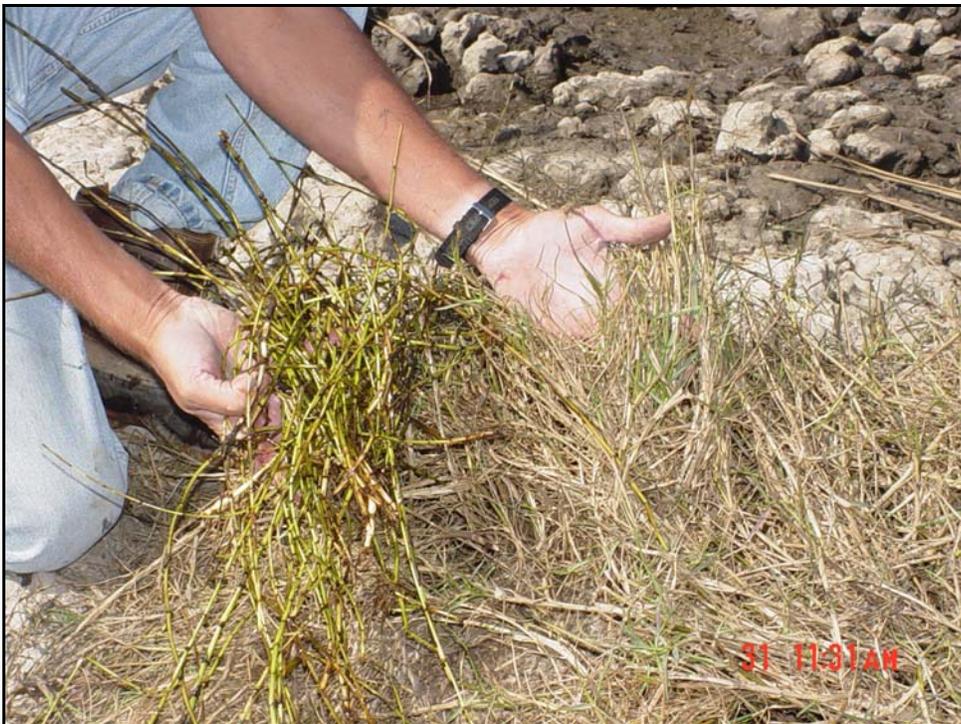
**Figure 9.** Photo of planted *Paspalum vaginatum* planted on crowns of terraces; taken October 31, 2005.

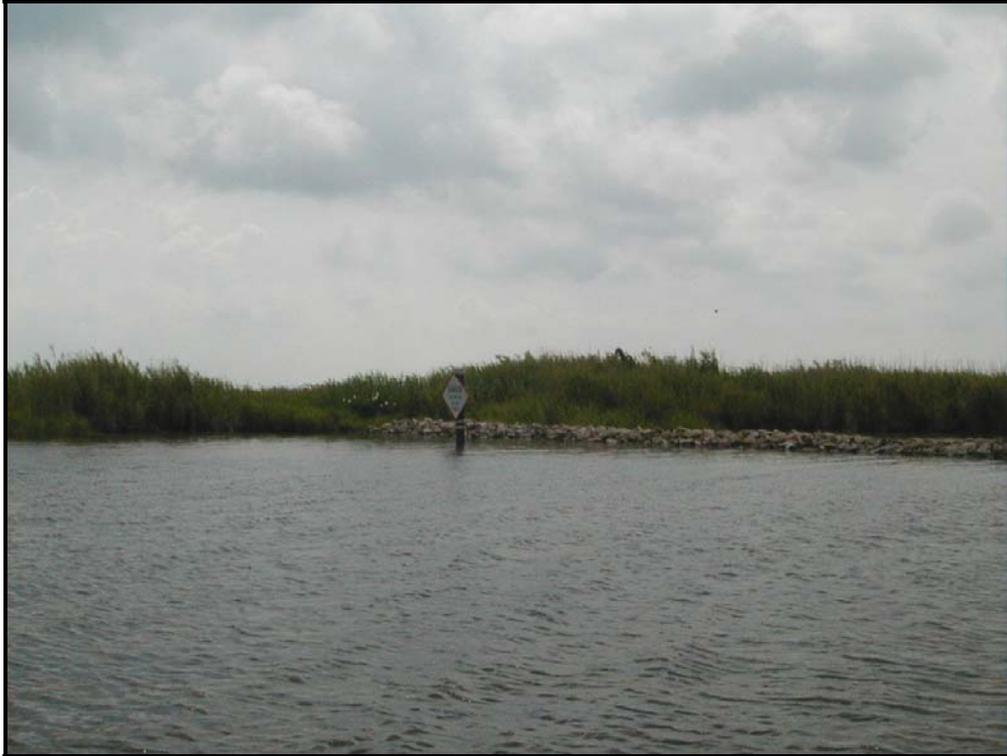
The foreshore rock dike feature is in excellent condition. No maintenance is required at this time. (Photos: Appendix B, Photos 1 and 2)

Photo 1, Typical rock dike.

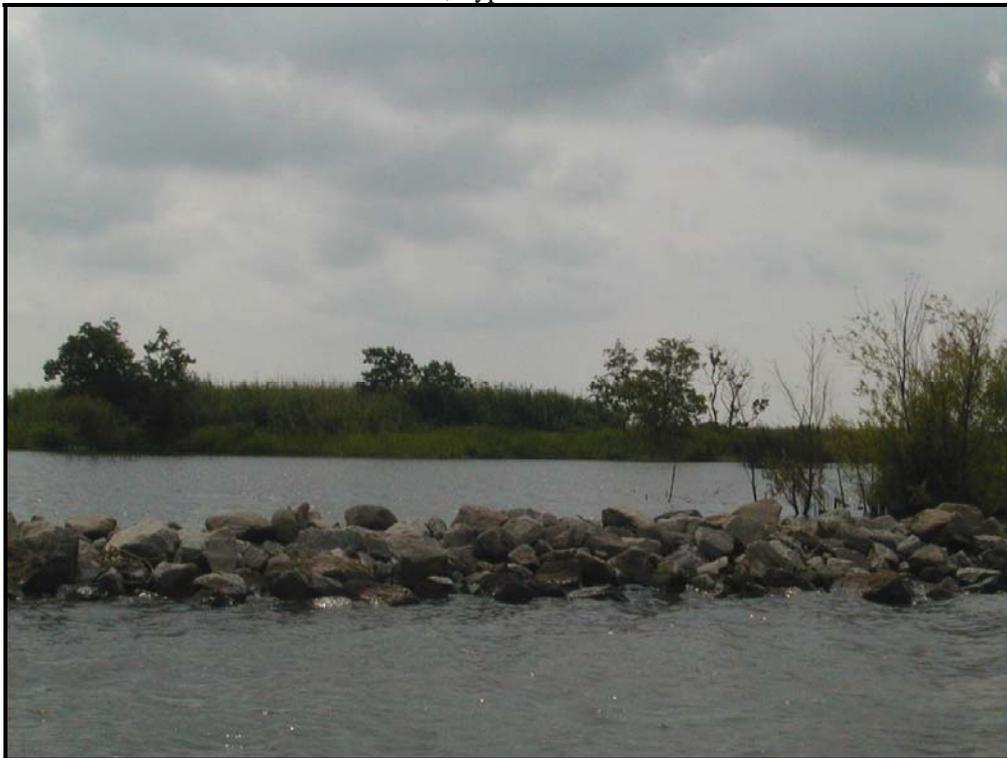
Photo 2, Rock foreshore dike.

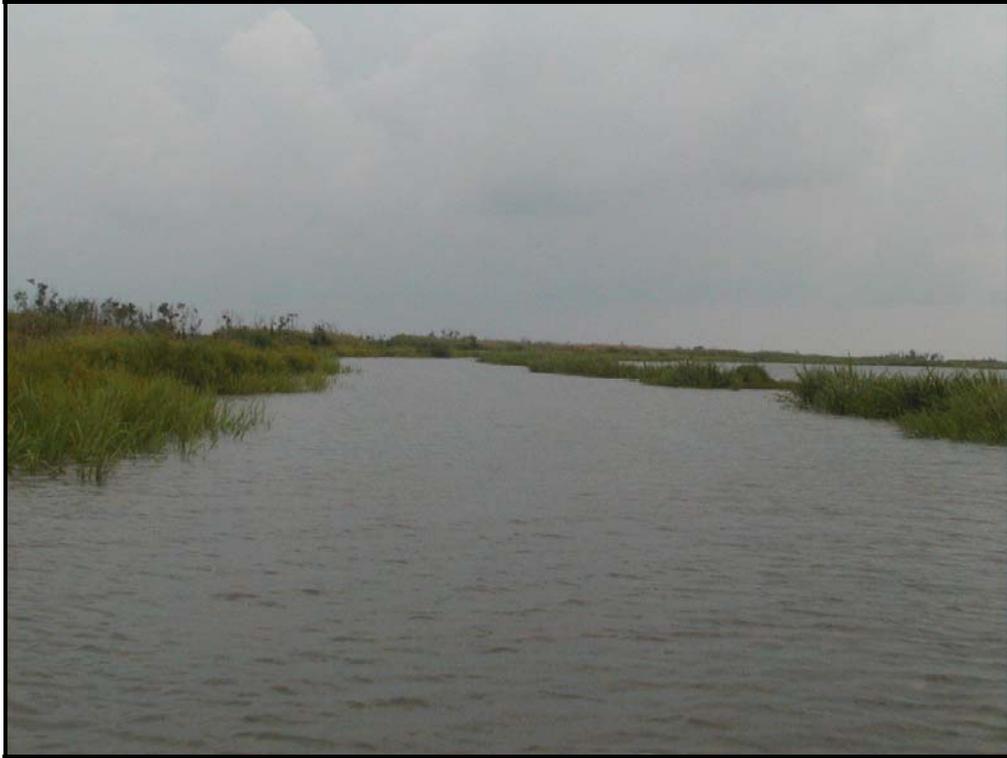
Marsh side and lake side earthen terraces along Collicon Lake continue to experience erosion, with the lake side sacrificial terraces being more severe. Original giant cutgrass plantings along the marsh side terraces were visible. (Photos: Appendix B, Photos 3 and 4)

Photo 3, Earthen terraces.

Item	Condition	Physical Damage	Corrosion	Photo #	Observations and Remarks
Steel Bulkhead / Caps	N/A				
Steel Grating	N/A				
Stop Logs	N/A				
Hardware	N/A				
Timber Piles	N/A				
Timber Wales	N/A				
Galv. Pile Caps	N/A				
Cables	N/A				
Signage / Supports	N/A				
Rip Rap (fill) Rock Dike	Good			1 & 2	Rock dike is in very good shape.
Earthen Terraces	Fair			3 & 4	Terraces will require vegetative planting.

Install vegetative plantings on the Collicon Lake terraces.

- Install 5,000 vegetative plantings on the Collicon Lake terraces.

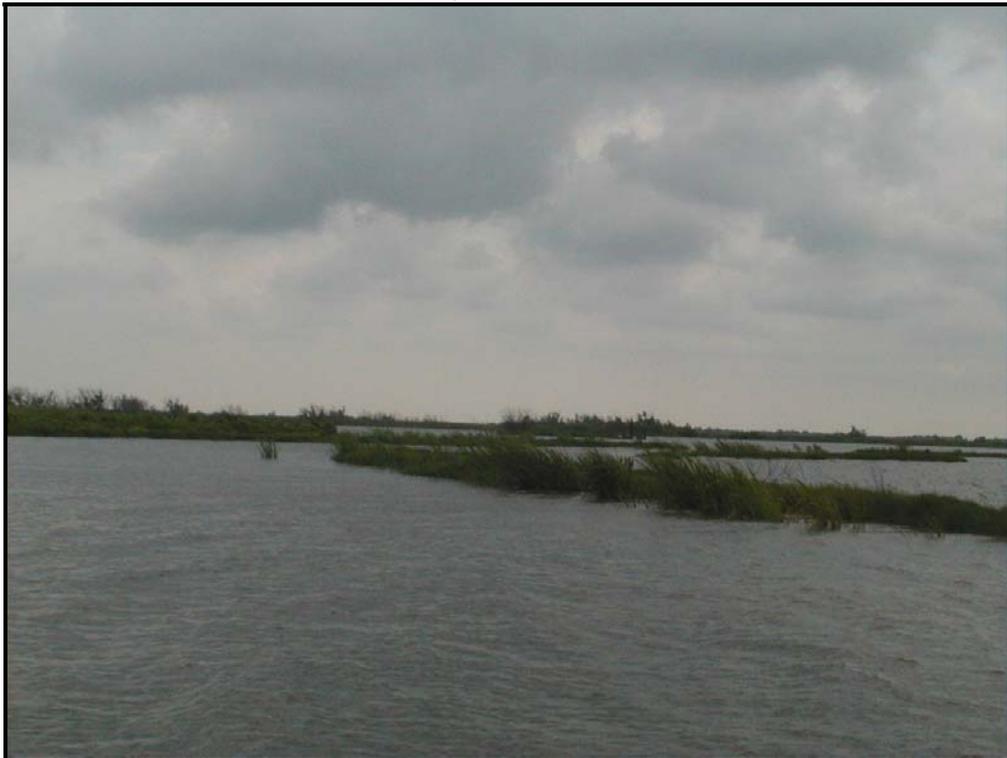
Photo 4, Earthen terraces.
