**2007 Operations, Maintenance,
and Monitoring Report**

**Marsh Island Hydrologic
Restoration**

State Project Number TV-14
Priority Project List 6

August 2007
Iberia Parish

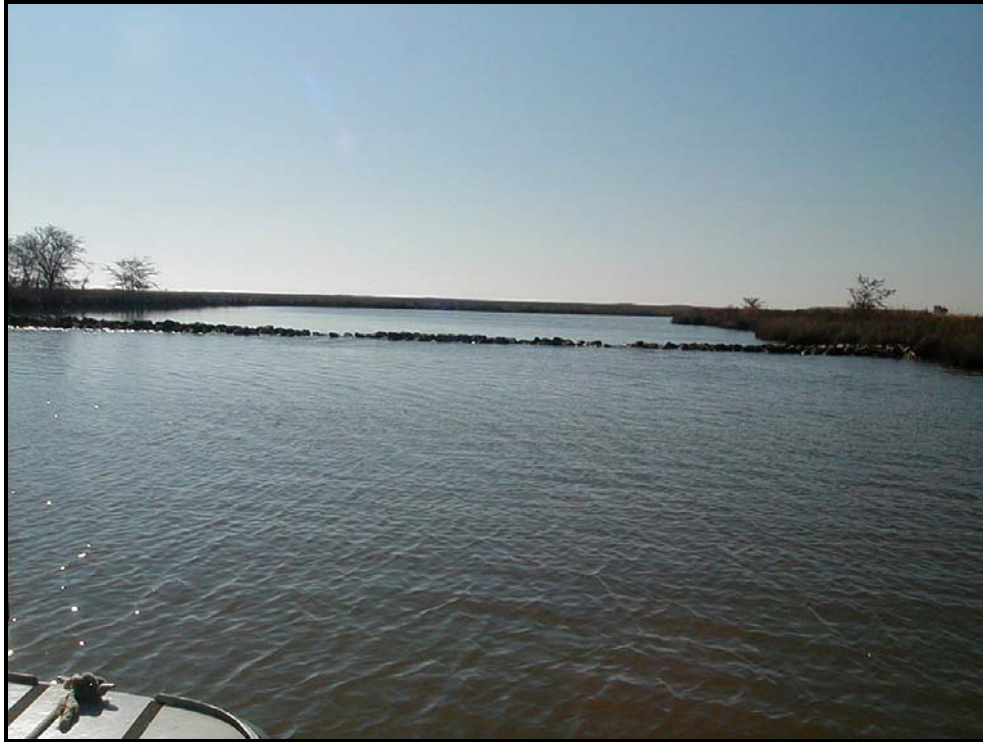
As per the results of the 2006 inspection there is some erosion on each end where the rock plug ties back into the adjacent marsh. Damages were determined to be related to Hurricane Rita. This condition will allow for additional erosion and eventual “flanking” of the canal closure. As a result of the inspection of Closure No. 1, LDNR and COE agree that corrective actions will be required this year. The marsh on each end of the closure should be paved with 15” of 110# stone to make this area “hard” and less subject to erosion and thereby prevent

eventual flanking of the structure. This proposed work is currently included in our maintenance project for repair of Hurricane Rita damages. (Photos: Appendix B, Photo 1).

Photo 1, Closure No. 1. Note low areas of stone in center of structure.

Item	Condition	Physical Damage	Corrosion	Photo #	Observations and Remarks
Steel Bulkhead / Caps	N/A				
Steel Grating	N/A				
Stop Logs	N/A				
Hardware	N/A				
Timber Piles	N/A				
Timber Wales	N/A				
Galv. Pile Caps	N/A				
Cables	N/A				
Signage / Supports	N/A				
Rip Rap (fill)	Good	Minor		1	Some erosion on each end of rock plug, marsh paving will be required to prevent further erosion.
Earthen Embankment	N/A

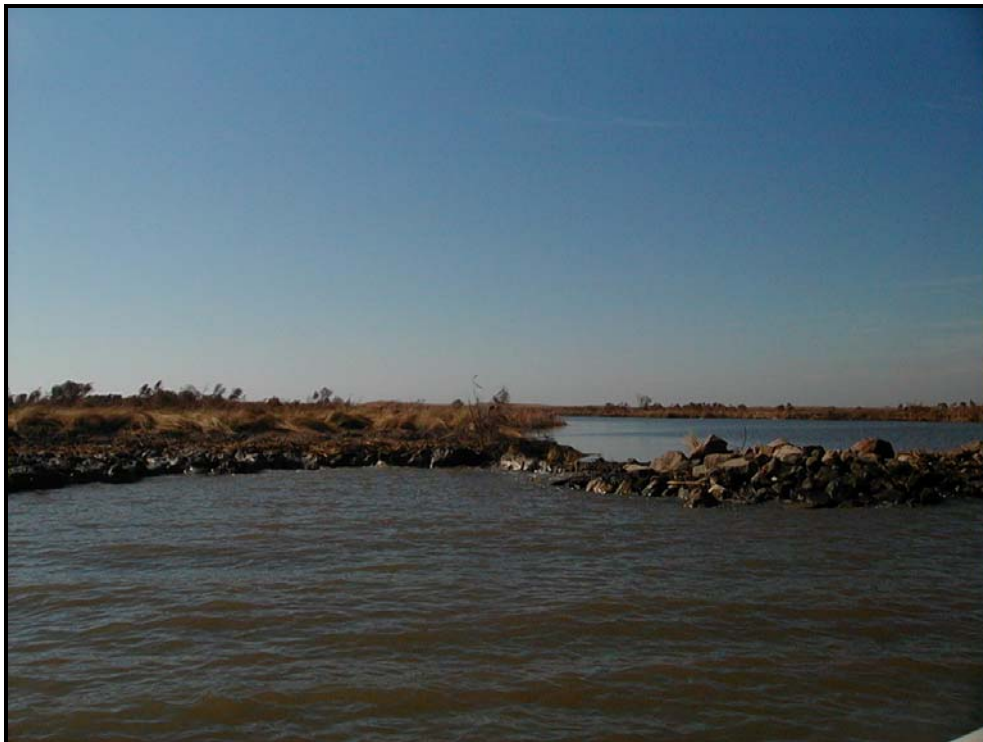
It was observed that extensive erosive damage by Hurricane Rita's surge to each end of the closure had occurred, especially on the east end, where there is now a major "flanking" cut that allows a water connection to the bay. The original rock structure that was constructed is still in good condition. LDNR and COE agree that maintenance will be required at this time. The closure dike needs to be extended on the east end to cut off and fill the flanking channel that was caused by Hurricane Rita. On the west end, the area that suffered erosion needs to be adjusted with some new stone paving. As a preemptive effort, the "new" ends of the closure dike should be paved and made "hard" as described for Closure No. 1. (Photos: Appendix B, Photo 2).

Photo 2, Closure No. 2. View showing “flanking” cut on east end.

Item	Condition	Physical Damage	Corrosion	Photo #	Observations and Remarks
Steel Bulkhead / Caps	N/A				
Steel Grating	N/A				
Stop Logs	N/A				
Hardware	N/A				
Timber Piles	N/A				
Timber Wales	N/A				
Galv. Pile Caps	N/A				
Cables	N/A				
Signage / Supports	N/A				
Rip Rap (fill)	Fair	Moderate		2	Some erosion on east end of rock plug, marsh paving will be required to prevent further erosion. A flanking cut has occurred on the west end of the plug and will need to be extended.
Earthen Embankment	N/A

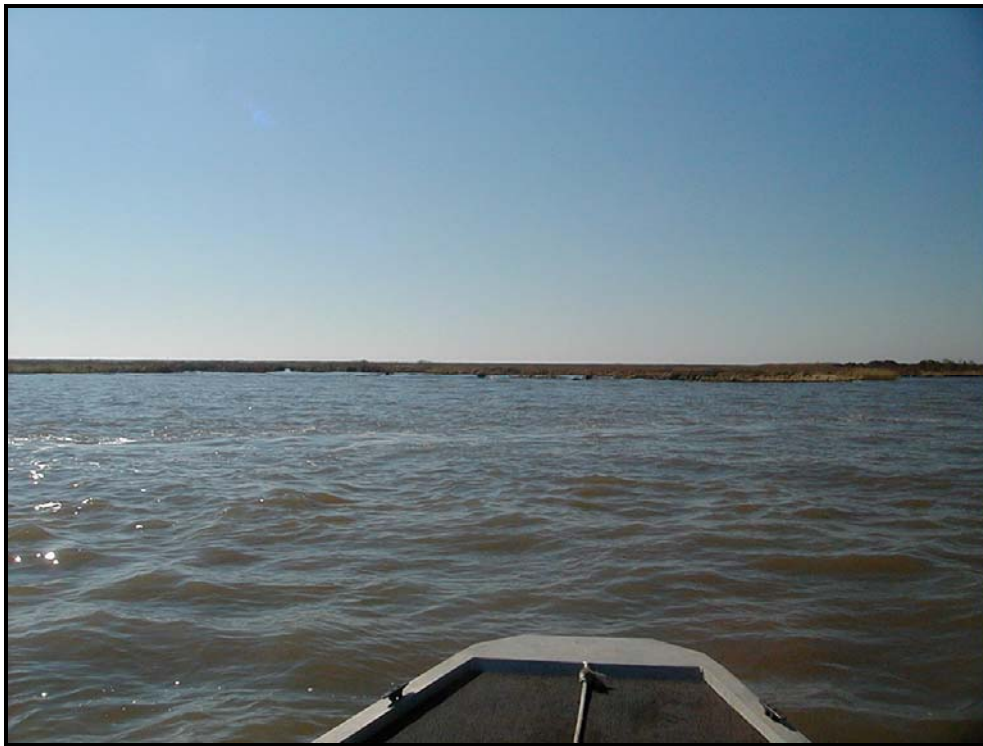
The rock closure dike appears in good condition and the stone appears to not have suffered major displacement. Also, it was observed (and confirmed with aerial photography post-Hurricane Rita) that a large open water area has developed within the marsh near the western terminus of Closure No. 3 and that the bankline between that point and the eastern end of Closure No. 2 has eroded very severely. These developments are such that the "landbridge" between Vermilion Bay on the north of Marsh Island and the northwestern portion of Lake Sand proper is now narrow and may become subject to breaching, thus allowing an undesirable water connection between the two bodies of water. LDNR and COE agree that this area is in poor condition and should be considered for maintenance at this time. It is recommended that an additional reach of shoreline protection dike be constructed, an estimated 1,500 to 1,800 linear feet, to connect the western end of Closure No. 3 to the eastern end of Closure No. 2. This reach of bank has been recently surveyed, and once an evaluation and cost data is developed, LDNR and COE will decide upon corrective action to be taken, if any. (Photos: Appendix B, Photos 3 and 4).

Photo 3, Area between west end of Closure No. 3 and east end of Closure No. 2, showing narrow section of marsh requiring shoreline protection.

Item	Condition	Physical Damage	Corrosion	Photo #	Observations and Remarks
Steel Bulkhead / Caps	N/A				
Steel Grating	N/A				
Stop Logs	N/A				
Hardware	N/A				
Timber Piles	N/A				
Timber Wales	N/A				
Galv. Pile Caps	N/A				
Cables	N/A				
Signage / Supports	N/A				
Rip Rap (fill)	Good			3 & 4	Hurricane RITA eroded the marsh between Str. No. 2 & 3, leaving a narrow piece of marsh, and it is recommended that the shoreline between Str. 3 & 4 (+/- 1,500 to 1,800 L.F.) be armored with a rock dike.
Earthen Embankment	N/A

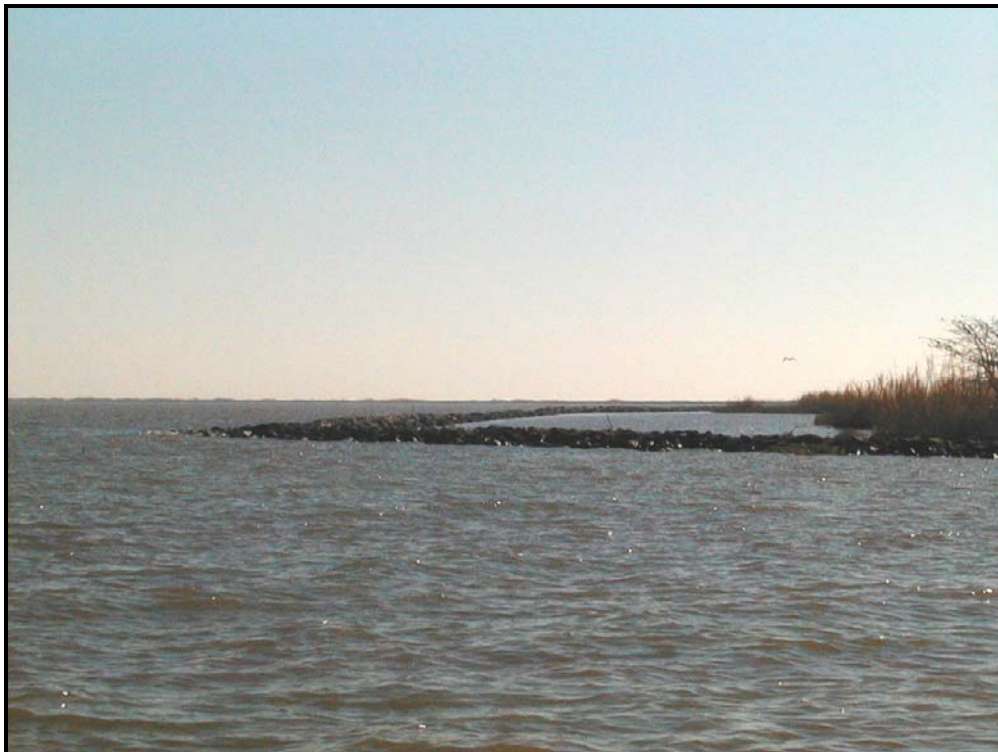
Photo 4, Closure No. 3. View looking east, Lake Sand Dike in the background.

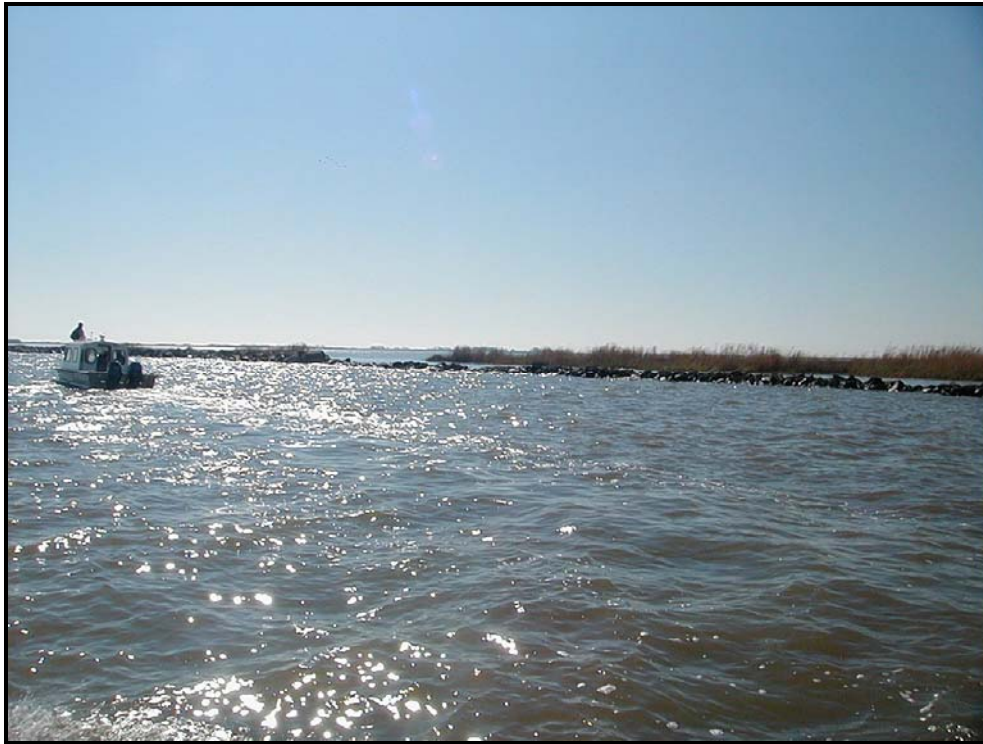
The Lake Sand Dike closure as originally constructed and recently repaired for Hurricane Lili damages, appears in good condition. The stone appears to have not suffered major displacement except for some of the eastern reach where some of the stone, which had existed to +4.0 NAVD88, appears to be a bit low in elevation. This latter reach is several hundred feet in length and the most easterly tie-in bank has been reduced in cross-section for 80 to 100 feet. LDNR and COE agree that this area is deficient and maintenance will be required at some time. The low areas described above in the reach within the old dike that was to +4.0 elevation will need to be restored with rock riprap, though bank protection is still being afforded by the existing stone shoreline protection. (Photos: Appendix B, Photo 5).

Photo 5, East end of Lake Sand Closure No. 4. Note low areas of stone.

Item	Condition	Physical Damage	Corrosion	Photo #	Observations and Remarks
Steel Bulkhead / Caps	N/A				
Steel Grating	N/A				
Stop Logs	N/A				
Hardware	N/A				
Timber Piles	N/A				
Timber Wales	N/A				
Galv. Pile Caps	N/A				
Cables	N/A				
Signage / Supports	N/A				
Rip Rap (fill)	Good	Minor		5	Several hundred feet of the rock dike on the eastern end has been displaced and will need to be restored to constructed height of +4.0.
Earthen Embankment	N/A

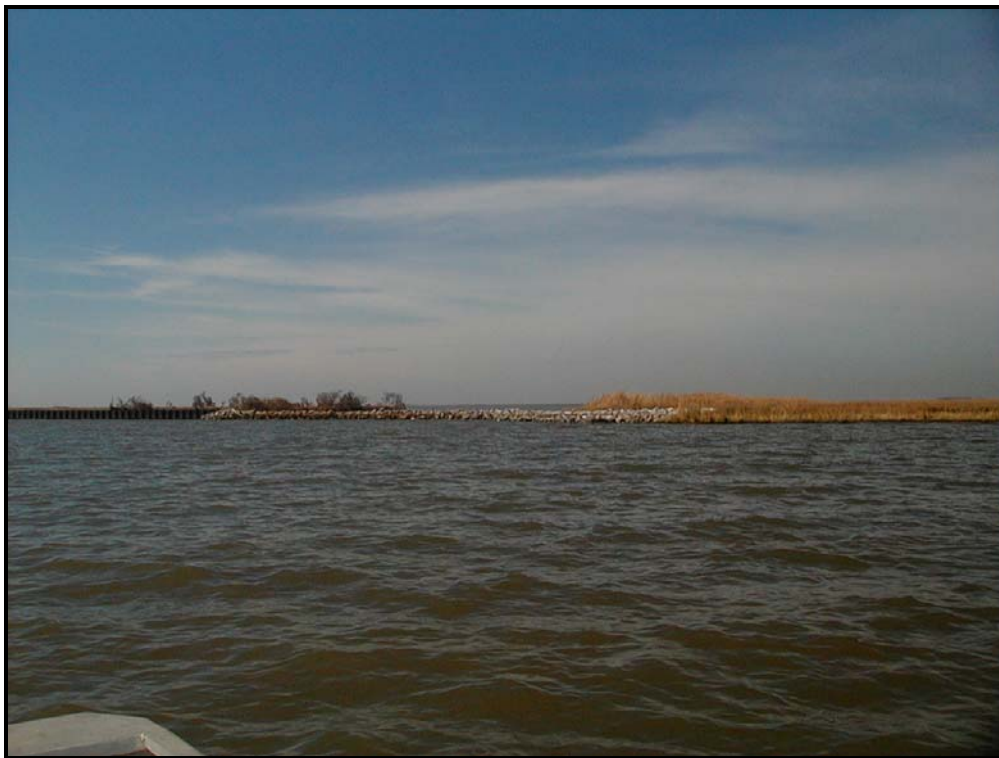
The inspection at Closure No. 5 revealed there had been some degradation of the earthen/marsh areas in the adjacent marsh. The steel sheet pile, rock riprap wingwalls, and stone bank/marsh paving placed as part of the Hurricane Lili repair project is in good condition and were apparently very effective in preventing additional damage by the erosive action of Hurricane Rita. The staff gauge needs to be re-set and made plumb to provide accurate readings. This work will be a part of a survey effort to be performed within the next year. The overbank marsh areas paved to make same “hard” and paid for with O & M funding need to be continually evaluated for their effectiveness. Marsh overbank areas, especially on the north end of the structure, sustained much erosion in areas not protected by the “hard” paving, such that it is possible that the unpaved area to the north end of the closure may not be wide enough to withstand many more years without experiencing storm-induced breaching. (Photos: Appendix B, Photo 6).

Photo 6, North end of Closure No. 5. View of northern portion of structure and of the repair work post-Hurricane Lili prior to Hurricane Rita landfall.

Item	Condition	Physical Damage	Corrosion	Photo #	Observations and Remarks
Steel Bulkhead / Caps	N/A				
Steel Grating	N/A				
Stop Logs	N/A				
Hardware	N/A				
Timber Piles	N/A				
Timber Wales	N/A				
Galv. Pile Caps	N/A				
Cables	N/A				
Signage / Supports	N/A				
Rip Rap (fill)	Good			6	Staff gage leaning, needs to be re-set. Marsh overbank area on the north needs to be evaluated for possible extended marsh paving.
Earthen Embankment	N/A

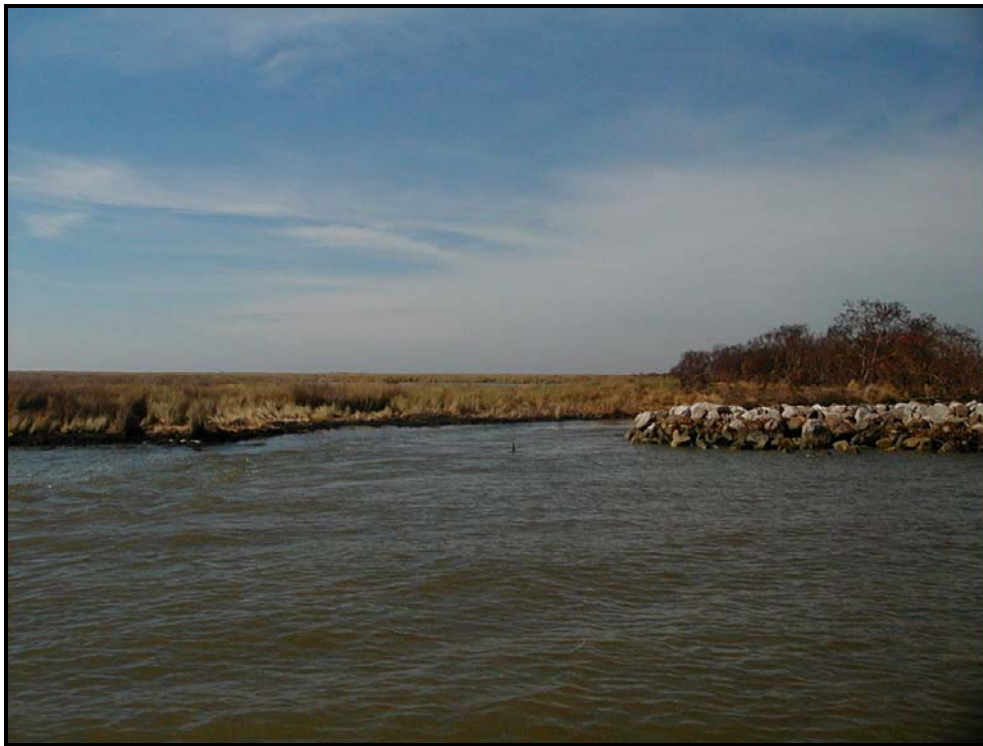
The initially constructed closure at this site still has an excellent cross-section, but the breach on the south end of the closure has been enlarged by Hurricane Rita. The repair of same is included in an upcoming maintenance contract currently being developed. (Note: the breach was discovered approximately one month prior to Rita and was narrow and about two feet in depth). The breach is now larger, post-Rita, and approximately one foot deeper in depth. On the north end of the closure, the erosion of the marsh area was sustained at the dike tie-in location, to an extent that it is predicted that “flanking” of the closure has occurred. LDNR and COE agree that this area is deficient and maintenance will be required at this time. The existing flanking channel cut needs to be plugged off by extending the rock riprap closure to the south with stone. Cost will be shared with the Federal Emergency Management Agency (FEMA) such that a channel breach existed pre-Rita. It is the opinion of this office that the cost-sharing proportions would be equitable if shared at 1/3 State and 2/3 FEMA as the storm event made the pre-existing flanking breach wider and deeper in about those proportions. Also, as a recommended additional preemptive work, each resulting end of the closure dike will be paved and made “hard” per discussion for Closure No. 1. Again this work is currently being designed for a maintenance contract to be performed, once a permit for the work is acquired. (Photos: Appendix B, Photo 7).

Photo 7, Closure No. 6. Note breach on south end of closure stone fill. Breach had begun prior to Hurricane Rita but was not as wide.

Item	Condition	Physical Damage	Corrosion	Photo #	Observations and Remarks
Steel Bulkhead / Caps	N/A				
Steel Grating	N/A				
Stop Logs	N/A				
Hardware	N/A				
Timber Piles	N/A				
Timber Wales	N/A				
Galv. Pile Caps	N/A				
Cables	N/A				
Signage / Supports	N/A				
Rip Rap (fill)	Poor	Major		7	The existing breach on the southern end has increased in size and depth and needs to be plugged. Some erosion on northern end of rock plug which will need marsh paving to harden this area.
Earthen Embankment	N/A

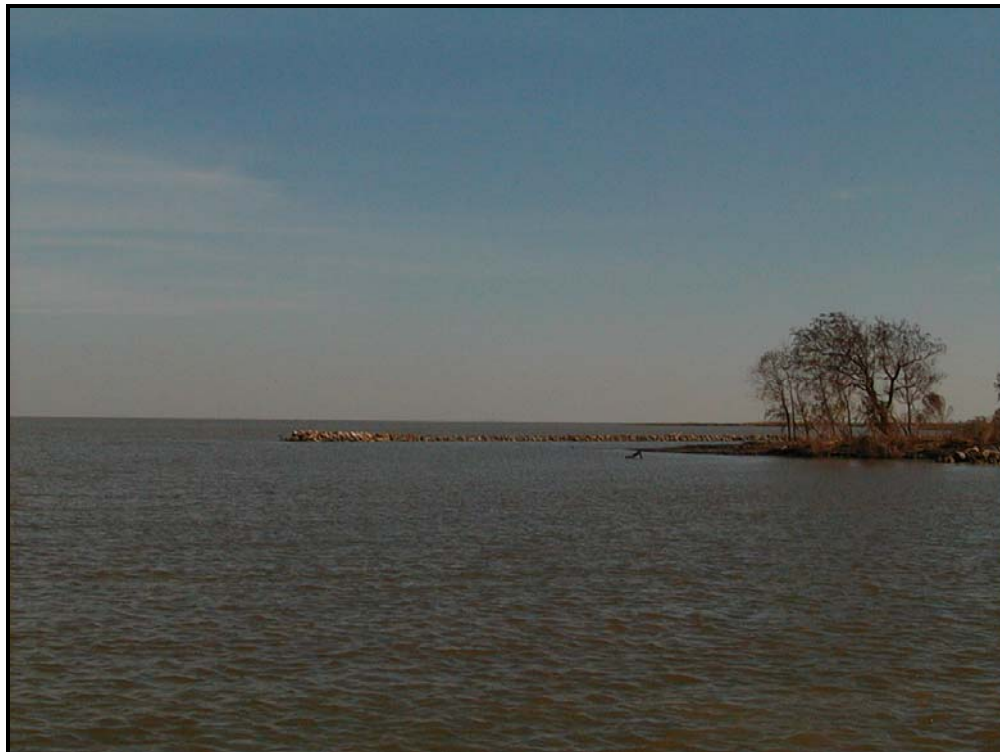
This closure site is in good condition except that the bank areas at both ends of the rock riprap have experienced some minor erosion. The closure tie-ins to the bank, however, appear still adequate at this time. LDNR and COE agree that this area is in good condition and no maintenance will be required at this time. (Photos: Appendix B, Photo 8).

Photo 8, Shoreline protection at Closure No. 7.

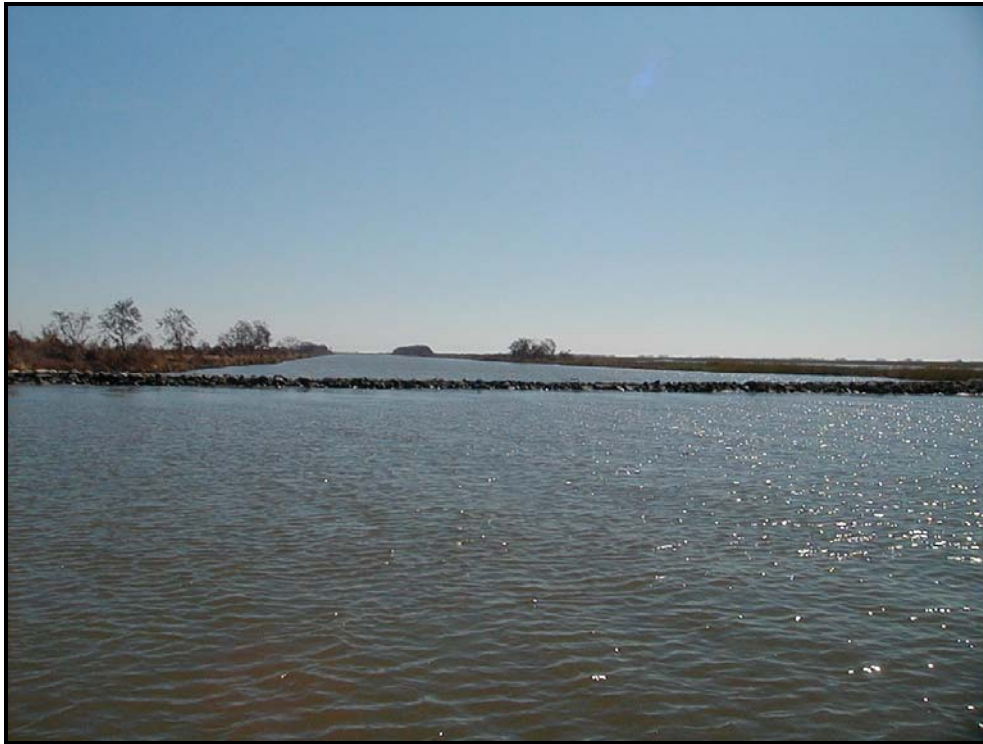
This closure site is in good condition and no damage was noted. LDNR and COE agree that this project feature requires no maintenance at this time. (Photos: Appendix B, Photo 9).

Photo 9, Closure No. 8. View looking east.

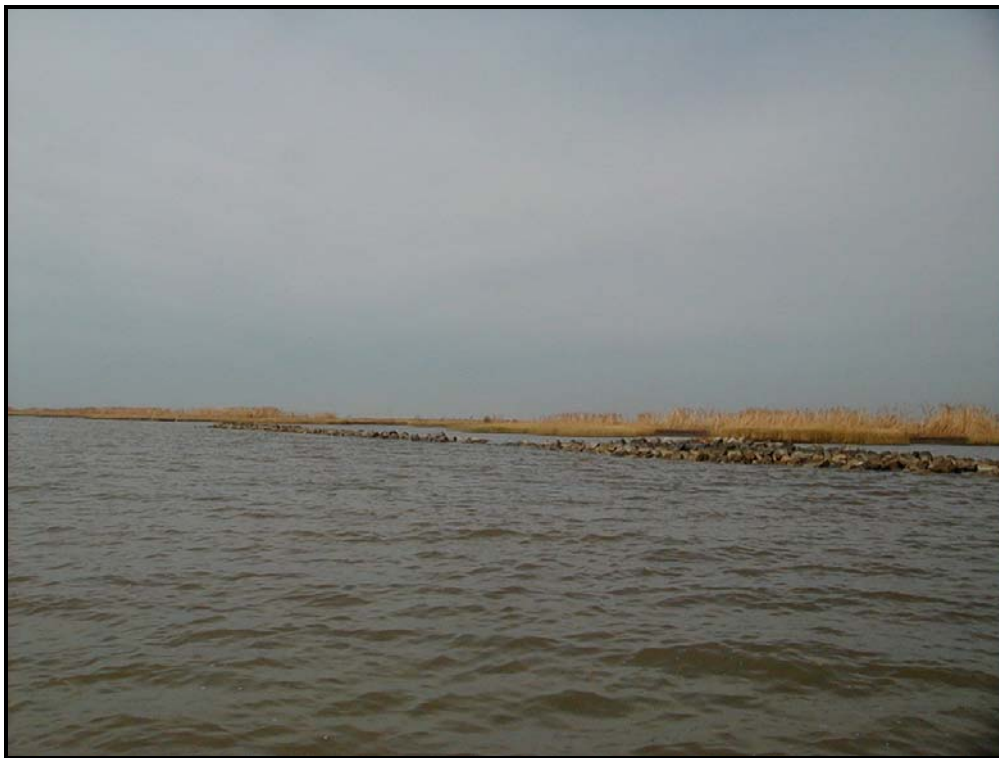
The rock riprap shoreline protection dike constructed on the south shoreline of Marsh Island was noted to now sit out farther into the waters of the Gulf as discussed in the last inspection. Conditions that existed pre-Rita were such that the feature was functioning well and that sediment had accreted and a growth of marsh vegetation had extended over the new fill. This rock shoreline feature will still function as a breakwater and extend the life of the earthen pipeline closure to the north. It was discussed that perhaps each end of the current rock riprap dike be extended to the east and to the west, or perhaps that extensions be constructed on each end of the existing stone to the northwest and northeast alignment directions to the shoreline. Conditions at this location need to be evaluated and a design for some east and west extensions of the current dike concluded after some study. (Photos: Appendix B, Photo 10).

Photo 10, Closure No. 9, along south shore of Marsh Island. Note that shoreline protection dike is now away from the current shoreline post-Hurricane Rita.

Item	Condition	Physical Damage	Corrosion	Photo #	Observations and Remarks
Steel Bulkhead / Caps	N/A				
Steel Grating	N/A				
Stop Logs	N/A				
Hardware	N/A				
Timber Piles	N/A				
Timber Wales	N/A				
Galv. Pile Caps	N/A				
Cables	N/A				
Signage / Supports	N/A				
Rip Rap (fill)	Poor	Moderate		10	Hurricane RITA has eroded the marsh/sediment behind the rock plug and has exposed the earthen keyway to further erosion. The rock dike needs to be extended on each end and tie back into existing shoreline.
Earthen Embankment	N/A
