**State of Louisiana
Office of Coastal Protection and
Restoration**

2009 Annual Inspection Report

**GIWW/ CLOVELLY HYDROLOGIC
RESTORATION**

State Project Number BA-02
Priority Project List 1

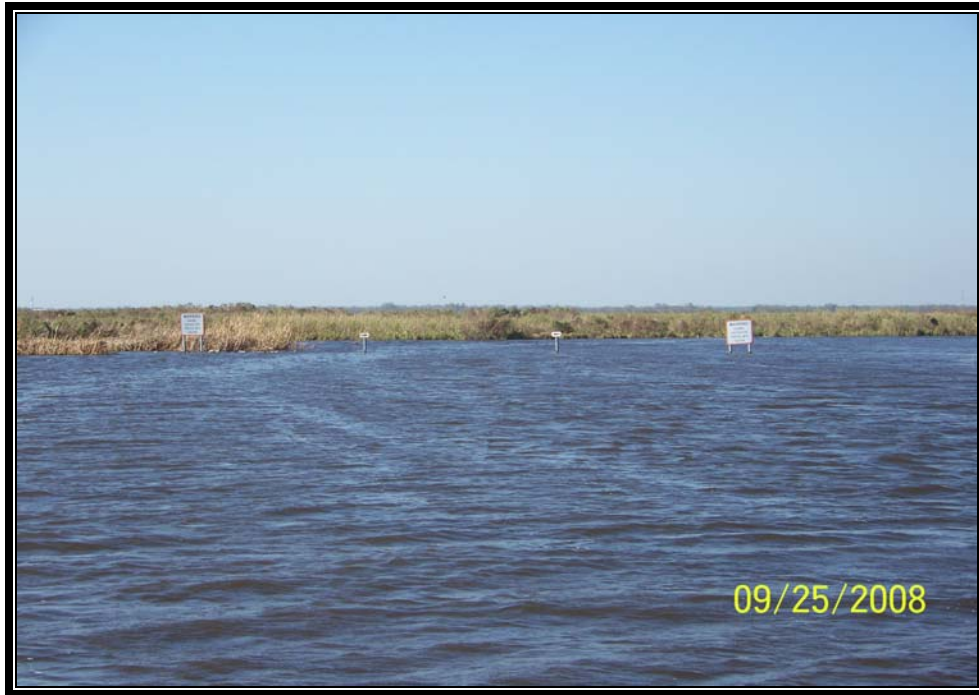
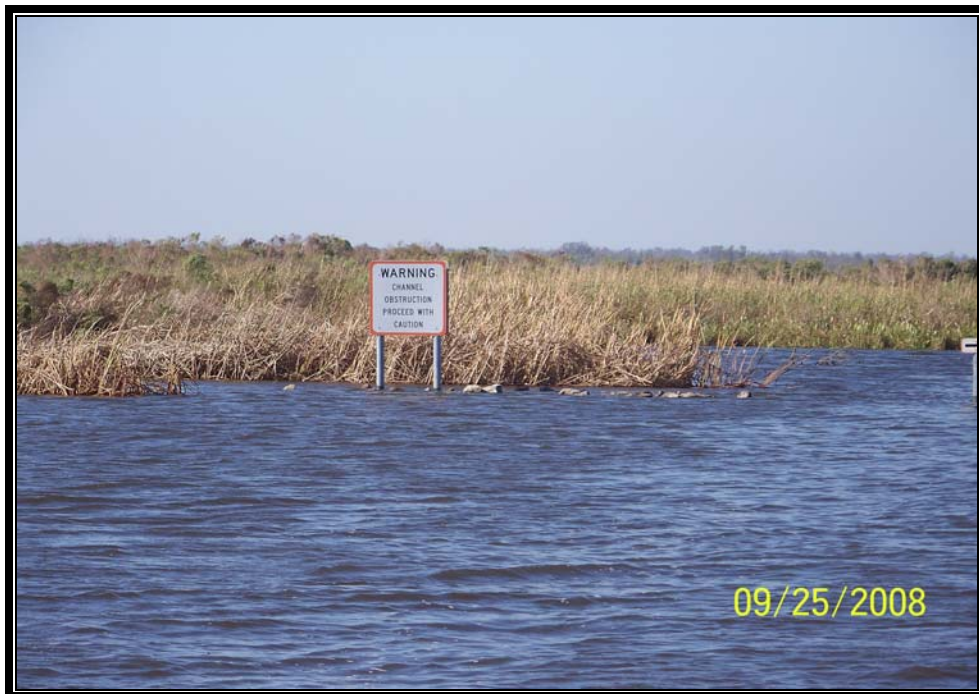
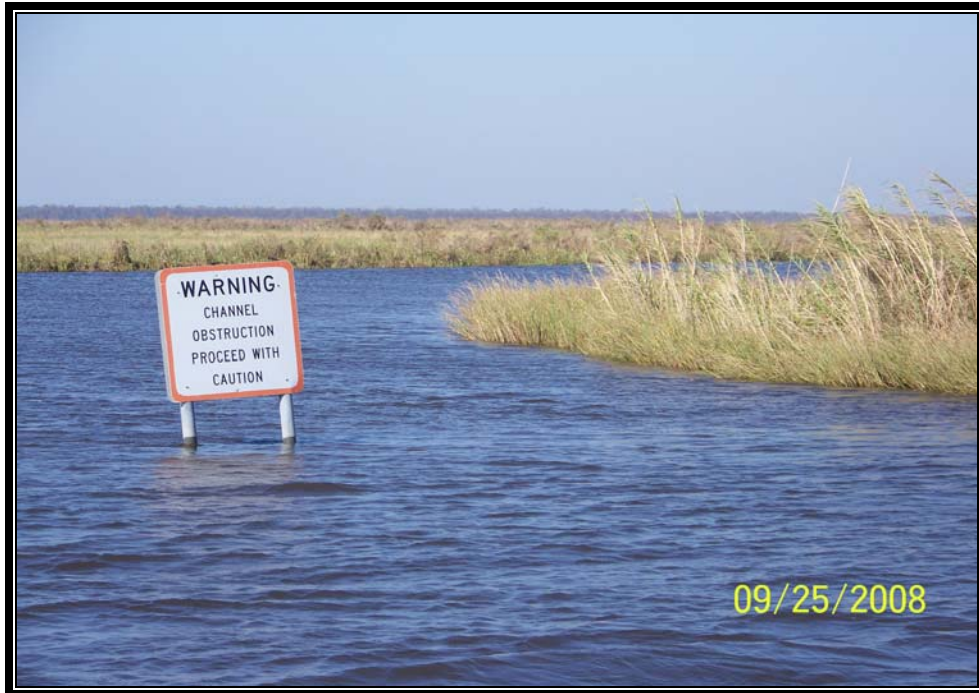
Photo No. 1 – View of fixed crest weir section with boat bay (Structure No.2)

Photo No.2 – view of the weir crest section on the south side of boat bay of Structure No.2.

Photo No. 3 – view of weir crest section on the north side of boat bay of Structure No.2

Structure No.2 was found to be in fair condition with approximately 4' of settlement within the boat bay section. We are recommending that the boat bay section and fixed crest sections be raised to the original constructed elevations using rock riprap. Due to shallow condition at the mouth of the channel near Bay L' Ours, access dredging may be required to facilitate the refurbishment of Structure No.2. Detailed itemized construction costs are shown in the budget worksheet in Appendix C.

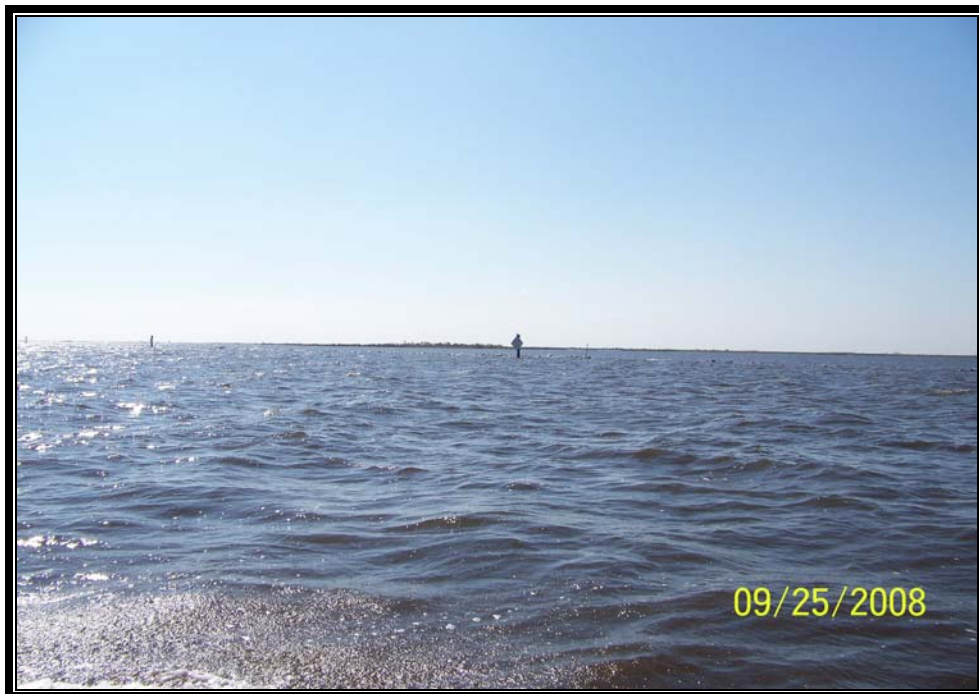
Photo No. 4 – view of rock dike structure along lake rim of Bay L' Ours south of Structure No.2.

As indicated in the inspection results and on previous inspections, a large portion of the rock dike along the lake rim has settled below the constructed crest elevation. From depths reading taken at random locations on the lake side of the structure, it was determined that access dredging is unlikely since depths appear to be adequate to float barges during construction. The method of repair includes recapping the foreshore rock dike with rip rap along entire length of the structure to the original design elevation. Detailed construction costs are outlined in the budget worksheet under Appendix C.

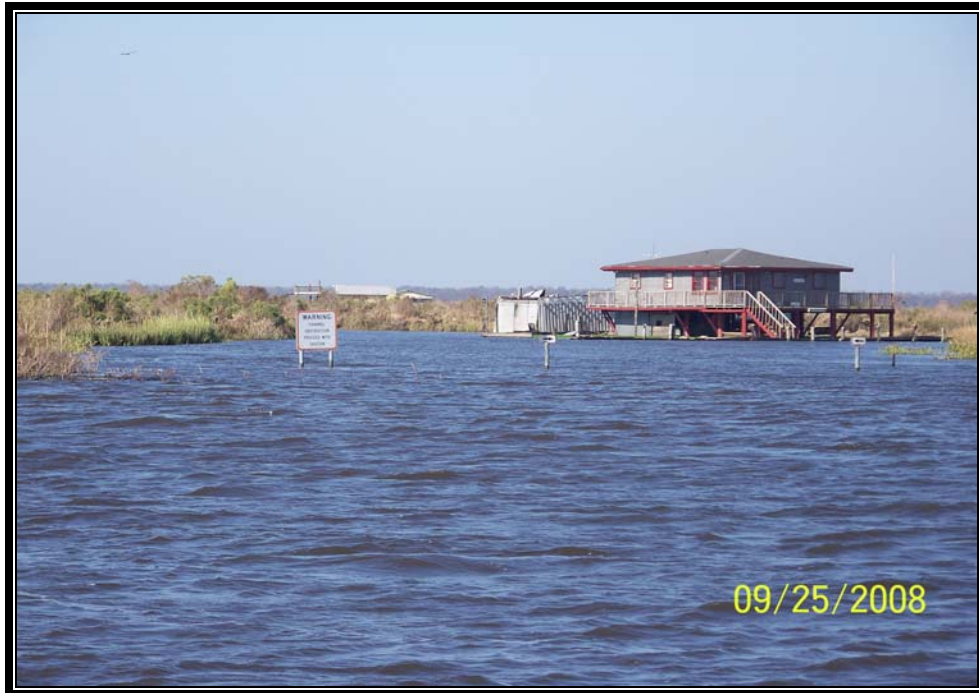
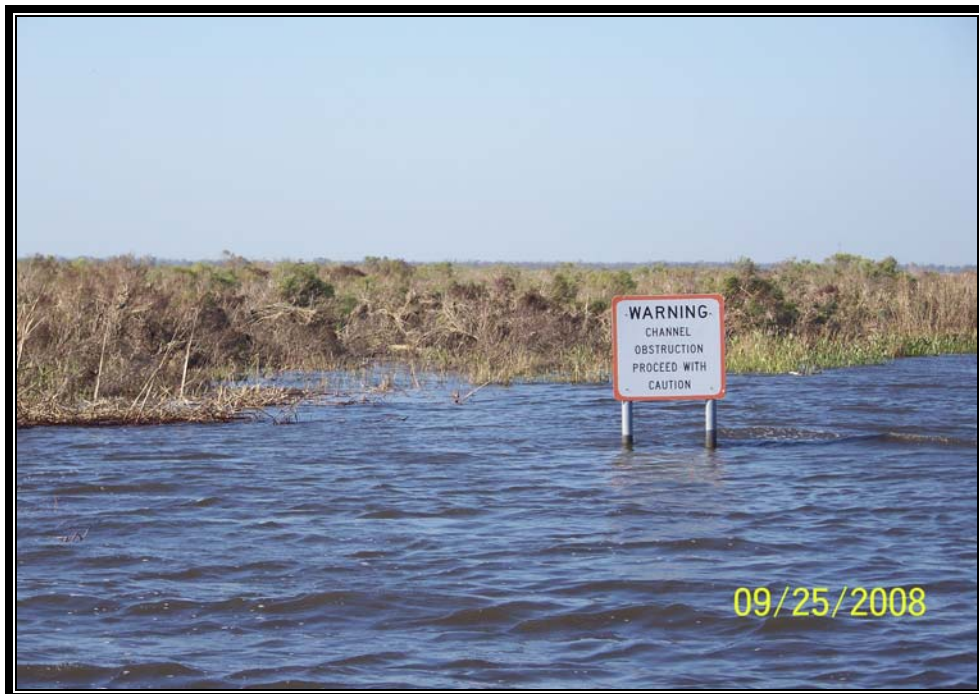
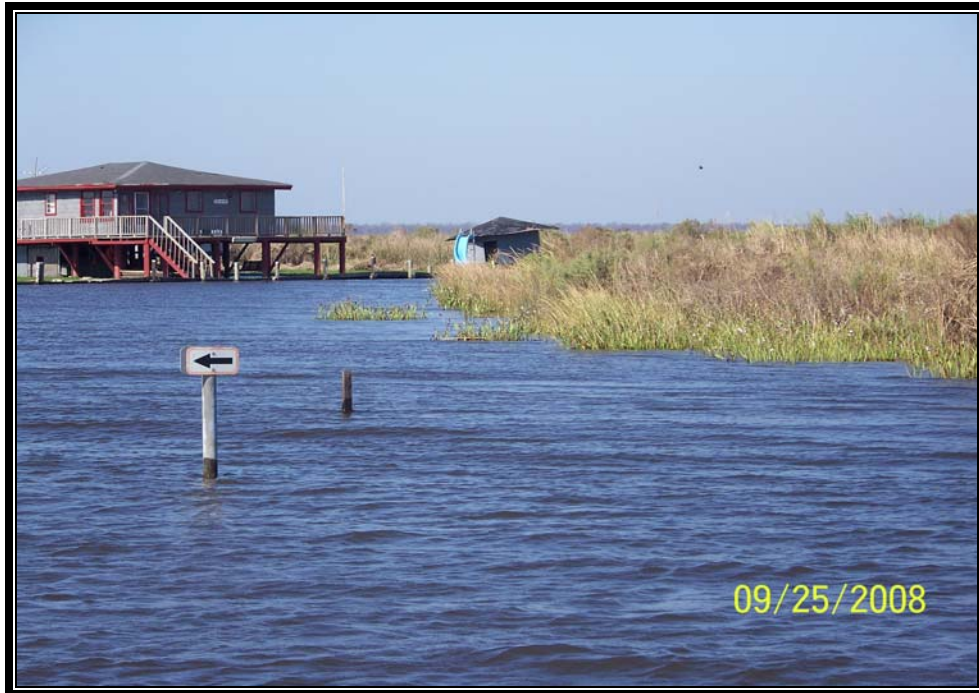
structure. Considering the large elevation differences on the south crest, it is apparent that rock structure was displaced from strong currents in the channel rather than settlement or compaction of soils beneath the structure only. The crest of the boat bay was constructed to an elevation of -3.9' NAVD. The most recent elevation data show that the lowest crest elevation of the boat bay is currently at -6.0' NAVD, resulting in a difference of approximately 2.0'. Due to the amount of settlement and displaced rock within the boat bay and southern weir section, it is recommended that Structure 4 be reconstructed to the original design crest elevations. To prevent the obvious displacement of rock material on the south side of the structure, it may be necessary to recap the structure with a larger stone which would minimize displacement during strong current conditions. As reported in previous inspection reports, the warning sign on the north side of the structure was destroyed during Hurricane Katrina and no longer exists. A warning sign on the north side of the structure shall also be replaced. (Appendix B: Photos 5-7). The 2008 survey profile of Structure No.4 plotted over the original as-built section is shown in Appendix D.

Structure No.5 – view of rock weir with boat bay along shoreline of Bay L' Ours (Structure No.4)

Photo No. 6 – view of the southwest end of weir crest of Structure No. 4.

Photo No. 7 – view of the northeast end of weir crest (Structure No.4)

Structure No.4 was found to be in fair to poor condition with severe settlement and/or displacement of the rock material on the south side of the structure and moderate settlement of the rock lining the boat bay and rock weir section on the north side. The warning sign on the north side of the structure was also missing. Recommendation for refurbishing this structure includes refurbishment of rock riprap along the entire structure by raising the crest to original design elevations and installation of a new warning sign. As in the case of Structure No.2, temporary access dredging may be required to complete maintenance of this structure. Detailed itemized construction costs are shown under the budget worksheet in Appendix C.

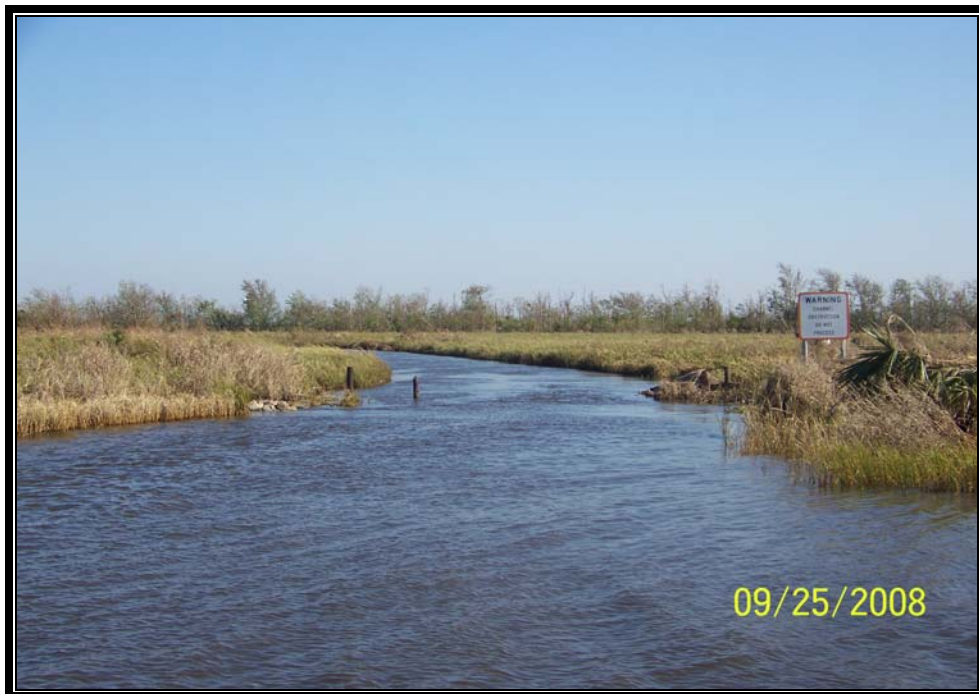
Structure No.7 appeared to be in fair condition with no visual damage to the rock weir. The as-built drawings indicate that the fixed crest rock weir was constructed to elevations of -4.4 NAVD 88 at the boat bay and +2.4' NAVD 88 on the north and south sides, between the bank section and the boat bay. The elevation profile of Structure No.7 in 2008 revealed that the rock weir had settled uniformly throughout with settlement ranging from 1.0' to 1.5'. All signs, supports and earthen embankment tie-ins appear to be in good condition. The settlement of Structure No.7 is considered to be minor and is not recommended for corrective actions at this time. (Appendix B: Photos 8-10). The 2008 survey profile and as-built section of Structure No.7 is shown in Appendix D.

Photo No. 8 – rock weir with boat bay (Structure No.7). Iron gate destroyed during storms.

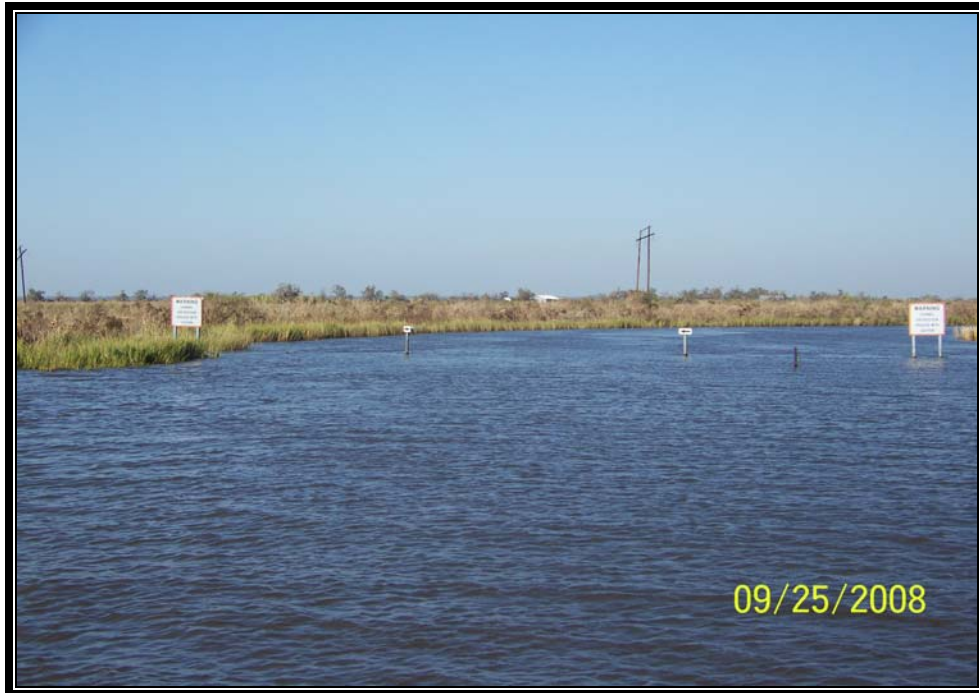
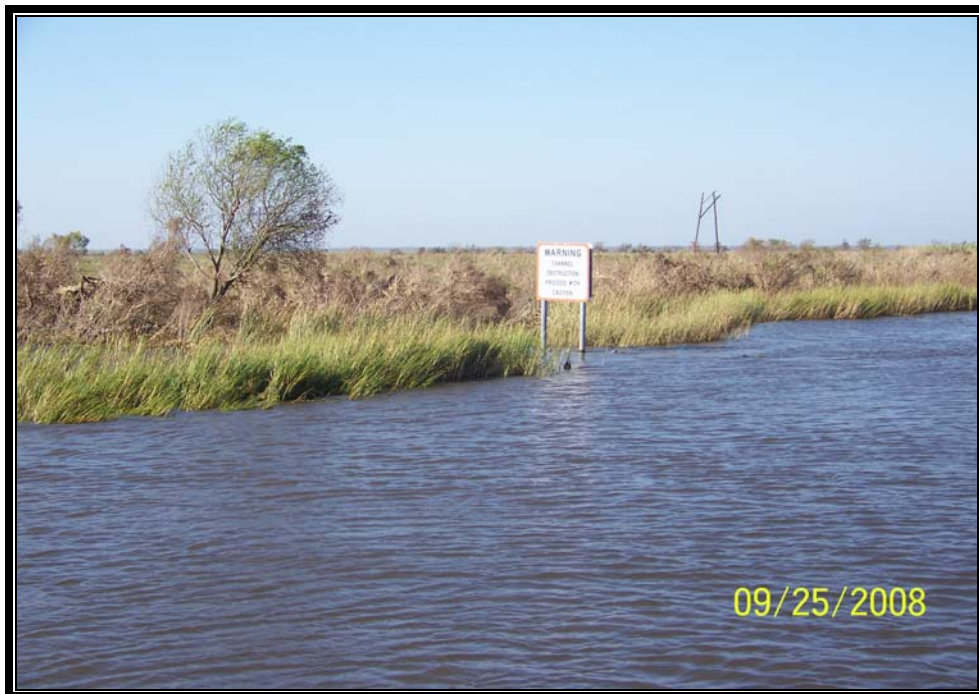
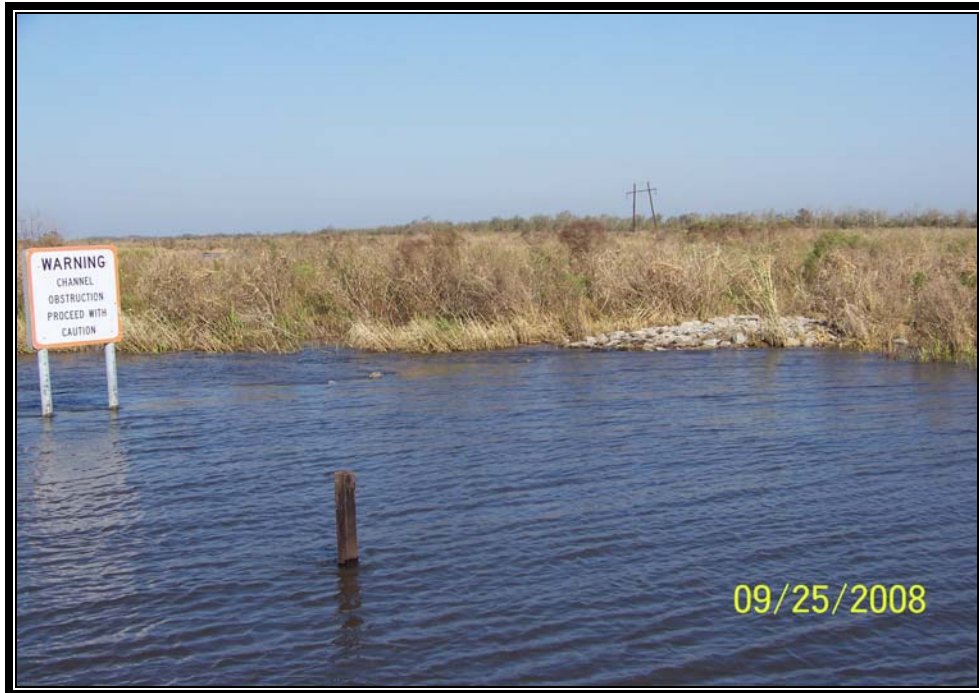
Structure No.8 is a small rock weir with boat bay located on the north side of Structure No.8. A steel gate was also constructed across the opening of the structure to prevent access to the marsh area behind the structure. Structure No.8 was not profiled during the most recent survey completed in 2008. From a visual inspection, rock weir appeared to be in fair condition with no erosion or washouts around the structure. The gate closure constructed across the weir was destroyed by Hurricanes Gustav and Ike and no longer exists. At this time, there are no recommendations for replacement of the steel gate. (Appendix B: Photo 11)

Photo No.9 – Photo of rock weir with boat bay (Structure No.8) looking west.

Photo No.10 – view of south side crest of weir with boat bay (Structure No.8)

Photo No.11 – view of north side crest of weir with boat bay (Structure No.8)

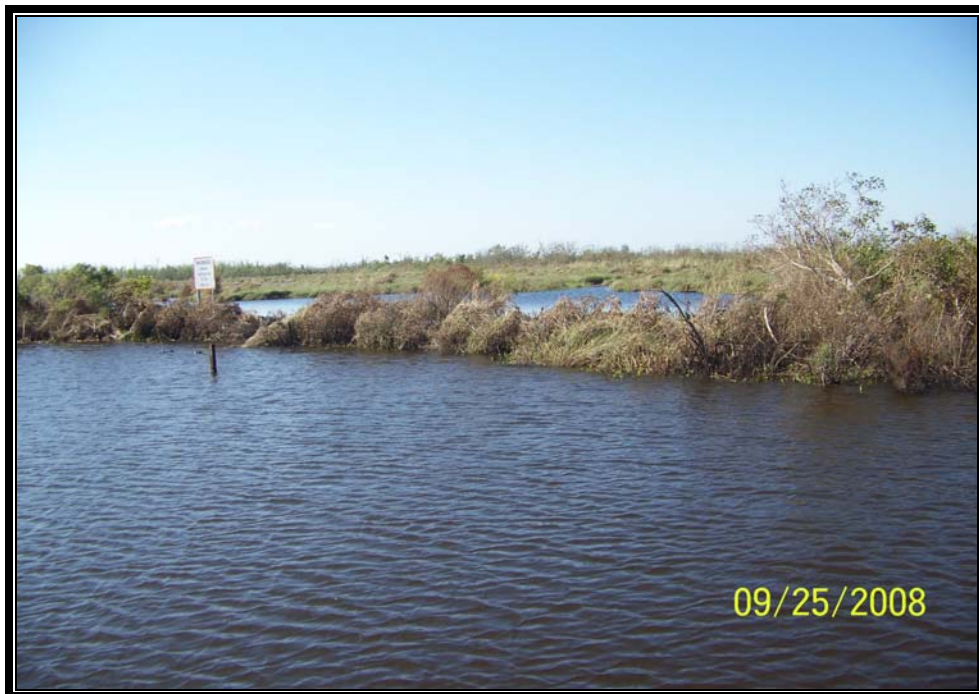
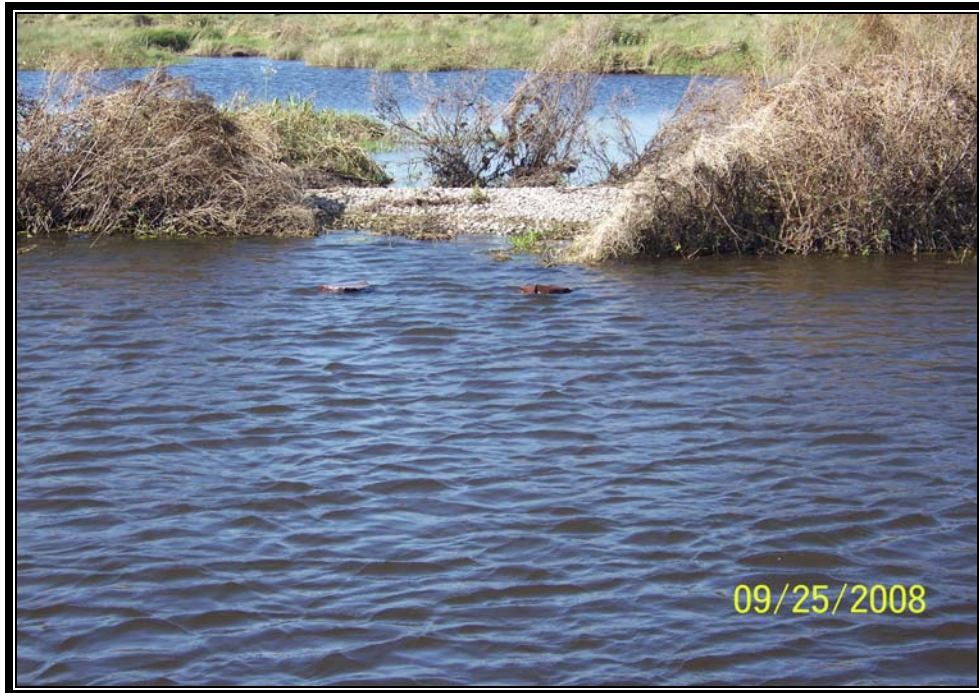
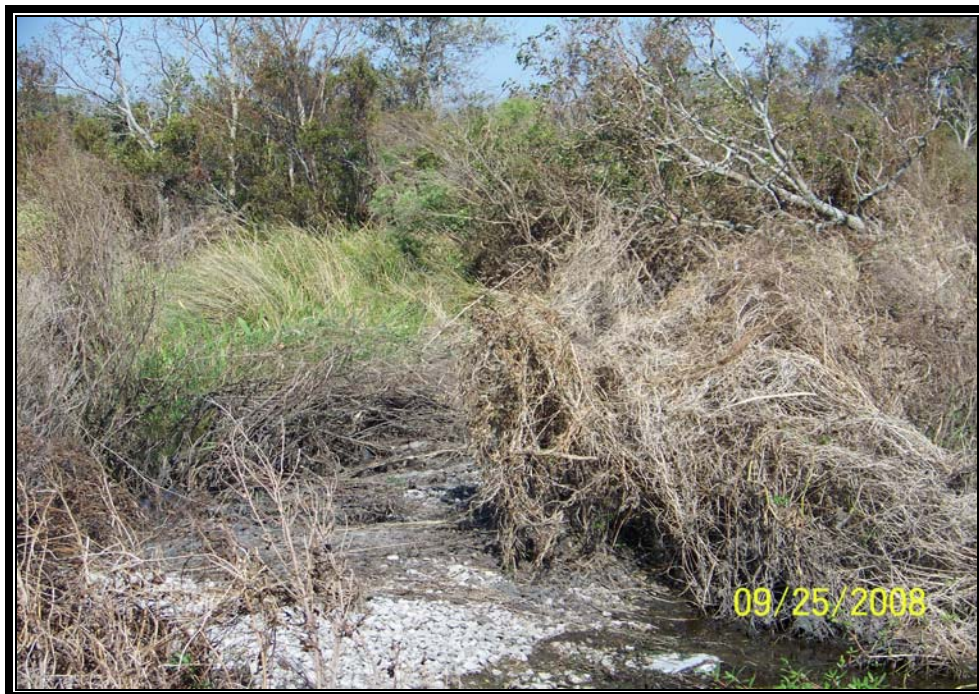
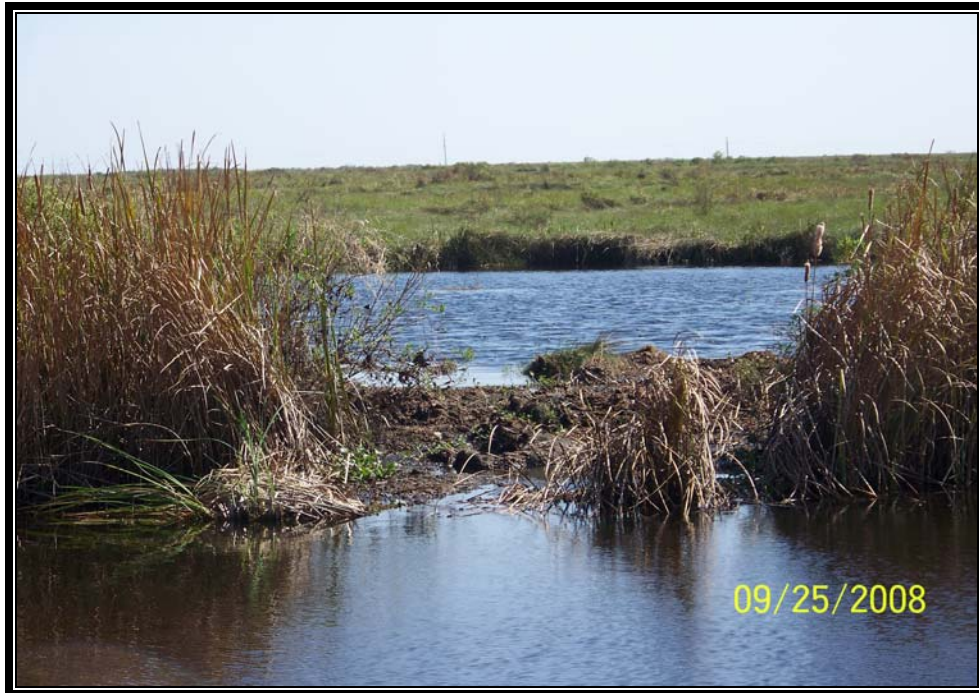
The rock plug structure with flap-gate appeared to be in very good condition with no visible indication of settlement or breaching around the structure. The culvert, flap gate, signs, timber supports and earthen embankments were also in good condition. The sheet metal covering the tops of the timber piles supporting the corrugated metal pipe were rusted and corroded. Although corrosion was present, the tops of the timber piles appeared to be in good condition. We did observe excessive barnacle growth in and around the flap-gated structure below the waterline. The barnacle growth does not appear to be having an adverse affect on gate operations. (Appendix B: Photo 12-15)

Photo No. 12 – view of the rock plug with corrugated culvert and flap gate (Structure No.91) located along a dead-end oilfield canal southwest of Structure No.35.

Photo No. 13 – view of submerged corrugated culvert and flap gate on Structure No. 91.

Photo No. 14 – view along centerline of rock plug w/ culvert (Structure No.91) looking east.

Photo No. 15 – view of low level earthen embankment at the end of and oilfield canal across from Structure No.91.

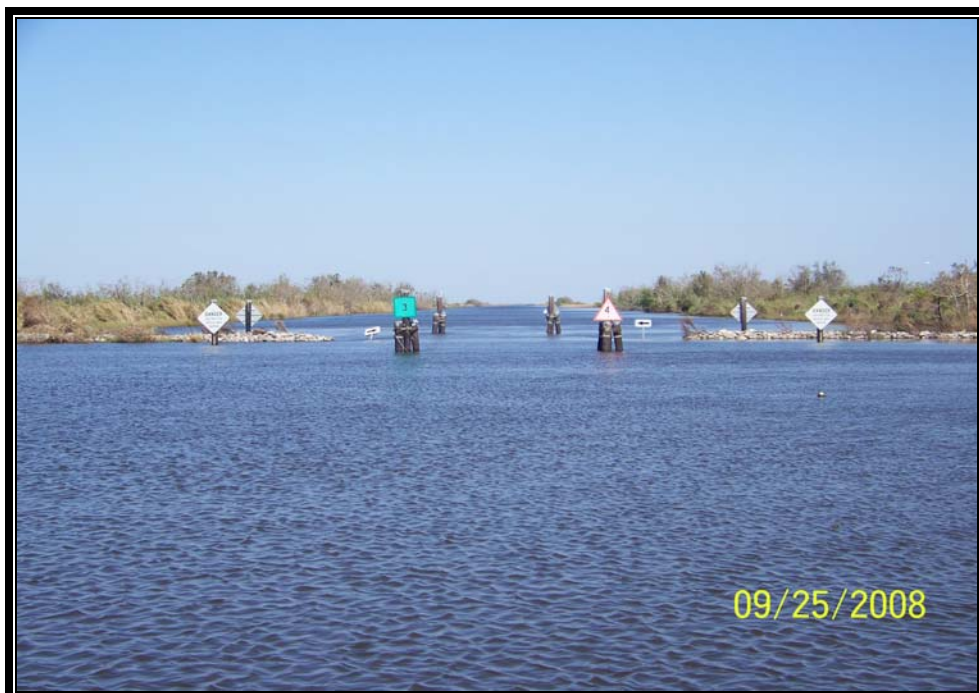
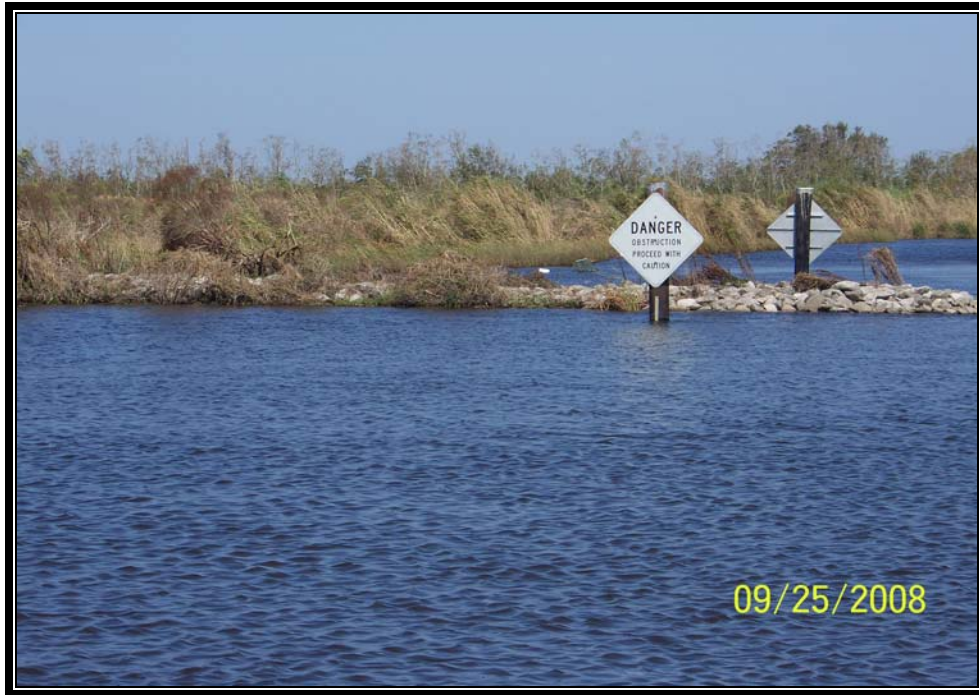
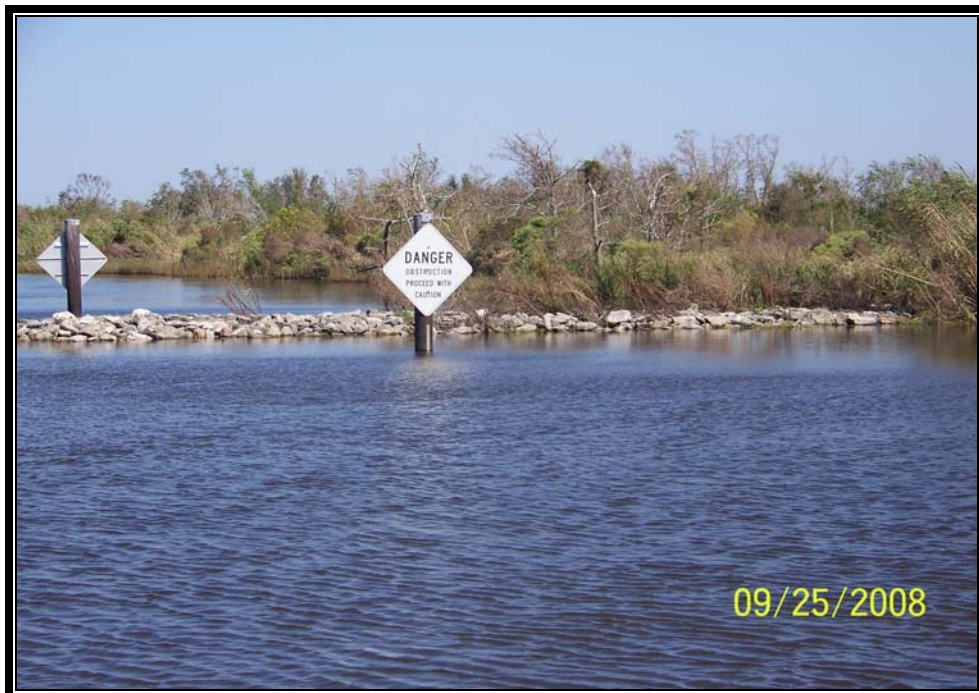
The rock weir with barge bay was in good condition with no apparent settlement. The rock weir was constructed to a -6.4' NAVD 88 at the barge bay and +4.0' NAVD 88 along the crest on each side of the structure between the barge bay and shoreline. Staff gauge readings from a CRMS station just north of the structure indicated a water elevation of 2.10' NAVD 88 at 11:03 a.m. on the date of the inspection. Using the water elevation, we estimated that the rock weir section on both sides of the structure to be approximately +3.5' to 4.0' NAVD 88, reinforcing our observations that no settlement has occurred. Over the years, we have noticed increased damage to the timber piles supporting the warning signs at the entrance to the barge bay. Several vertical piles are split, the batter piles are off center and the surface of all the piles are worn or scarred from vessels rubbing the timbers while accessing the barge bay. To avoid the possibility of structural failure of the timber support piles, we are recommending that the all four (4) timber cluster piles be replaced. It is also recommended that the timber pile structures be moved slightly outward, towards the bank (approximately 1'), to allow for additional clearance for barges to move through the barge bay without interference from the timber pile clusters. (Appendix B: 16-21)

Photo No. 16 – photo of the fixed crest rock weir with barge bay (Structure No.1) looking north.

Photo No. 17 - view of the fixed crest rock weir section on the east side of the barge bay of Structure No.1.

Photo No. 18 - view of the fixed crest rock weir on the west side of the barge bay at Structure No.1

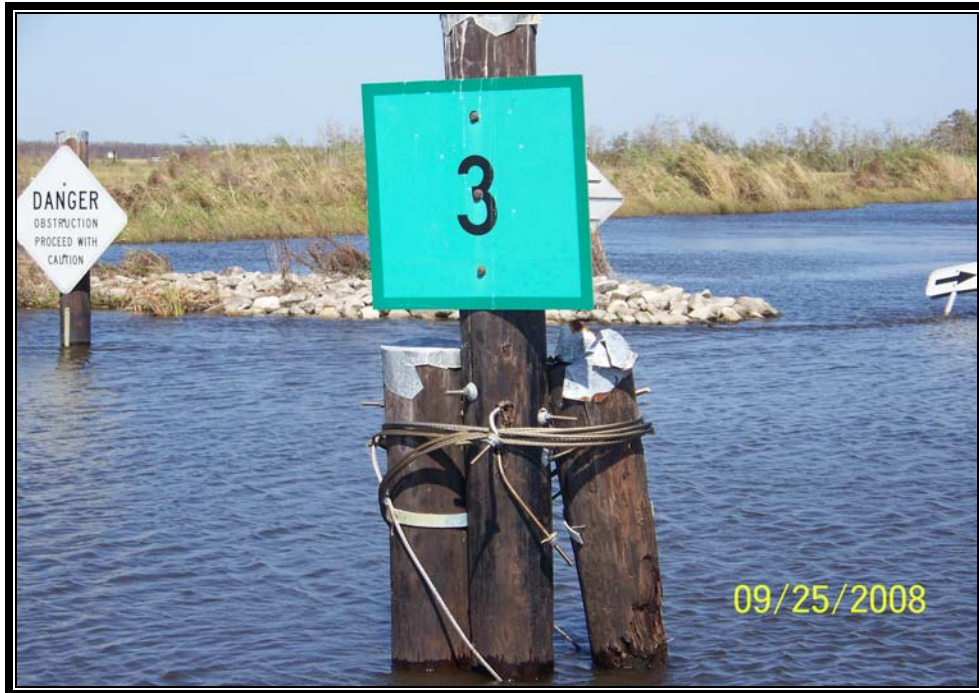
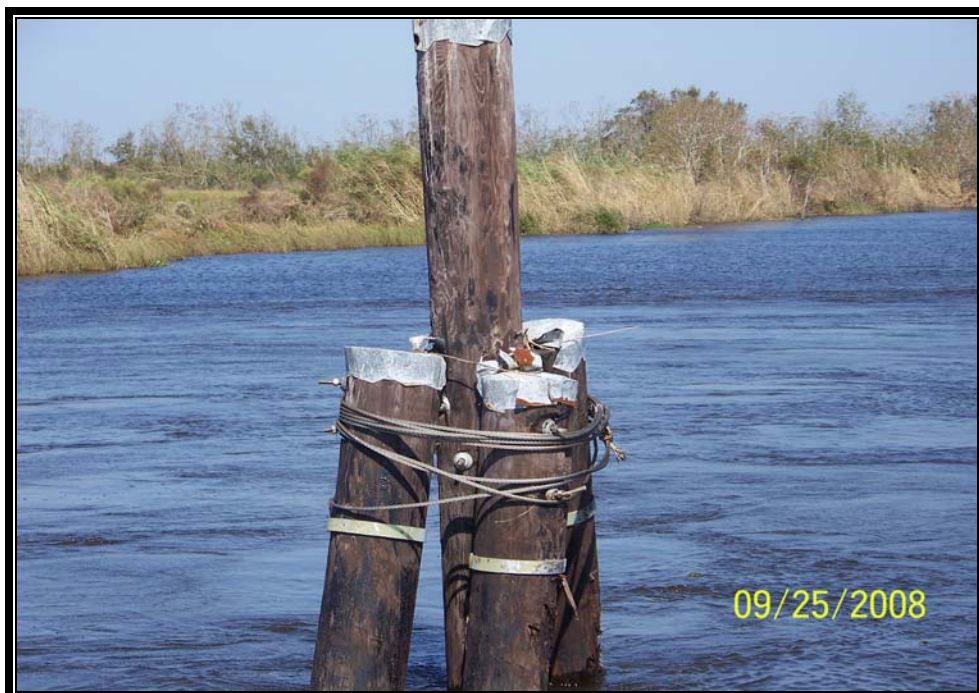
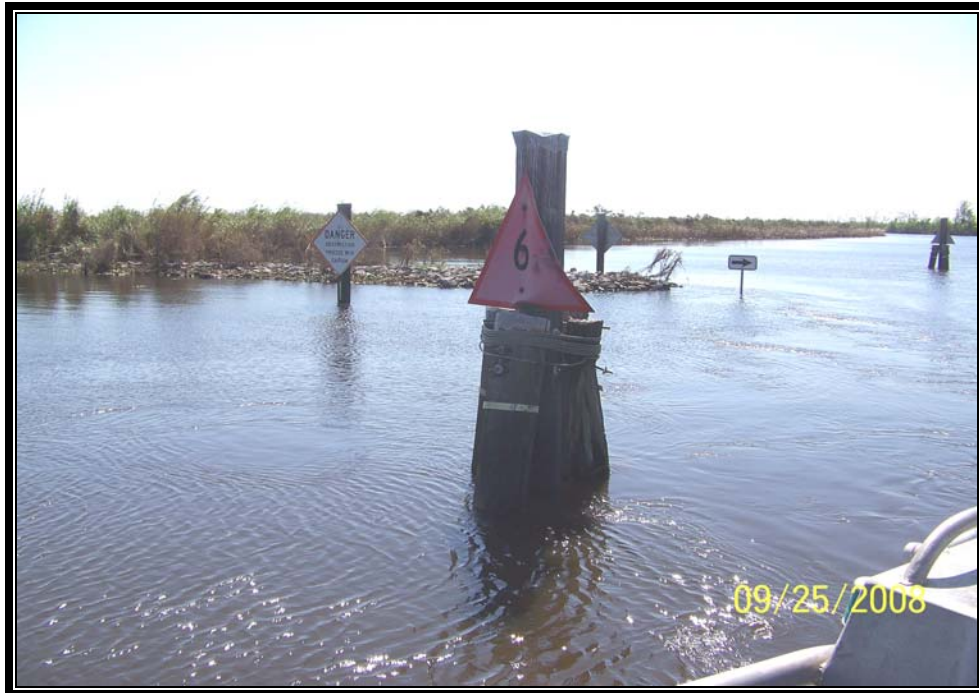
The deficiencies at Structure No.1 were limited to the four (4) timber cluster piles near the entrance of the barge bay. Several of the vertical piles were split down the middle, the batter piles were off center and the surface of all the timbers were worn or scarred from marine vessels rubbing the timbers while accessing the barge bay. We are recommending total replacement of all four (4) cluster piles. The method of construction would included removing

Photo No. 19 – damaged timber pile support on the navigational aid structure at the barge bay opening of Structure No. 1.

Photo No. 20 – damaged timber pile cluster on the navigation aid structure near the barge bay opening of Structure No.1.

Photo No. 21 – damaged timber pile cluster on the navigational aid structure at the barge bay opening of Structure No.1.

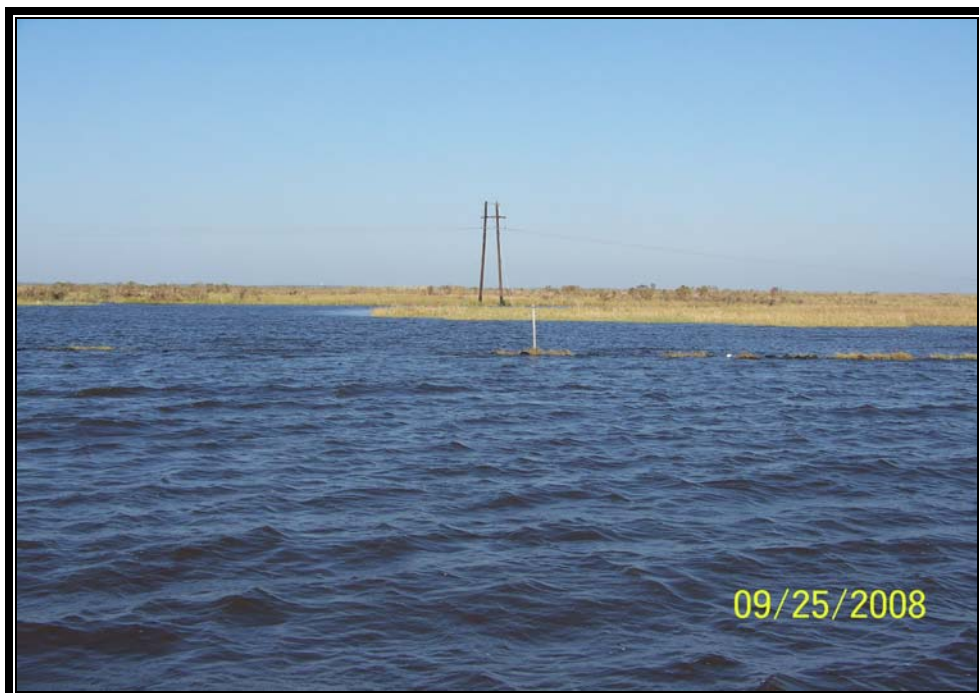
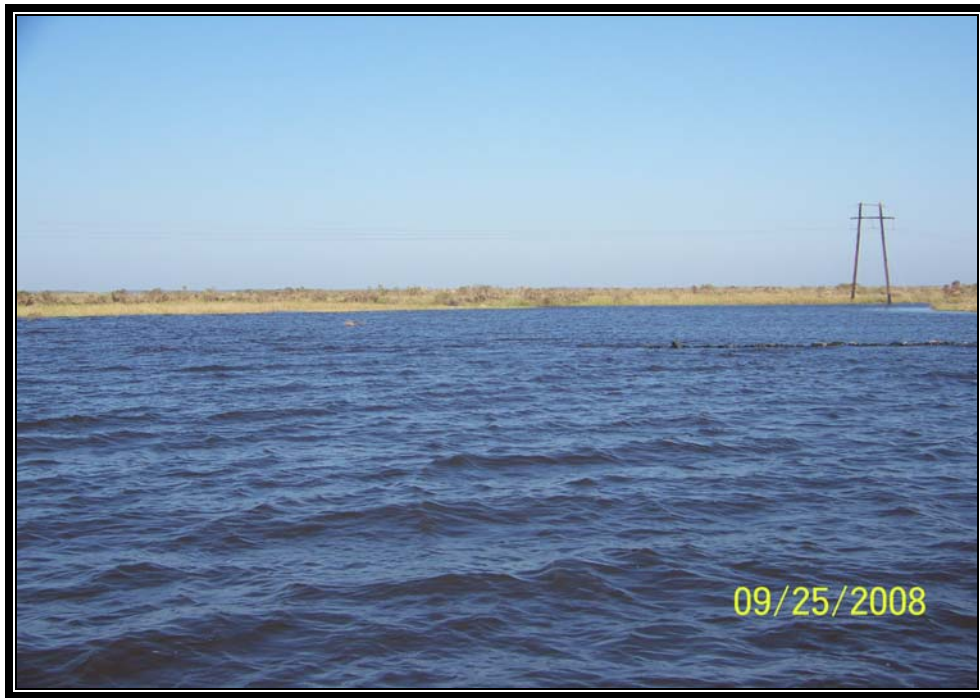
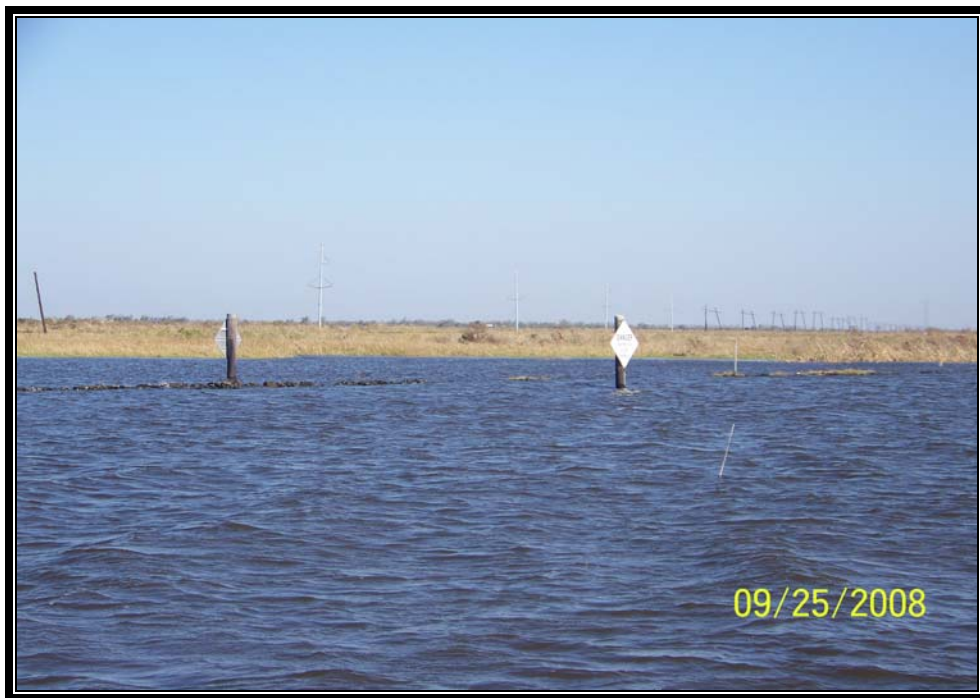
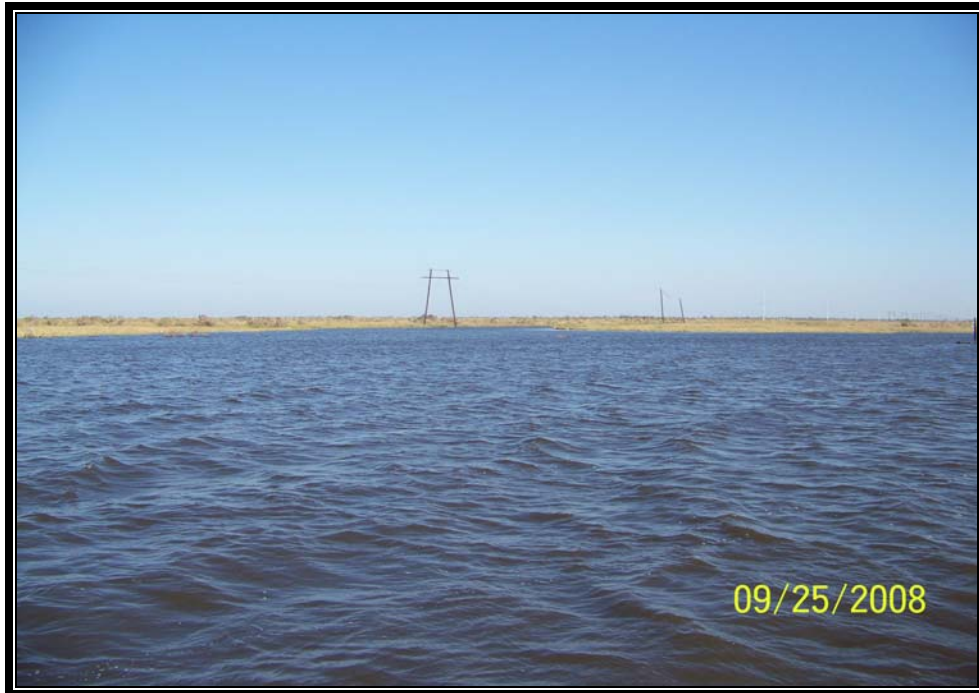
Structures 4A & 4B appeared to be in fair condition with average crest elevations of approximately 1.5' NAVD. . From as-built drawings prepared by NRCS, it was determined that the crest of the rock plug was constructed to an elevation of 3.0' NAVD. The most recent survey data collected by John Chance Surveys in 2008 show settlement ranging from 1.5' to 2.0'. It is recommended that the existing plug be recapped with rock riprap to raise the crest elevation to the original design elevation. The 2008 survey profile of Structures 4A & 4B are shown in Appendix D.

The marsh tie-in on the south side of the structure was severely damaged. We found that a large section of the existing marsh on the south side of the structure had eroded away during Hurricanes Gustav and Ike. Prior to the 2008 storms, the marsh on the south side of the structure was very thin with a narrow strip of marsh connecting the rock plug to the existing shoreline. The post-storm assessment of this area revealed extensive erosion which resulted in a breach, estimated to be approximately 1,500' wide, between the current marsh bank and the structure, leaving a large opening behind the structure to the interior marsh. Due to lack of stable marsh on the south side of the structure and high wave energies generated from the bay,

Photo No. 22 – view of large opening in marsh on the south side of Structures 4A & 4B, resulting from Hurricanes Gustav and Ike.

Photo No. 23 – view of large opening in marsh on the south side of Structures 4A & 4B, resulting from Hurricanes Gustav and Ike.

Photo No. 24 – view of rock plug along the west bank of Bay L' Ours (Structure 4A & 4B)

Photo No.25 – another view of large opening along shoreline of Bay L' Ours adjacent to Structures 4A & 4B. Hurricane Gustav and Ike decimated the marsh south of this structure.

we are recommending that the rock plug be extended across the open water approximately 1,500' to the north side of Structure No.4. Although a lengthy structure, it is necessary to provide protection from the bay and to reduce the risk of future breaching, thus compromising the hydrology of the project. (Appendix B: Photos 22-25)

The rock plug structures appeared to be in fair condition with moderate settlement. The critical area of concern associated with this structure is large breach that has developed on the south side of the structure resulting from the 2008 storms. The marsh on the south side of the structure is completely gone with little remaining shoreline to facilitate a breach closure by extending the structure. Due to the lack of stable marsh along the shoreline in this area, we are recommending that the rock plug be extended from the south side of Structure 4A & 4B, approximately 1,500 linear feet, to the north side of Structure No.4. It is estimated that approximately 8,384 tons of rip rap will be required to rehabilitate Structures 4A and 4B and extend the rock plug to the north side of Structure No.4. Detailed itemized construction costs for the rock plug extension are outlined in the budget worksheet in Appendix C.
