**State of Louisiana
Office of Coastal Protection and
Restoration**

2009 Annual Inspection Report

**GIWW/ CLOVELLY HYDROLOGIC
RESTORATION**

State Project Number BA-02
Priority Project List 1

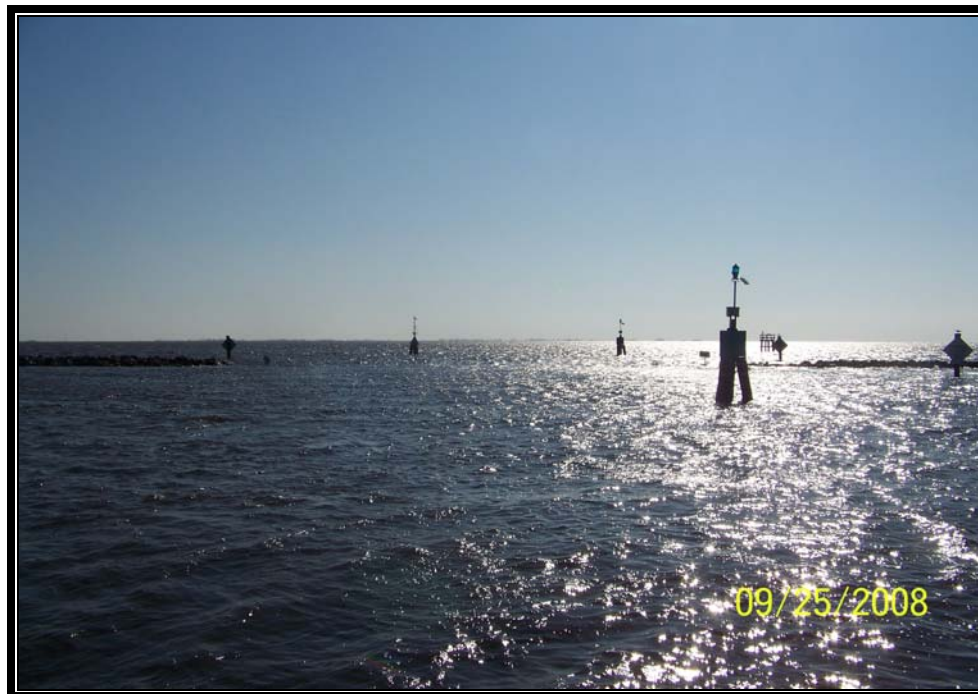
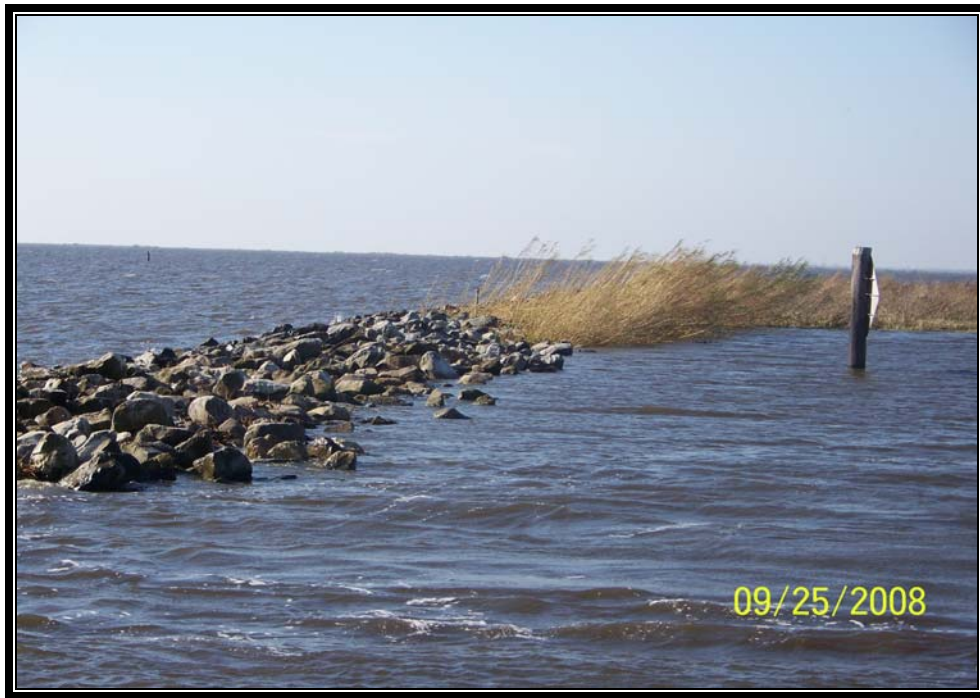
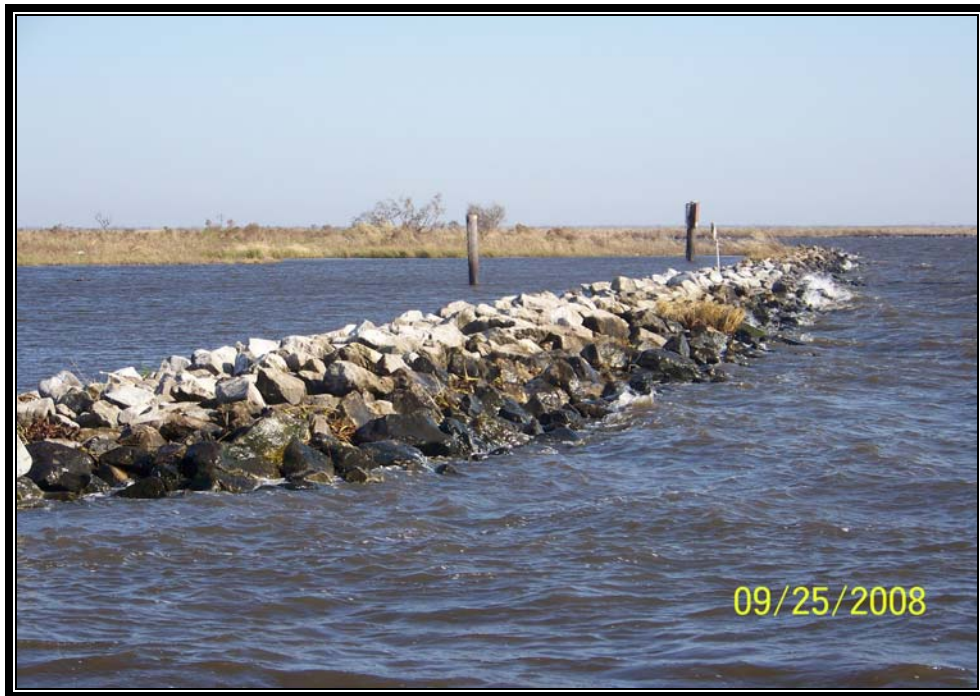
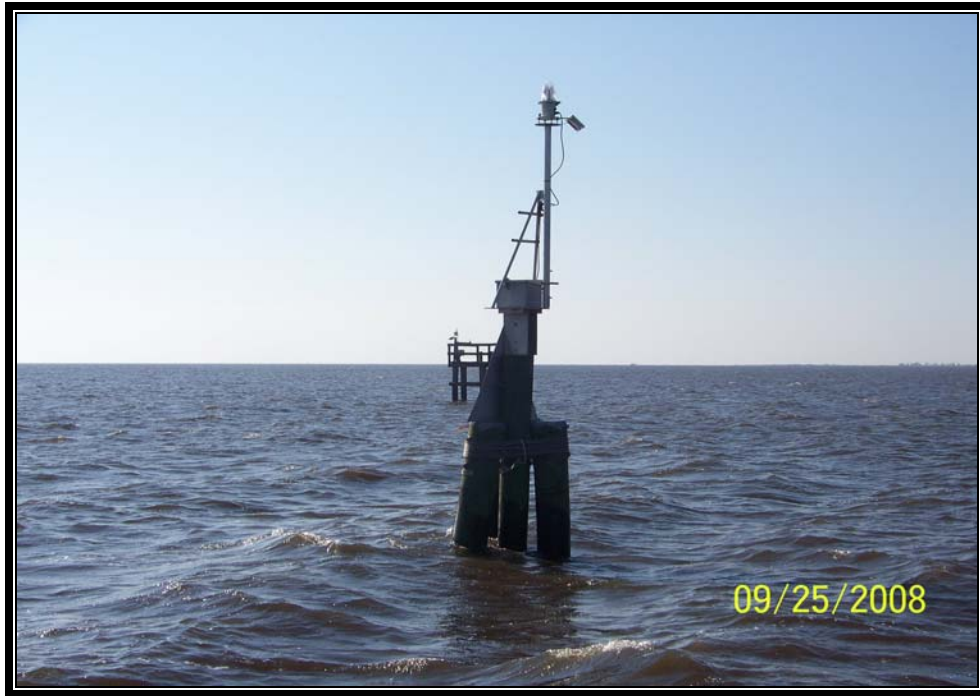
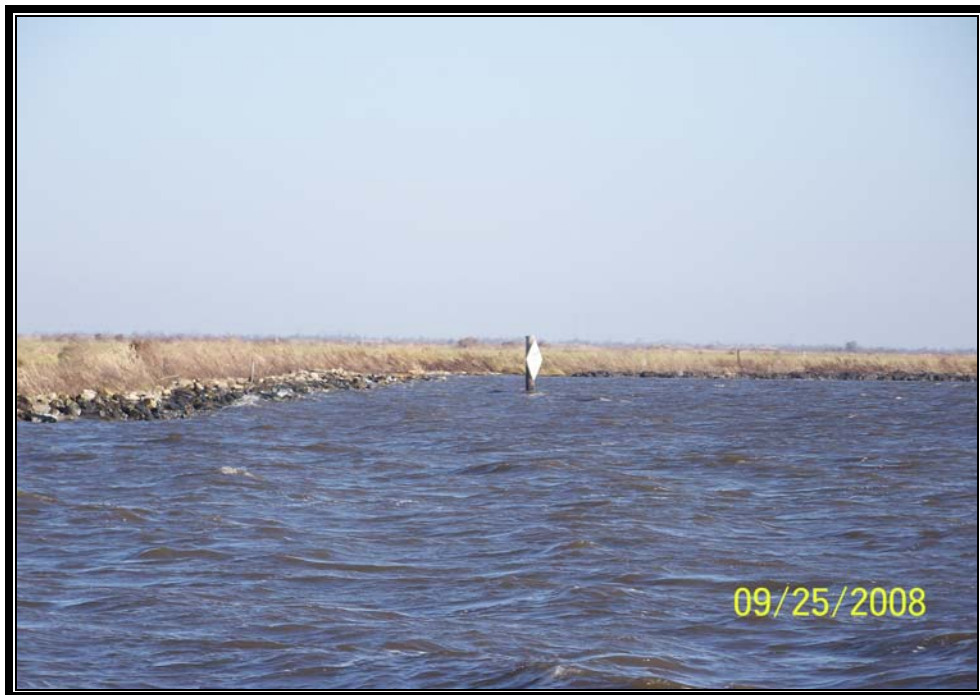
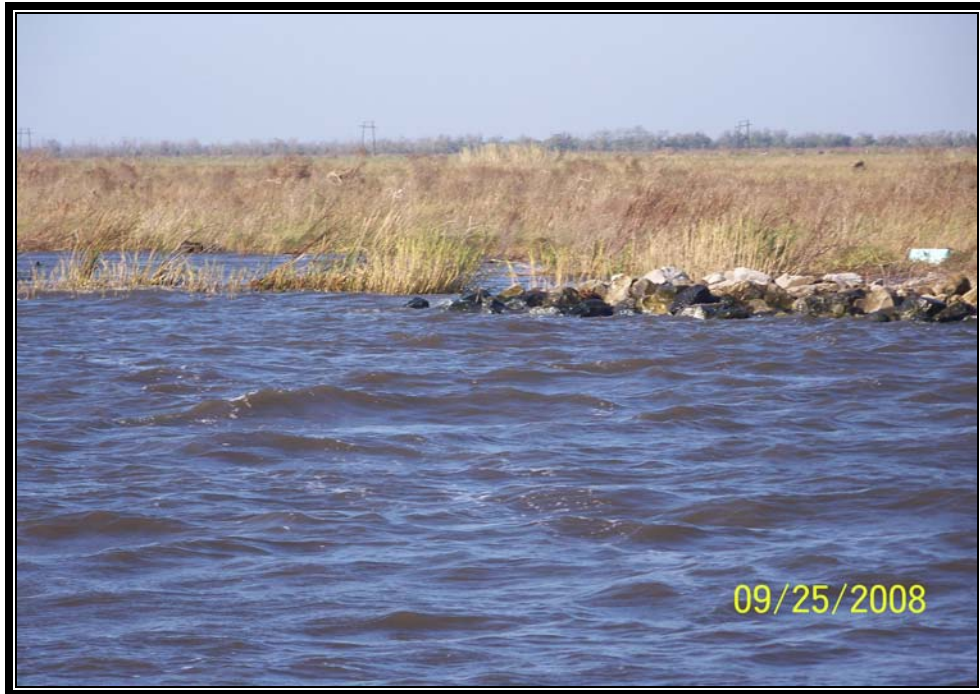
The fixed crest weir with barge bay was in fair to good condition with minor settlement and displacement of rock rip-rap on the south side of the barge bay. The crest of the structure on both sides of the barge bay was constructed to an elevation of +4.0 NAVD. The scour pad at the bottom of the barge bay was constructed to -6.5' NAVD. From the most recent survey information collected in 2008, it was determined that the crest elevations of the rock weir on both sides of the barge bay faired very well since construction. It appears that the crest elevations north of the barge bay did not settle at all, while the crest elevations on the south side experienced only minor settlement, less than 1.0'. The most noticeable settlement and/or scour were at the bottom of the barge bay itself. The 2008 survey data show bottom depths ranging from -6.5' to -15' NAVD88 indicating that the scour pad and riprap at the bottom of the channel had eroded or washed out by the strong currents through the structure. It is recommended that the rock scour pad be reconstructed to the original design elevations. Due to the strong currents through the barge bay, we are also recommending that a larger rock be used to slow the rate of scour. The 2008 survey profiles of Structure No.14A are shown in Appendix D.

Photo No.26 - view of rock weir at barge bay location looking east towards Little Lake.

Photo No. 29 - view of the southern rock weir section of Structure 14a near the barge bay to the marsh tie-in.

Photo No.30 – view along the centerline of the northern weir section of Structure 14A to the marsh tie-in.

Photo No.31 - view of the navigational aid structure on the northeast side of Structure 14A.

Photo No.32 – northern most rock weir section of Structure 14A near the terminus.

Photo No.33 – southern end of the rock weir (Structure 14A) near the marsh tie-in.

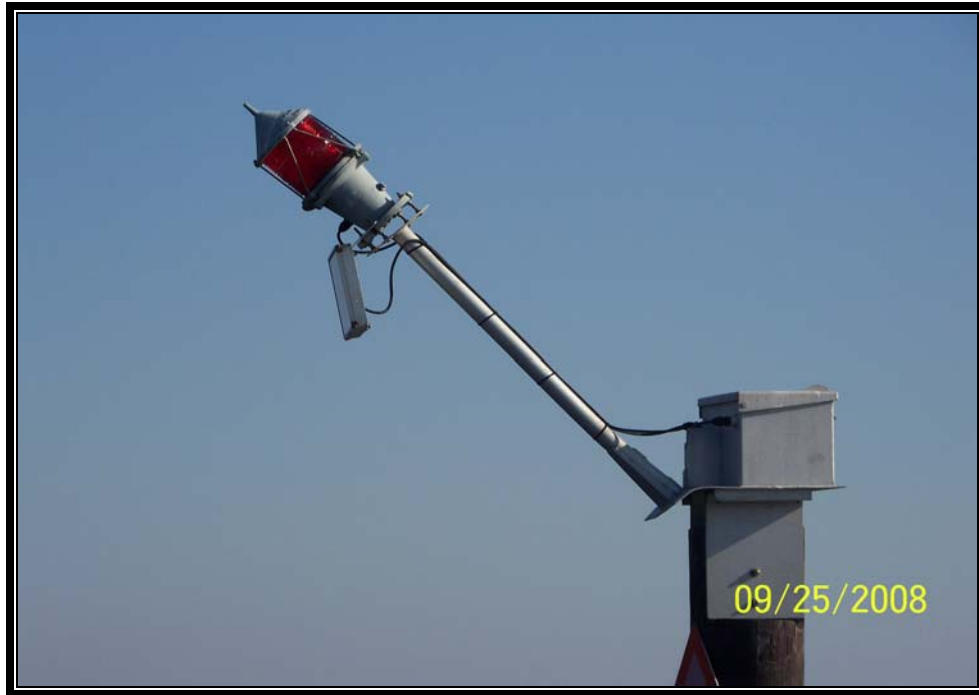
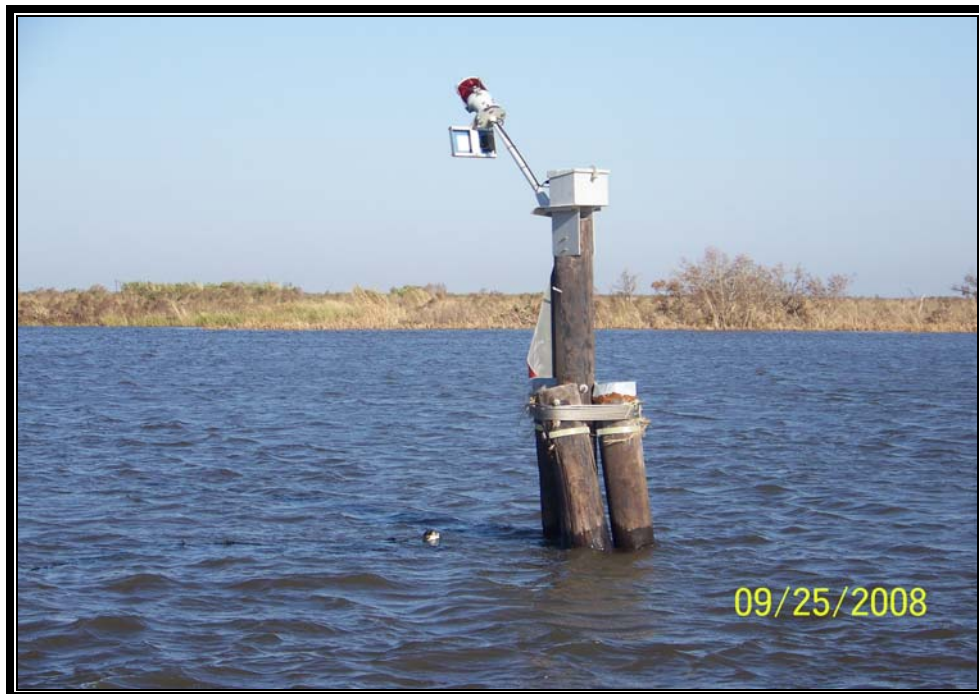
The timber navigational aid supports were in fair condition with visible damage to the southwest timber support structure and navigation lights on the northwest support structure. Longitudinal cracks, scrapes and abrasions were noted on the face of the timber batter piles on the northwest support structure. There is no indication that the structural integrity of the timber dolphin is compromised by the observed damage at this time. However, we are recommending that the two (2) timber cluster piles on the west side of the structure be replaced during the next maintenance cycle. We also noticed that the support pole on the navigation aid unit on the southwest timber structure was bent. It is apparent that this is a direct result of Hurricanes Gustav and Ike. The damage to the navigational aid system shall be repaired under the Inspection, Diagnostic Testing and Maintenance contract between

Photo No.27 – damaged navigational aid light northwest of barge bay at Structure 14A.

Photo No.28 – view of damaged navigational aid light and timber pile support on the northwest side of Structure 14A.

Structure No.14A was in fair to good condition with moderate damage to the timber cluster piles on the west side of the structure in Clovelly Canal and severe settlement and/or scour along the bottom section within the limits of the barge bay. It is recommended that the two (2) timber cluster pile support structures be replaced and the navigational aid systems cleaned and reinstalled. It is also recommended that the rock scour pad be reconstructed to the original design elevations. Due to the strong currents through the barge bay, it is also recommended that a larger rock be used to slow the rate of scour. Detailed itemized construction costs for replacement of the timber cluster piles are outlined in the budget worksheet in Appendix C.

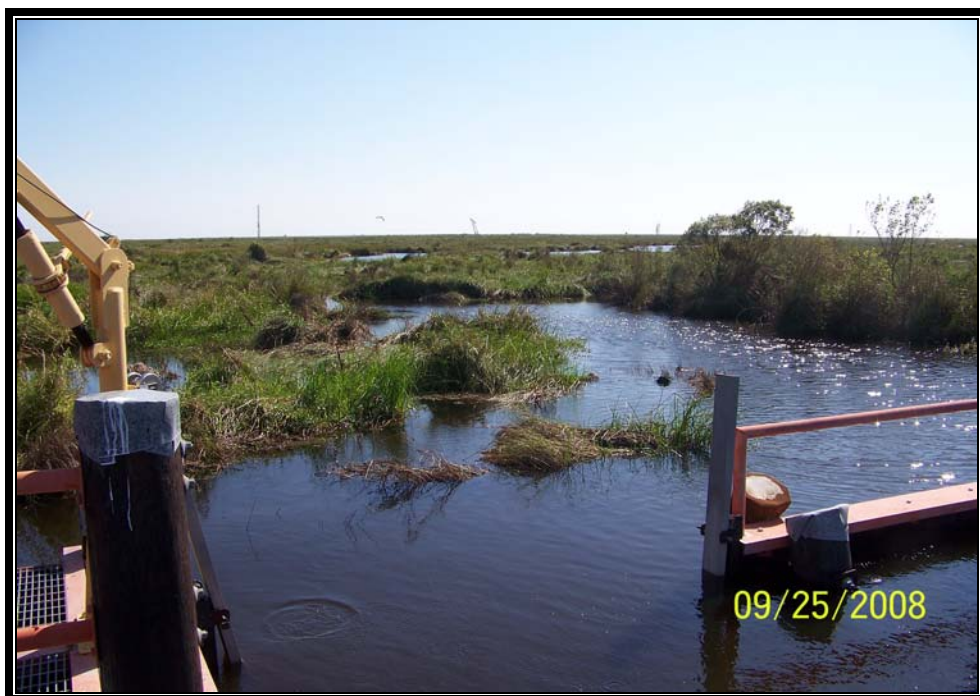
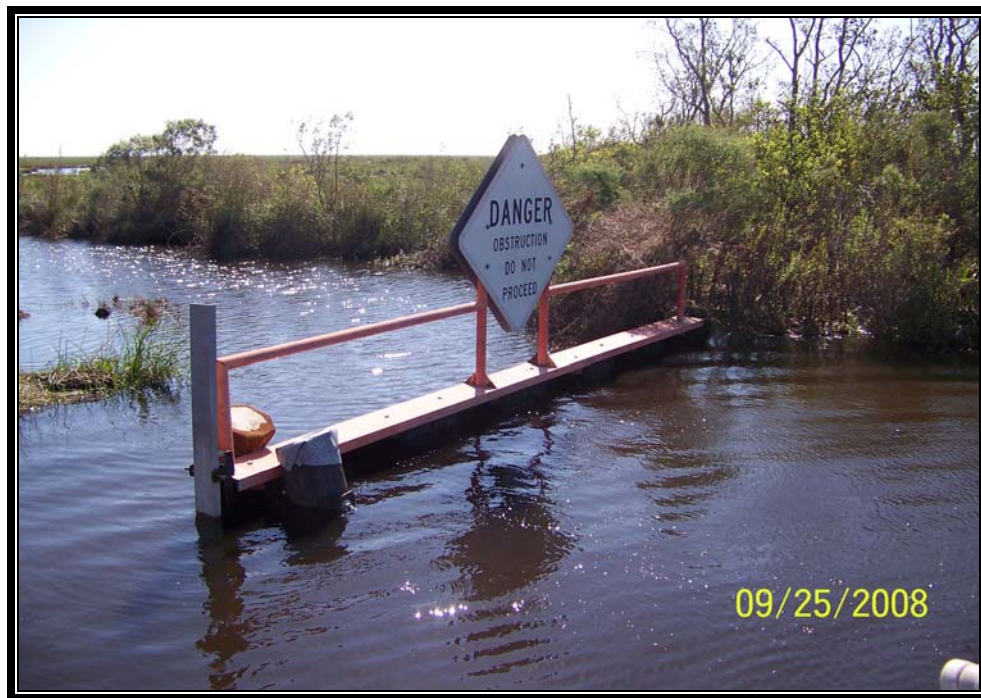
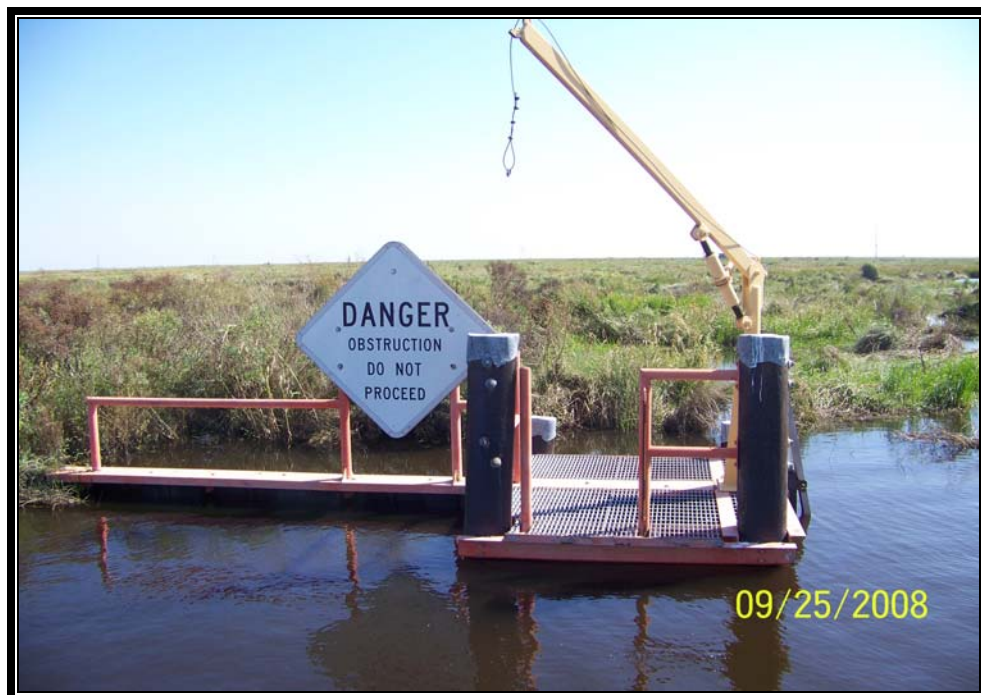
Other than minor corrosion and paint chipping along the channel cap of the bulkhead, handrails and movable boom deck, the structure itself was in good condition. The stop logs, cables, signs, supports and other hardware appear to be operable and in good condition. The stop logs were manipulated in November 2008 and May 2009 as per the permitted operations schedule. Although there was no damage to the structure itself, we did note that marsh material had accumulated on the marsh side of the structure partially blocking the conveyance channel to the interior marsh. Hurricanes Gustav and Ike produced similar conditions as in the case of Hurricane Katrina where large sections of floating marsh were lodged in the conveyance channel directly behind Structure No. 35. Although a considerable amount of marsh material was present in the channel, the inlet from the interior marsh to the weir opening was not completely closed, allowing water to freely flow through the structure under normal tidal conditions. At this time, we are not recommending any corrective actions to open the channel. We believe that the width of the channel will continue to widen over time through natural tidal action as in the case following Hurricane Katrina. (Appendix B: Photos 34-36)

Photo No. 34 – view of the broken marsh clumps in the tidal channel behind Structure No. 35.

Photo No. 35 – view of the steel bulkhead section on the south side of Structure No. 35.

Photo No. 36 – view of the steel bulkhead section, deck grating and lifting boom on the north side of Structure No.35.

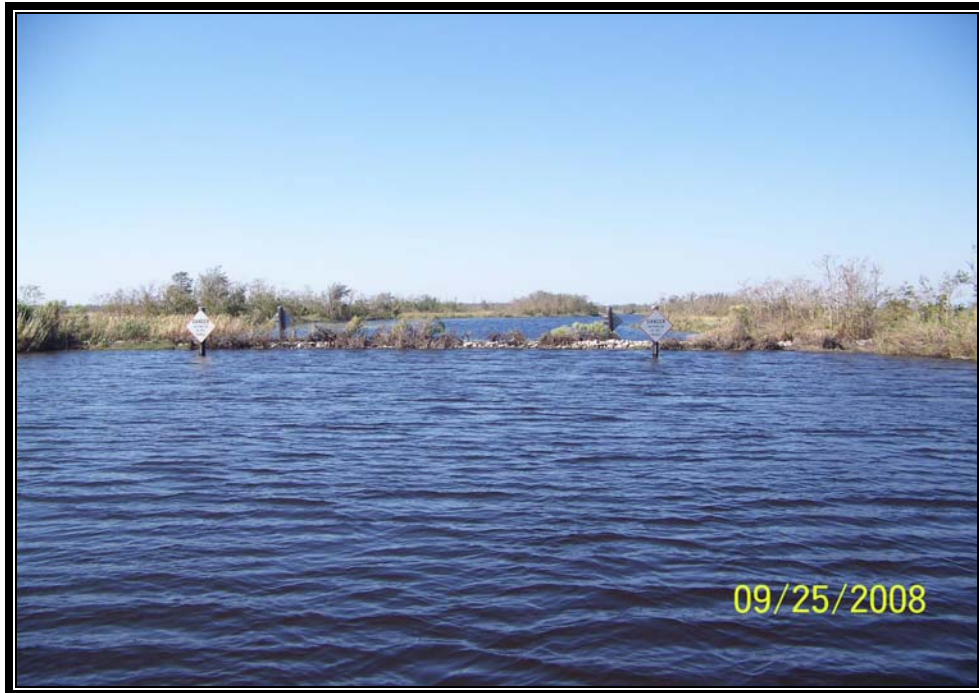
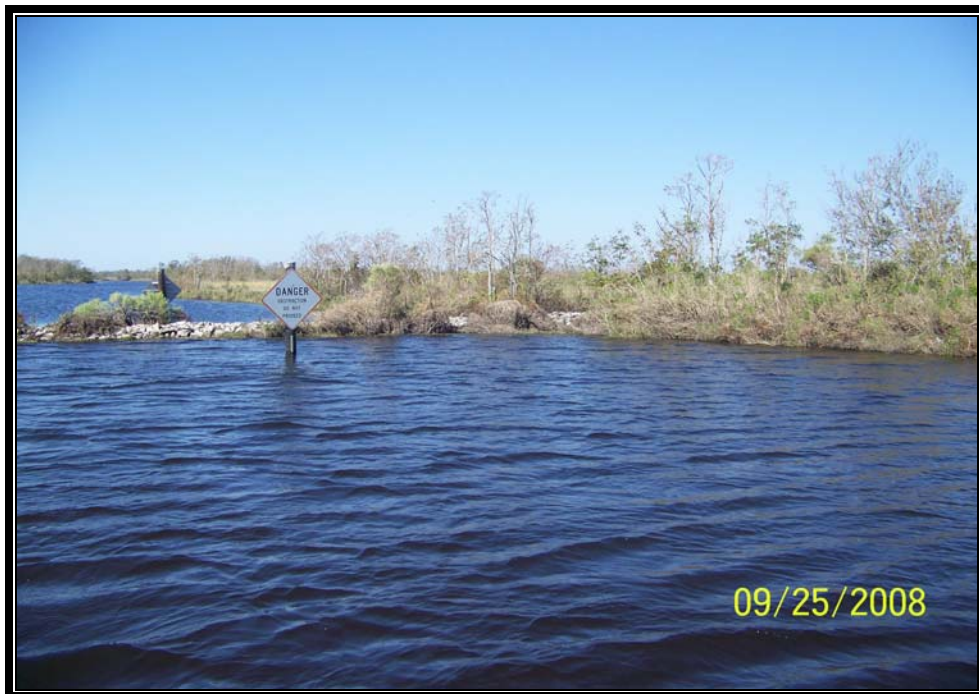
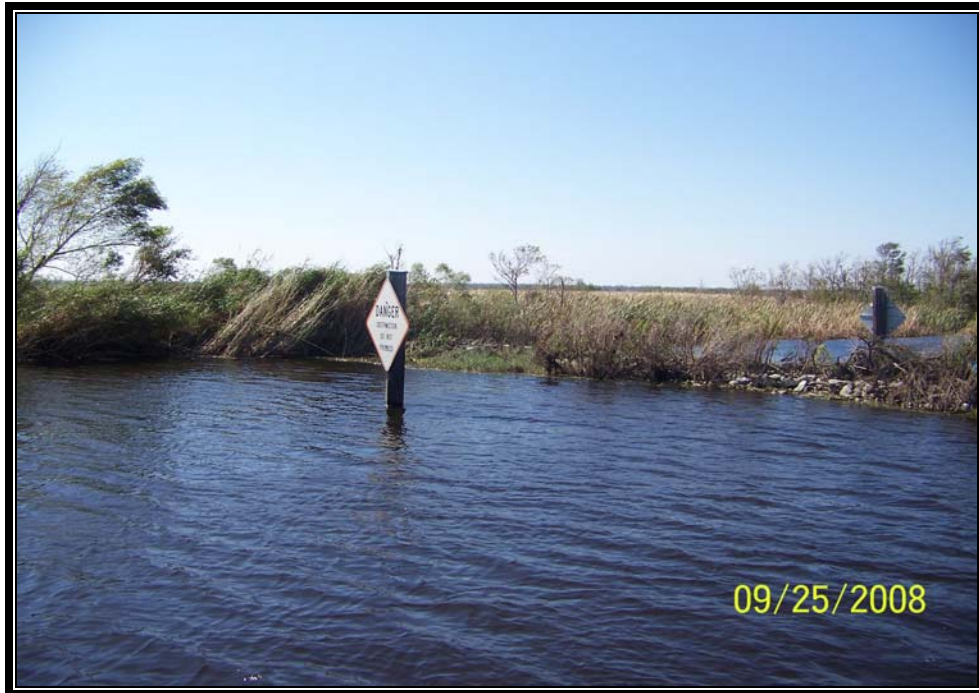
The rock riprap channel plug appeared to be in very good condition with no apparent settlement or breaching around the ends of the structure. The signs and supports were also in good condition. (Appendix B: 37-39)

Photo No. 37 – view of rock plug (Structure No. 90) located across an existing oilfield canal just northeast of Structure No.1.

Photo No.38 – view rock plug and bank tie-in on the north side of Structure No. 90.

Photo No. 39 – view of the rock plug and bank tie-in on the south side of Structure No.90.

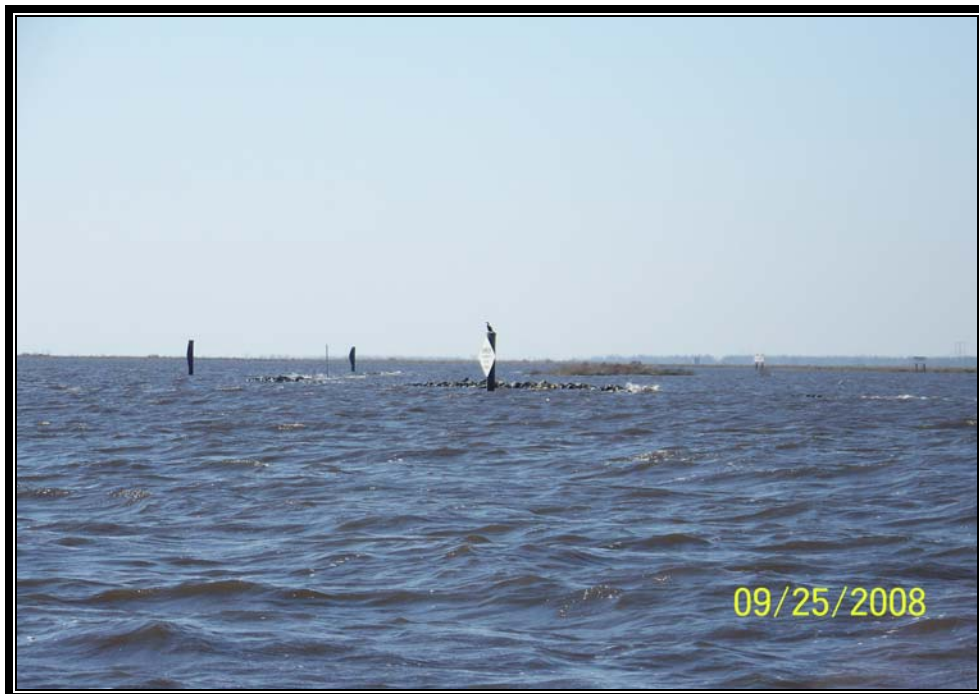
Photo No.40 - view of rock dike along the lake rim of Bay L' Ours near the entrance of Brenton Canal.

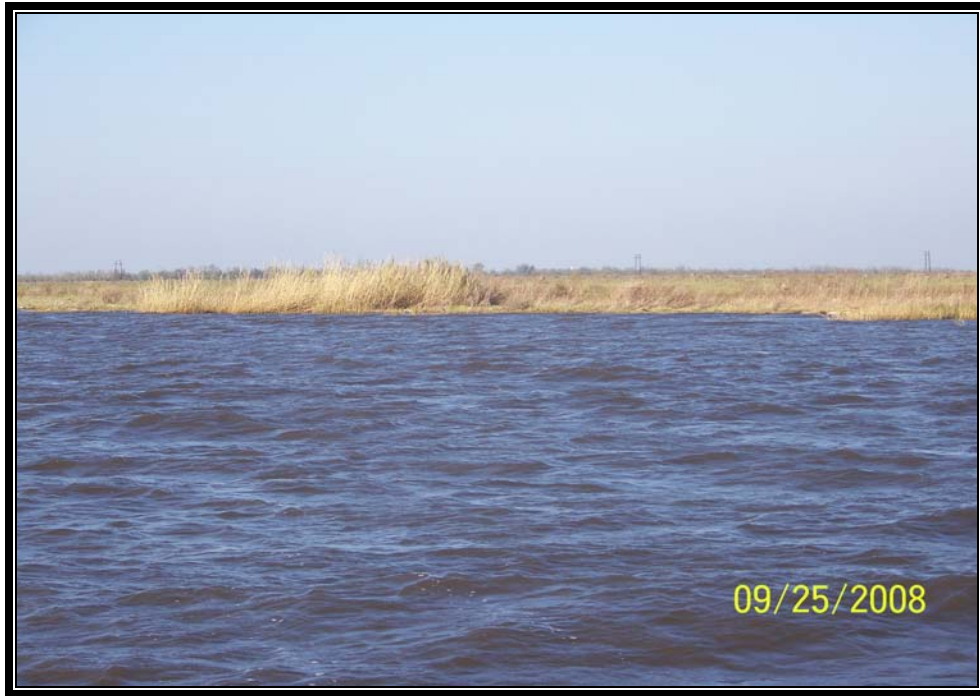
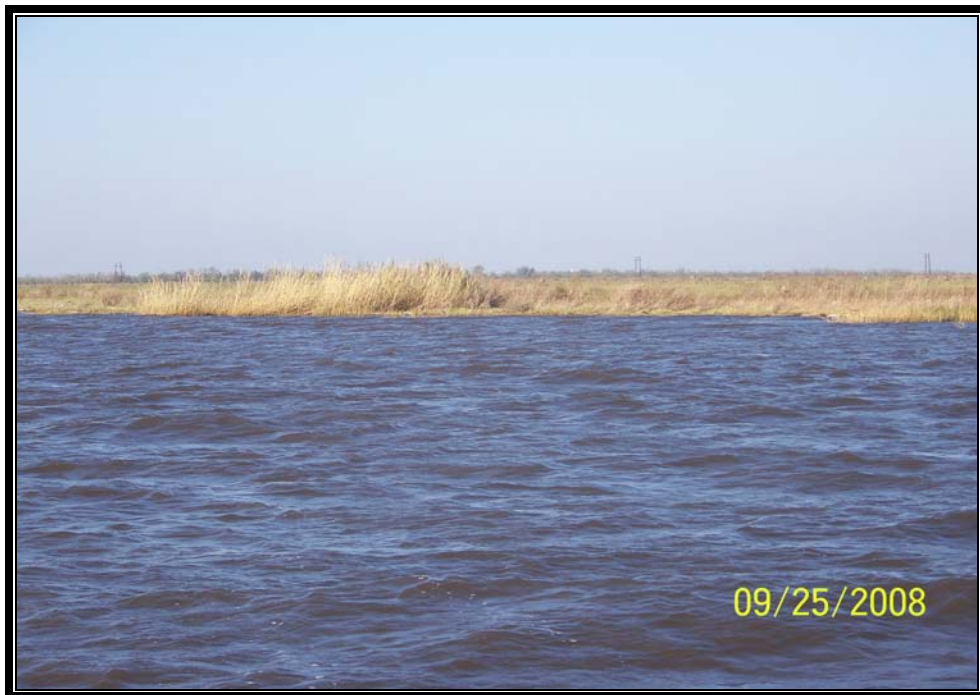
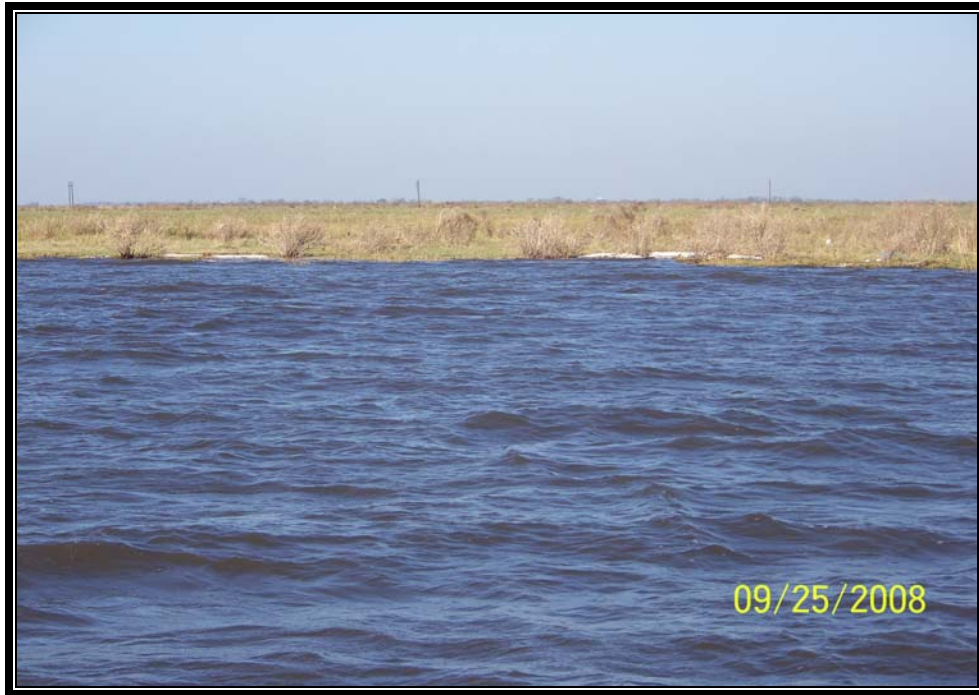
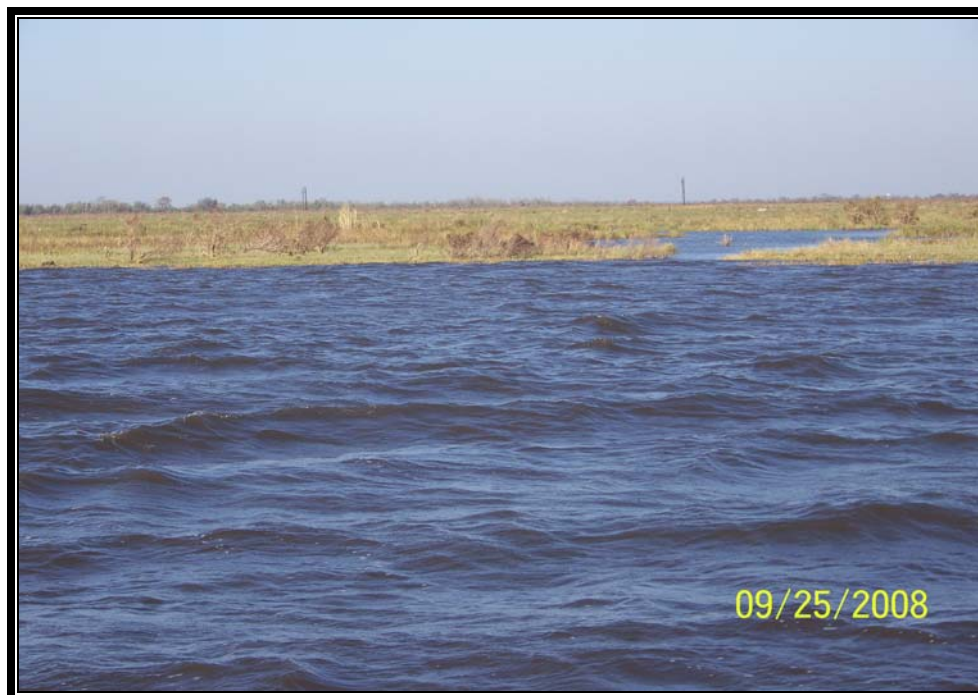
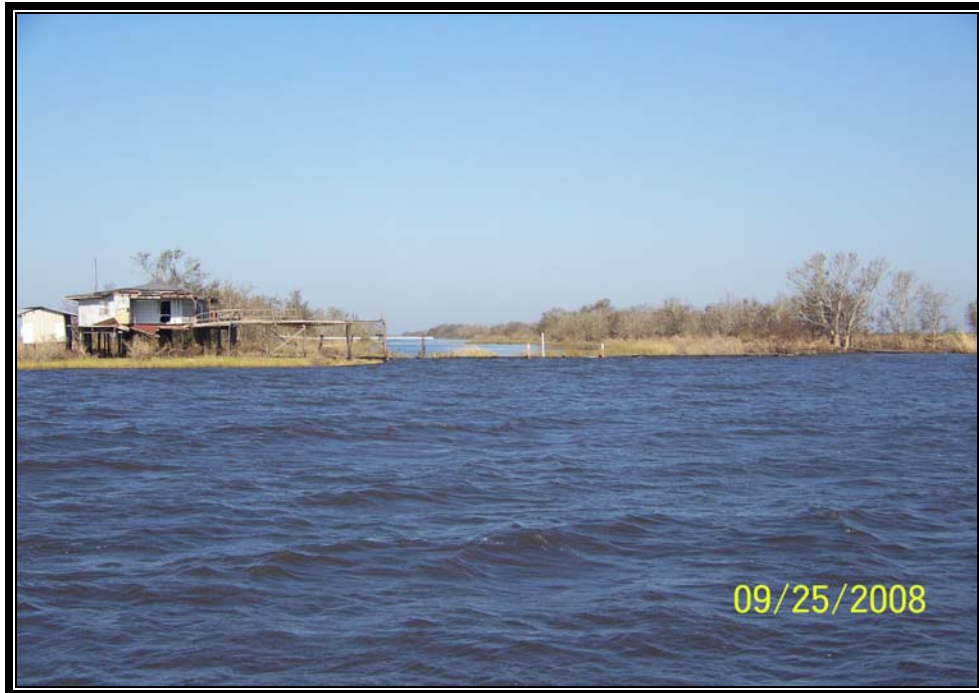
Other minor deficiencies noted during this inspection included shoreline erosion and small cuts banks along the west bank of Little Lake south of Structure 14A. Since there are no major breaches in the shoreline, that is currently jeopardizing the internal hydraulics of the project, we are not recommending any improvements or maintenance at this time. The inspection team will closely monitor the shoreline in this area on future site visits to determine if conditions have changed.

Photo No.41 – existing shoreline along the west bank of Little Lake south of Structure 14A.

Photo No.42 – existing shoreline along the west bank of Little Lake south of Structure 14A.

Photo No. 43 – small shell midden along the western shoreline of Little Lake south of Structure 14A.

Photo No. 44 – small breach in the existing shoreline opening into a small pond along the west bank of Little Lake south of Structure 14A.

Photo No. 45 – view of exiting wooden bulkhead at the head of an oilfield canal along the shoreline of Little Lake.

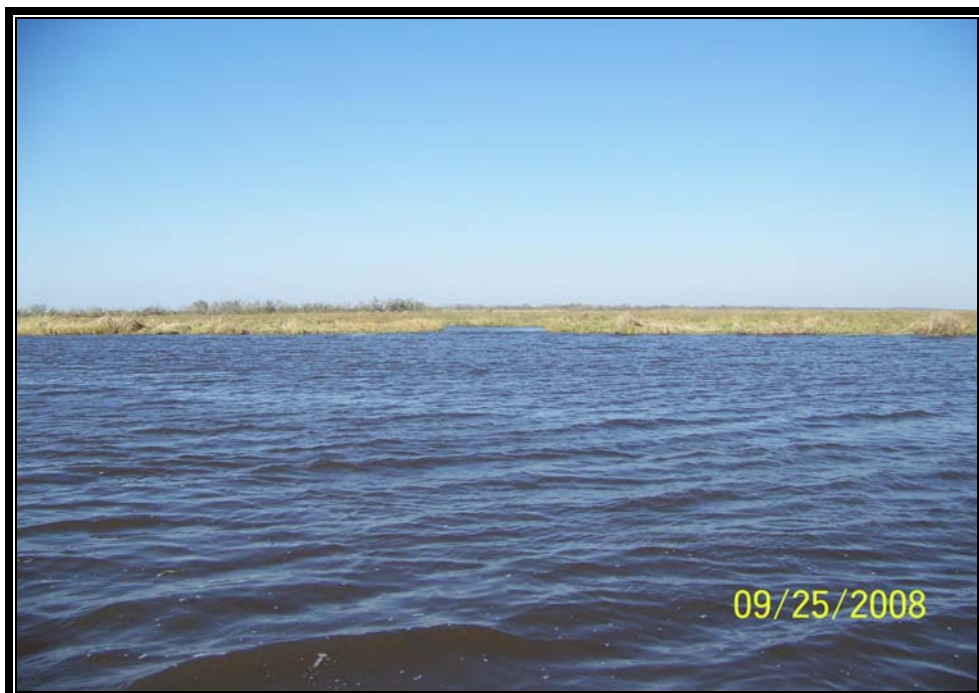
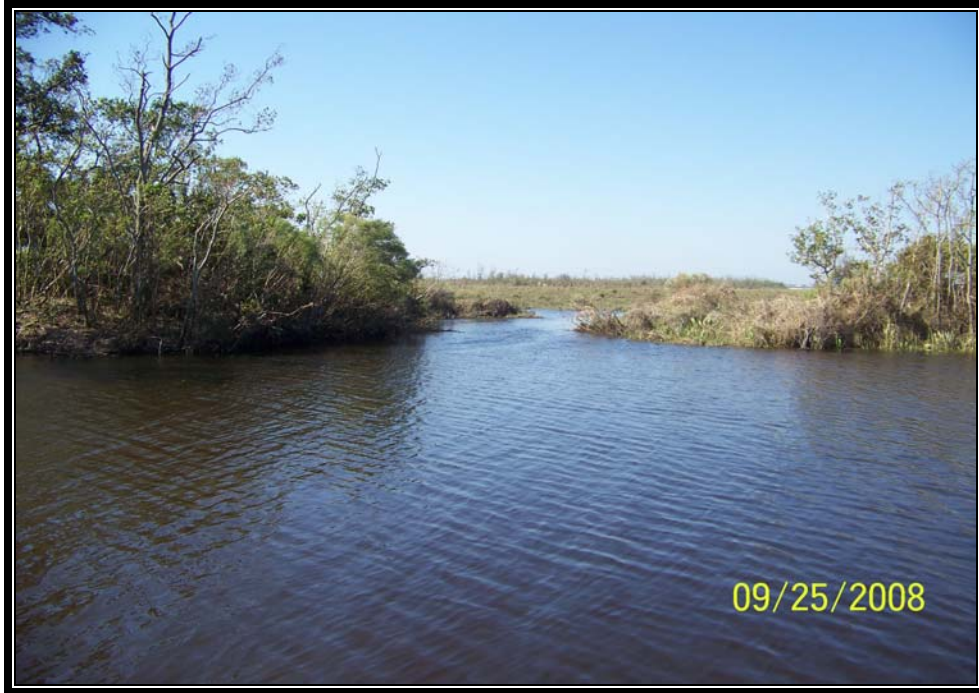
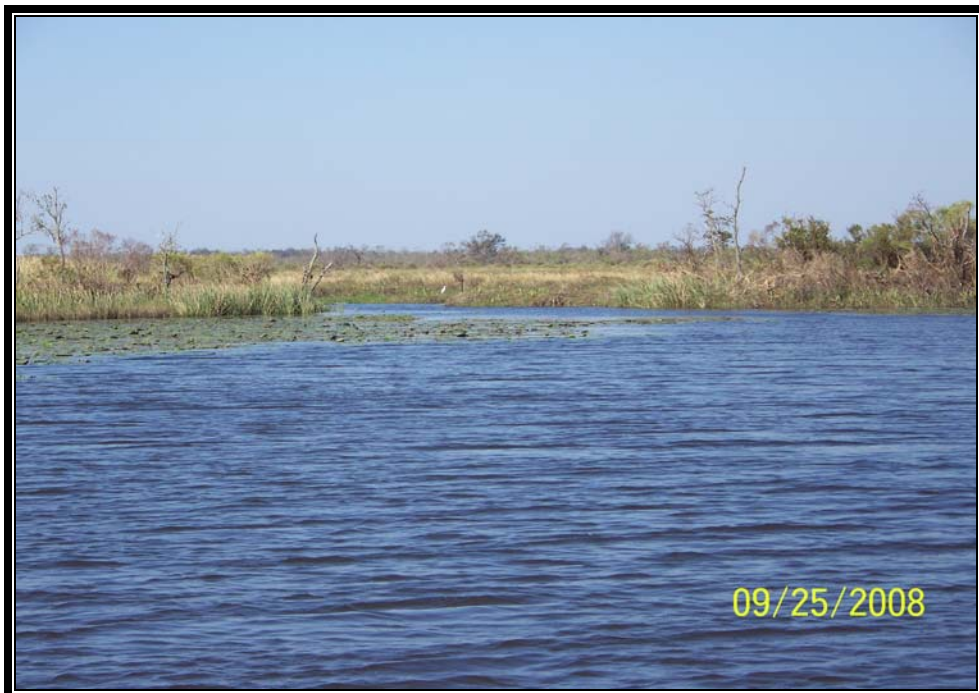
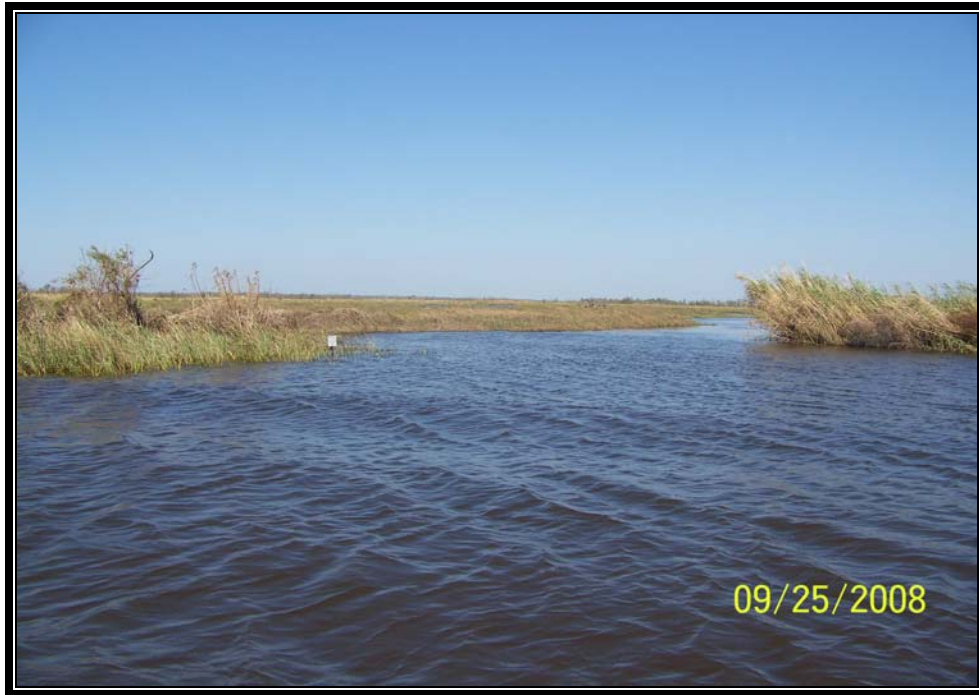
The earthen embankments located near the southern boundary of the project appear to be in a similar condition as observed during the March 2008 inspections. There are five (5) breaches identified for repairs and/or refurbishment to be included in the 2009/2010 Work Plan. Breach 1 is located along the north bank of Breton Canal just southwest of the first location canal from Bay L' Ours and is approximately 15' wide. Breach 2 is located along the northeast bank of the second location canal north of Breton Canal and is approximately 10' wide. Breach 3 is located on the south bank of the same location canal as Breach 2 and is approximately 15' wide. Breach 4 is located on the west bank of a location canal that intersects Superior Canal east of Structure No. 1 and is approximately 30' wide. Another breach, designated as Breach 5, was discovered at the end of a dead end channel south of Breach 4. (Typical breach photos are shown in Appendix B).

Photo No. 46 – view of a small breach located along Breton Canal just south of oilfield channel leading to Structure No.35

Photo No. 47 – view of breach location on the south bank of the second oilfield canal from Bay L’ Ours.

Photo No. 48 – view of typical breach in the earthen embankment.

Photo No. 49 – view of typical breach in the earthen embankment.

In all, five (5) breaches ranging from 10' to 30' wide were identified within the southern portion of the project area which will require maintenance. Breach locations are shown in the Work Plan Map of Appendix E. It is recommended that breaches 1 through 5 be closed and re-constructed to the original design elevations utilizing available in situ material from adjacent channel bottoms. Detailed construction costs are outlined in the budget worksheets under Appendix C.

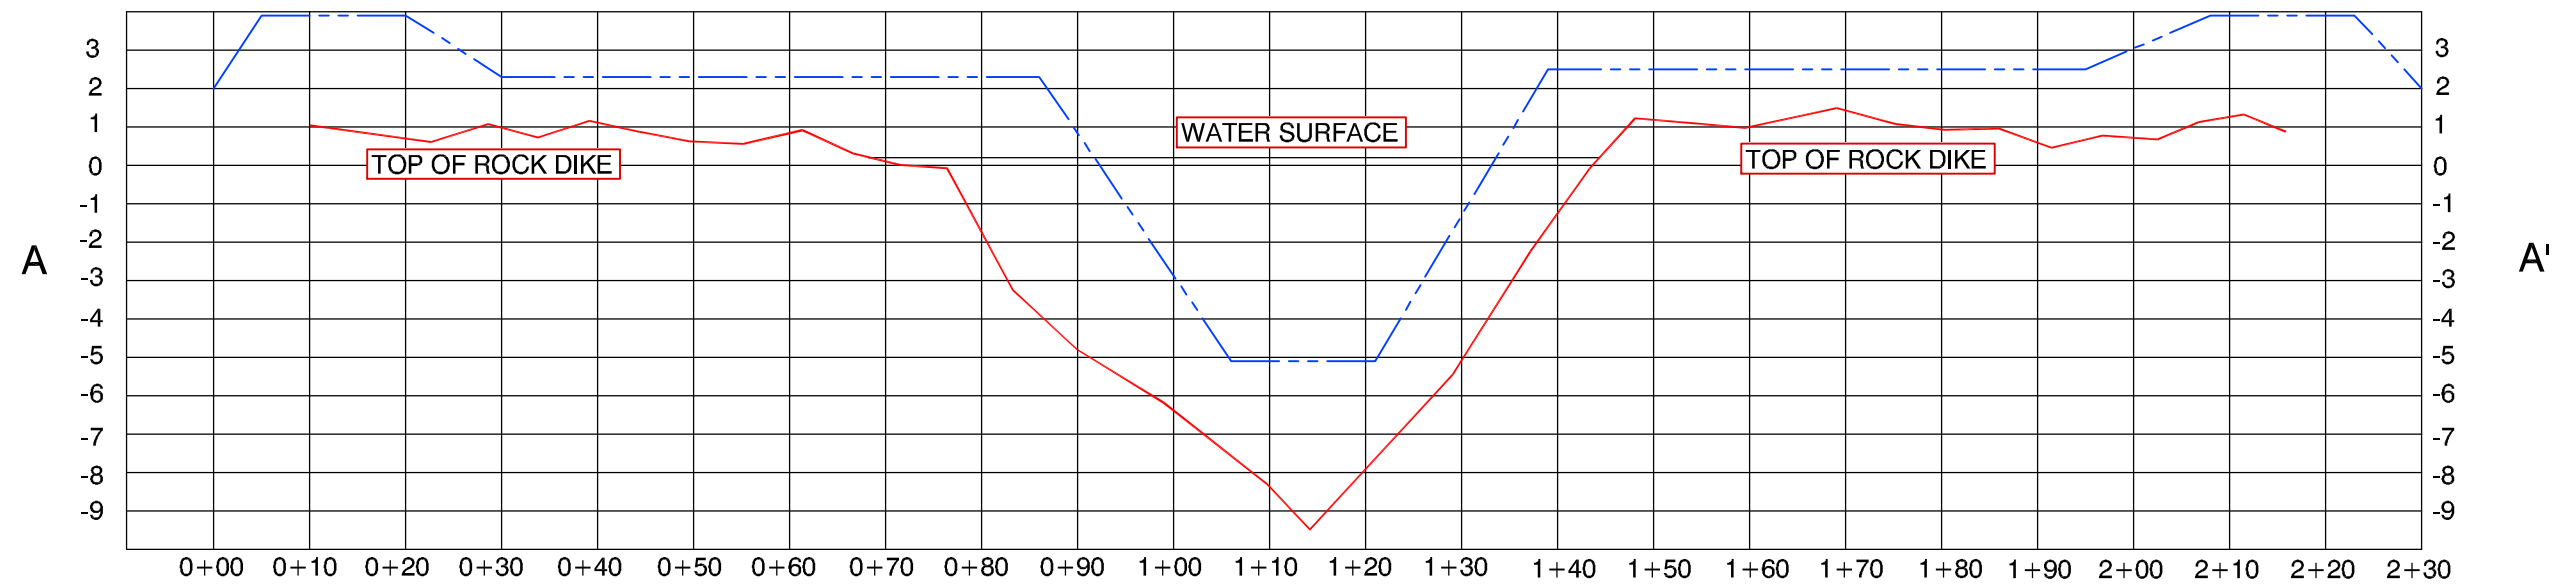
STRUCTURE 2 PROFILE

Structure No.2 was found to be in fair condition with approximately 4' of settlement within the boat bay section. We are recommending that the boat bay section and fixed crest sections be raised to the original constructed elevations using rock riprap. Due to shallow condition at the mouth of the channel near Bay L' Ours, access dredging may be required to facilitate the refurbishment of Structure No.2. Detailed itemized construction costs are shown in the budget worksheet in Appendix C.

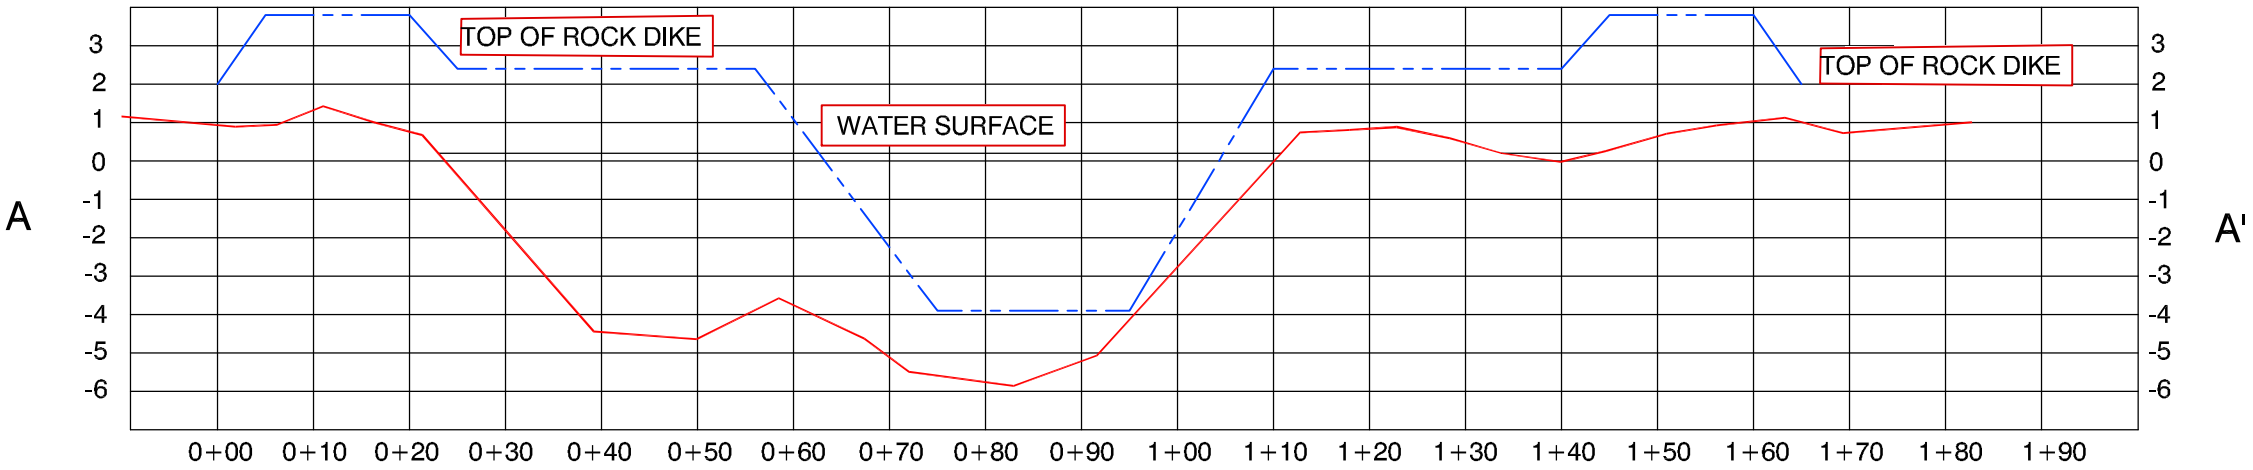
STRUCTURE 4 PROFILE

structure. Considering the large elevation differences on the south crest, it is apparent that rock structure was displaced from strong currents in the channel rather than settlement or compaction of soils beneath the structure only. The crest of the boat bay was constructed to an elevation of -3.9' NAVD. The most recent elevation data show that the lowest crest elevation of the boat bay is currently at -6.0' NAVD, resulting in a difference of approximately 2.0'. Due to the amount of settlement and displaced rock within the boat bay and southern weir section, it is recommended that Structure 4 be reconstructed to the original design crest elevations. To prevent the obvious displacement of rock material on the south side of the structure, it may be necessary to recap the structure with a larger stone which would minimize displacement during strong current conditions. As reported in previous inspection reports, the warning sign on the north side of the structure was destroyed during Hurricane Katrina and no longer exists. A warning sign on the north side of the structure shall also be replaced. (Appendix B: Photos 5-7). The 2008 survey profile of Structure No.4 plotted over the original as-built section is shown in Appendix D.
