**State of Louisiana
Office of Coastal Protection and
Restoration**

2009 Annual Inspection Report

**GIWW/ CLOVELLY HYDROLOGIC
RESTORATION**

State Project Number BA-02
Priority Project List 1

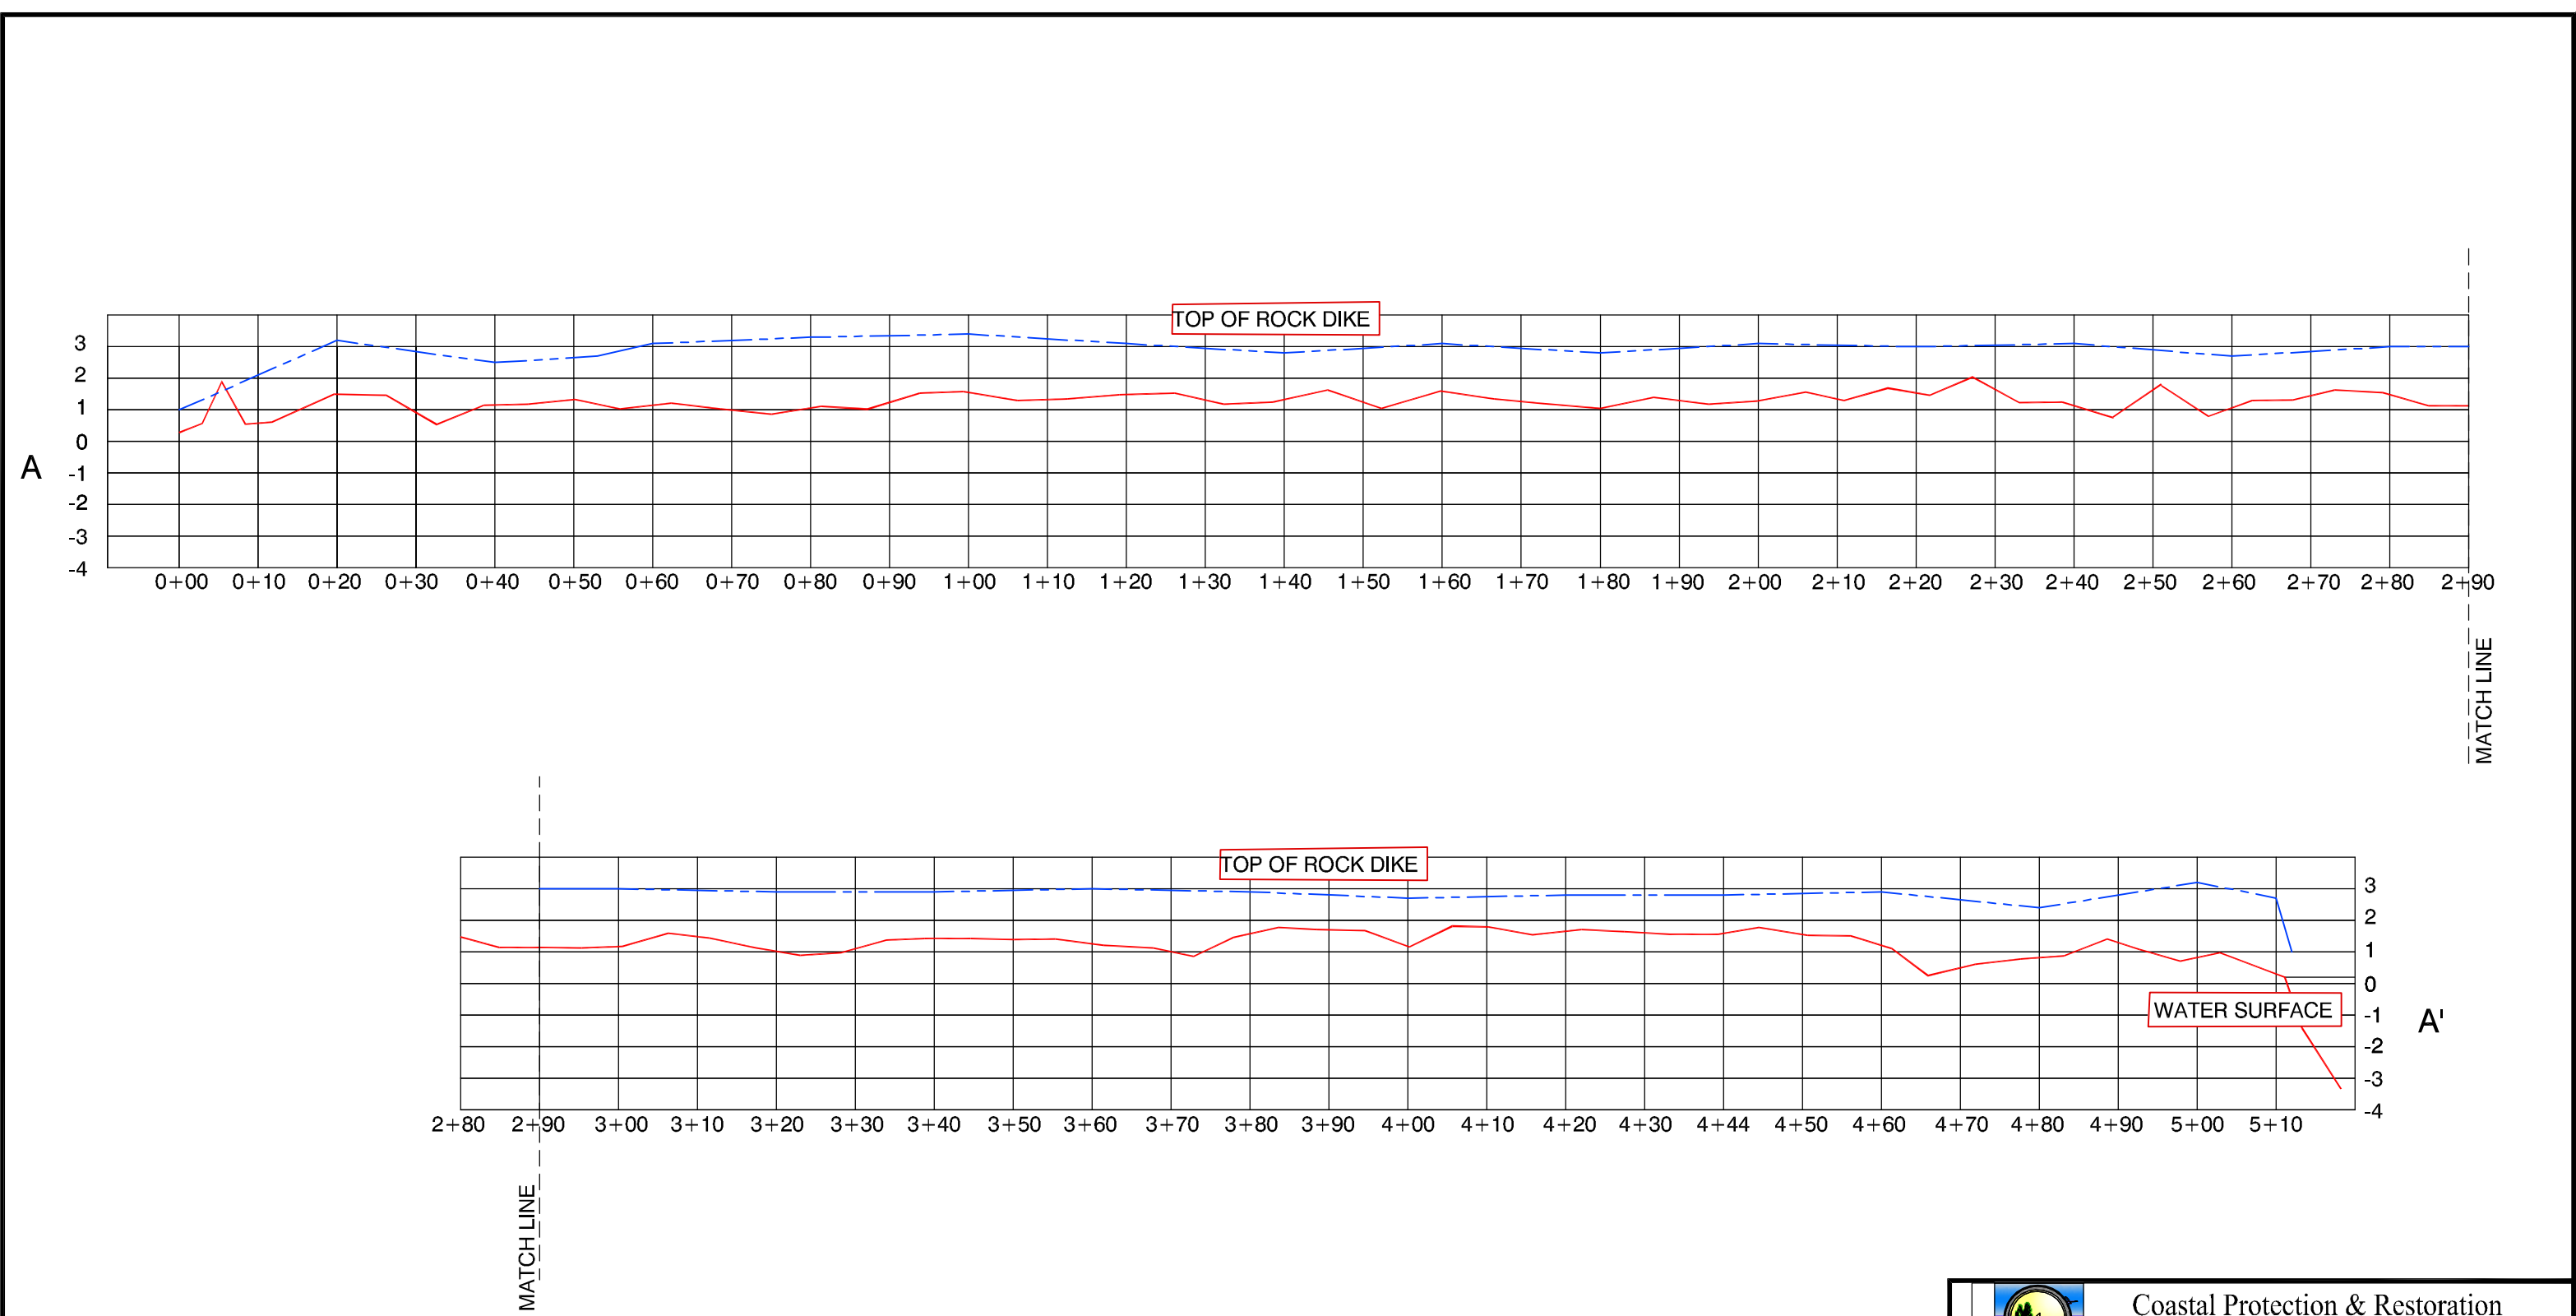
STRUCTURE 4A-4B PROFILE

Structures 4A & 4B appeared to be in fair condition with average crest elevations of approximately 1.5' NAVD. . From as-built drawings prepared by NRCS, it was determined that the crest of the rock plug was constructed to an elevation of 3.0' NAVD. The most recent survey data collected by John Chance Surveys in 2008 show settlement ranging from 1.5' to 2.0'. It is recommended that the existing plug be recapped with rock riprap to raise the crest elevation to the original design elevation. The 2008 survey profile of Structures 4A & 4B are shown in Appendix D.

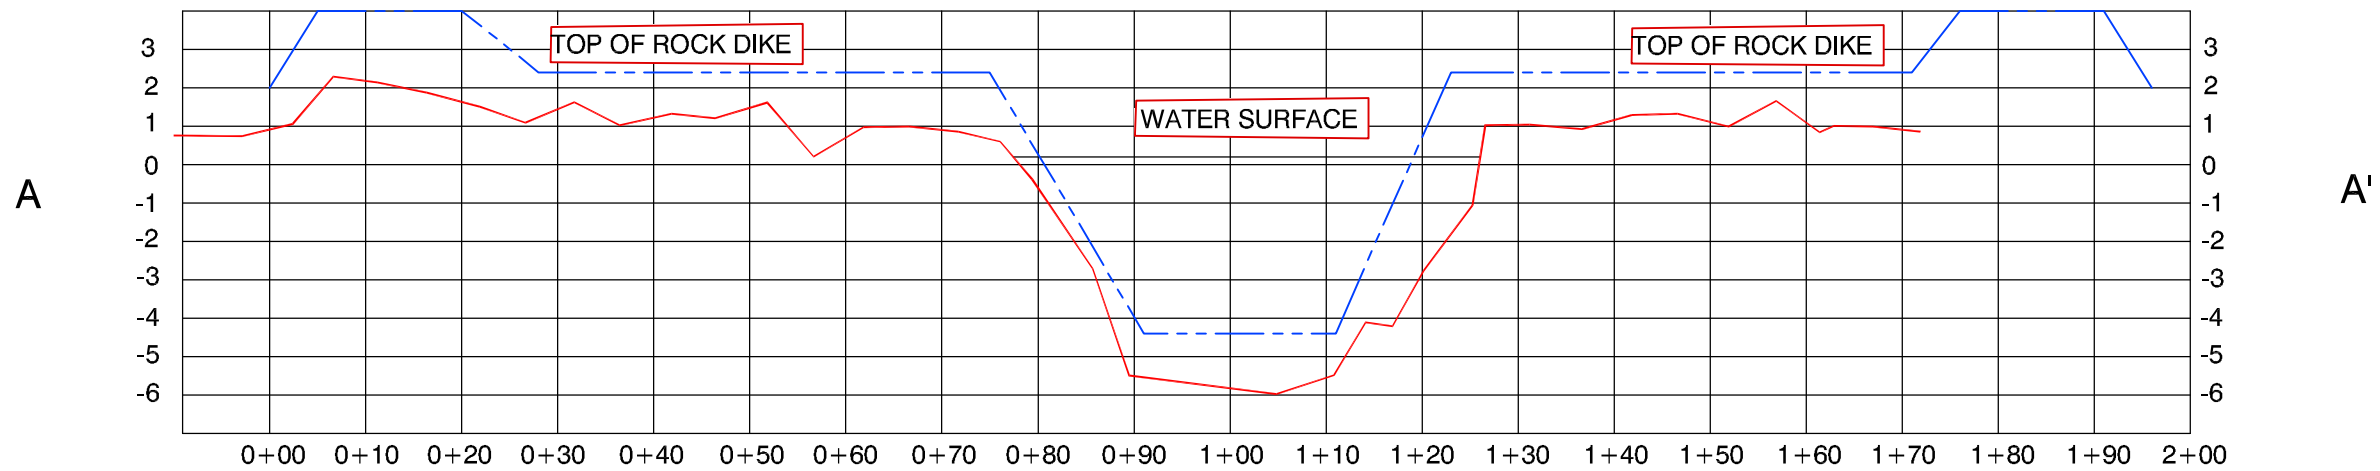
SRUCTURE 7 PROFILE

Structure No.7 appeared to be in fair condition with no visual damage to the rock weir. The as-built drawings indicate that the fixed crest rock weir was constructed to elevations of -4.4 NAVD 88 at the boat bay and +2.4' NAVD 88 on the north and south sides, between the bank section and the boat bay. The elevation profile of Structure No.7 in 2008 revealed that the rock weir had settled uniformly throughout with settlement ranging from 1.0' to 1.5'. All signs, supports and earthen embankment tie-ins appear to be in good condition. The settlement of Structure No.7 is considered to be minor and is not recommended for corrective actions at this time. (Appendix B: Photos 8-10). The 2008 survey profile and as-built section of Structure No.7 is shown in Appendix D.

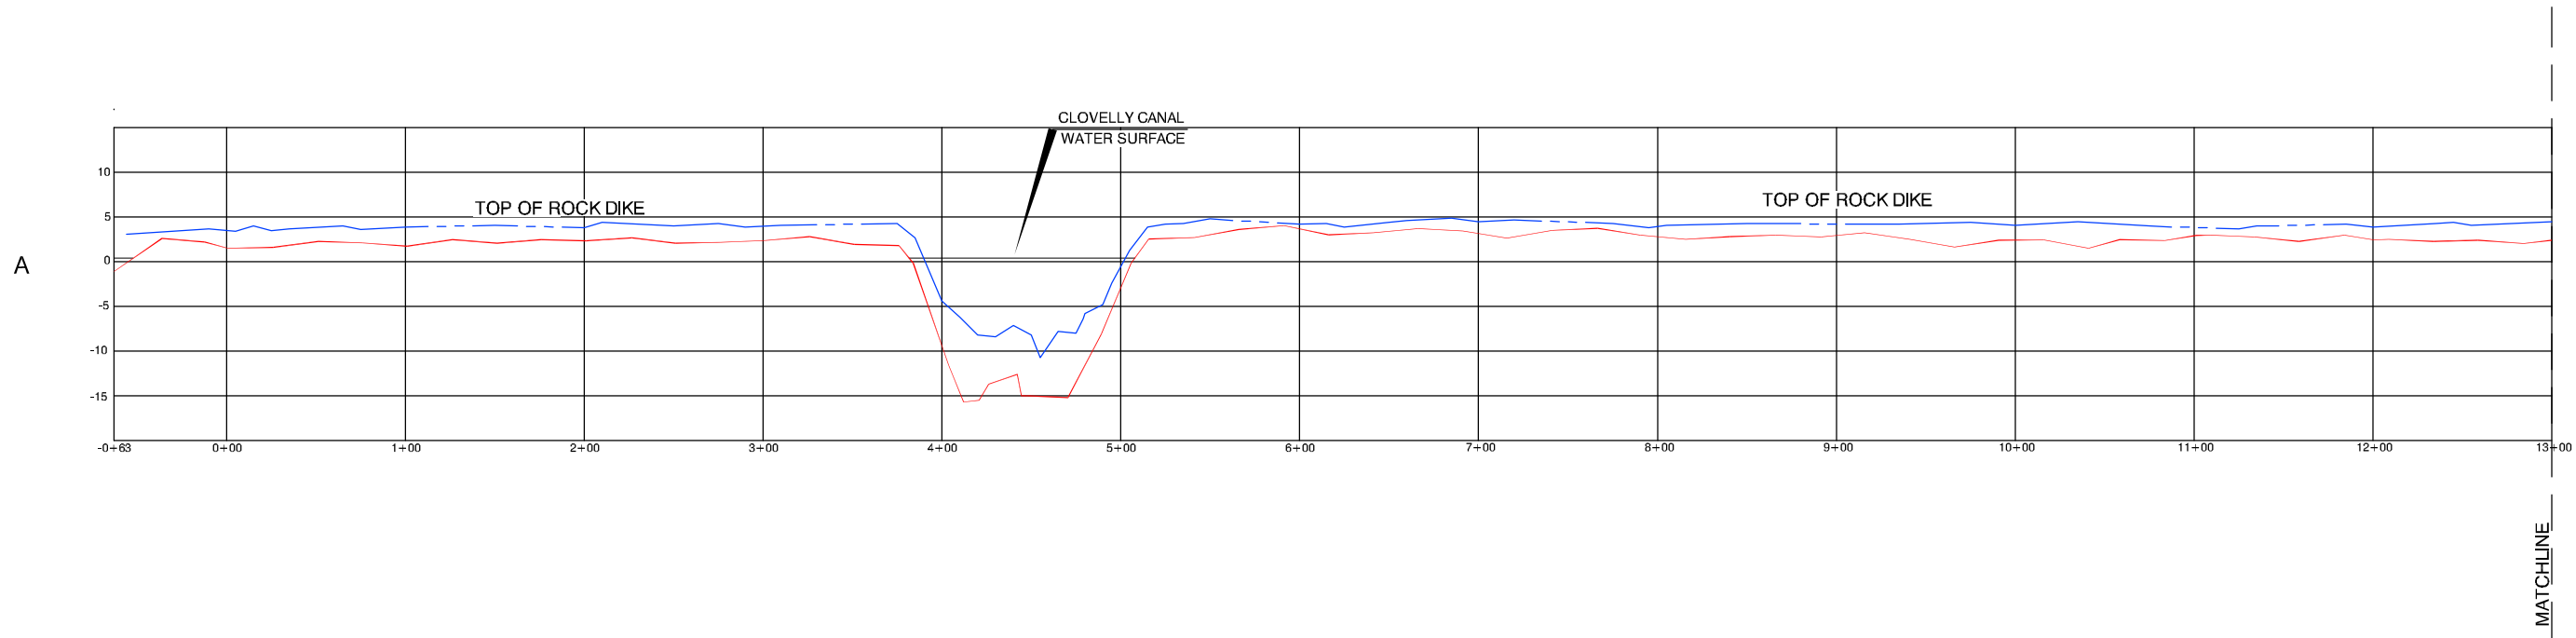
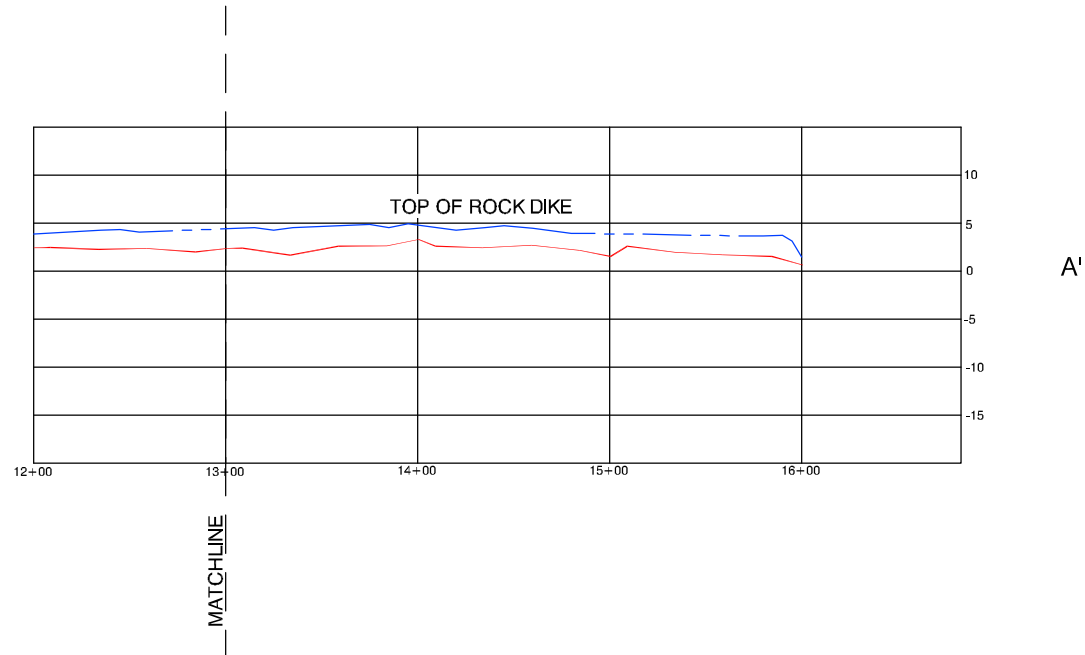
STRUCTURE 14A PROFILE

The fixed crest weir with barge bay was in fair to good condition with minor settlement and displacement of rock rip-rap on the south side of the barge bay. The crest of the structure on both sides of the barge bay was constructed to an elevation of +4.0 NAVD. The scour pad at the bottom of the barge bay was constructed to -6.5' NAVD. From the most recent survey information collected in 2008, it was determined that the crest elevations of the rock weir on both sides of the barge bay faired very well since construction. It appears that the crest elevations north of the barge bay did not settle at all, while the crest elevations on the south side experienced only minor settlement, less than 1.0'. The most noticeable settlement and/or scour were at the bottom of the barge bay itself. The 2008 survey data show bottom depths ranging from -6.5' to -15' NAVD88 indicating that the scour pad and riprap at the bottom of the channel had eroded or washed out by the strong currents through the structure. It is recommended that the rock scour pad be reconstructed to the original design elevations. Due to the strong currents through the barge bay, we are also recommending that a larger rock be used to slow the rate of scour. The 2008 survey profiles of Structure No.14A are shown in Appendix D.

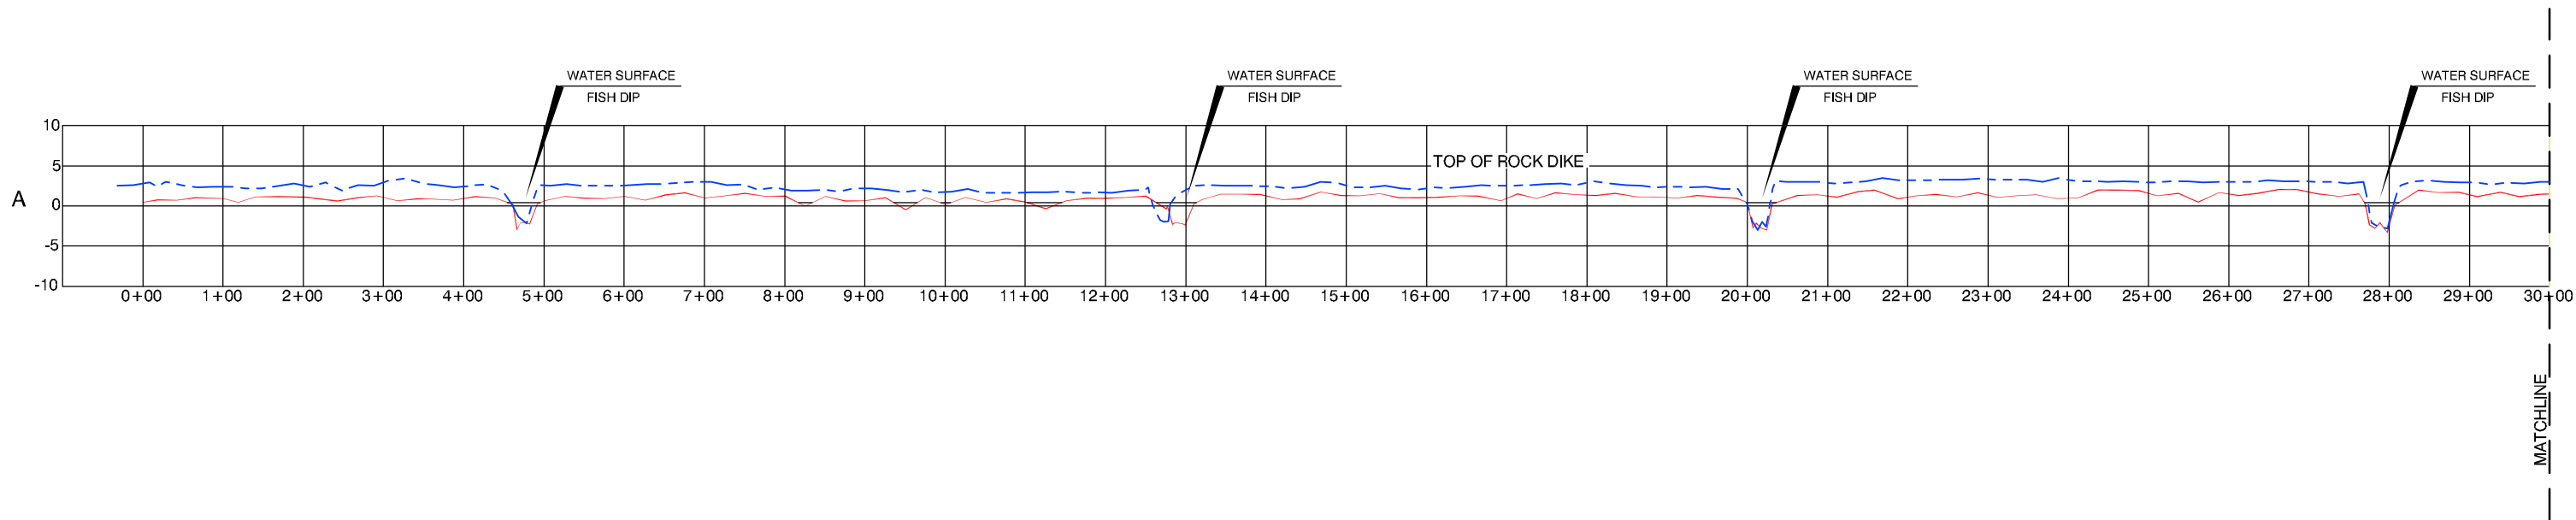
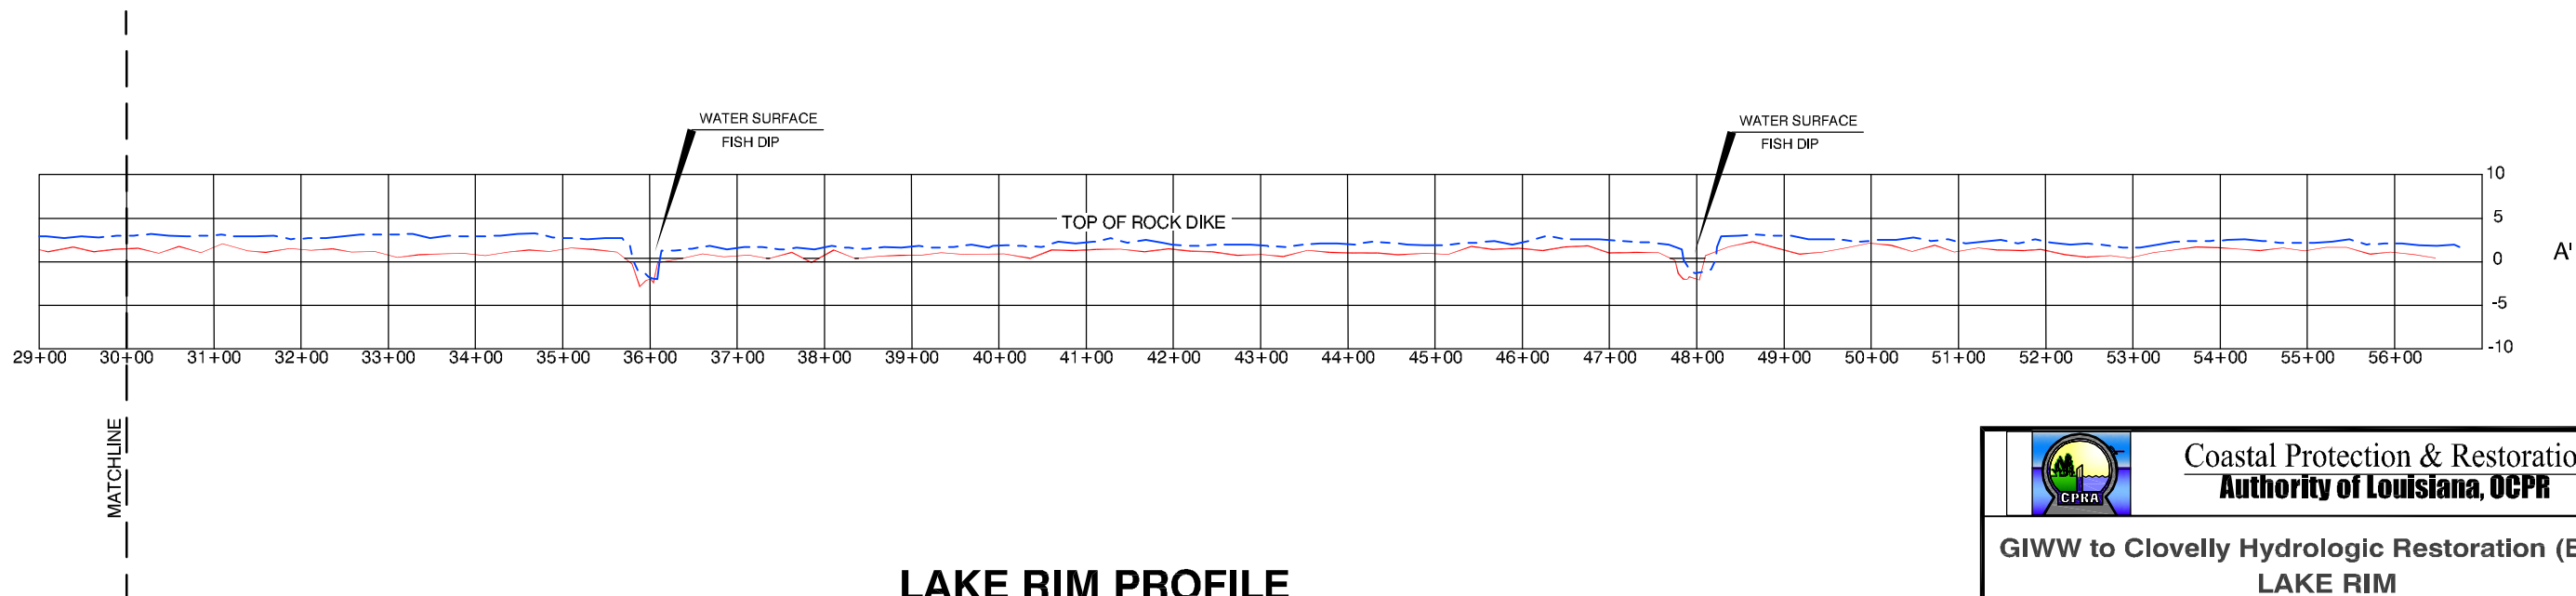
LAKE RIM PROFILE

As indicated in the inspection results and on previous inspections, a large portion of the rock dike along the lake rim has settled below the constructed crest elevation. From depths reading taken at random locations on the lake side of the structure, it was determined that access dredging is unlikely since depths appear to be adequate to float barges during construction. The method of repair includes recapping the foreshore rock dike with rip rap along entire length of the structure to the original design elevation. Detailed construction costs are outlined in the budget worksheet under Appendix C.
