**State of Louisiana
Office of Coastal Protection and
Restoration**

2009 Annual Inspection Report

**POINT AU FER ISLAND
HYDROLOGIC RESTORATION**

State Project Number TE-22
Priority Project List 1

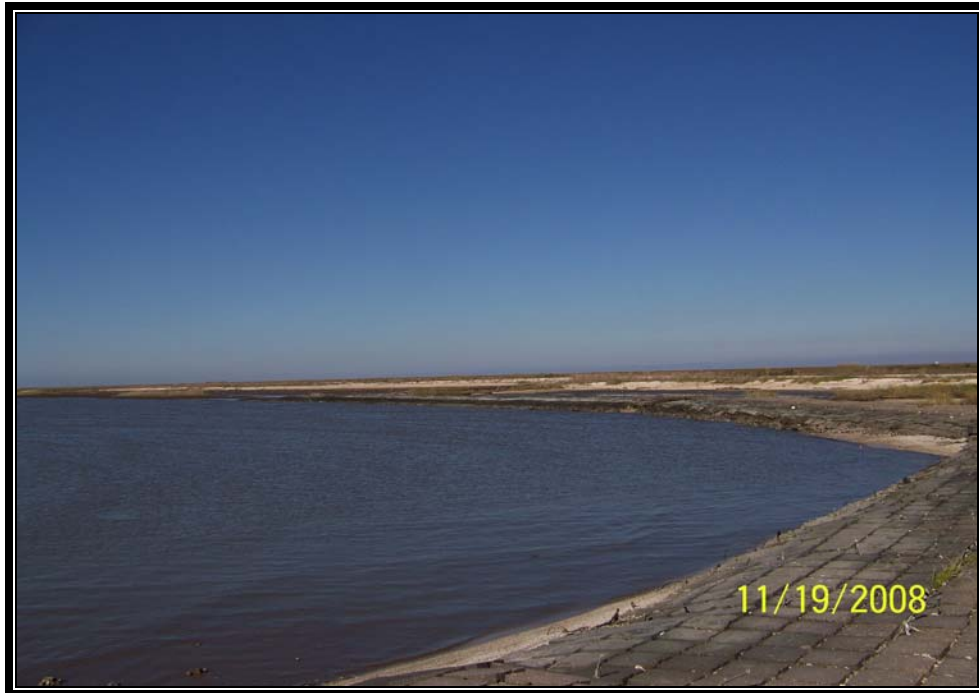
Photo No. 1 (0922) – view of Petraflex mats on the west side of Plug No.4A looking west.

Immediate maintenance recommendations include surveying of the shoreline and shoreline protection along both the west and east mats and tie-ins in order to determine the best course of action to prevent breaching of the Gulf into the Canal. Preliminary recommendations would include constructing a rock lift on the west mats, closing off the connection behind those mats with a rock dike extension back to the shoreline, and for the east extending and constructing a rock lift on the 2005 extension dike.

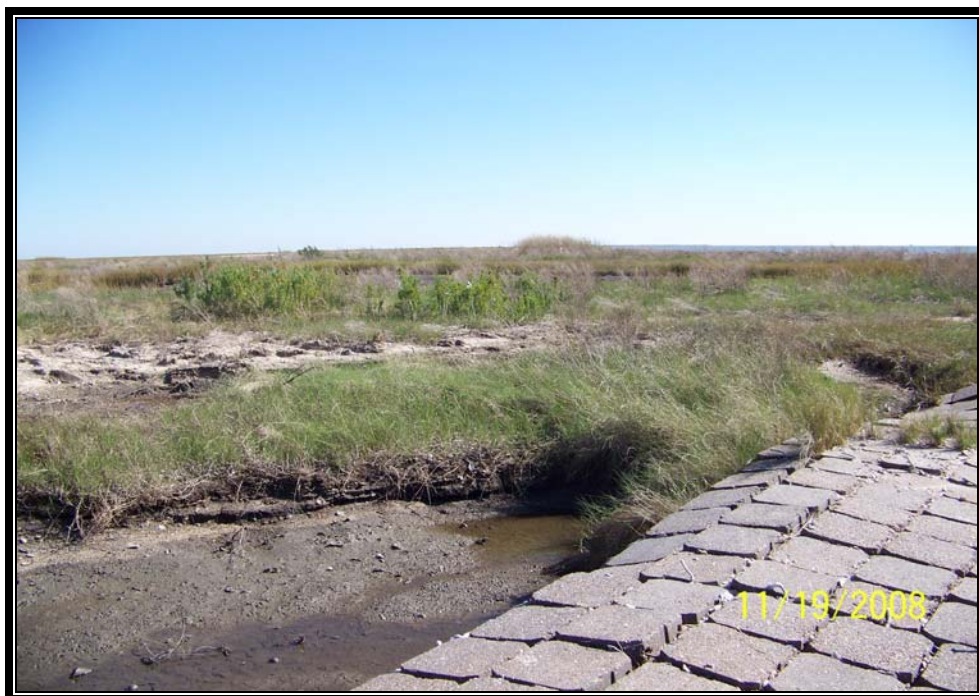
Photo No.2 (0923) – view of marsh behind Petraflex mats on the west side of Plug No. 4A looking east. Erosion can be seen behind the mats.

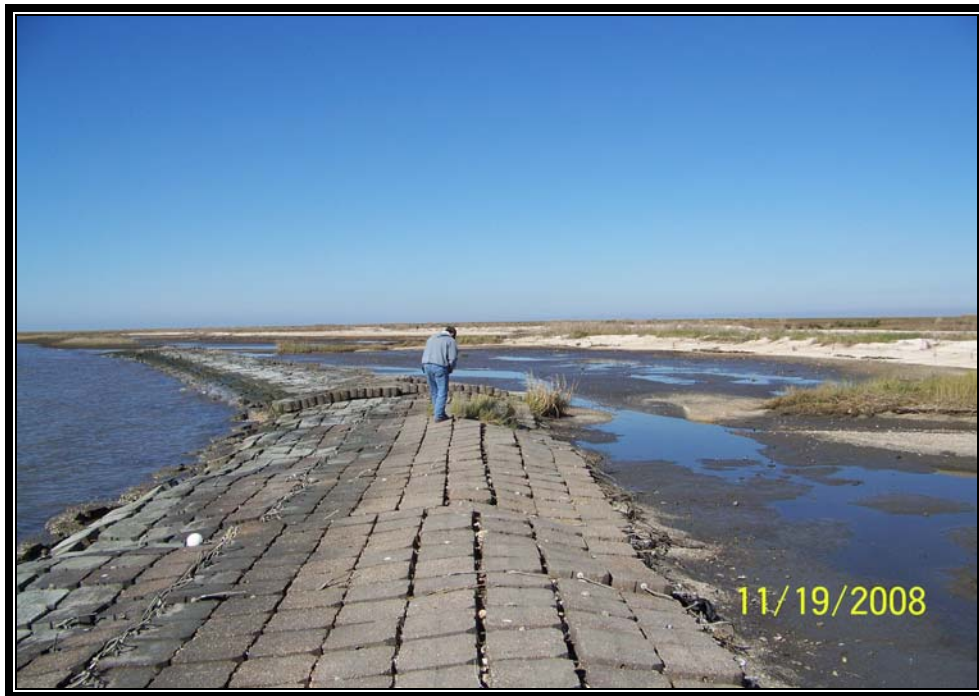
Photo No.3 (0924) – view of Petraflex mats on the west side of Plug No. 4A looking west along the shoreline. The shoreline has retreated as a result of erosion around the mats.

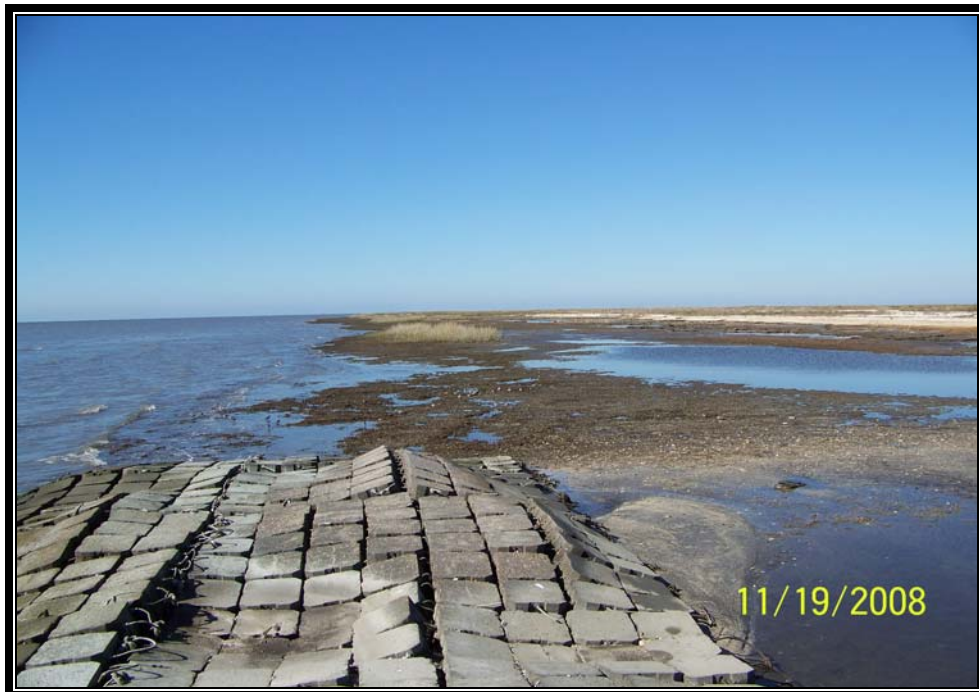
Photo No.4 (0925) - view at the end of the Petraflex mats on the west side of Plug No. 4A looking west. Erosion pattern typical at termination point of shoreline protection can be seen.

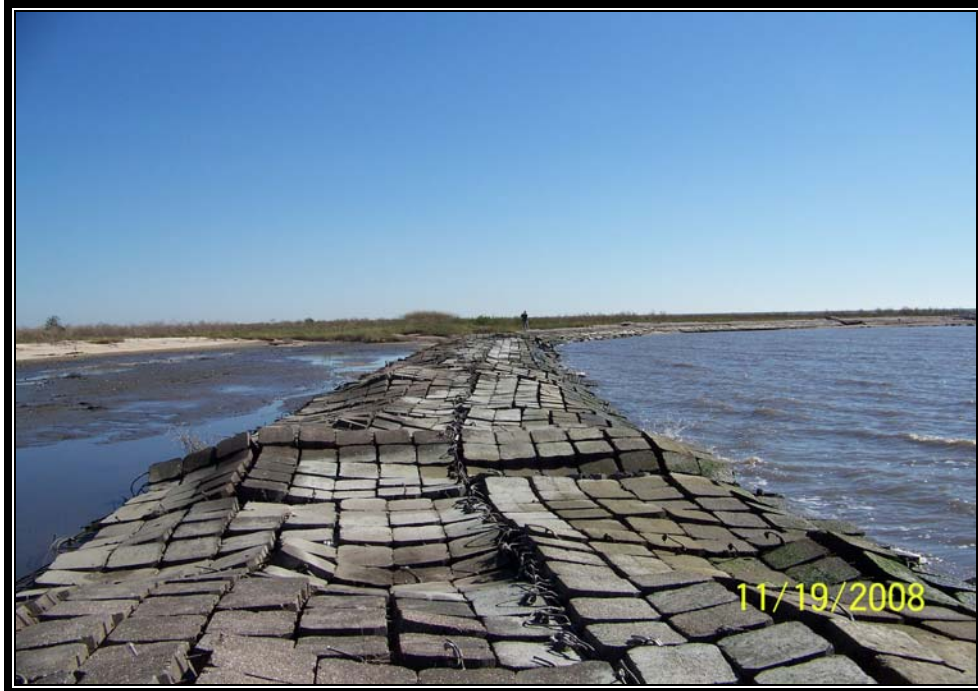
Photo No.5 (0926) – view of Petraflex concrete mats on the west side of Plug No. 4A looking east. Erosion can be seen between the concrete mats and shoreline which has receded inland.

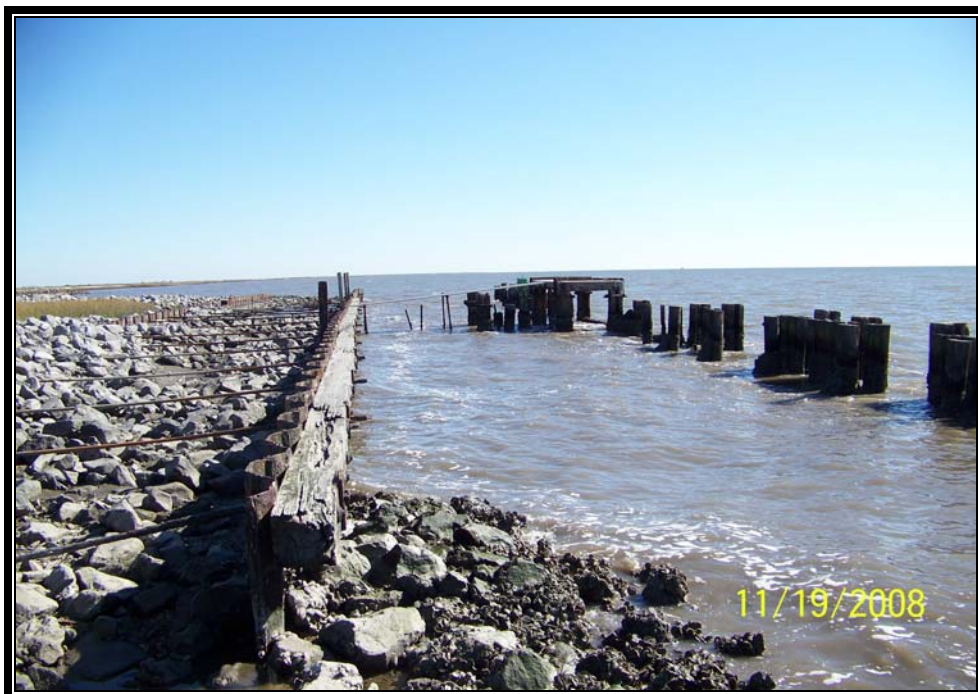
passing behind the bulkhead and over the rocks into Transco Canal. The steel sheetpile and tie-rods are heavily corroded and should continue to be monitored.

Photo No. 6 (0927) – Plug No. 4A – view of steel sheet pile at the south end of Transco Canal looking east.

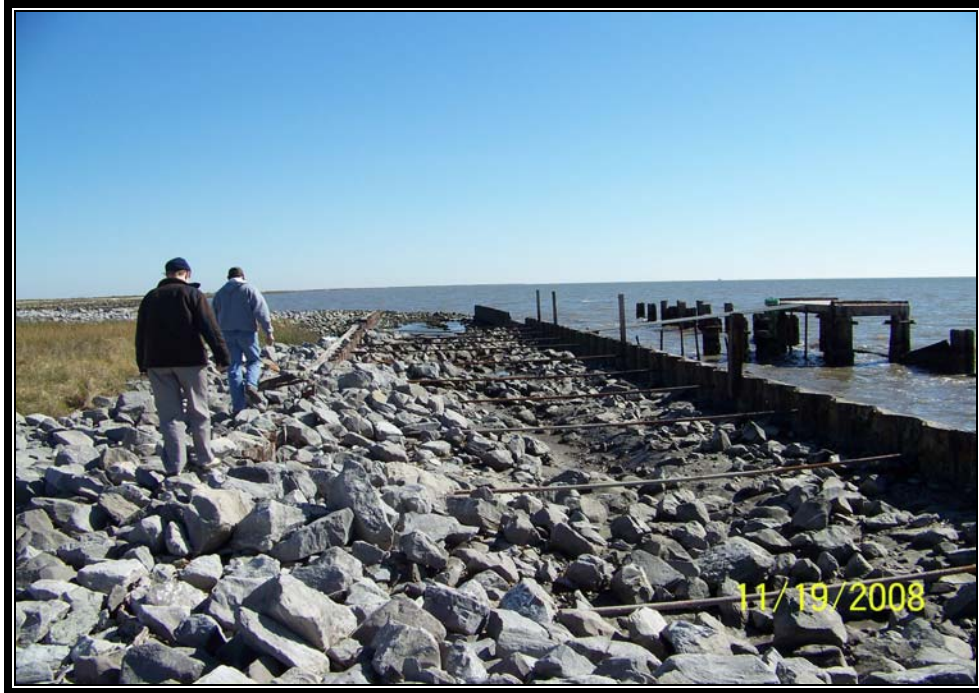
Photo No.7 (0928) - Plug No. 4A – view of steel sheet pile and rock riprap behind bulkhead looking east.

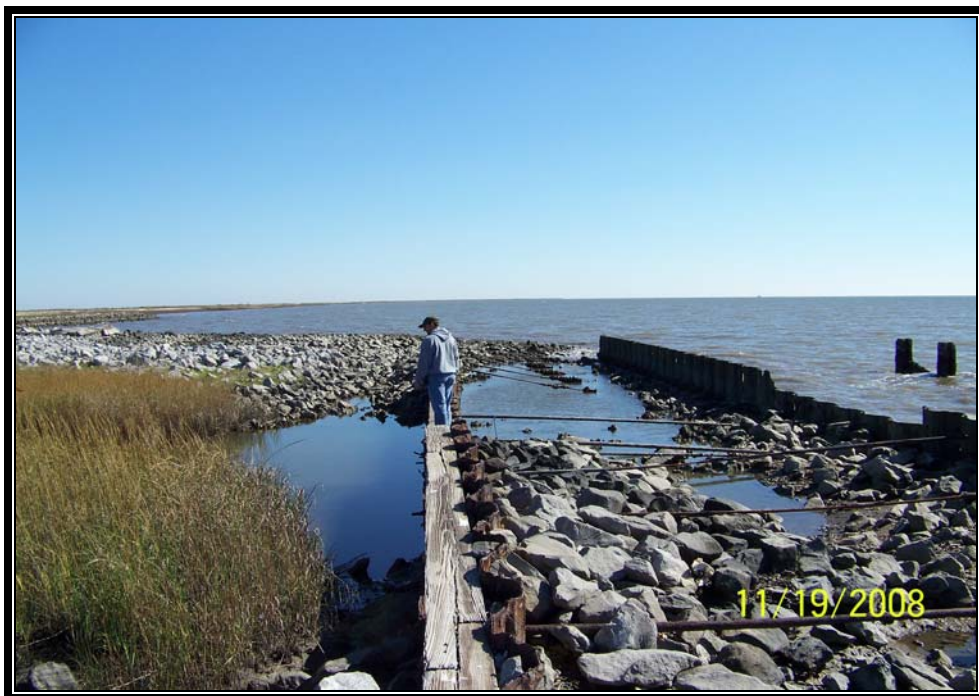
Photo No.8 (0929) – view of Plug No. 4A looking east. The rock material behind the sheet pile placed by the pipeline company has been displaced by recent topical events.

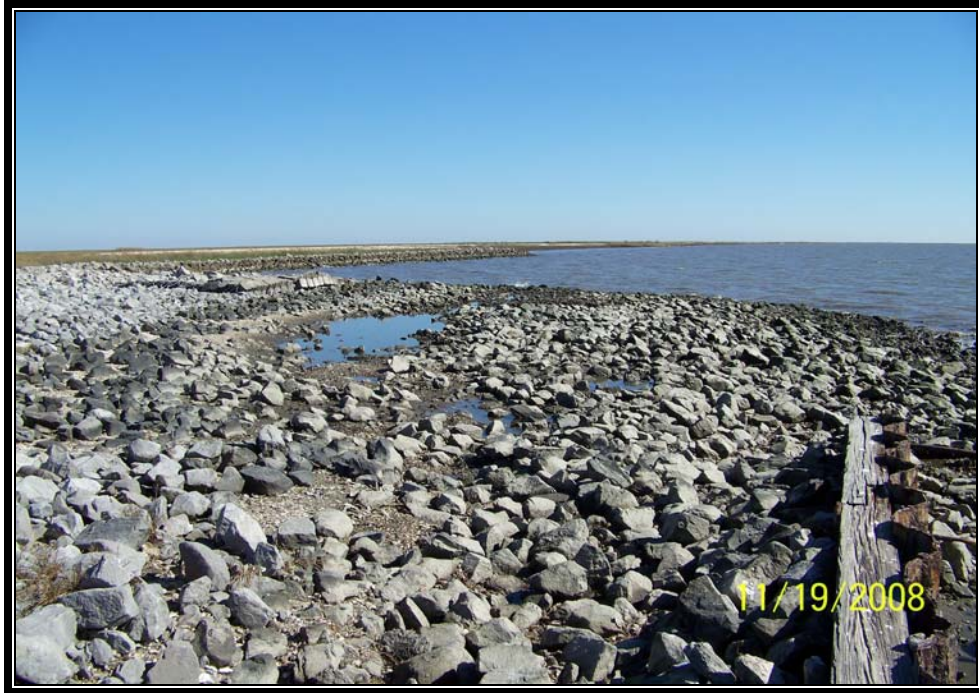
Photo No.9 (0930) – displaced rock on the back side of Plug No. 4A looking east. This rock was installed by the pipeline company.

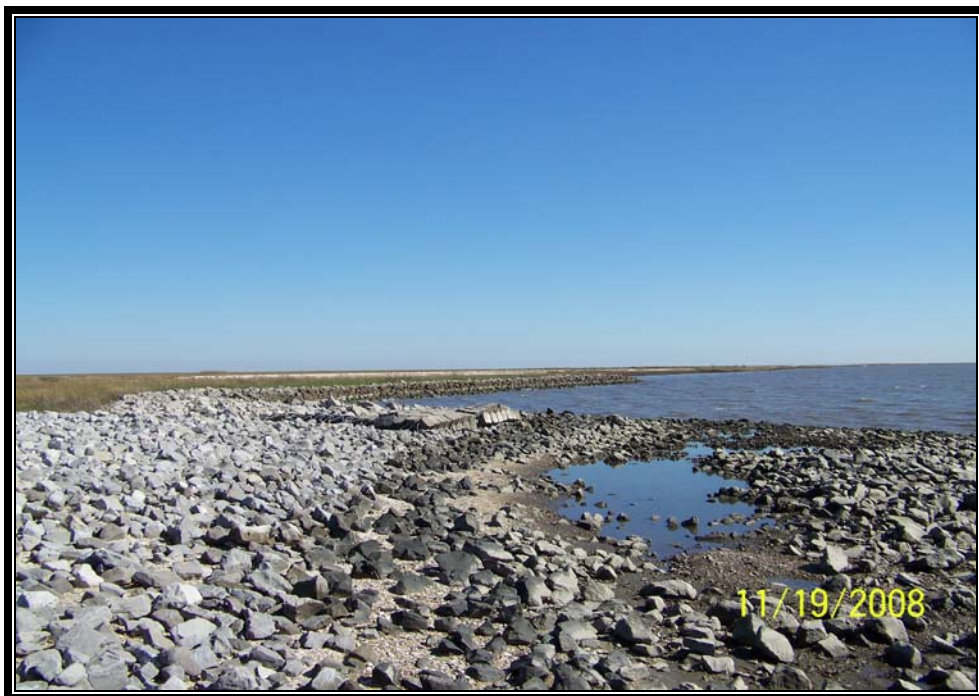
Photo No.10 (0931) – rock covering the existing Petraflex mats on the east side of Plug No. 4A. The rock installed by the pipeline company has been displaced along the shoreline.

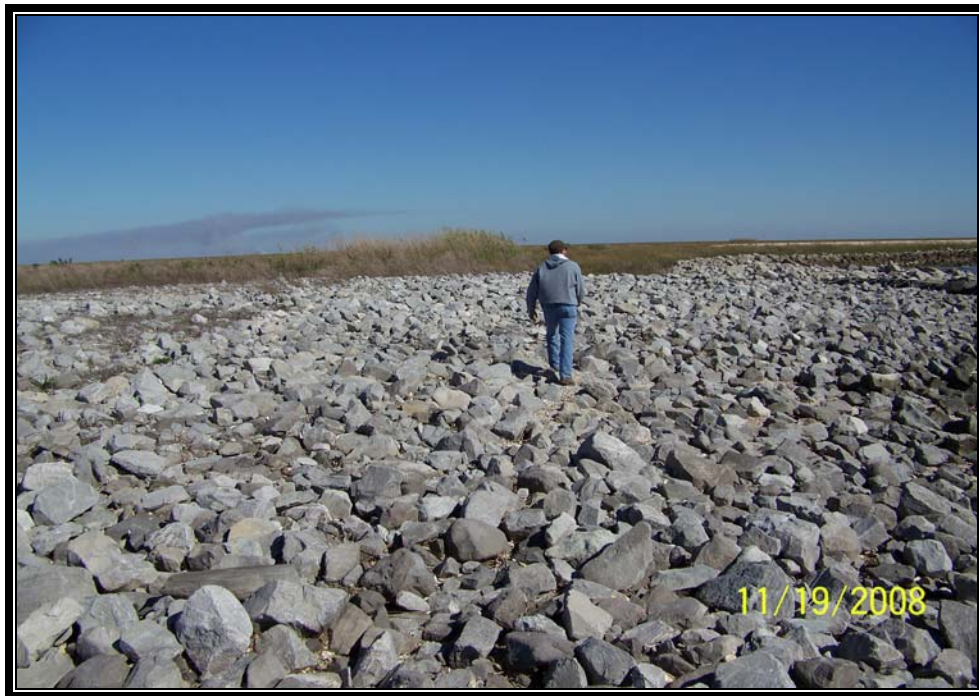
Photo No.11 (0932) – dispersed rock installed by the pipeline company on the east side of Plug No. 4A looking east.

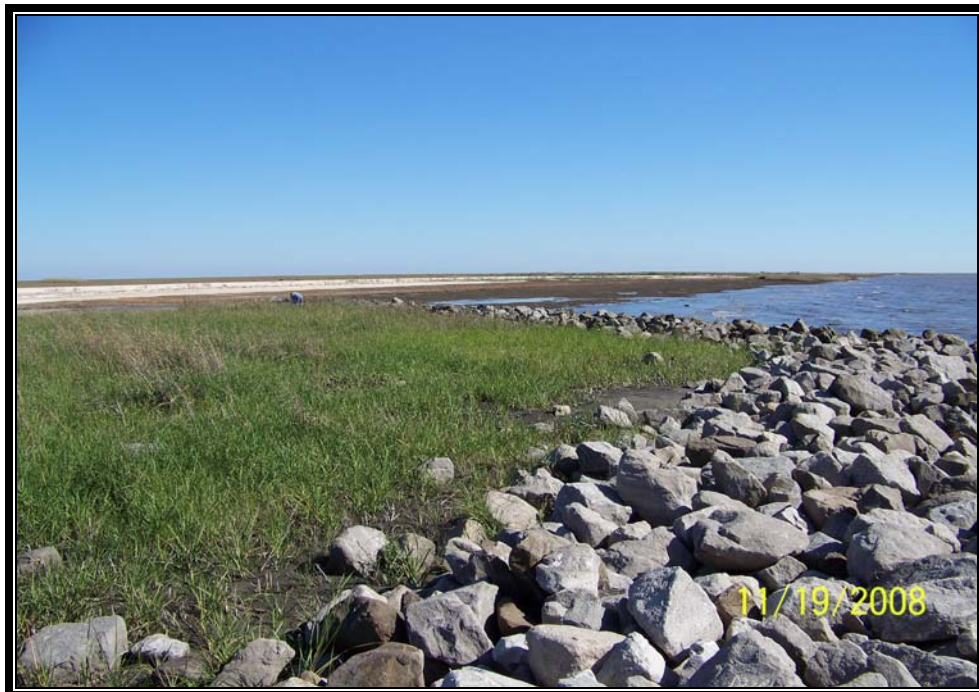
Photo No.12 (0933) – view of the CWPPRA maintenance project completed in 2005. The project capped mats on the east side of Plug No. 4A with rock and extended the rock dike to the shoreline.

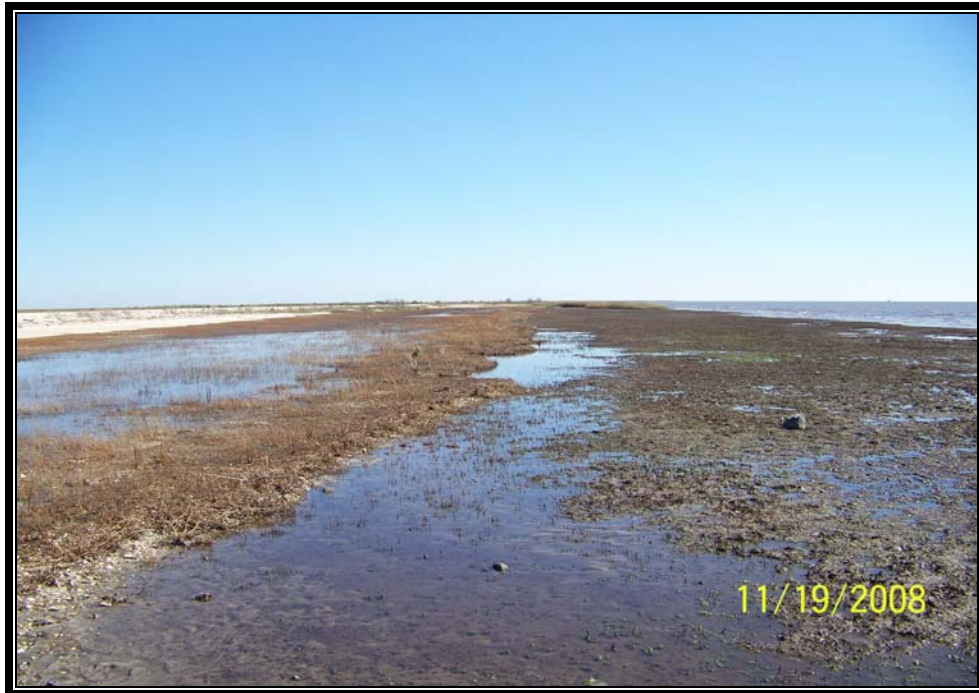
Photo No.13 (0934) – Shoreline erosion at termination point of the rock dike on the east side of Plug No. 4A.

At Plug No. 4A (Transco at Gulf) in order to address the continued erosion at the west shoreline tie-in, behind the west mats, and at the east shoreline tie-in, recommendations include surveying of the west mats and tie-in area and the east rock dike extension and shoreline tie-in. Depending on the results of the survey, maintenance activity recommendations may include constructing a rock lift on the west mats, closing off the connection behind those mats with a rock dike extension back to the shoreline, and for the east extending and constructing a rock lift on the 2005 extension dike (See Appendix D).

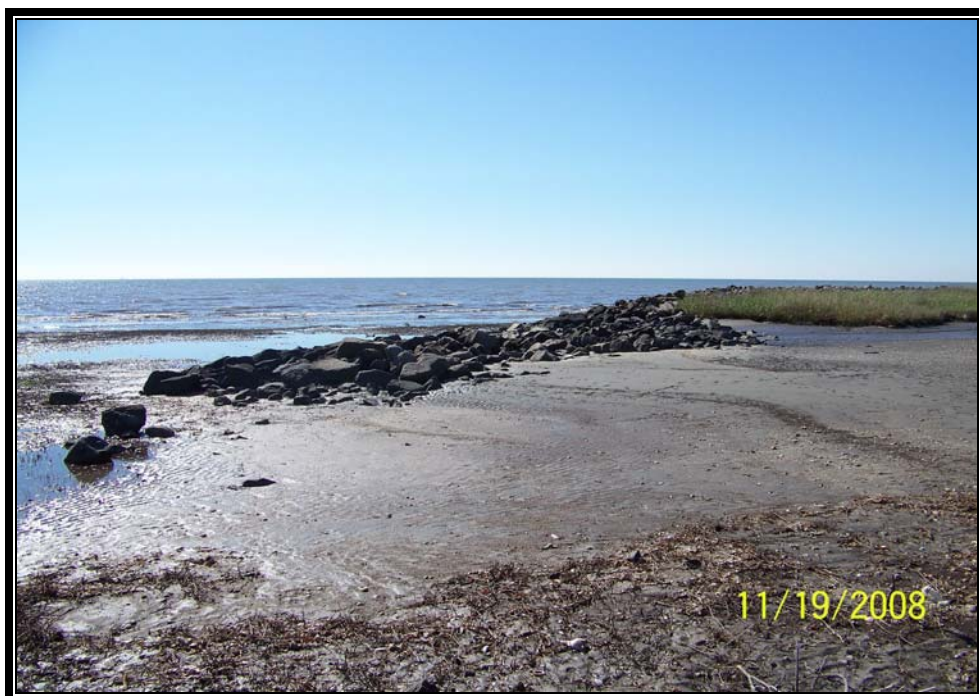
Photo No.14 (0935) – rock dike extension at shoreline on the east side of Plug No. 4A.

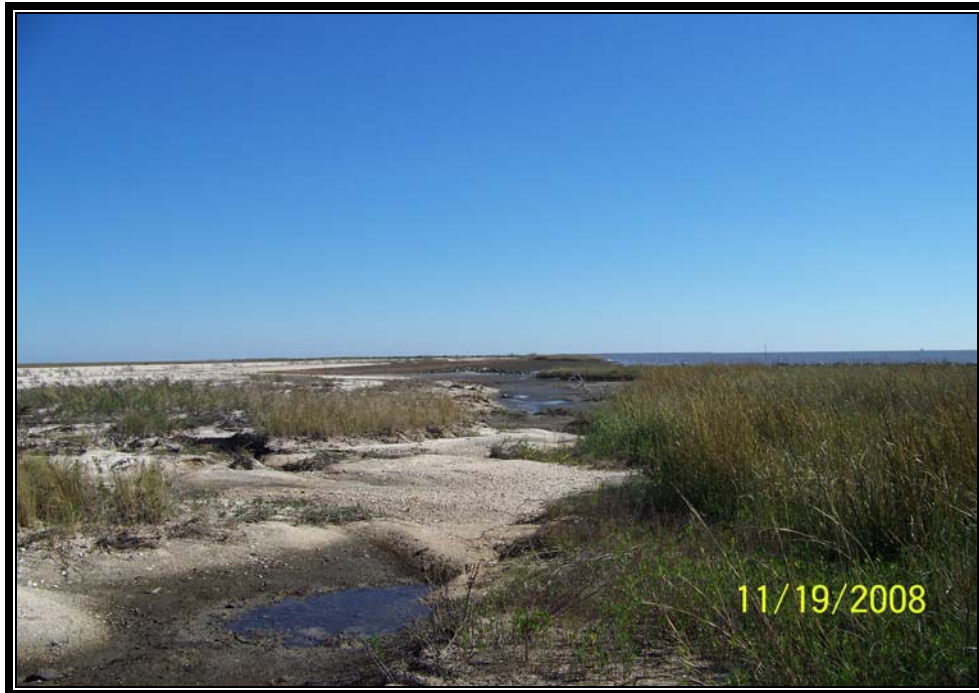
To the east of the bulkhead, the erosion directly behind the east mats noted on inspections prior to 2006 has been slowed or halted since the rock lift placed in 2005. Material has accreted behind the rock lift, and that deposited material is now vegetated. However, continued shoreline erosion was noted at the shoreline tie-in of the 2005 maintenance rock (east end of extension dike). On the west side, the west mats appear to have settled some but are in good condition. The west end of the mats is no longer connected to the shoreline due to erosion of the shoreline around the tie-in. Consequently tidal exchange is now occurring behind the mats, and erosion of the shoreline behind the mats was noted similar to that observed behind the east mats prior to the 2005 maintenance event. At the existing bulkhead, there continues to be a small exchange between the Gulf and Transco Canal where water is

Photo No.15 (0936) – vegetation on accreted material behind the rock dike on the east side of Plug No. 4A.

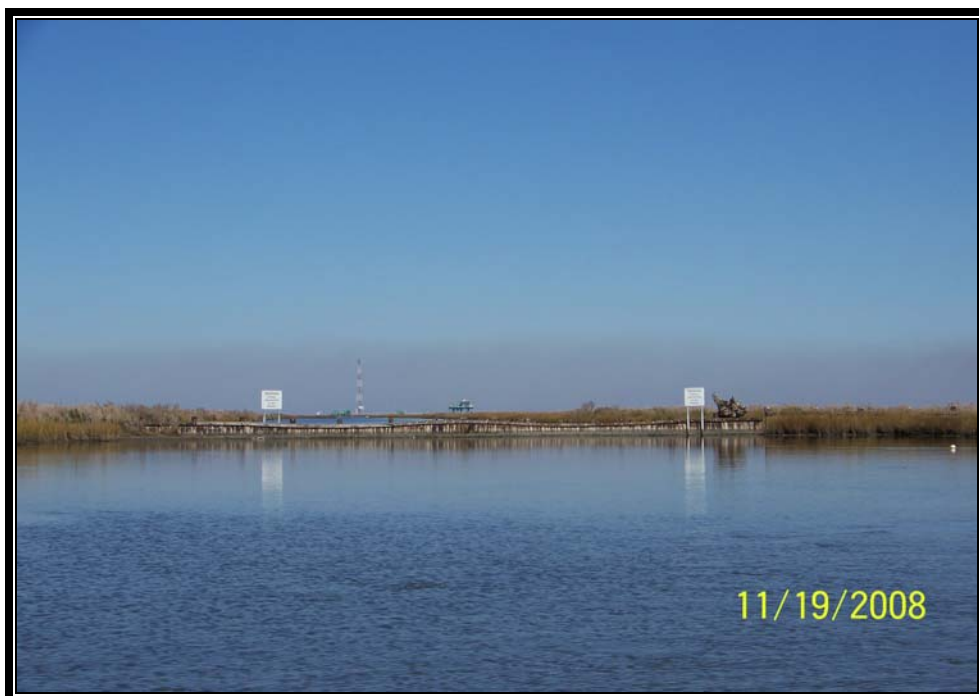
The timber bulkhead appears to be in good condition despite the existing deflection of the middle of the structure which occurred during construction. Both tie-ins appear intact with no apparent signs of erosion. The warning signs and supports were also in good condition. At this time no maintenance is recommended at Plug No. 6; however, the condition of the timber bulkhead should continue to be monitored on future site visits.

Photo No.16 (0937) – Plug No.6 – view of timber bulkhead plug looking north in Transco Canal.

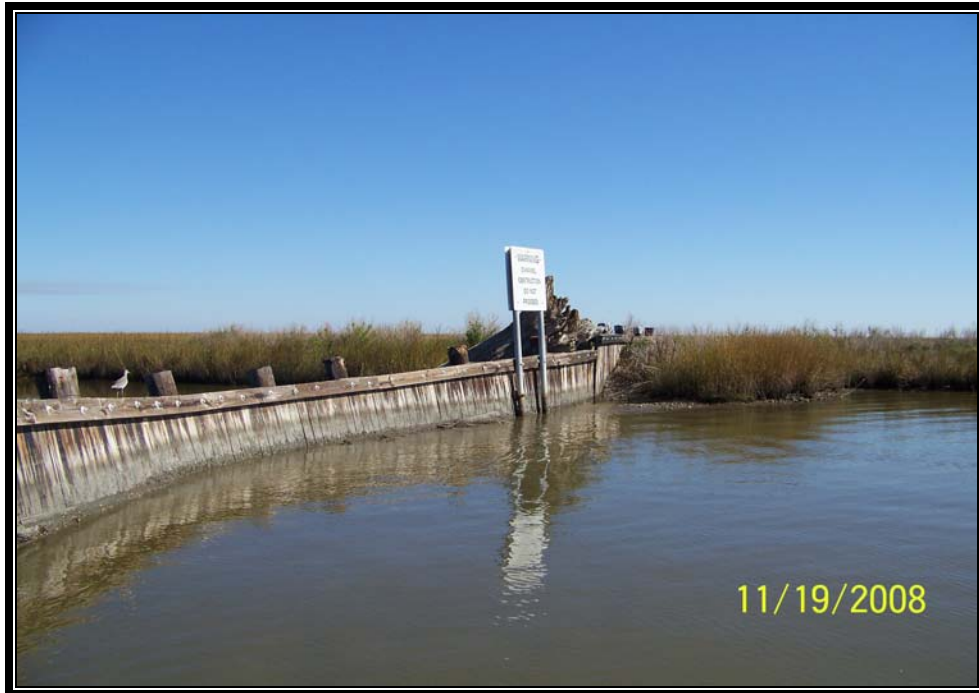
Photo No.17 (0938) – Plug No.6 – view of plug looking east along the timber bulkhead in Transco Canal. The deflection of the bulkhead occurred shortly after construction.

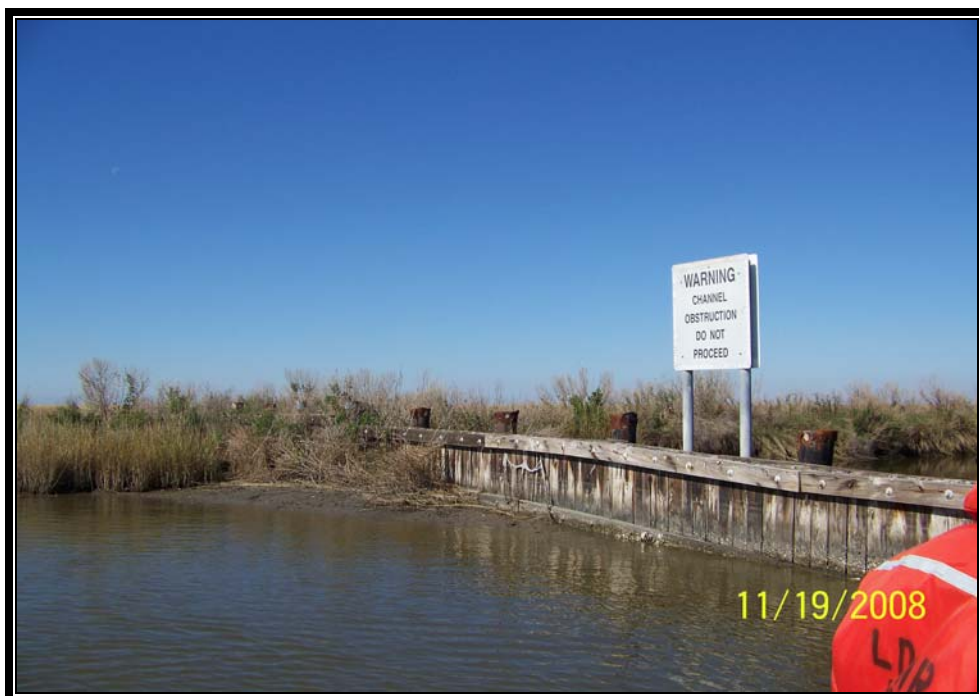
Photo No. 18 (0939) – Plug No.6 – view of plug looking west along the timber bulkhead in Transco Canal.

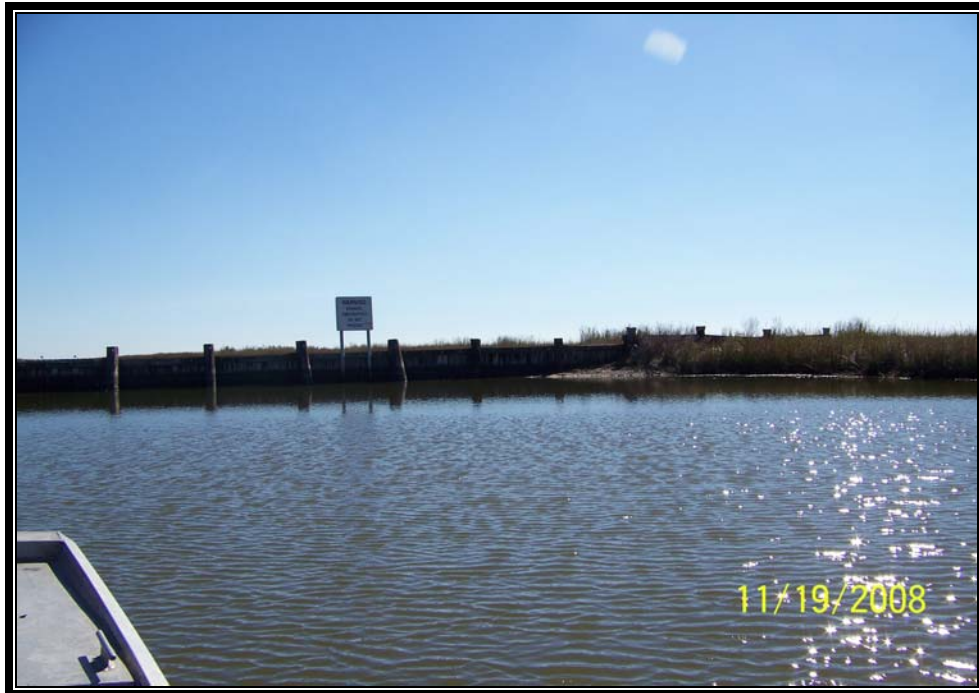
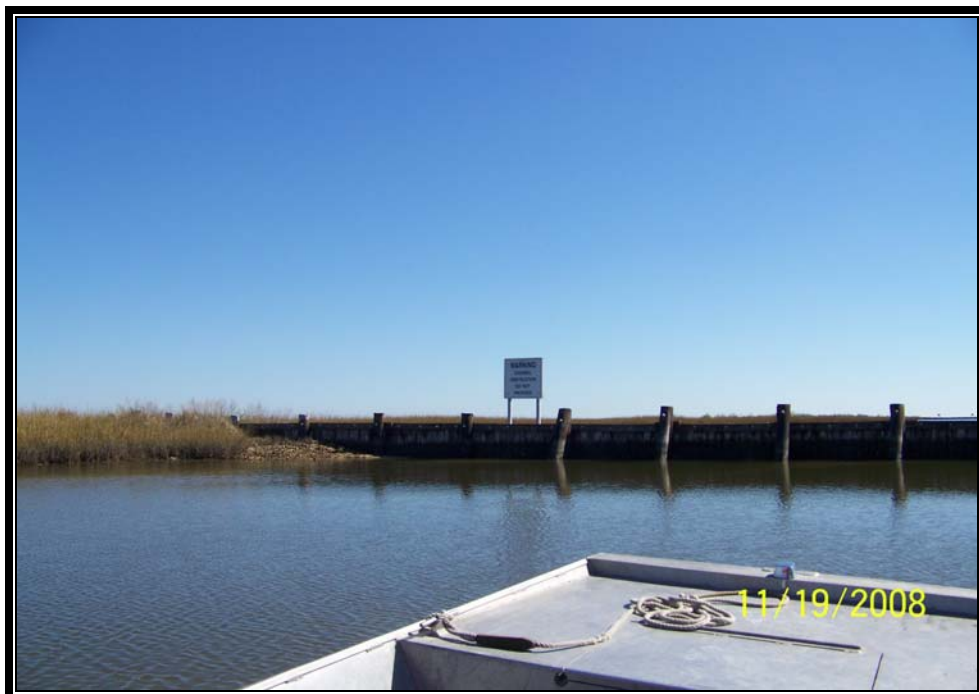
The timber bulkhead plug located across Hester Canal east of Transco Canal appeared to be in good condition with no noticeable structural defects. The tie-ins at the banks had no apparent signs of erosion. The warning signs and supports were also in good condition. No maintenance will be required at Plug No. 7.

Photo No. 19 (0940) - Plug No.7 – view of plug and tie-in at south bank from inside looking southeast in Hester Canal.

Photo No. 20 (0941) – Plug No.7 – view of plug and tie-in at north bank from inside looking southeast in Hester Canal.

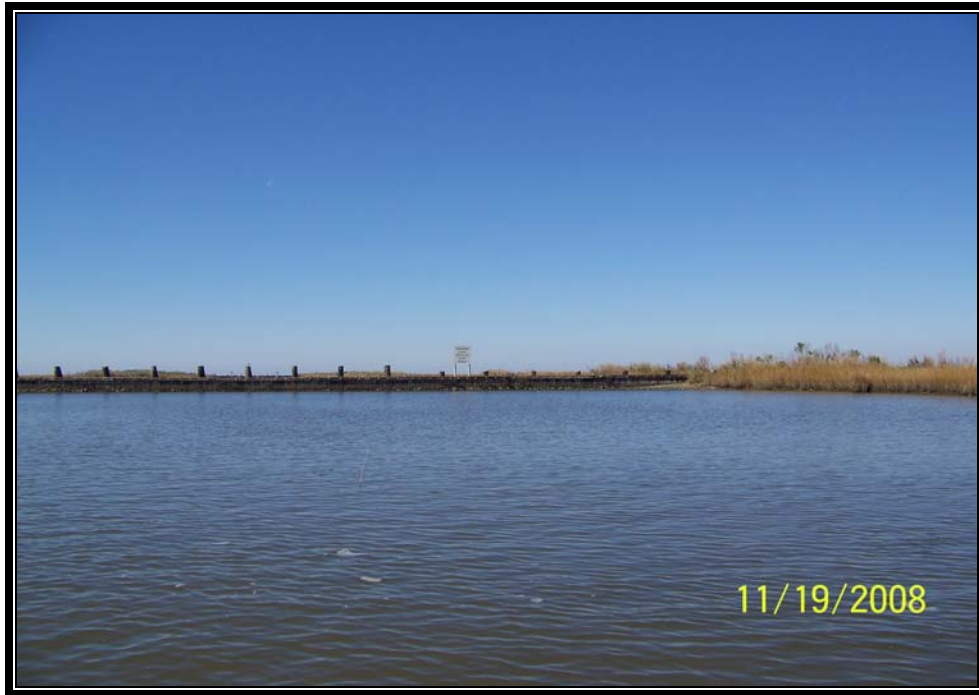
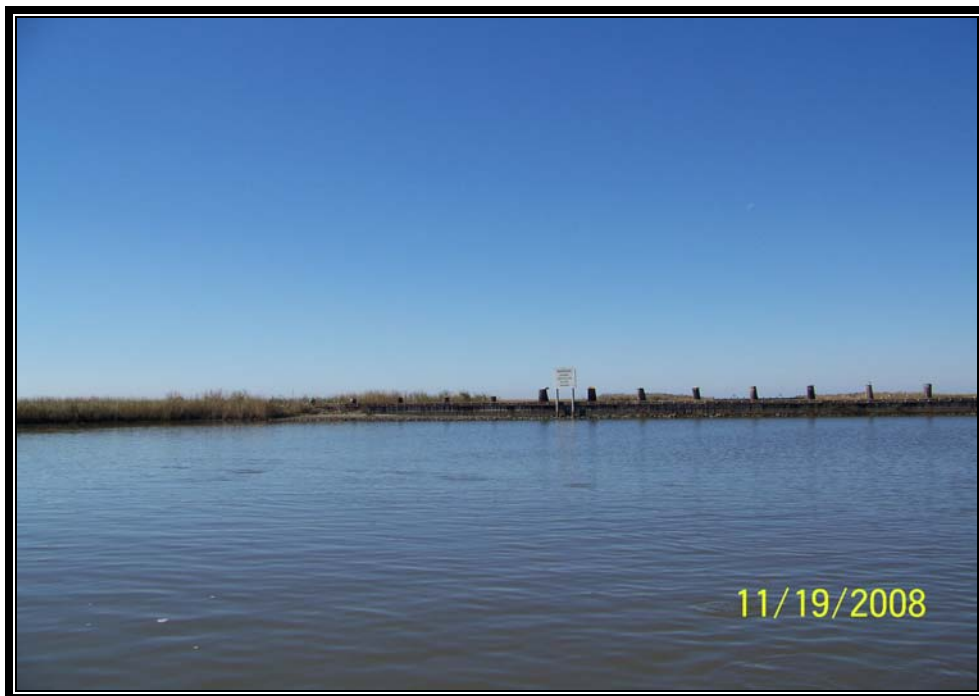
The timber bulkhead plug located across Hester Canal just west of Transco Canal appeared to be in good condition with no noticeable structural defects. The tie-ins at the banks had no apparent signs of erosion. The warning signs and supports were also in good condition. No maintenance will be required at Plug No. 2.

Photo No.21 (0942) – Plug No.2 – view of the timber bulkhead plug in Hester Canal from inside (east side).

Photo No.22 (0943) – Plug No.2 – view of timber bulkhead plug in Hester Canal from inside (east side).

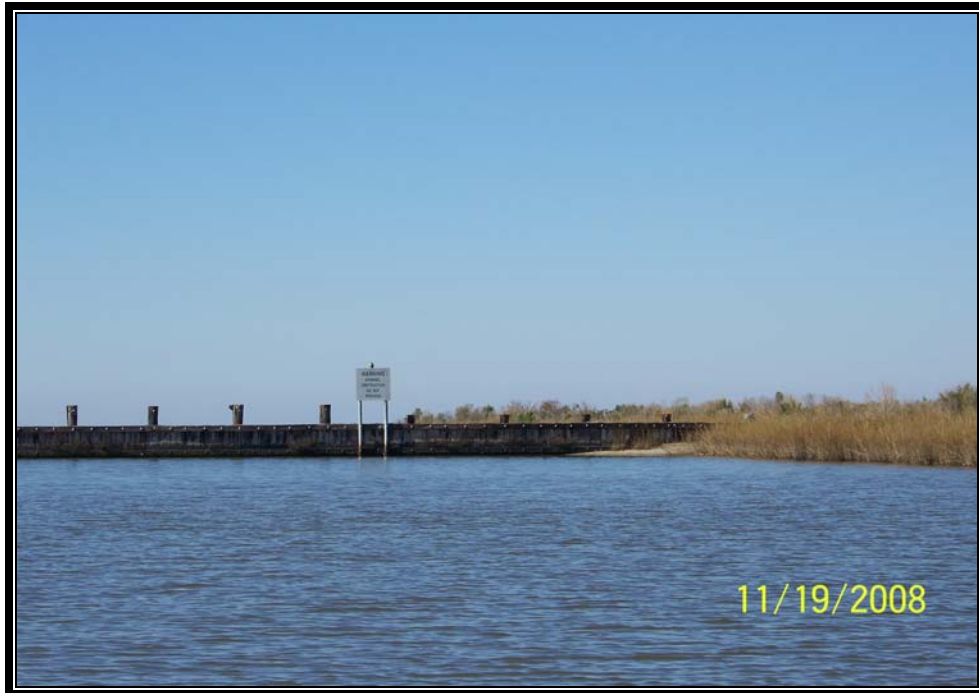
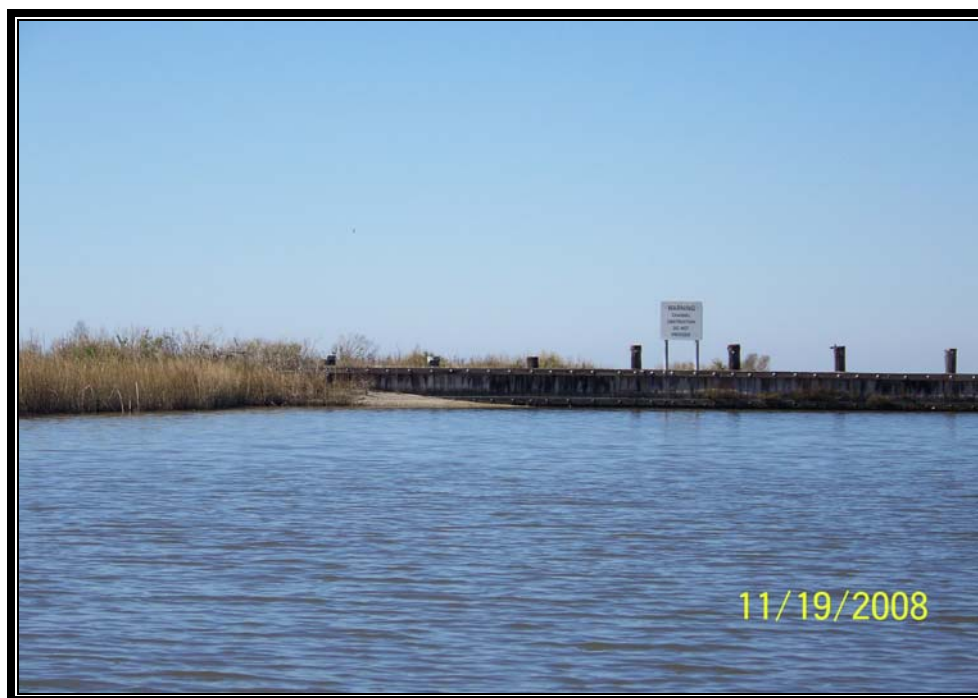
The timber bulkhead plug located on the west end of Hester Canal near Mosquito Bay appeared to be in good condition with no noticeable structural defects. The tie-ins at the banks had no apparent signs of erosion. The warning signs and supports were also in good condition. No maintenance will be required at Plug No. 1.

Photo No. 23 (0942) – Plug No.1 – view of timber bulkhead plug and north bank tie-in from inside (east side) in Hester Canal looking west.

Photo No.24 (0945) – Plug No.1 – view of timber bulkhead and south bank tie-in from inside (east side) in Hester Canal looking west.

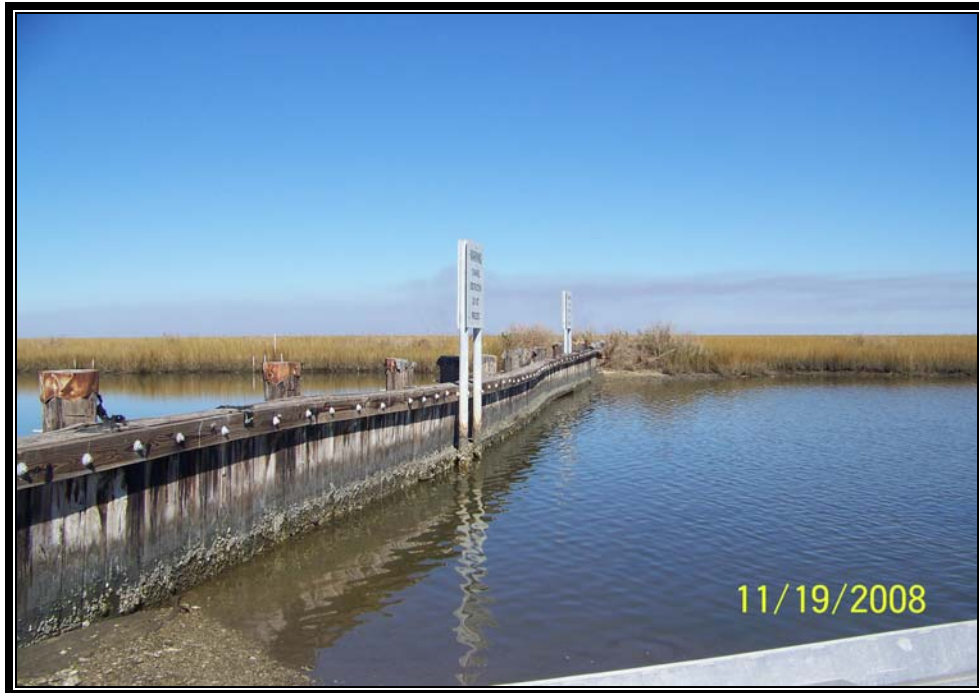
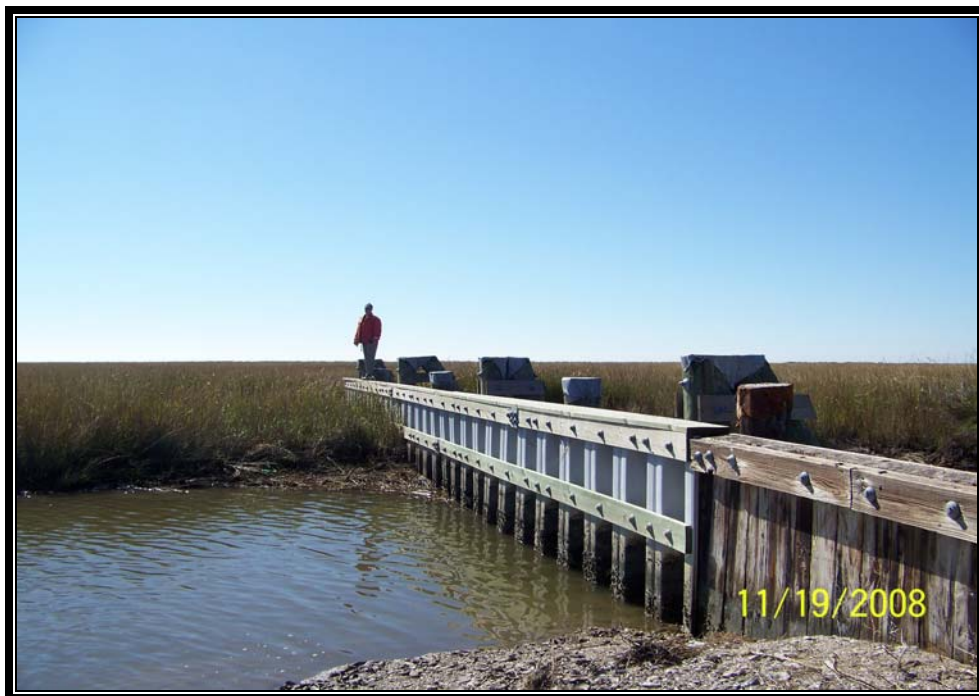
The timber bulkhead is in good condition. The breach around the south end noted on inspections prior to 2006 was closed in 2005 by construction of a vinyl sheet pile bulkhead extension approximately 60' in length. The concrete mats (scour pad) have limited the erosion at the south tie-in. The north tie-in at the canal bank had no apparent signs of erosion. The warning signs and supports were in good condition. No maintenance will be required at Plug No. 8.

Photo No.25 (0946) – Plug No.8 - view of plug looking north along timber bulkhead in Hester Canal.

Photo No. 26 (0947) – Plug No. 8 - view of the south bank tie-in and maintenance extension of sheet pile wall.

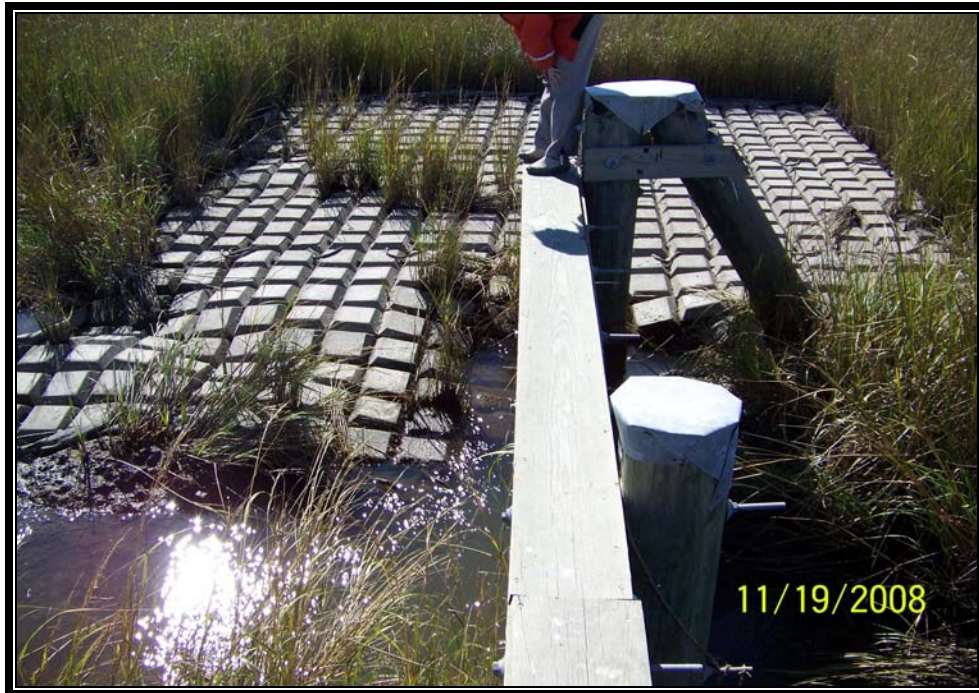
Photo No.27 (0948) – Plug No.8 – View of south tie-in at end of 2005 maintenance extension of sheet pile wall. Submar mat scour pads can be seen. No new scour or erosion of marsh on the southern end of the structure.

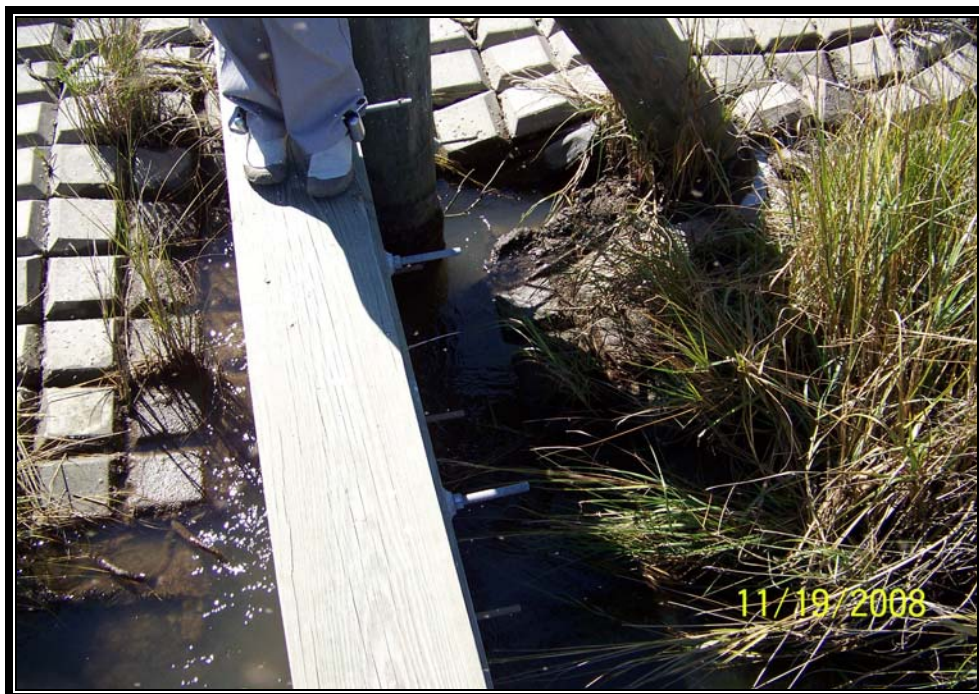
Photo No.28 (0949) - Plug No.8 – view of the Submar scour mats on the southern end of the vinyl bulkhead extension constructed under the 2005 maintenance project. No further erosion or breaching of the structure was found.

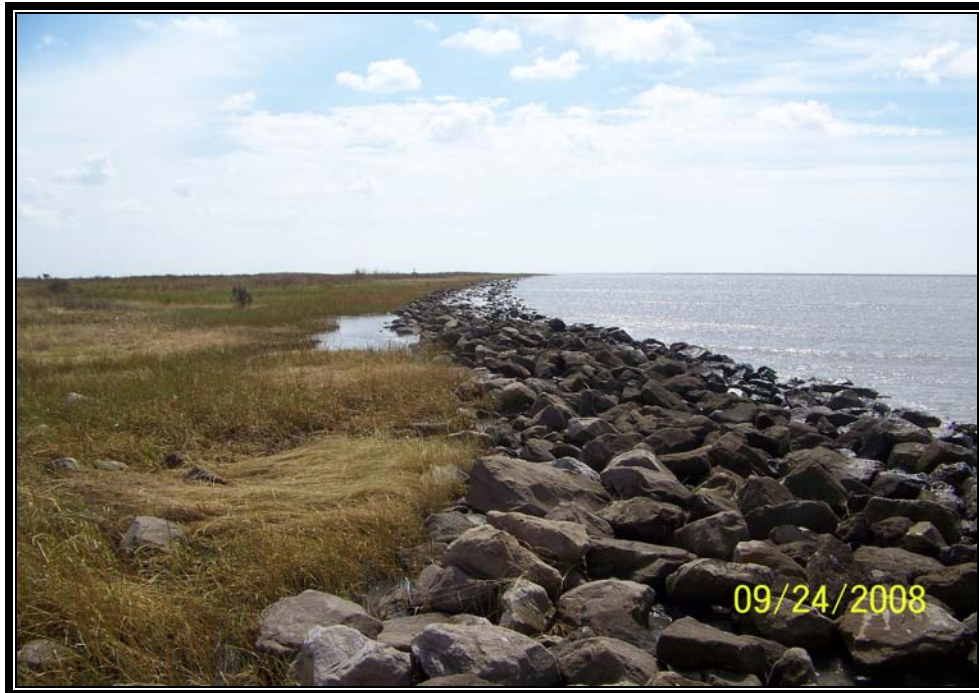
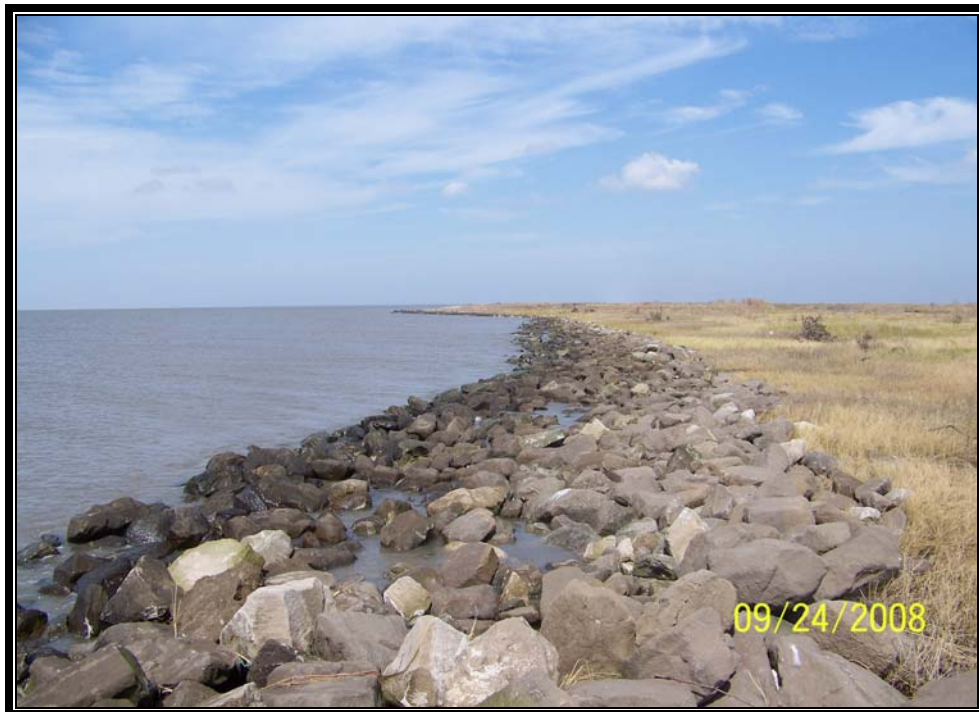
It appears that settlement has occurred along the dike. Continued shoreline erosion was noted at the east end shoreline tie-in. Immediate maintenance recommendations include surveying the rock dike.

Photo No.29 (0423) – Shoreline Protection, Phase III, Area 4 rock shoreline along the Gulf of Mexico looking east

Photo No.30 (0424) – Shoreline Protection, Phase III, Area 4 rock dike long the Gulf of Mexico looking west.
