**State of Louisiana
Office of Coastal Protection and
Restoration**

2009 Annual Inspection Report

**POINT AU FER ISLAND
HYDROLOGIC RESTORATION**

State Project Number TE-22
Priority Project List 1

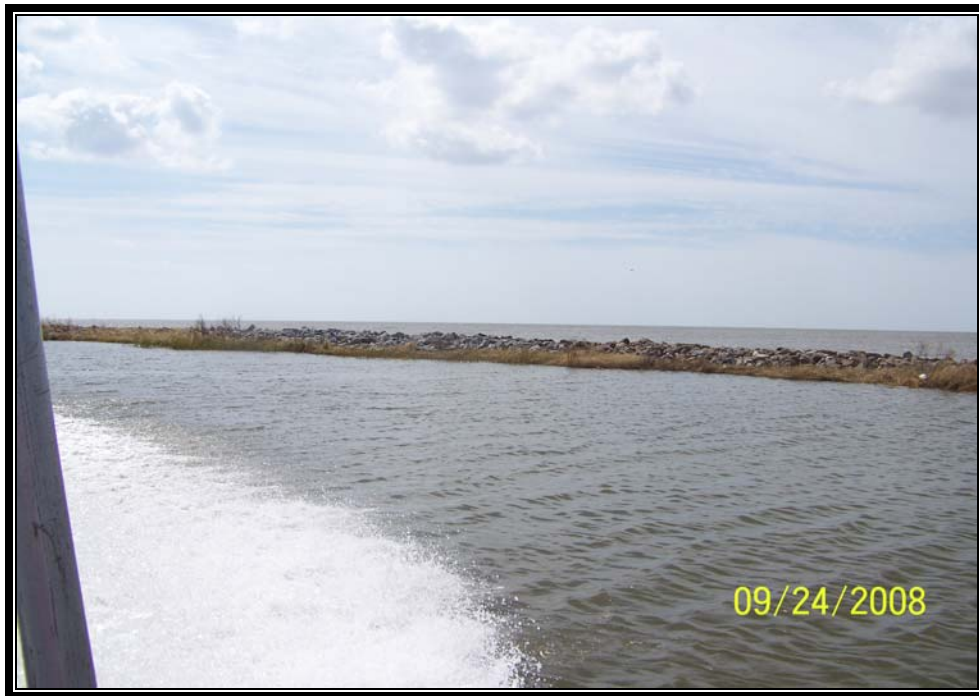
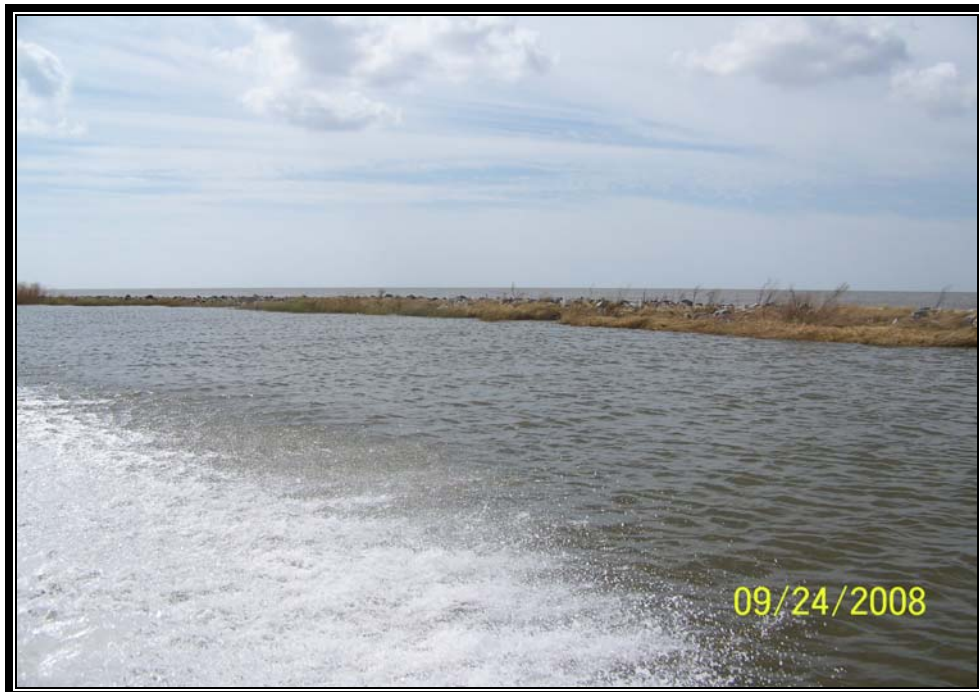
Some areas appear low. Also, the shoreline or south bank of Mobil Canal is narrow behind the rock dike. Immediate maintenance recommendations include surveying the rock dike.

Photo No.31 (0427) – Shoreline Protection - view of Phase II rock dike along the Gulf of Mexico looking south from Mobile Canal.

Photo No.32 (0428) – Shoreline Protection - view of Phase II rock dike along the Gulf of Mexico looking south from Mobile Canal. The existing shoreline in this area is narrow with very little land remaining between the rock shoreline and the south bank of Mobile Canal.

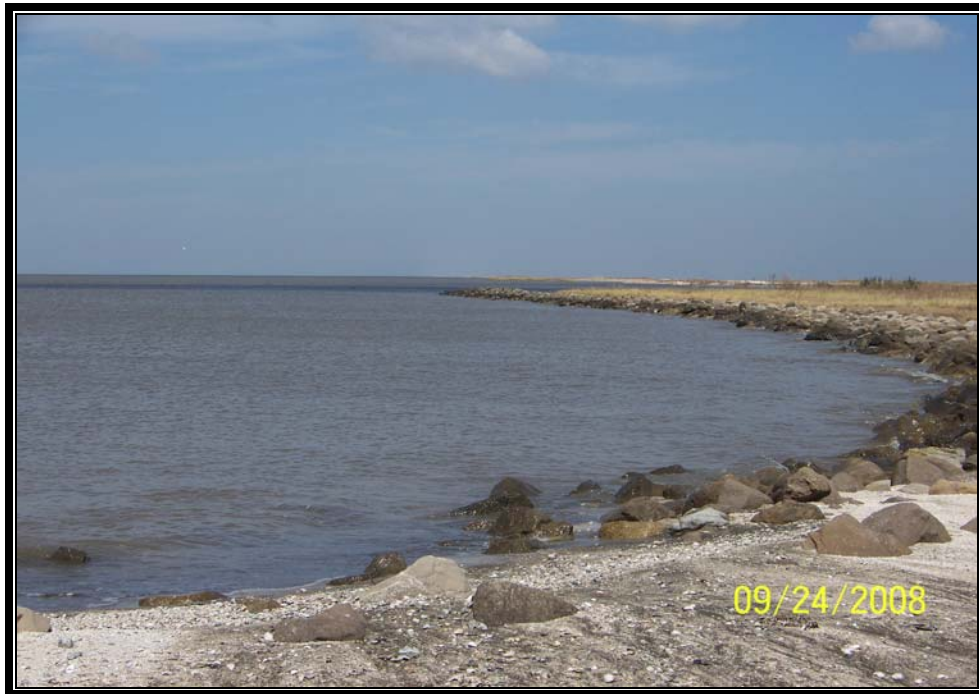
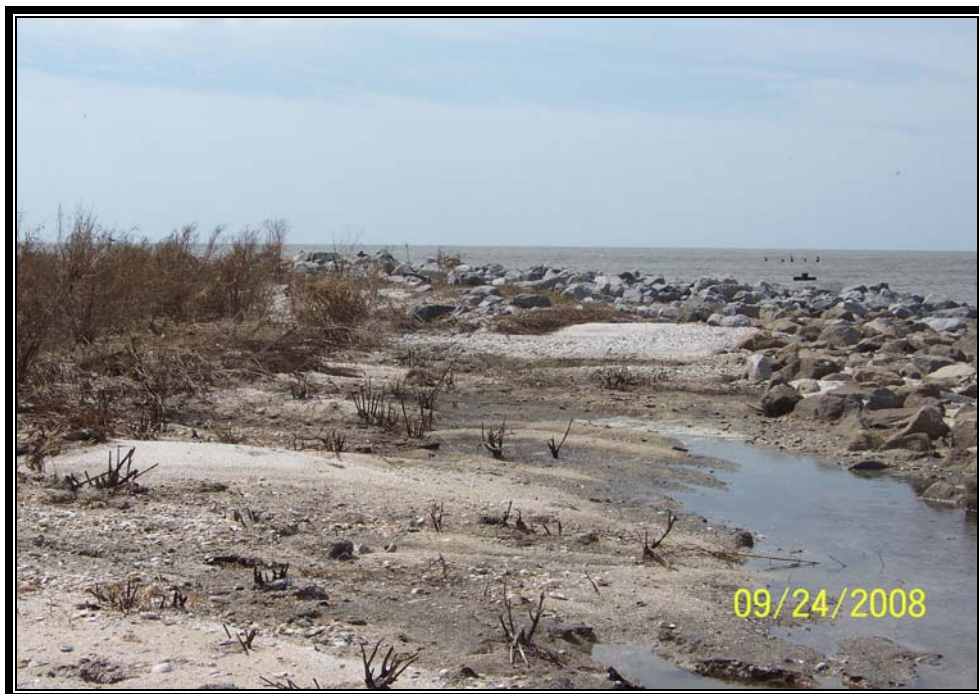
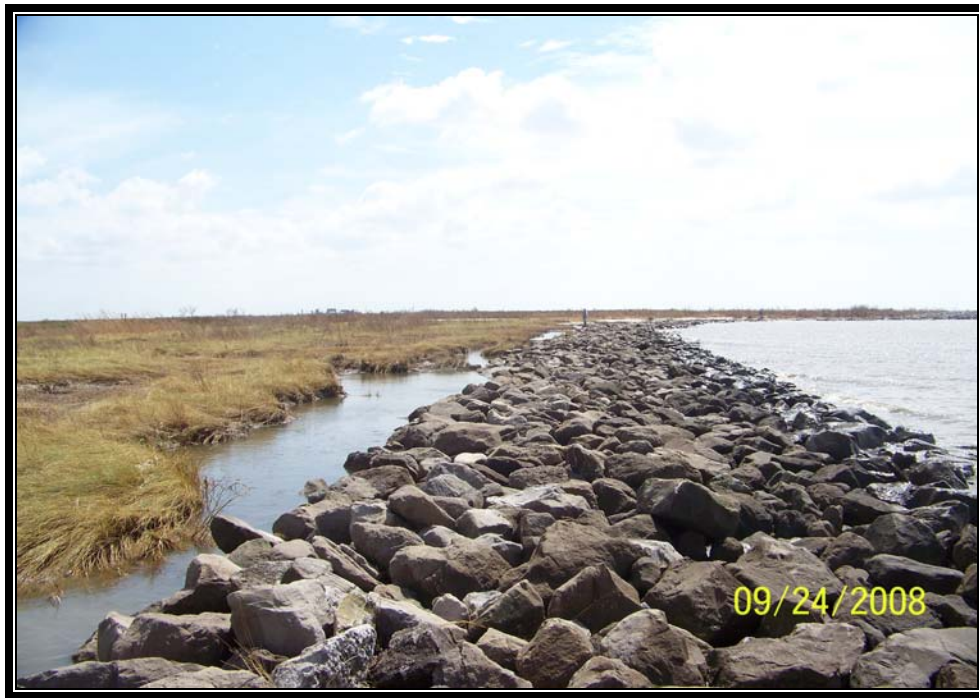
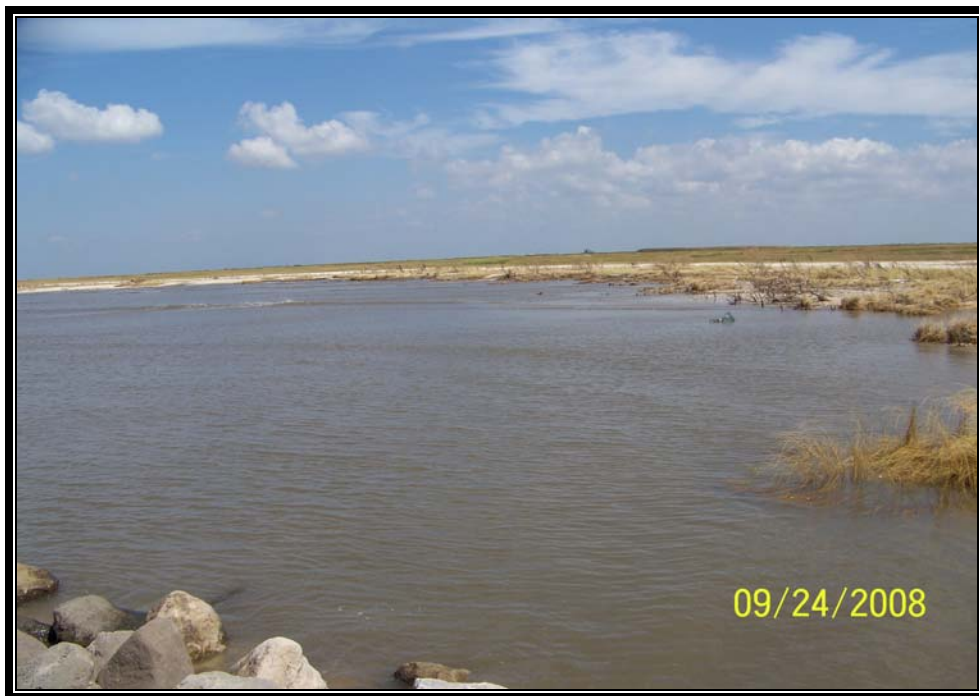
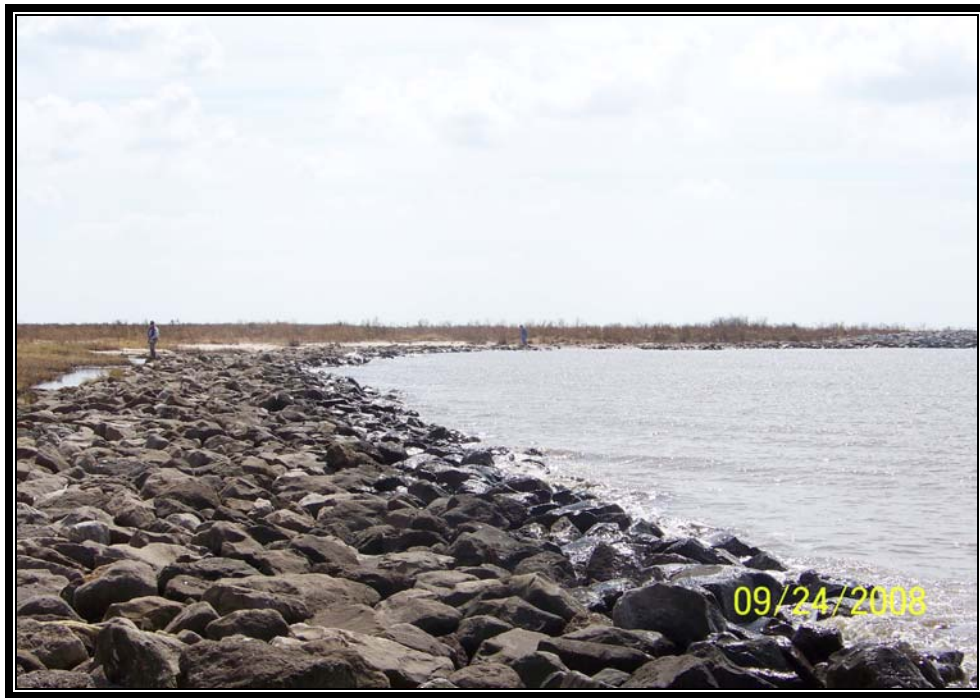
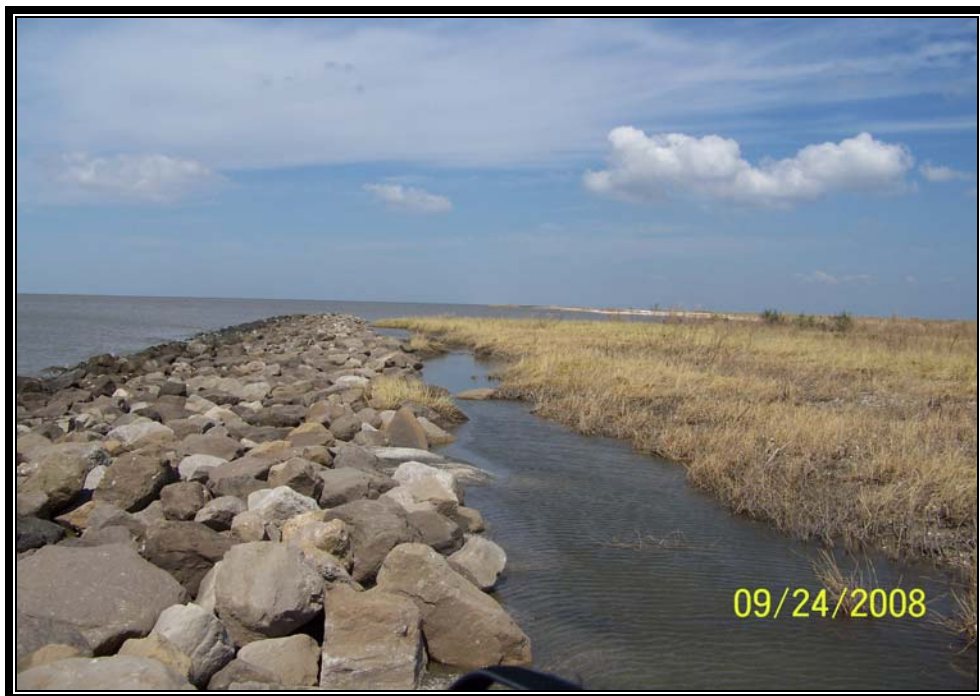
The rock dike along Area 5 of Phase III appeared to be in good condition with no noticeable settlement of the structure. Beyond the west end of the dike, erosion of the beach face has increased and the shoreline has moved inland. Consequently tidal exchange is now occurring behind the mats, and erosion of the shoreline behind the mats was observed. Immediate maintenance recommendations include surveying the rock dike and shoreline at tie-in.

Photo No.33 (0434) – Shoreline Protection - view of Phase III, Area 5 rock dike (west end) looking west.

Photo No.34 (0435) - Shoreline Protection – Phase II and Phase III (Area 5) rock dike looking south.

Photo No. 35 (0436) – Shoreline Protection – view of Phase III, Area 5 rock dike looking east.

Photo No.36 (0437) – Shoreline Protection – Phase III, Area 5 rock, view of the existing shoreline behind the rock structure on the west end of the rock structure looking west.

Photo No. 37 (0438) – Shoreline Protection – view of Phase III, Area 5 rock dike looking east.

Photo No. 38 (0442) – Shoreline Protection – Phase III, Area 5 rock dike (west end) looking west.
