2009 Annual Inspection Report

**LAKE CHAPEAU SEDIMENT INPUT
AND HYDROLOGIC RESTORATION
PROJECT**

State Project Number TE-26
Priority Project List 3

June 1, 2009
Terrebonne Parish

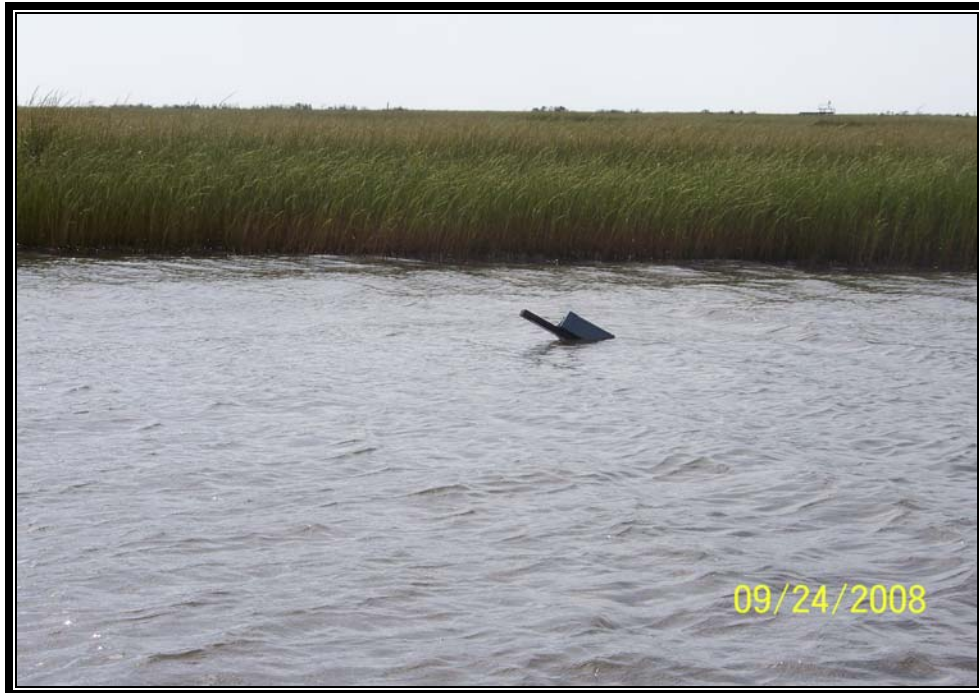
Overall, the rock weir appeared to be in good condition with no apparent erosion or breaching around the ends of the weir. The timber barricade system and warning signs were also in good condition with no visible damage or corrosion. We did notice that the galvanized metal cap on the top of two (2) of the timber piles were missing. With the timber barricade system extending across the channel, we were unable to access the rock weir to measure water depths above the crest of the structure. The latest elevation data available from the 2004 survey profile of the structure indicates that the crest of the rock weir has settled approximately 1.39' since 1999. The water level data at the time of the inspection was not available. The TE26-03 data recorder station adjacent the structure was severely damaged during the 2008 storms

Photo No.1 – view of damaged sonde station near Structure No.1

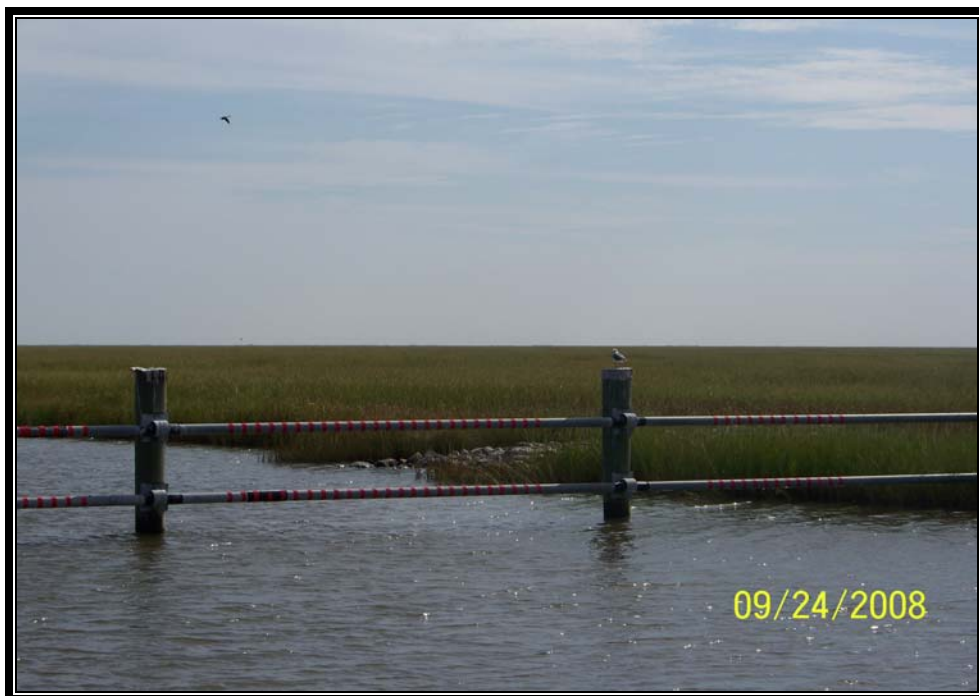
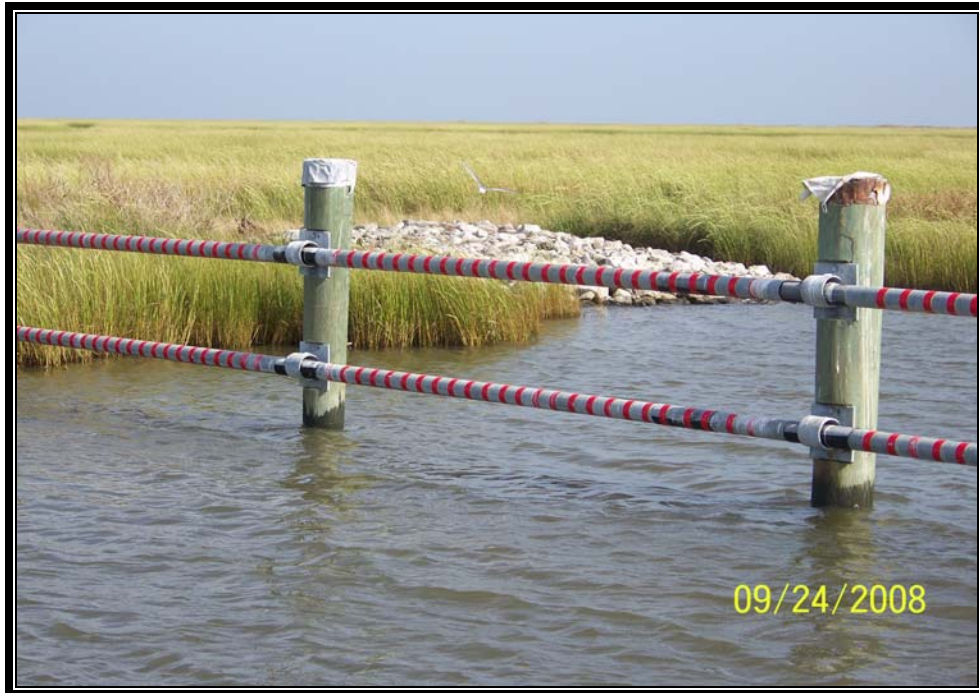
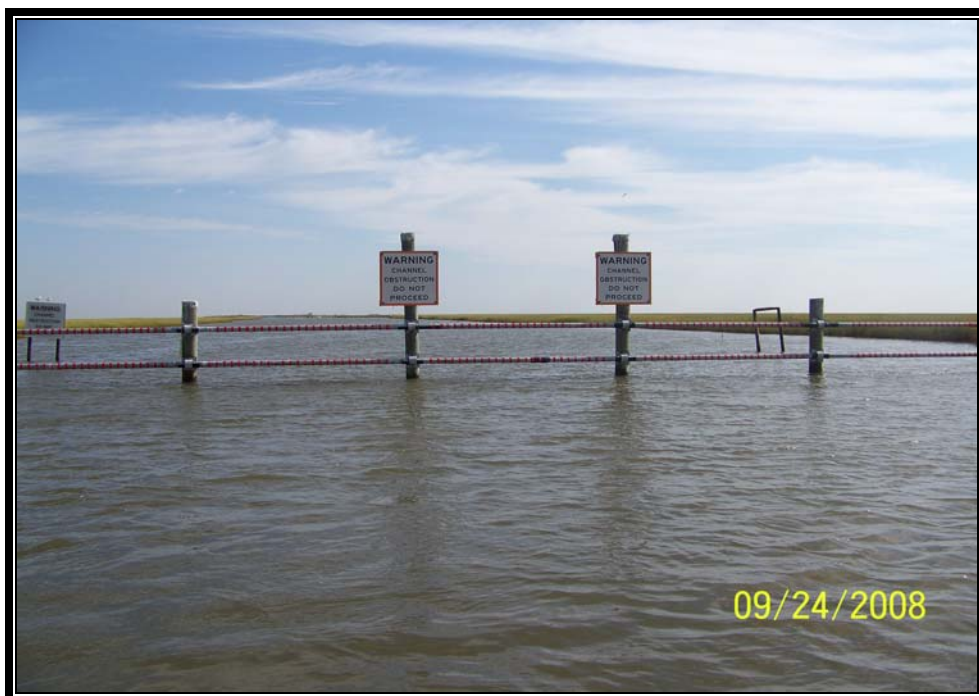
Photo No.2 – view of the barricade system and rock weir tie-in on the east end of Structure No.1

Photo No.3 – view of the barricade system and rock weir tie-in on the west side of Structure No.1

Photo No.4 – view of the barricade system and rock weir of Structure No.1

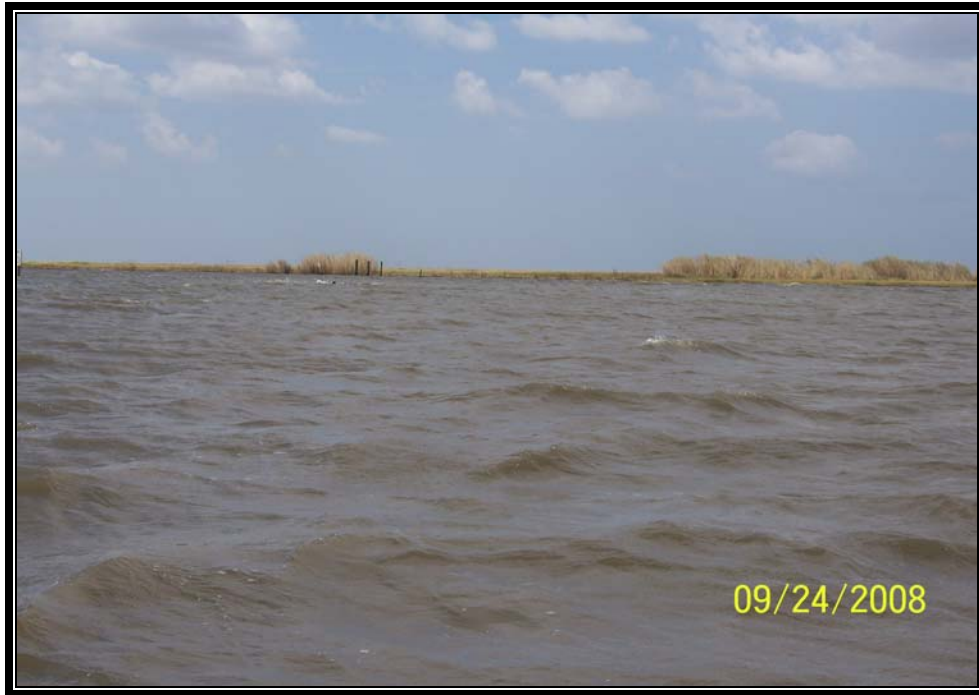
Prior to Hurricanes Gustav and Ike, the OCPR was in the process of receiving bids to close a 60 ft. wide breach on the north side of Structure No.3 and armoring approximately 200 linear feet of shoreline to the north. Following the 2008 storms, the existing shoreline on the north side of the structure had sustained significant land loss, leaving a 350 ft. wide breach on the north side. Considering the change in the scope of the breach repair project, the bids were subsequently canceled. After discussions with the federal sponsor (NMFS), it was determined that repairing the structure was no longer an option due to the amount of land loss along the shoreline north of the structure. With erosion rates in this area exceeding 60 ft/year, it is no longer feasible to maintain Structure No.3. We are proposing that the structure be permanently removed. It is recommended that all sign supports be removed and the rock rip rap and aggregate material be uniformly spread along the channel bottom to an elevation that would not interfere with navigation in the channel. (Appendix B, Photos 5 - 8).

the weir, particularly on the north side of the structure. The existing breach on the north side, which was approximately 70' wide prior to the 2008 storms, had increased in width to approximately 350'. Prior to Hurricanes Gustav and Ike, the Office of Coastal Protection and Restoration (OCPR) was in the process of receiving bids for the repair of the breach and extension of the rock revetment northward. Due to the substantial change in the scope of the project, the bids were canceled in late September 2008.

Photo No. 5 – view of large breach opened after Hurricane Gustav on the north side of Structure No.3. Due to high tides during the inspection, the north side of the rock weir is at the water surface elevation and is not visible.

In evaluating each alternative, the OCPR considered the initial cost of repairs and/or replacement of the structure, the implications of removing the structure and the affects on the island hydrology, and the anticipated future maintenance of the structure. A review of the conclusions in the 2007 Operation, Maintenance and Monitoring Report revealed that the project objectives and goals of restoring the historical hydrology of the island is inconclusive at this time and that land water analysis indicated continued land loss inside the project boundary (Lear E., T. Folse and B. Babin, 2007). Based on this analysis, the OCPR does not believe that removing Structure No.3 will significantly worsen the hydrologic conditions of the island. Regarding alternatives 1 and 2, the reconstruction of Structure No.3 at the current location or moving further inland towards Crab Lake will most likely require significant maintenance and possible expansion along the shoreline to protect the structure from breaching as the shoreline retreats. As the marsh on the south side of the structure continues to erode at an estimated 60ft/year, it will become more difficult and expensive to prevent breaching around the structure. Considering that project benefits are inconclusive and the cost of maintaining the structure for the remaining 20 year project life will be exorbitant, the OCPR is recommending that the third alternative of complete removal of the structure be implemented.

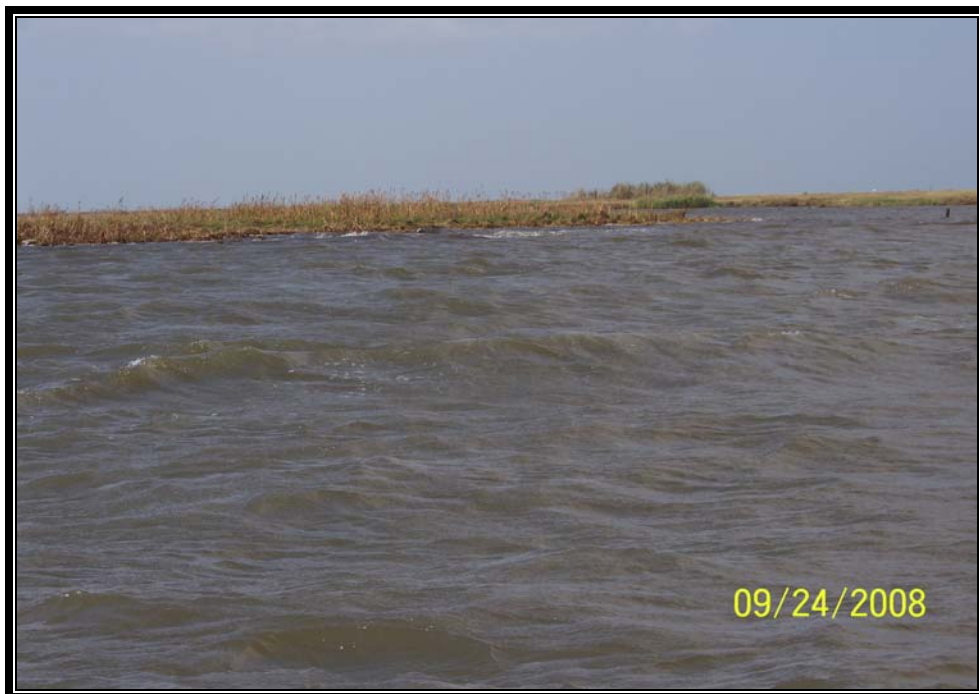
Photo No. 6 – rock weir and concrete mats on the south side of Structure No.3. The rock structure is barely visible due to high tides at the time this photo was taken.

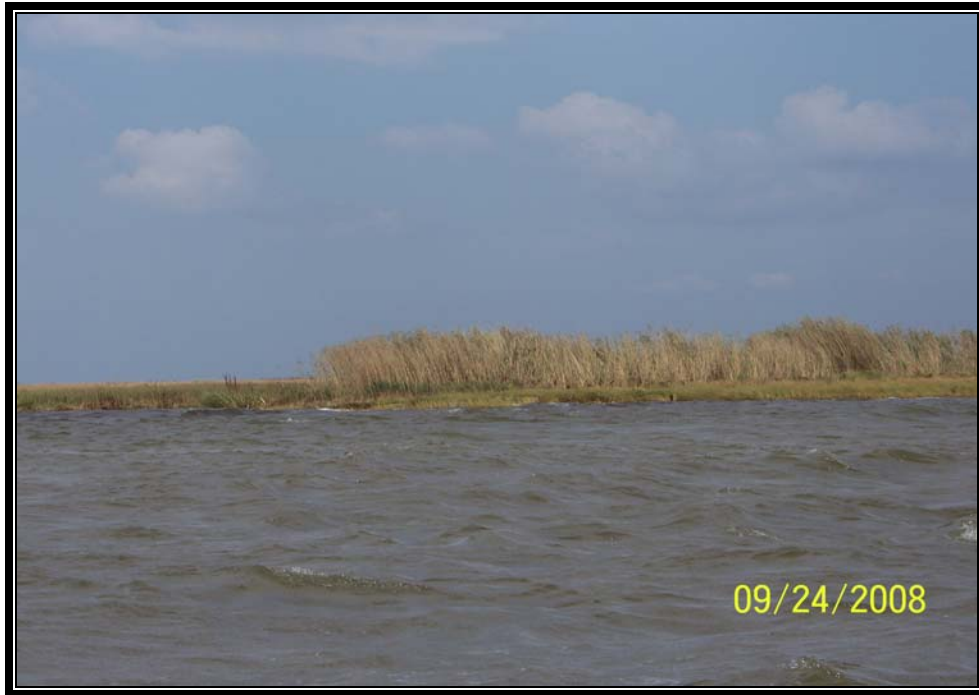
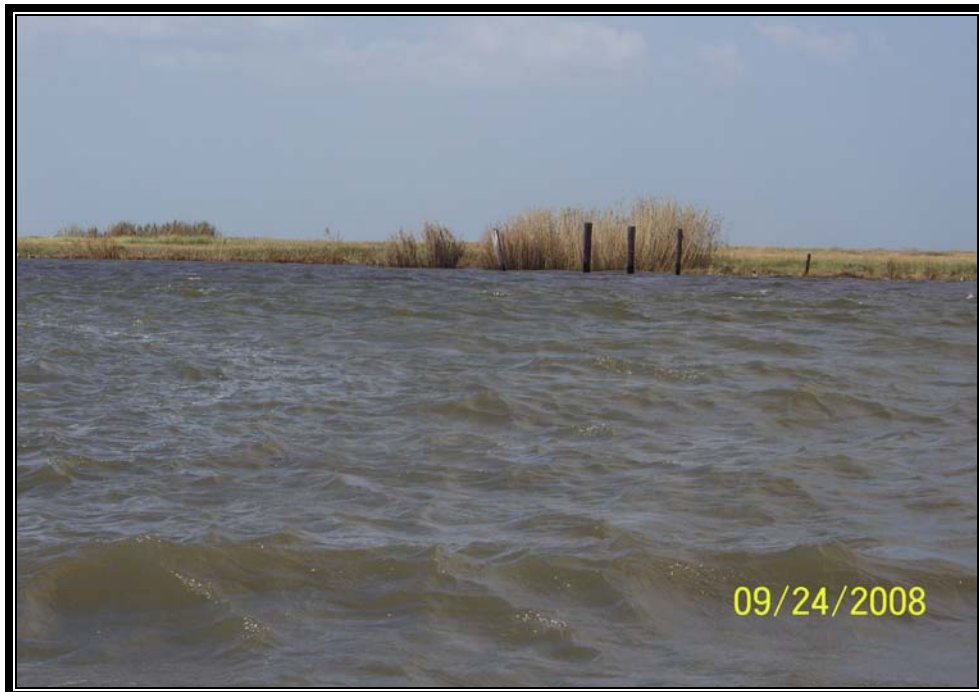
Photo No. 7 – view of the existing shoreline on the north side of the weir structure and breach at Structure No.3.

Photo No. 8 - view of the existing shoreline on the north side of Structure No.3

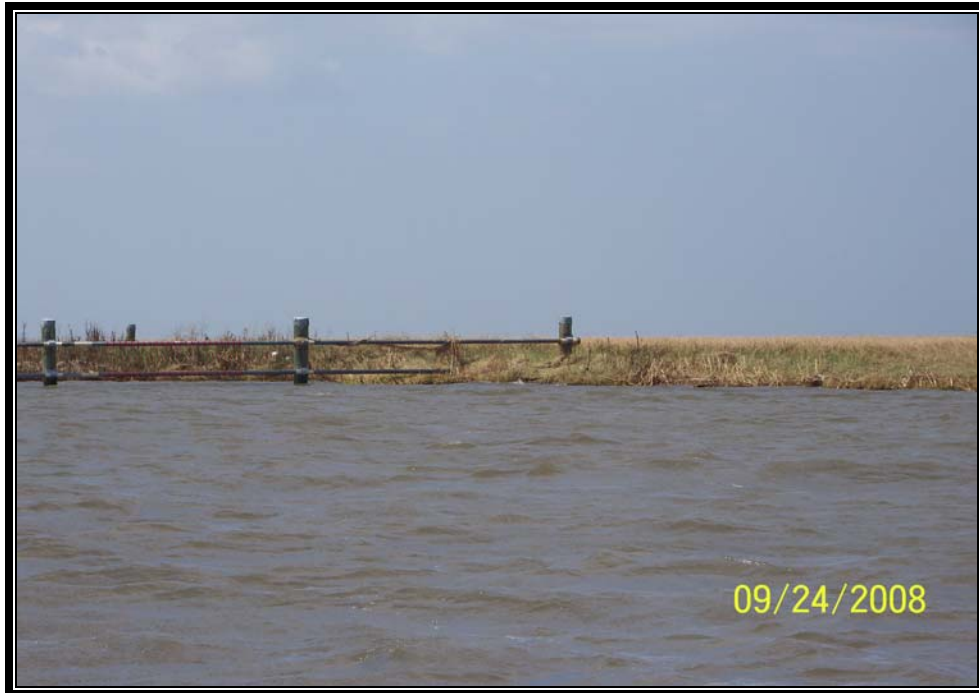
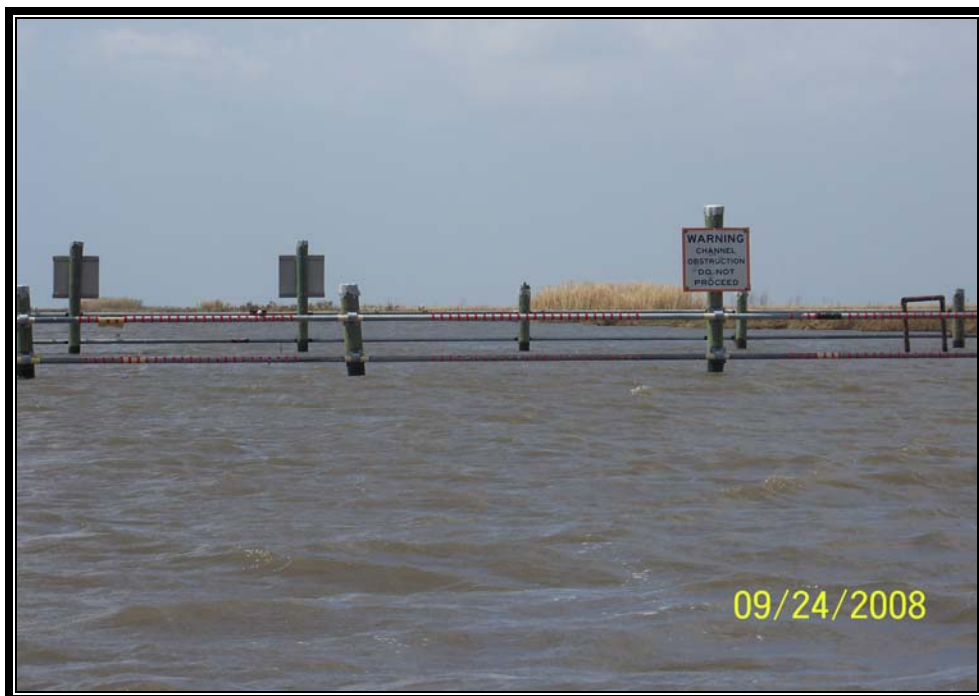
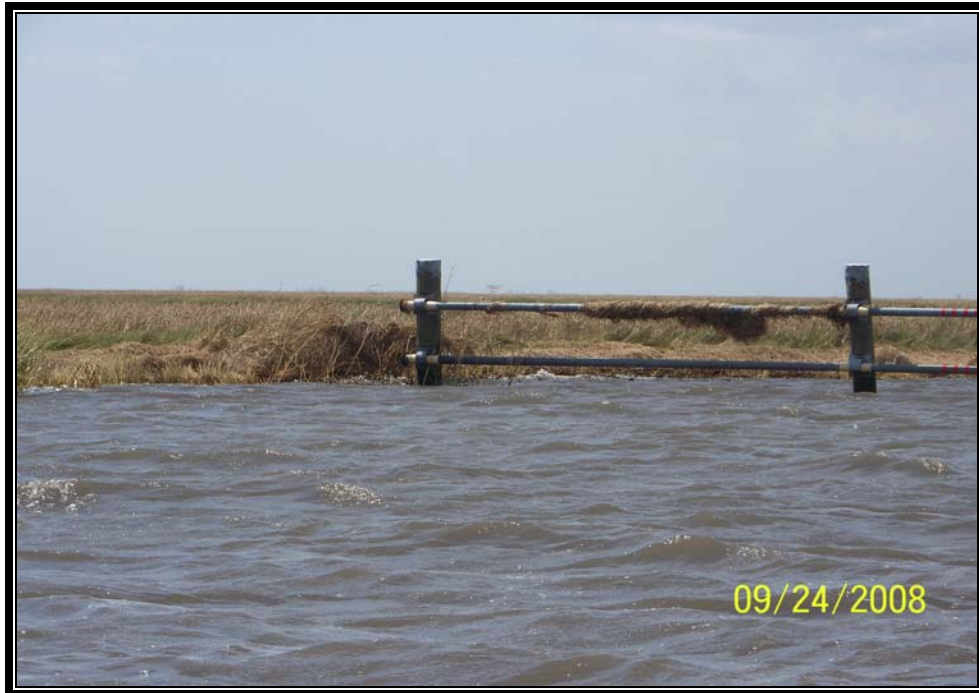
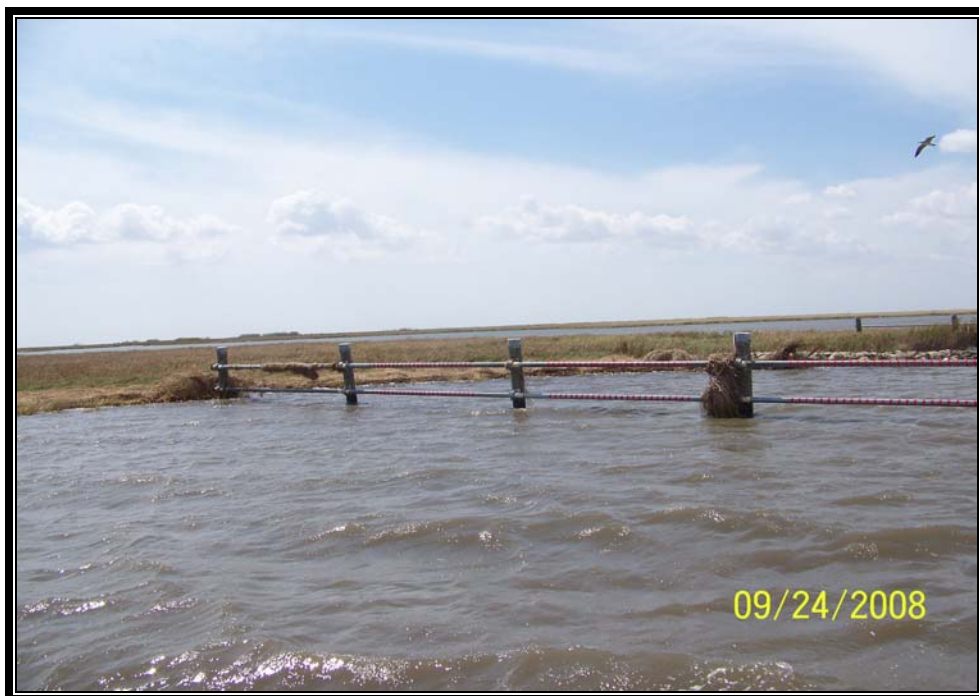
The rock weir appeared to be in good condition with no breaching around the ends. As in previous inspections, we found that the existing marsh connecting the structure to land on the south side of the weir was thin. Situated between Four League Bay and an open body of water, there is a potential for breaching to develop should erosion continue on the south side of the structure. The erosion rates at this location are not nearly as high as in the area adjacent to Structure No.3 estimated to be 60 ft/ year. From shoreline erosion data over the past few years, the marsh on the south side of Structure No.4 has eroded at an estimated rate of 13 ft/ year since 1998. Based on the condition of the marsh at this time and the short-term predicted erosion rates, we believe that the shoreline will eventually erode beyond the structure causing the weir to become ineffective. However, at this time, the weir appears to be functioning as designed with no indication that breaching will occur in the immediate future; therefore, we are not recommending that the structure be removed or the marsh tie-ins repaired until the weir is no longer functioning.

The timber barricade system and signage appeared to be in good condition. As reported in previous inspections, the two (2) center pilings were found to be slightly unstable. A combination of the inadequate embedment depths and poor soil conditions could have caused the instability in these piles. With the lateral support provided by the two (2) horizontal steel pipe members, we do not believe that minor instability in the center piles is a cause for concern at this time. The inspection team will continue to monitor the stability of the timber pile supports on future field trips. (Appendix B, Photos 9 - 12).

Structure No.4, located on the west bank of Four League Bay, was in good condition with no apparent storm damage other than moderate erosion of the marsh platform connecting the rock weir to the land. Contrary to our assessment in the 2008 Annual Inspection Report stating that the marsh tie-in will likely erode in a couple of years, we are currently uncertain and unable to predict at time-frame that the shoreline will erode to a point where the structure is rendered ineffective. Based on the current short-term shoreline erosion rates from 1998 to 2008, there is a possibility that shoreline adjacent to structure No.4 may remain intact for the remainder of the project life, barring any extreme storm events. Based on the newly acquired erosion data, we are not recommending maintenance, corrective actions or removal of Structure No.4. The inspection team will continue to monitor the condition of the marsh platform adjacent to Structure No.4 on future site visits.

Photo No.9 – view of the barricade system and rock weir on the north side of Structure No.4.

Photo No. 10 – view of the barricade system and rock weir at Structure No.4 looking southwest.

Photo No. 11 – rock weir tie-in and barricade system on the south side of Structure No.4

Photo No. 12 – view of the rock weir tie-in to the existing marsh and barricade system on the south side of Structure No.4

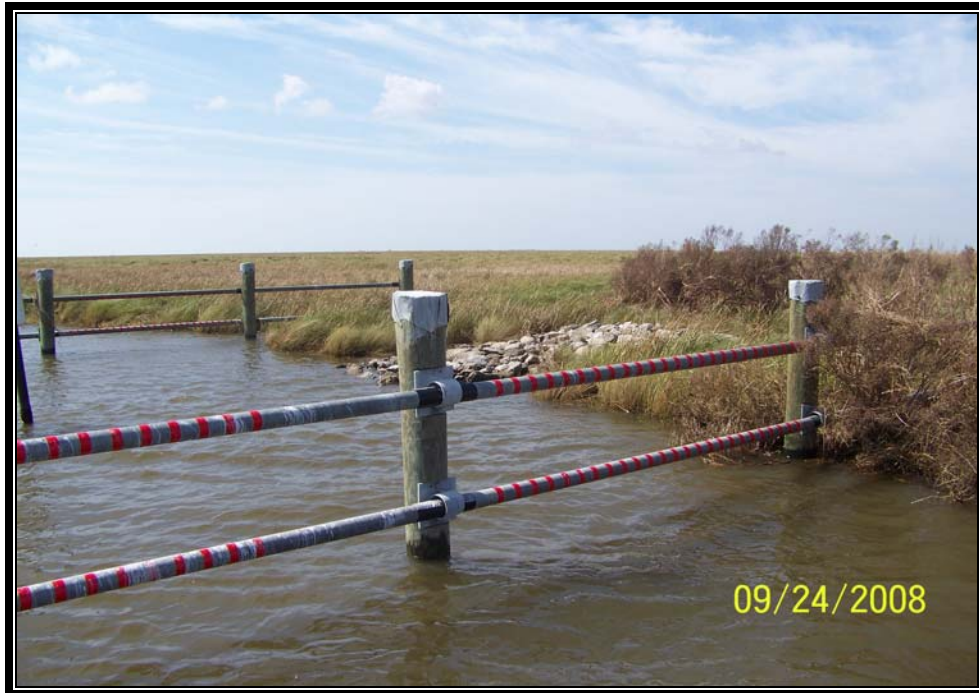
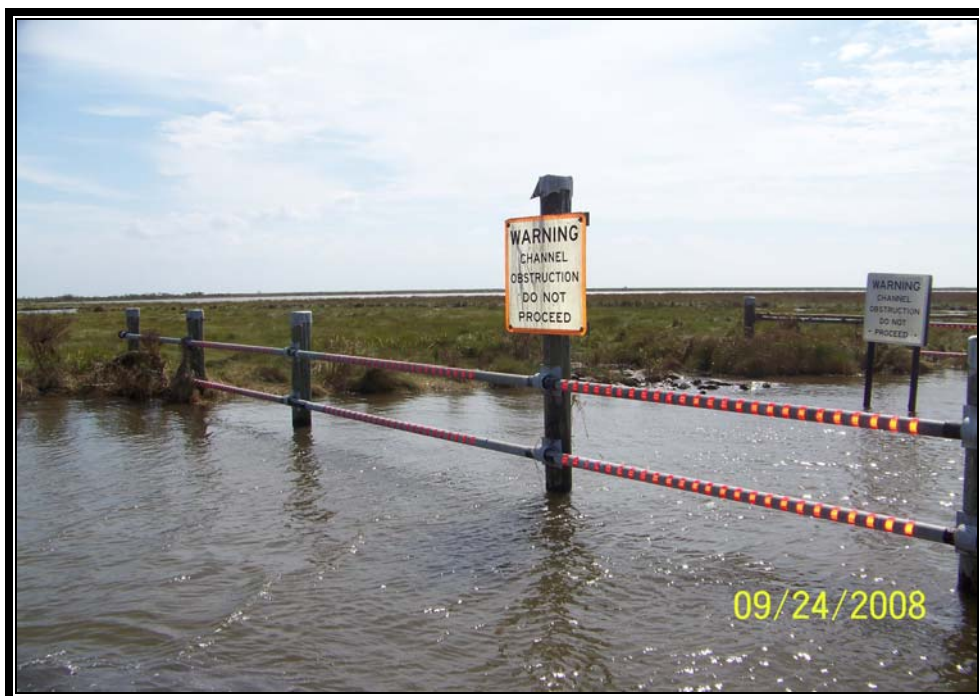
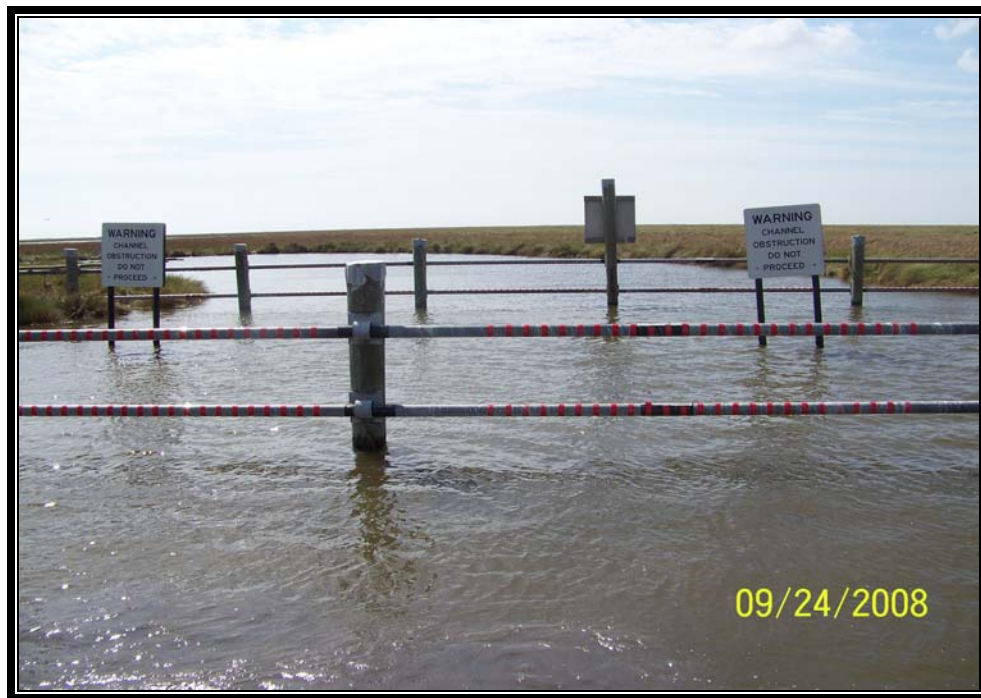
The rock plug, tie-ins, earthen embankments, barricade system, warning signs and supports appeared to be in good condition with no visible signs of marsh erosion adjacent to the structure or damage to the barricade system. The latest elevation data from the 2004 survey profile of Structure No.5 indicates that the structure has settled on average of 0.14' from the designed elevation. (Appendix B, Photos 13 - 15)

Photo No. 13 – rock weir tie-in to marsh and barricade system on the south side of Structure No.5.

Photo No.14 – rock weir tie-in to marsh and barricade system on the north side of Structure No.5.

Photo No. 15 – overall view of the Structure No.5 weir and barricade system looking east.

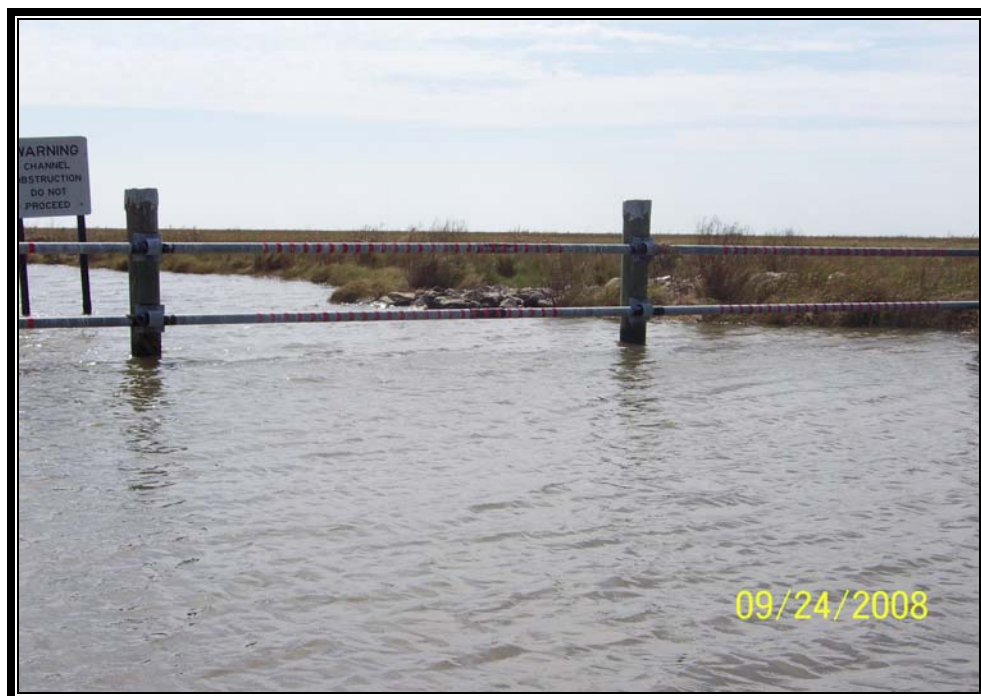
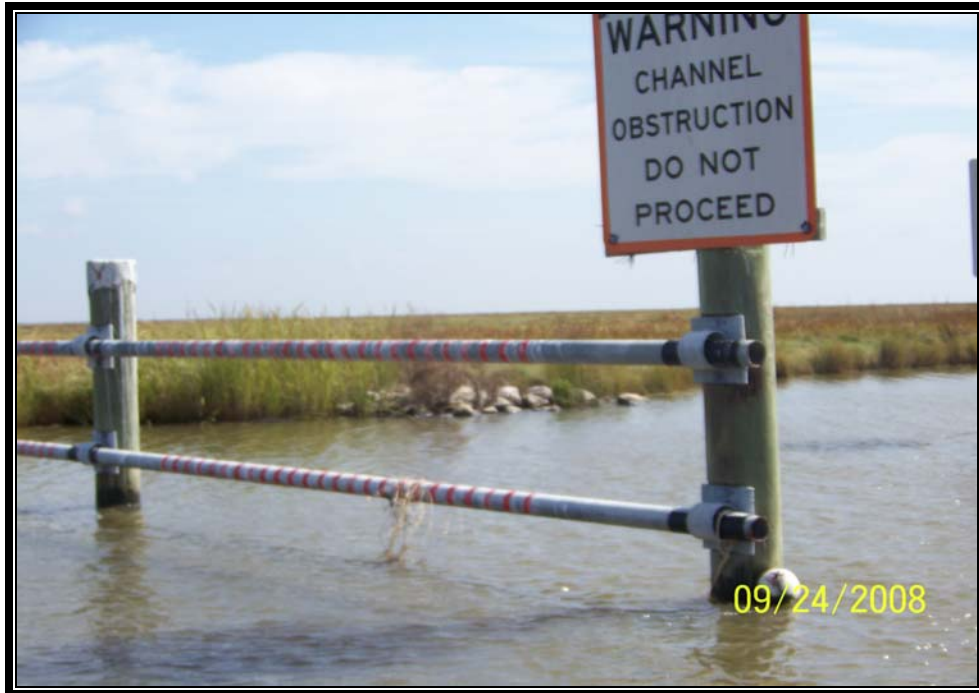
Photo No. 16 – rock weir tie-in to marsh and barricade system on the south side of Structure No.6.

Photo No. 17 – rock weir tie-in to marsh and barricade system on the north side of Structure No.6.

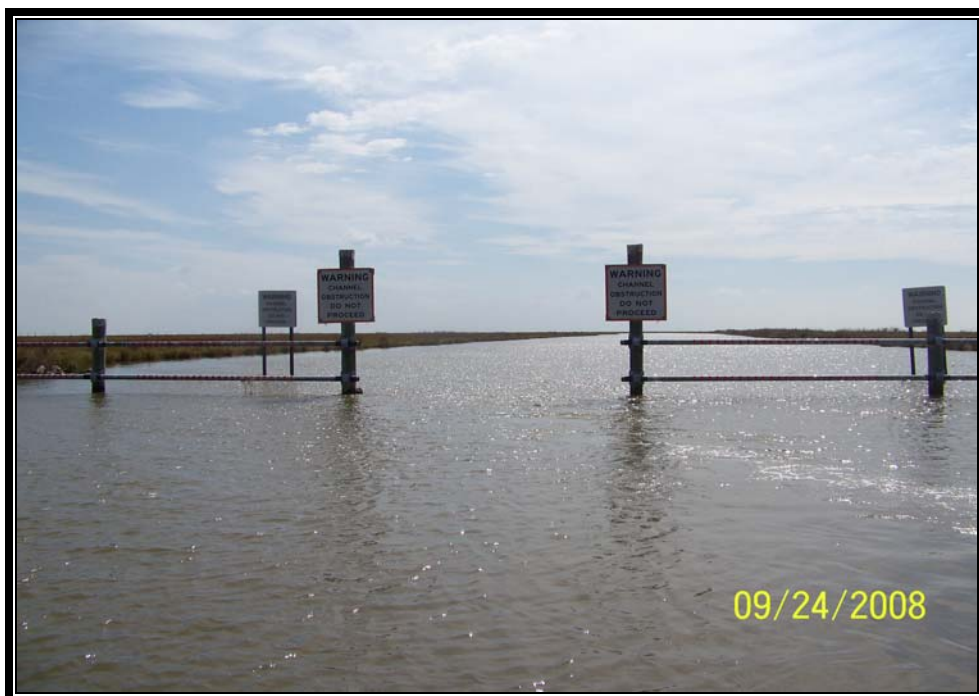
It was discovered during the 2008 Annual Inspection that the timber barricade system in from of the structure had been vandalized. A ten (10) foot section of the two (2) steel pipe cross members between the center piles had been cut with a torch and were missing. It remains our opinion that any attempt to repair the damage to the barricade system, preventing access across the weir, would be unsuccessful; therefore, we are not recommending repairs to the steel pipe cross members. Other than the damage to the barricade system, the rock weir, earthen embankments, warning signs and supports were in very good condition. From the 2004 profile survey of the structure, it was determined that the rock weir had settled an average of approximately 1.1 ft. (Appendix B, Photos 16 - 18)

Photo No.18 – overall view of Structure No.6 and steel pipe cross members cut by vandals.

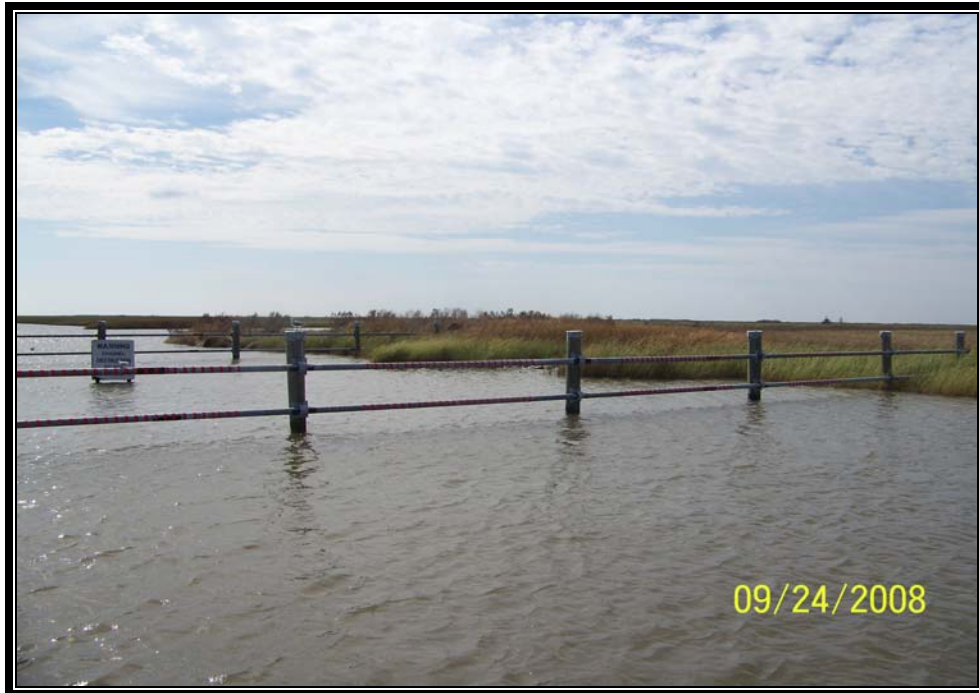
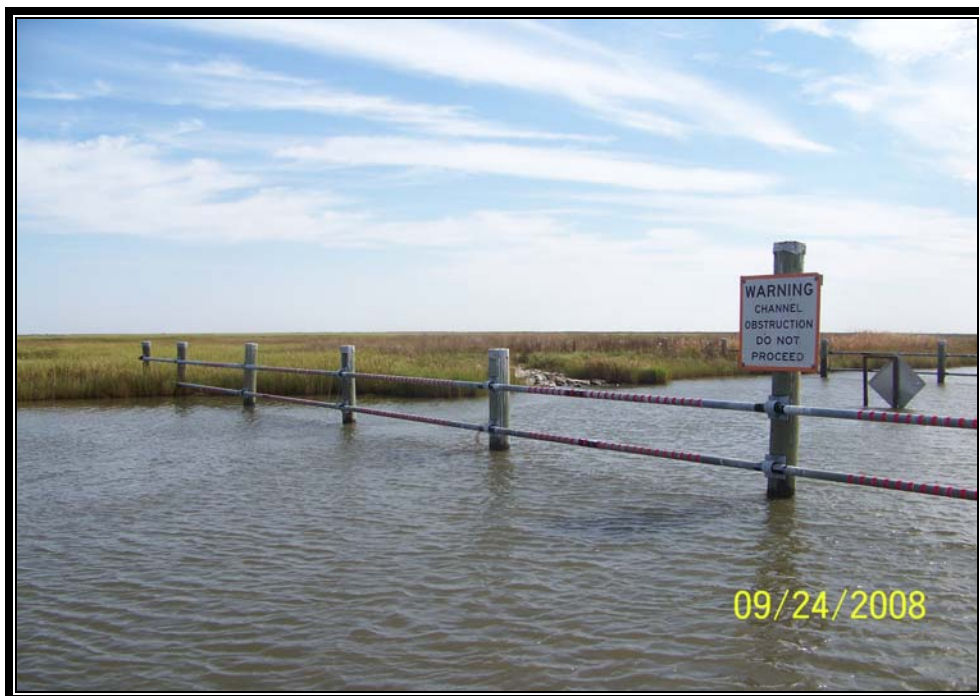
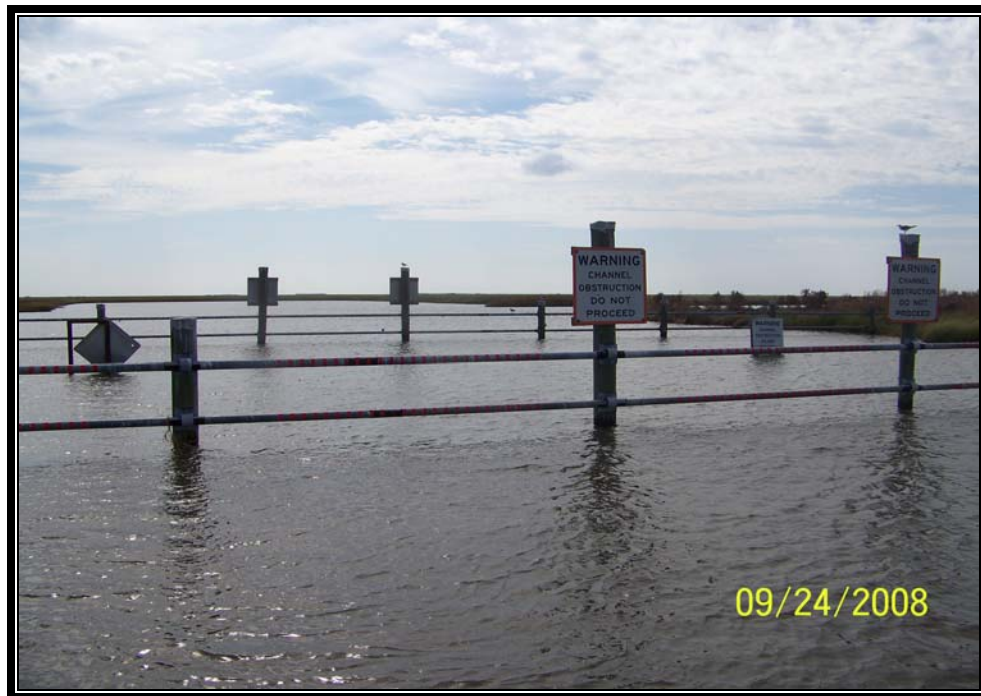
The rock weir, earthen embankments, timber barricade system and signs and supports were all in very good condition with no apparent structure damage or erosion problems. Based on a survey profile of the rock weir in 2004, the structure has settled approximately 1.7' from its designed elevation. (Appendix B, Photos 19 - 21).

Photo No. 19 – barricade system and rock weir tie-in to marsh on the south side of Structure No.7.

Photo No. 20 – barricade system and rock weir tie-in to marsh on the north side of Structure No.7.

Photo No. 21 – Overall view of barrage system and rock weir of Structure No.7.

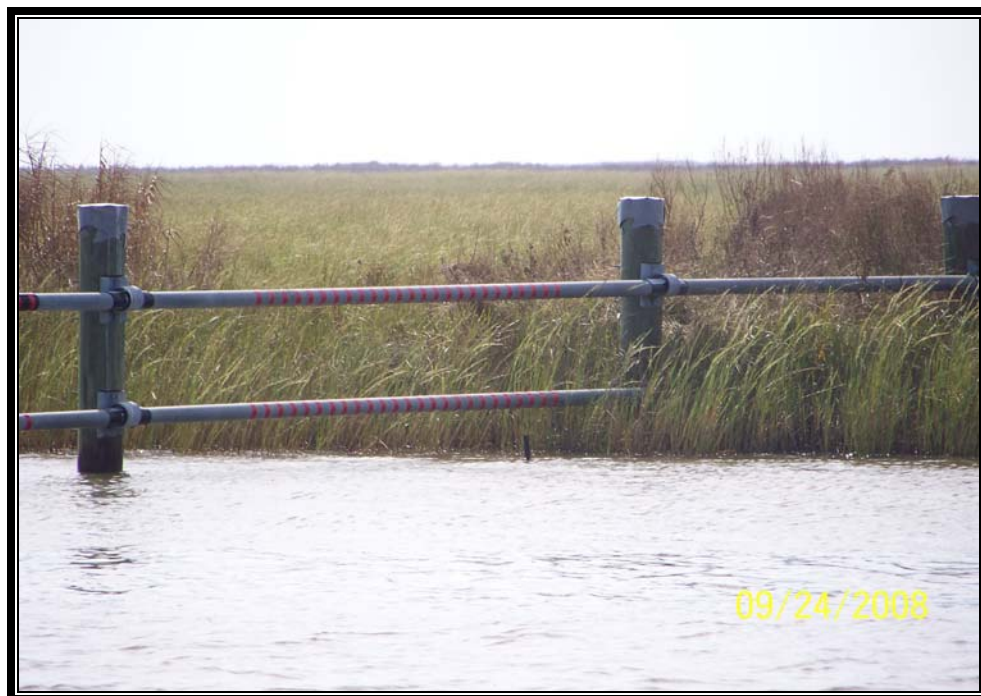
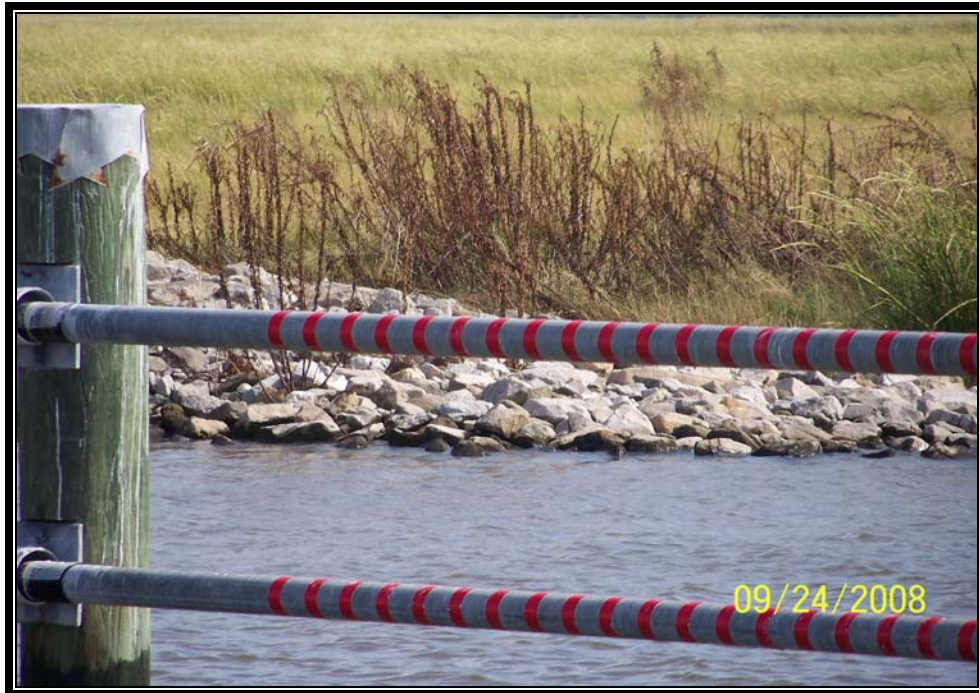
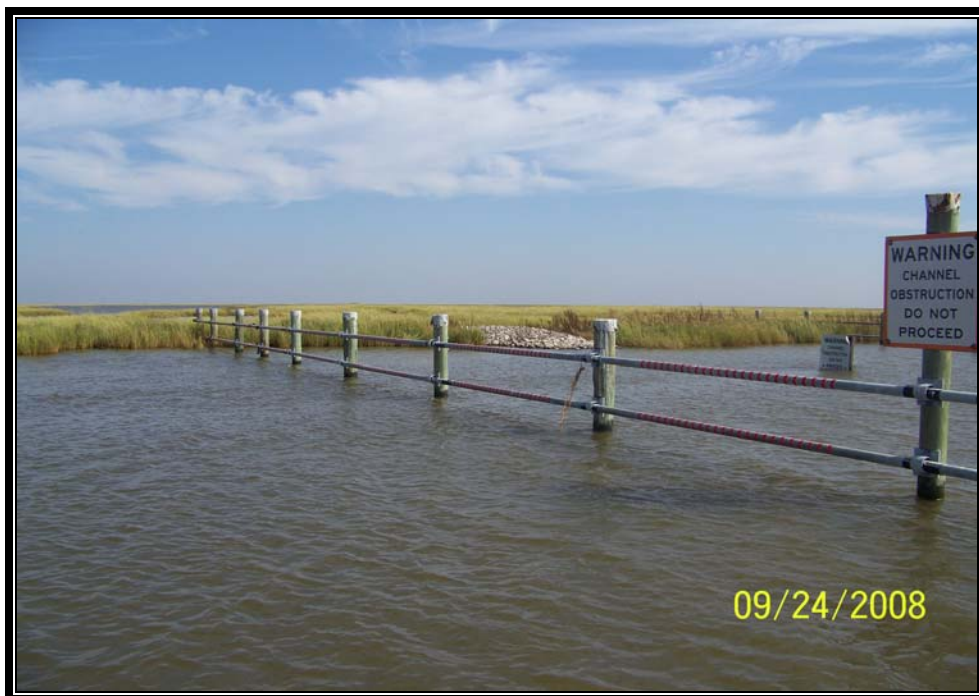
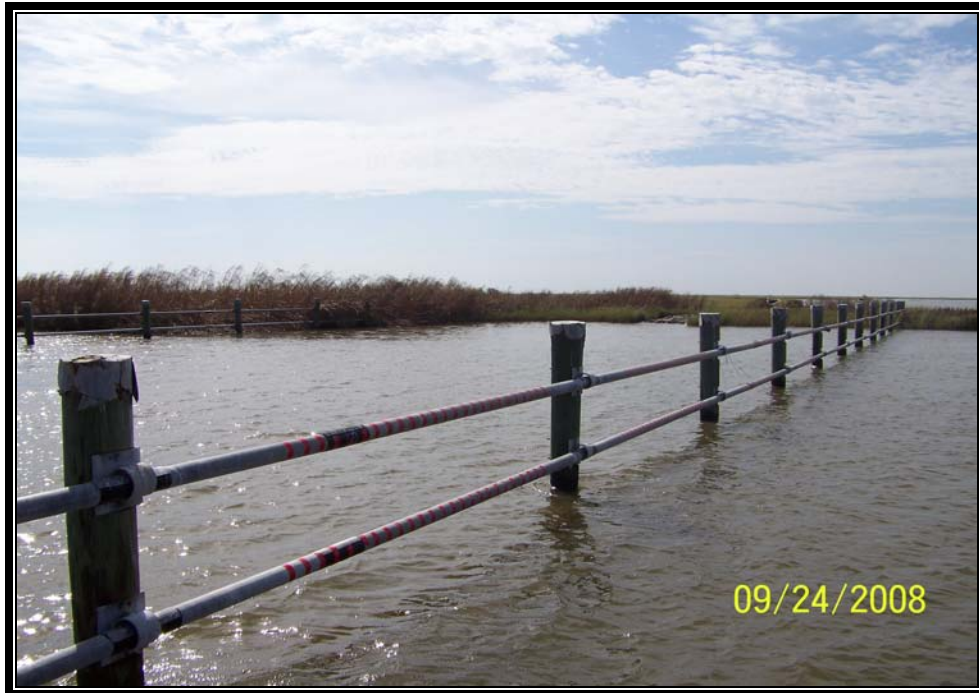
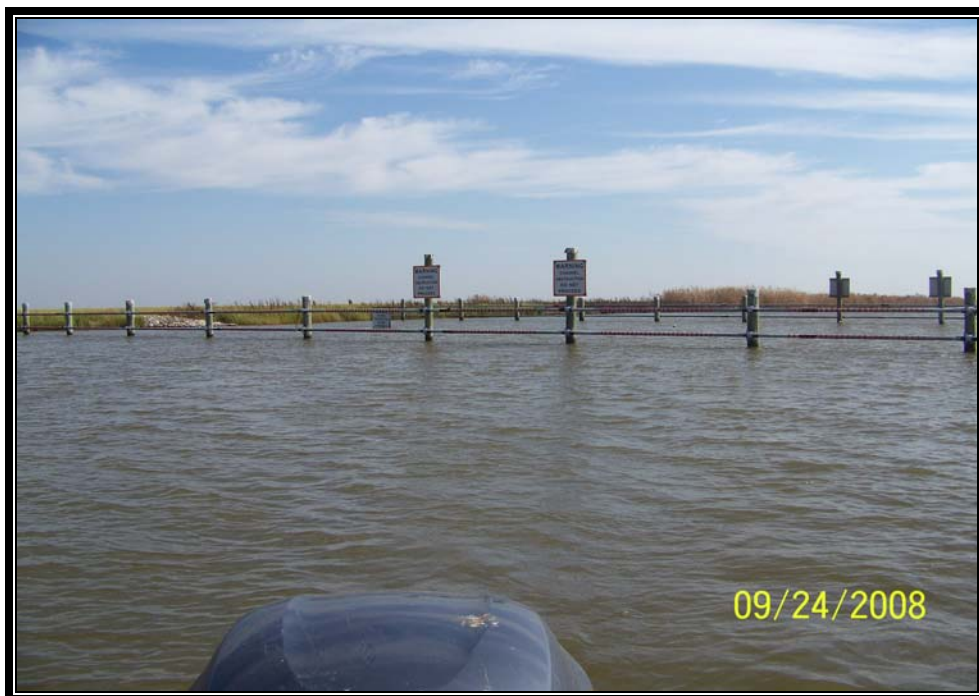
The rock weir at this location was in good condition with no noticeable damage to the timber barricade system or erosion around the ends of the weir. Based on the 2004 survey profile of the structure, it was determined that the rock weir had settled an average of 1.7' from the designed elevation. (Appendix B, Photos 22 - 26).

Photo No.22 – barrage system and rock weir tie-in along the east bank of Structure No.9

Photo No.23 – barricade system and rock weir tie-in along the west bank of Structure No.9.

Photo No.24 – barricade system and rock weir of Structure No.9 looking west.

Photo No.25 – barrage system and rock weir of Structure No.9 looking east.

Photo No.26 – overall view of the barrage system and rock weir at Structure No.9.
