**Coastal Protection and Restoration  
Authority of Louisiana**

**2008/2009 Annual Inspection  
Report**

**COTE BLANCHE HYDROLOGIC  
RESTORATION PROJECT  
(TV-04)**

September 30, 2008  
St. Mary Parish

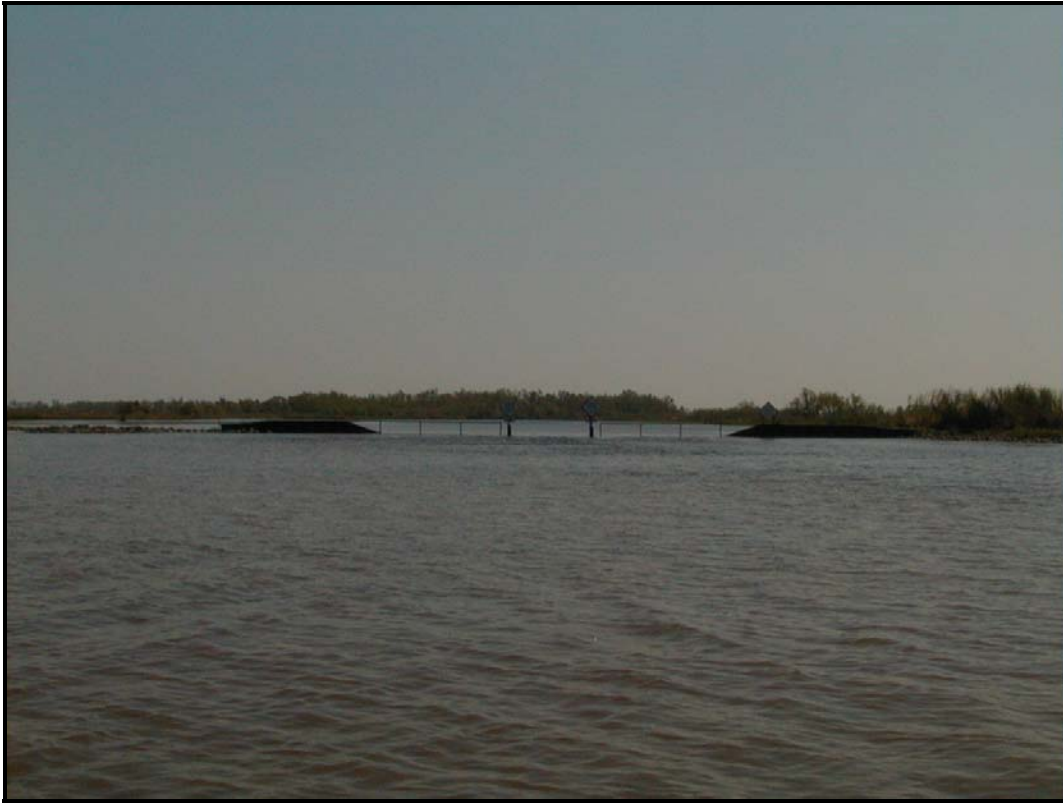
The Mud Bayou structure appears to be holding up fairly well. The coating on the sheet piles is peeling. The steel is beginning to show signs of rust and will need to be monitored. Signage is ok. (Photos: Appendix B, Photo 1).

**Photo 1**—signage at Mud Bayou

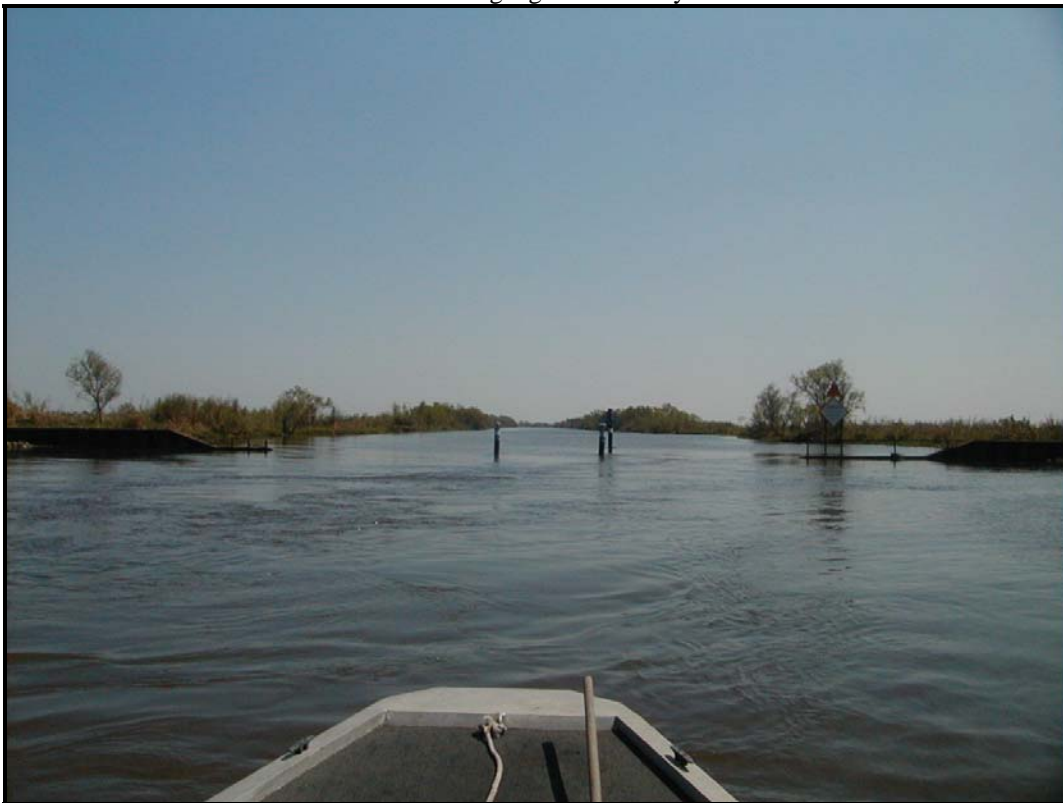
The warning sign, day-marker, and railing on the north side of the structure are gone and will need to be replaced. Sheet piles and rocks on the end of the structure are stable and functioning as intended. The coating on the sheet piles is rusting on this structure and will be monitored as well. The south arrow sign is missing. (Photos: Appendix B, Photo 2).

**Photo 2**— Missing sign, nav-aid marker, and railing @ Humble F Canal (on left)

| Item | Condition | Physical Damage | Corrosion | Photo # | Observations and Remarks |
|---|---|---|---|---|---|
| Steel Bulkhead / Caps | good | | | 2 | Structure in good condition. Some slight rusting of pile caps. Warning sign, day marker and railing missing |

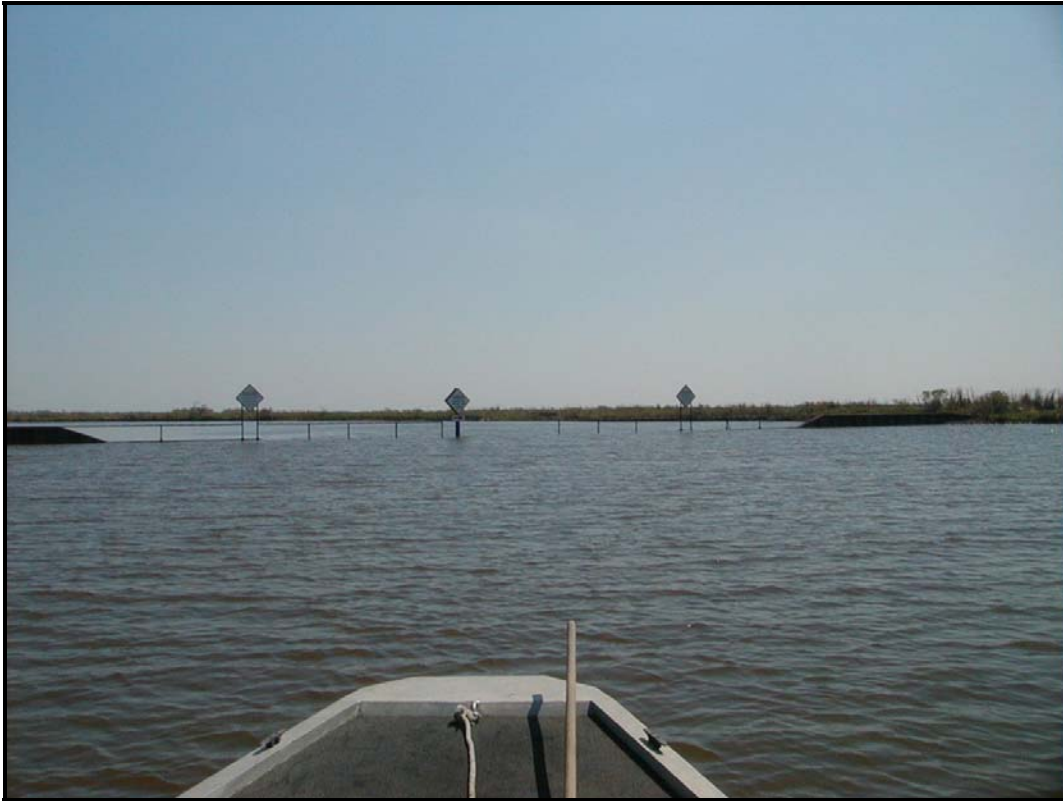
The Bayou Long structure and signage are stable. The coating on the sheet piles is rusting on this structure and will be monitored as well. Staff gauges are gone at this site. (Photos: Appendix B, Photo 3)

**Photo 3** – Bayou Long

| Item | Condition | Physical Damage | Corrosion | Photo # | Observations and Remarks |
|---|---|---|---|---|---|
| Steel Bulkhead / Caps | good | | | 3 | Structure in pristine post-construction condition. Some slight rusting of pile caps. No immediate action necessary. |

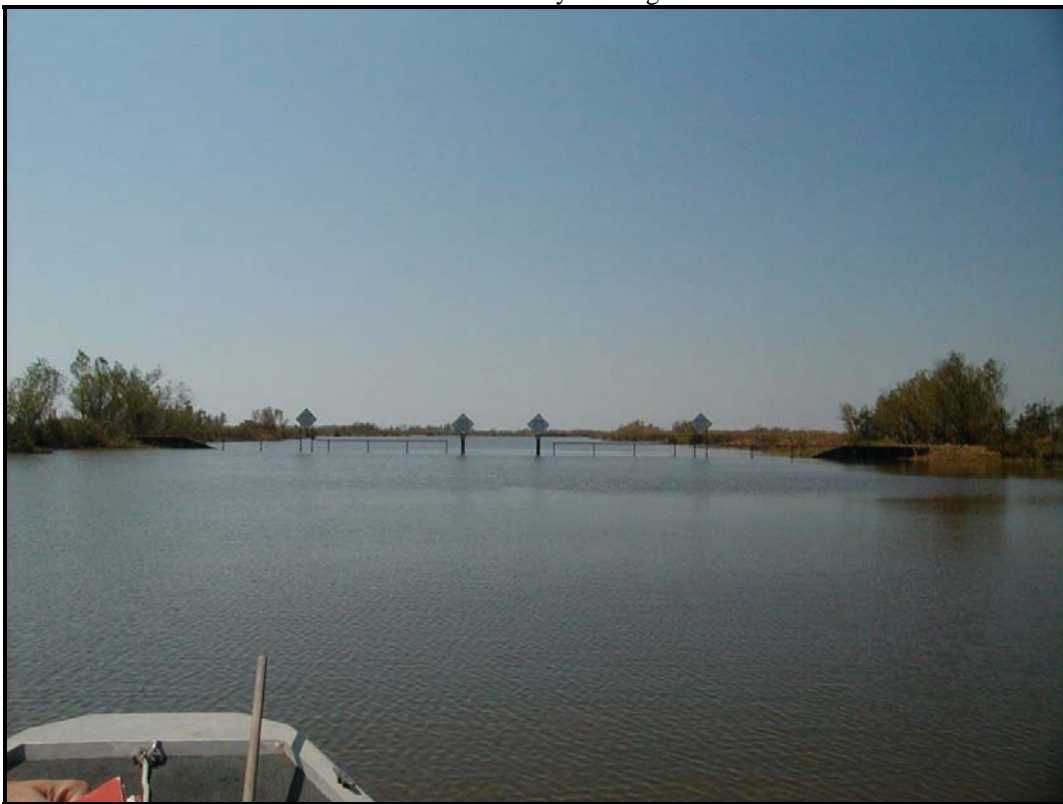
The structure is in excellent post-construction condition. The canal, between Humble Canal and the structure is beginning to silt in. This may or may not be a result of the hurricanes. It shouldn't, however, significantly affect the function of the structure. The Bayou Carlin structure and signage are stable. The coating on the sheet piles is rusting on this structure and will be monitored as well. (Photos: Appendix B, Photo 4)

**Photo 4**—Bayou Carlin Structure and signage

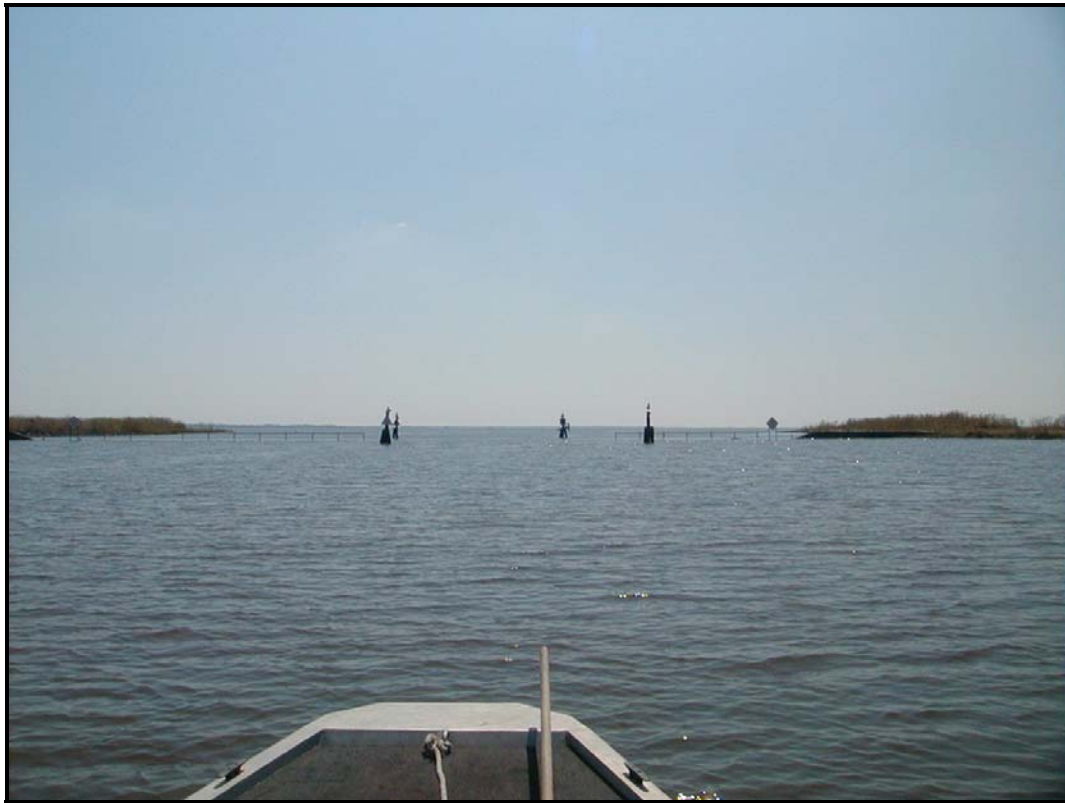
There is some minor rail damage on the structure. The rocks placed on the ends of the structure, as well as the signage are stable and suffered no damage. On the southern end of the rock on the eastern location closure, some erosion was noticed and will be monitored. The NW nav-aid sign is missing but this occurred before the storm. The shoreline at the south end of the rock riprap dike has experienced some erosion and the marsh area remaining is narrow and now subject to being breached allowing water to flow around the weir. Budget limitations will not allow this area to be addressed; however, Miami Corporation has proposed to address this area with mitigation dollars in the future. In the meantime, it will continue to be monitored. One of the staff gauges needs to be replaced. (Photos: Appendix B, Photos 5, 8).

**Photo 5**—missing sign and Nav-Aid lights at Humble Canal

| Item | Condition | Physical Damage | Corrosion | Photo # | Observations and Remarks |
|---|---|---|---|---|---|
| Steel Bulkhead / Caps | good | | | | 5 Some initial post construction rusting. No action needed. |
| Hardware | fair | | | | 5 Handrail on western side of structure is damaged. |
| USCG Lights | poor | | | | 5 NW nav-aid sign is missing and needs replacement. |

09/10 Description: Replace two staff gages, replace one nav.aid sign

| CONSTRUCTION DESCRIPTION: | Replace Nav. Aid sign at Humble Canal. | | | | | |

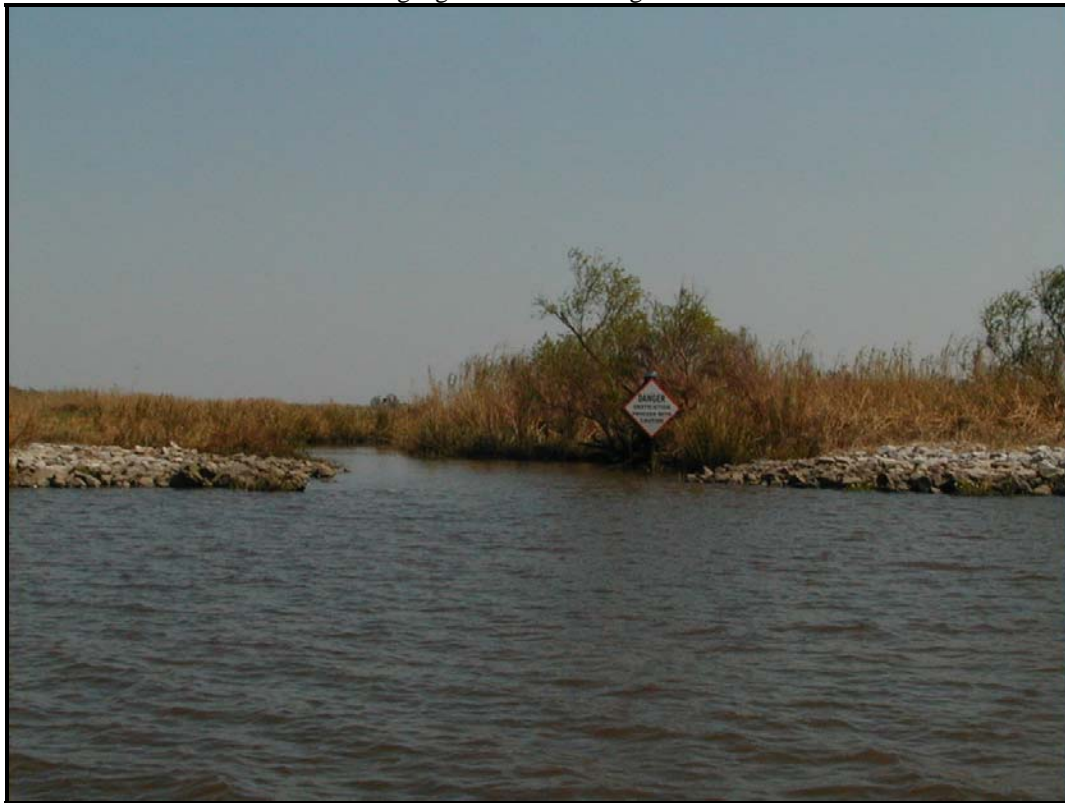
The dike has settled to an approximate average elevation of +2.0NAVD and survived the hurricane intact. Spoil placed behind the dike is nearly all gone. Rock placed across School Bus Bayou on the west side of Humble Canal is gone from the channel but the rock on the bank is still present and stable. This condition will be monitored. One warning sign on the foreshore dike was leaning and may need to be straightened. (Photos: Appendix B, Photos 6-7, 9-10).

**Photo 6**—eastern weir at School Bus Bayou

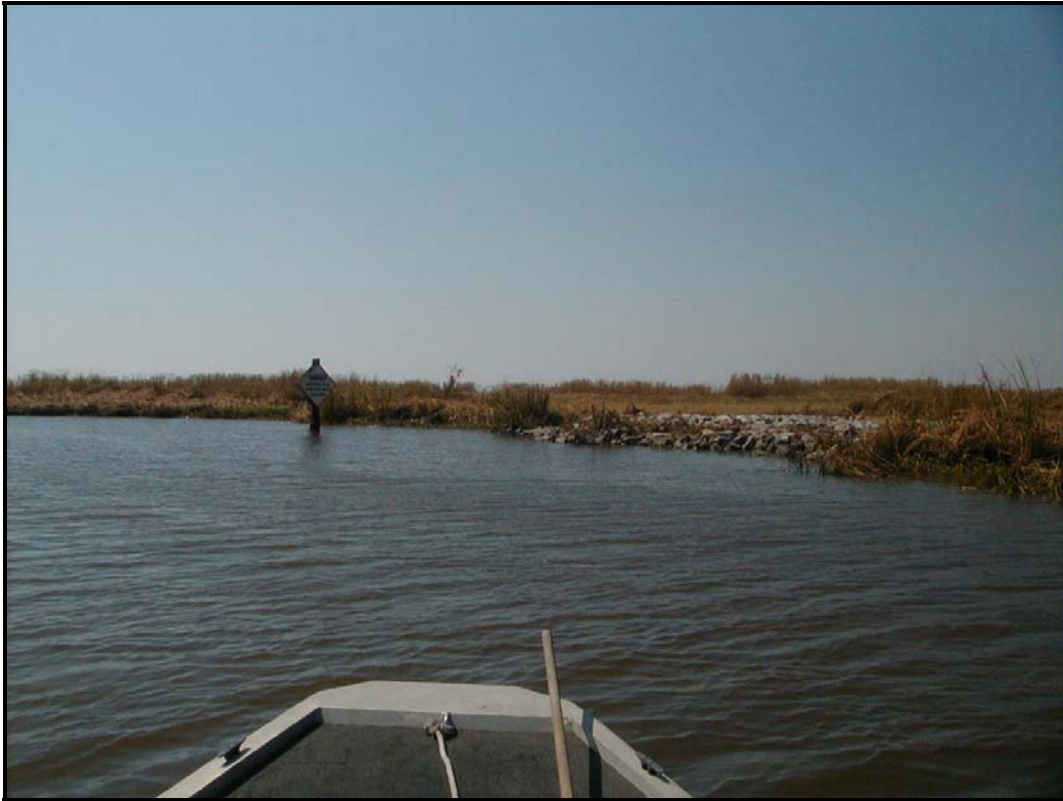
**Photo 7**—western weir at School Bus Bayou

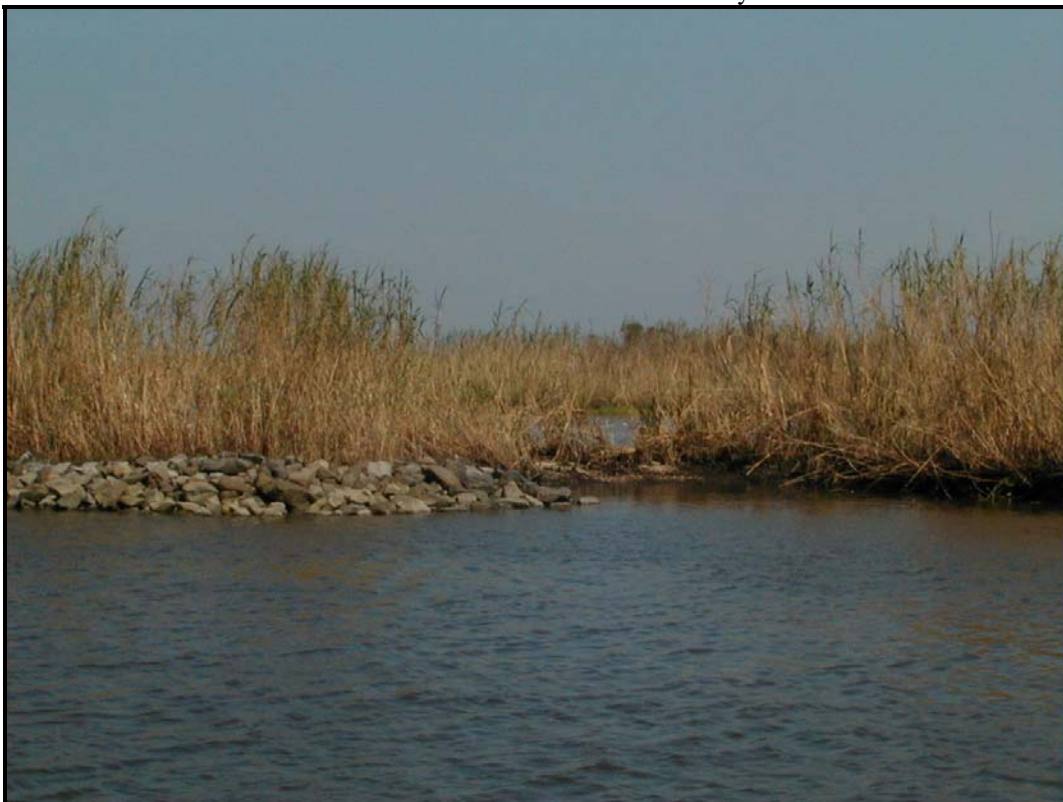
**Photo 8**— south end of rock dike at location closure near Humble Canal

| Item | Condition | Physical Damage | Corrosion | Photo # | Observations and Remarks |
|---|---|---|---|---|---|
| Rip Rap (fill) | fair | | | | 8 Some erosion on eastern closure, will be monitored |

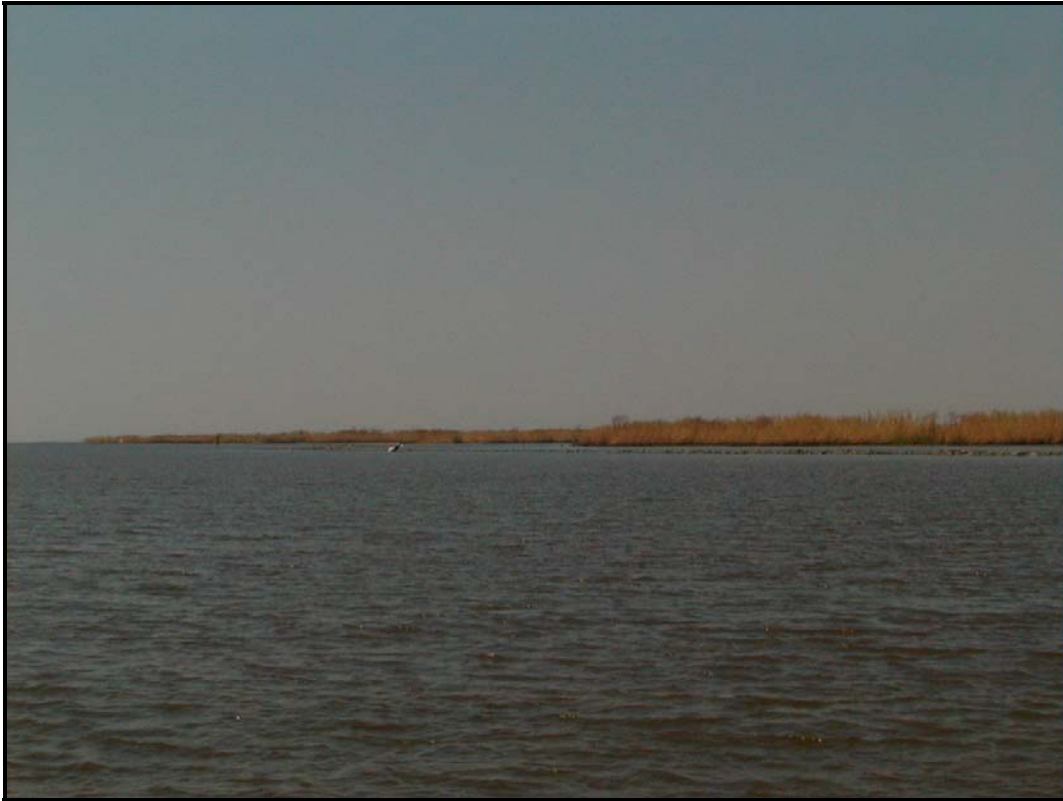
**Photo 9**—typical section of School Bus dike

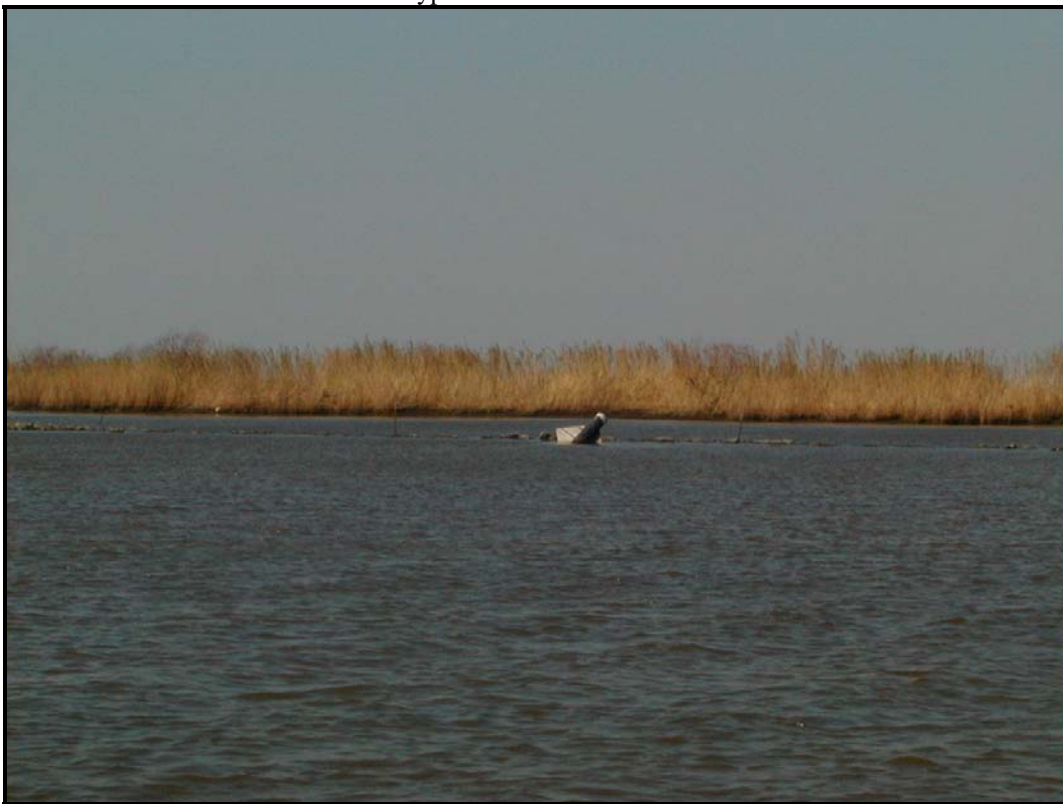
**Photo 10**— damaged warning sign on School Bus Bayou dike

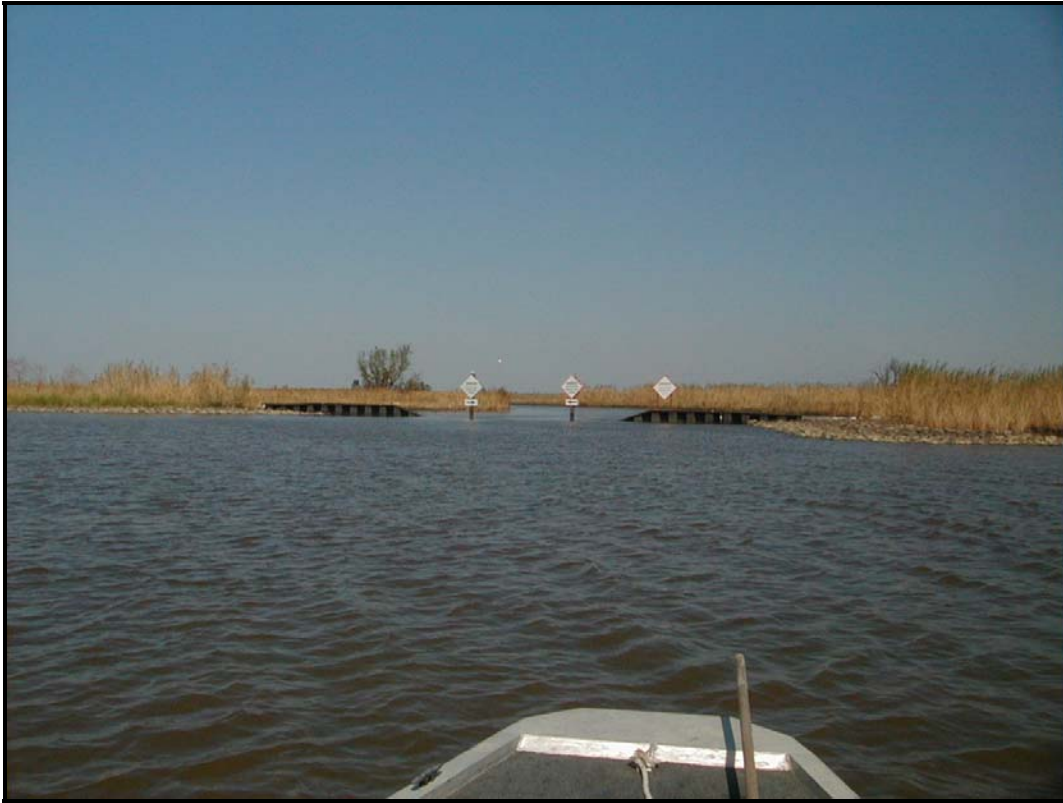
The Jackson Bayou structure and signage are stable. The coating on the sheet piles is rusting on this structure and will be monitored as well. The west warning sign is gone and will need to be replaced. (Photos: Appendix B, Photo 11).

**Photo 11**— missing warning sign on Jackson Bayou

| Item | Condition | Physical Damage | Corrosion | Photo # | Observations and Remarks |
|---|---|---|---|---|--|
| Steel Bulkhead / Caps | good | | | 11 | Some slight rusting of pile caps. West warning sign is missing |

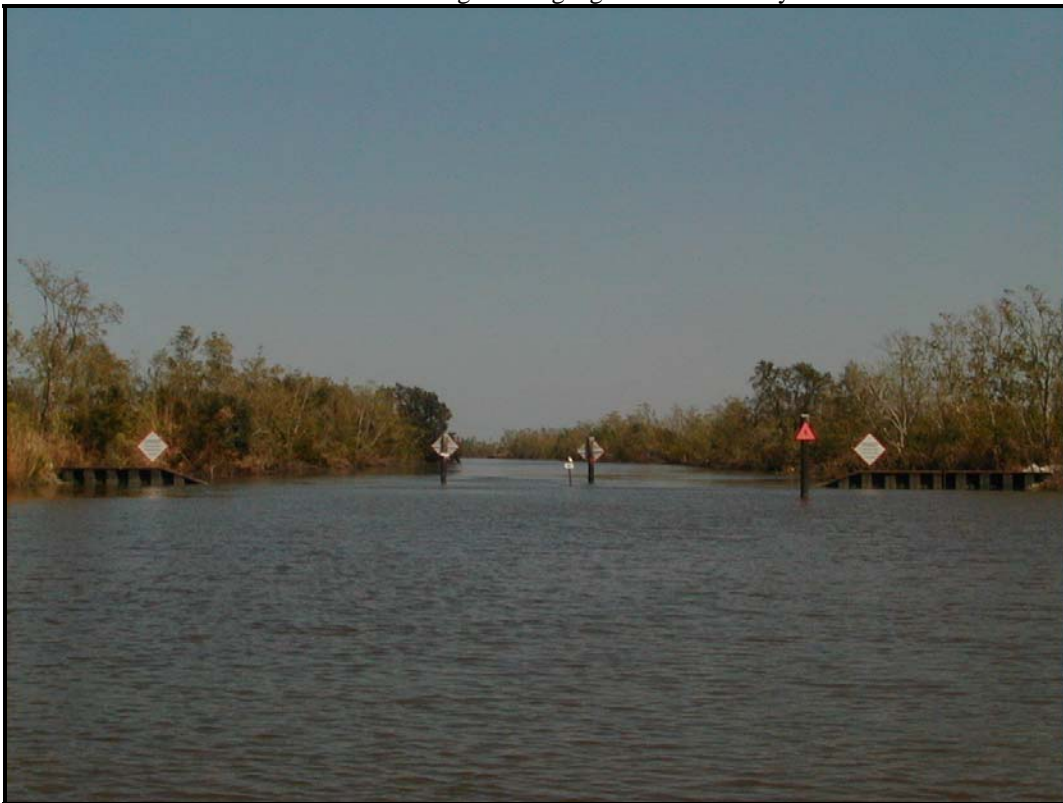
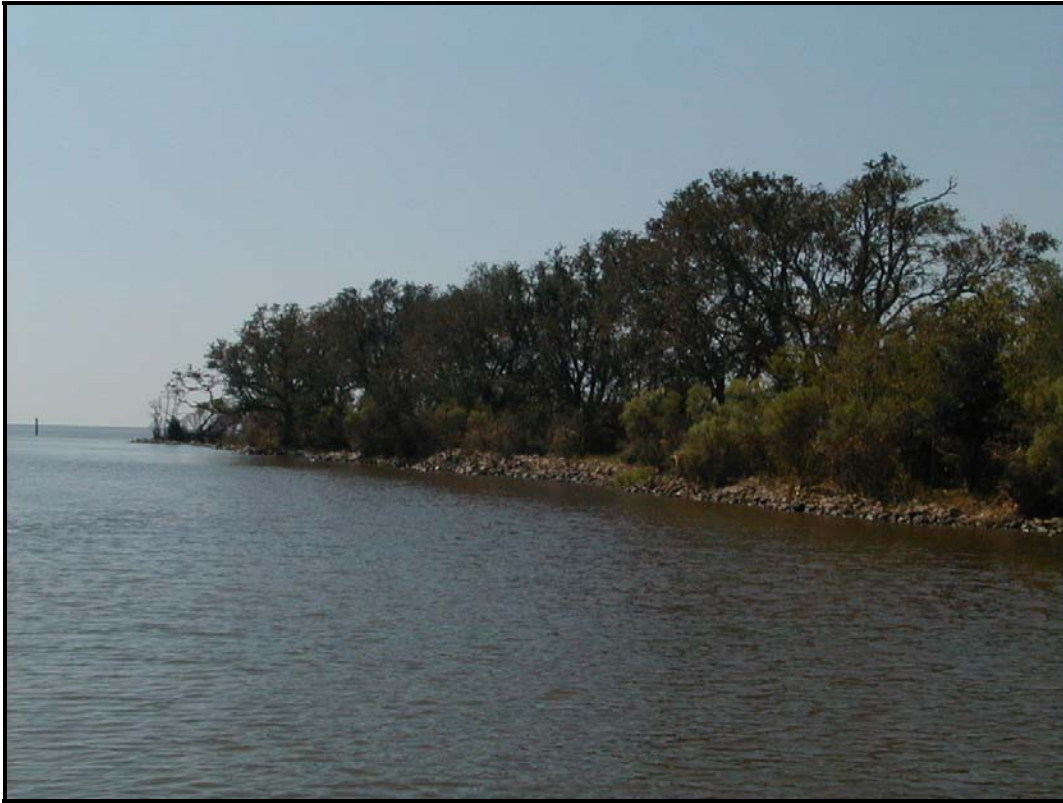
The western (green) navigational aid marker is gone and will need to be replaced. The coating on the sheet piles is rusting on this structure and will be monitored as well. One of the directional arrows is missing and will be replaced. (Photos: Appendix B, Photos 12-13).

**Photo 12**—British American Canal structure and signage

**Photo 13**—rock along British American Canal

| Item | Condition | Physical Damage | Corrosion | Photo # | Observations and Remarks |
|---|---|---|---|---|---|
| Steel Bulkhead / Caps | good | | | 12,13 | Some initial post construction rusting. No action needed. |

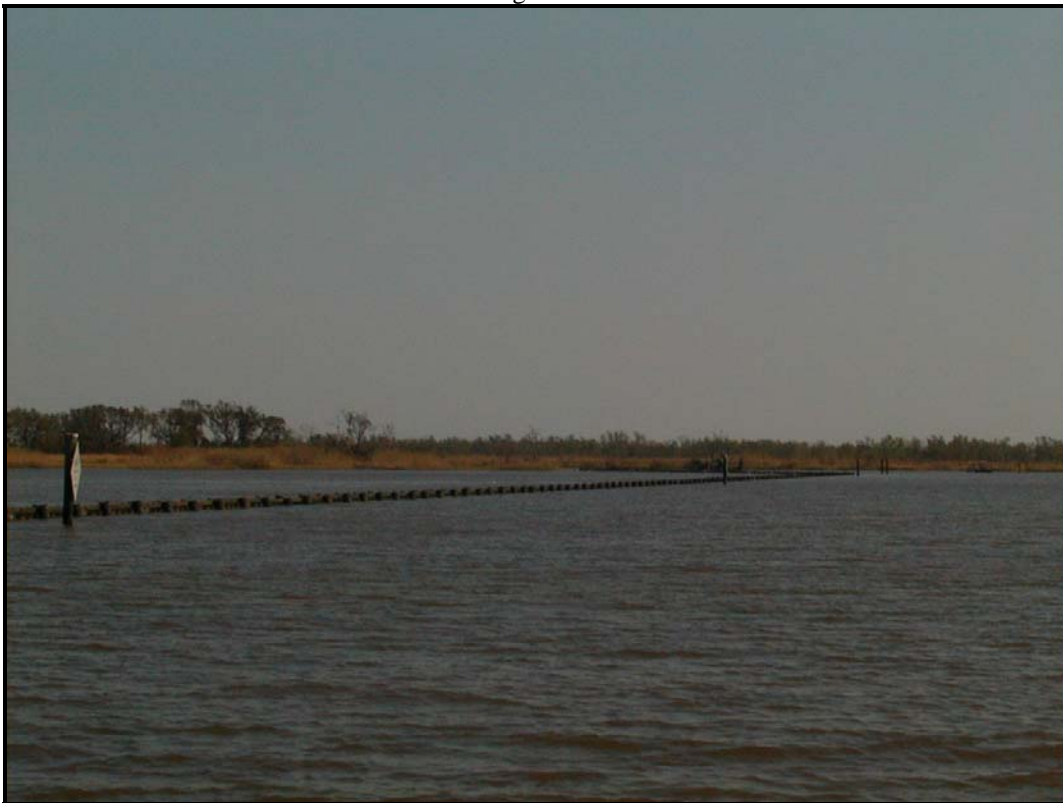
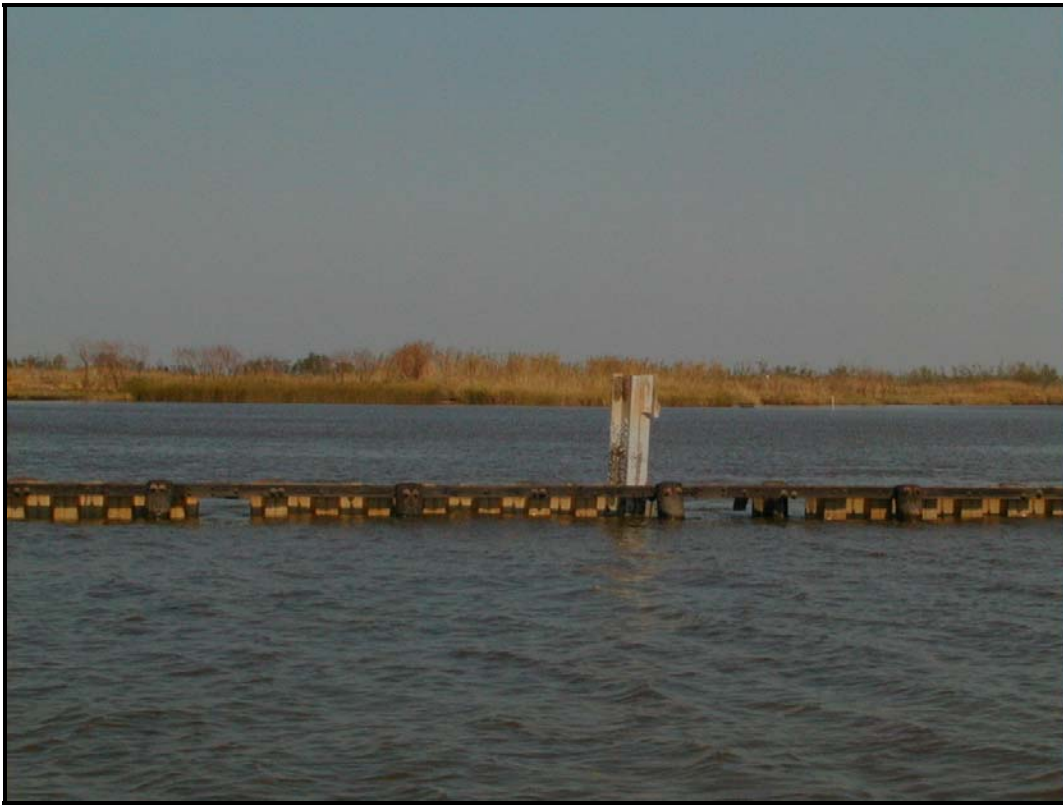
The PVC shoreline protection wall and signage are stable. Several pile caps are missing but no damage to the timber piles was noticed. Previous attempts to replace these pile caps have been unsuccessful. The piles will be monitored and should the need arise, will be painted or coated for protection. Sheet piles in several locations are missing. Replacement of these sheet piles may not be possible due to the rock at the base. There aren't enough missing to cause any problems as of yet. (Photos: Appendix B, Photos 14-15).

**Photo 14**—PVC wall near British American Canal

**Photo 15**—typical section of PVC wall

| Item | Condition | Physical Damage | Corrosion | Photo # | Observations and Remarks |
|---|---|---|---|---|---|
| PVC sheet piling / Caps | fair | | | 14,15 | PVC wall appears to be in post construction condition and holding up well. |
