**2006 Operations, Maintenance,
and Monitoring Report**

**Hopedale Hydrologic Restoration
(PO-24)**

State Project Number PO-24
Priority Project List 8

August 14, 2007
St. Bernard Parish

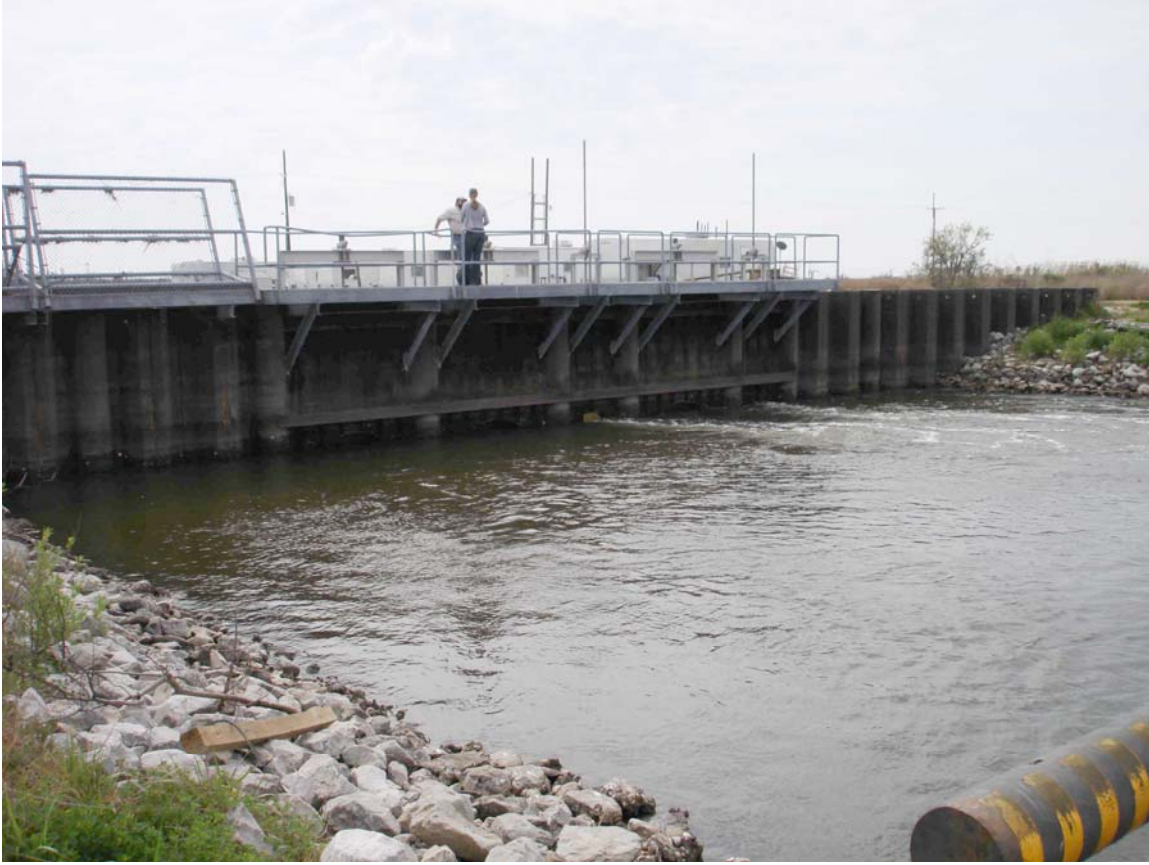
The transparent vinyl gate stem protective covers were missing on all five gates, and some of the chain link security fencing on the structure had been dislodged and was lying on the structure floor (Appendix A, Photo #1). The embankment adjacent to the structure was substantially eroded, and some of the upper bank rock protection around the

structure was displaced by the storm surge. It is estimated that 75 cubic yards of earthen material was eroded and 60 tons of class “B” stone was displaced.

Photo #1 – Water Control Structure. Standing on the East bank looking south. Note the damage to the railing and fencing.

The structure; however, is operational in its present condition. A maintenance contract is being designed to address the structure damage. The estimated cost of these repairs is:

- Repair all the damage mentioned in Section II d “Inspection Results.”

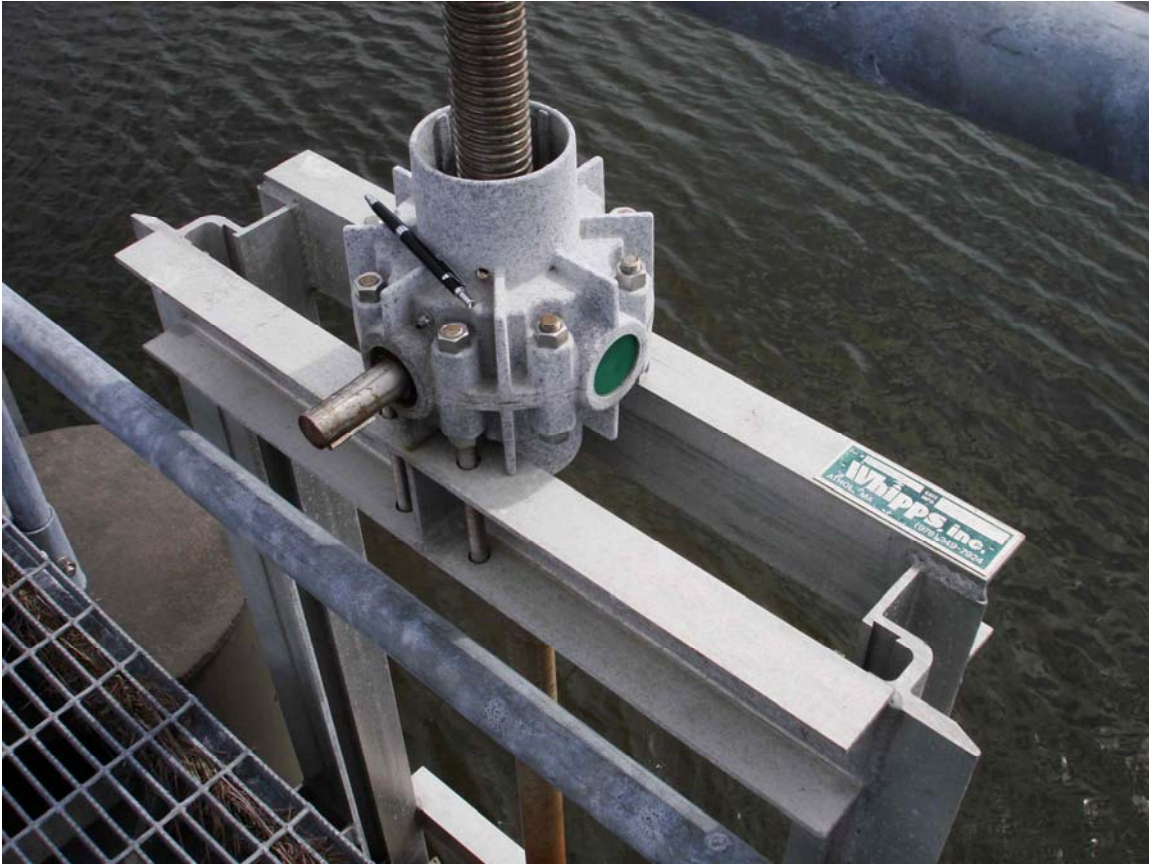
Photo #2 – Fish Gate Operator. The stem protective cover is missing and needs to be replaced on both fish gates and all three flap/slucice gates. A locking mechanism should be installed to prevent unauthorized operation of the gates.

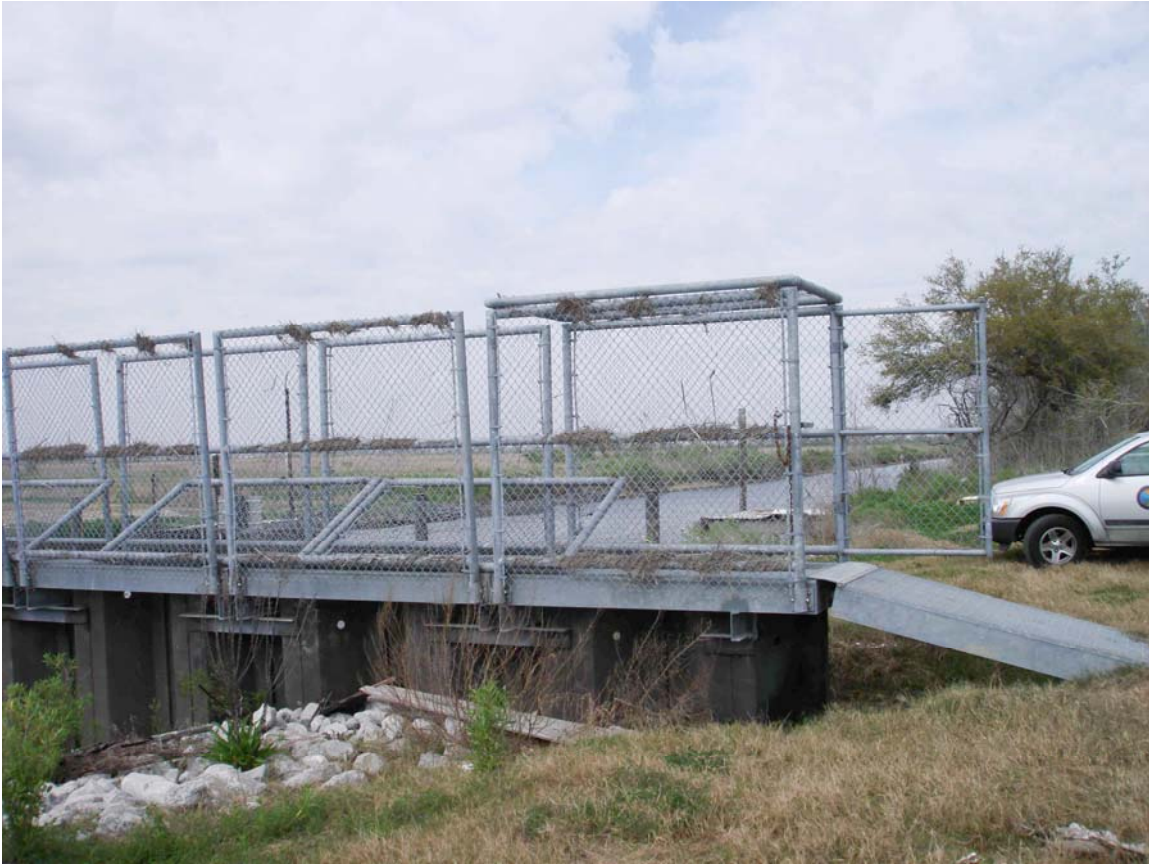
Photo #3 – Ramp and Entry. Standing on the East bank looking north. Note the damage to the railing and fencing and the scour around the end of the sheet pile wall.
