2007/2008 Annual Inspection Report

SWEET LAKE/ WILLOW LAKE HYDROLOGIC RESTORATION PROJECT (CS-11b)

State Project Number CS-11b
Priority Project List 5

May 1, 2008
Calcasieu Parish

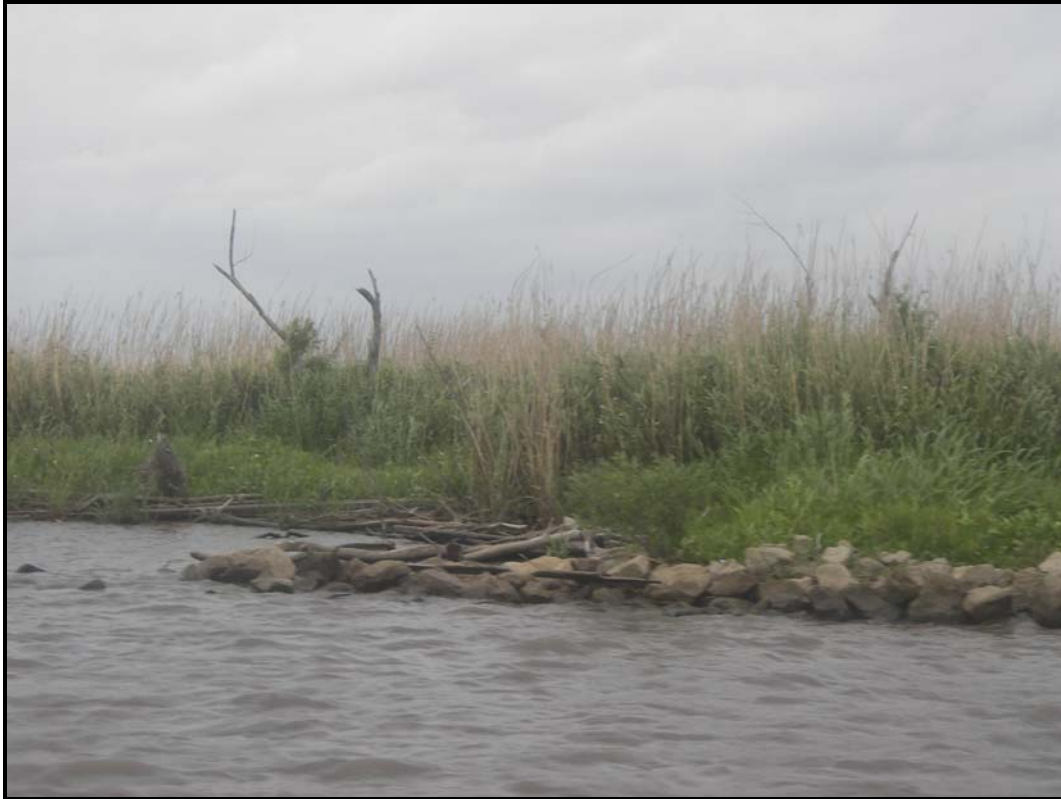
The dikes are in reasonably good condition. There are a few low places along the length of the rock dike with the most significant stretches along the open water areas adjacent to Sweet Lake along with an area approximately 50 feet wide along the very eastern end of the project area in which the dike appears to have been “pushed back” 10-12 feet apparently by a barge. There is another area approximately 4 feet wide in which the dike appears to have been removed by hunters or fishermen. Several settlement plates are either broken or leaning and are of no use. No gauges were available in the vicinity to determine water levels. The condition of the shallow water terraces feature of the project was unable to be determined due to high water conditions in Sweet Lake and Willow Lake. (Photos: Appendix B, Photos 1 & 2).

Photo No.1, Area of rock dike pushed back by barge.

The foreshore rock dike feature of the Sweet Lake/Willow Lake Hydrologic Restoration Project is in good condition and functioning as designed. The areas along the foreshore rock dike identified as being below constructed height were noted in previous inspections and will continue to be monitored to determine the need for a maintenance event.

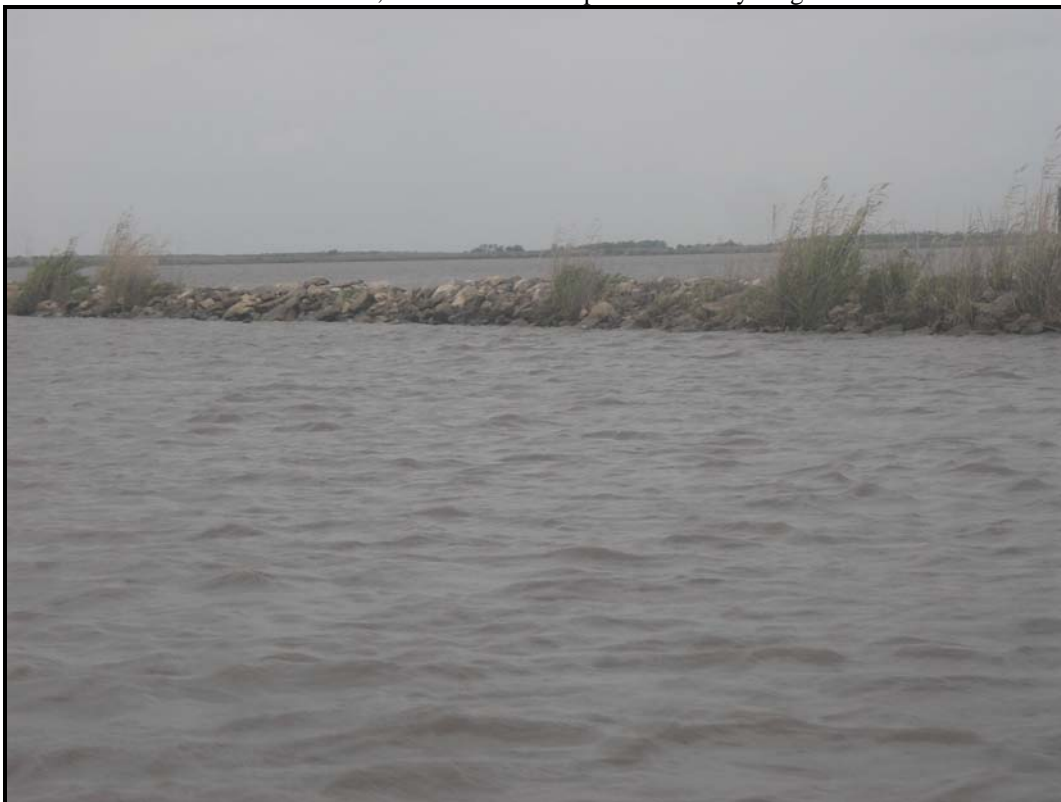
Photo No.2, Typical rock dike section.
